AKH FASHIONS LTD (EXTENSION)

133-134, Hemayetpur, Savar, Dhaka

15 December 2024

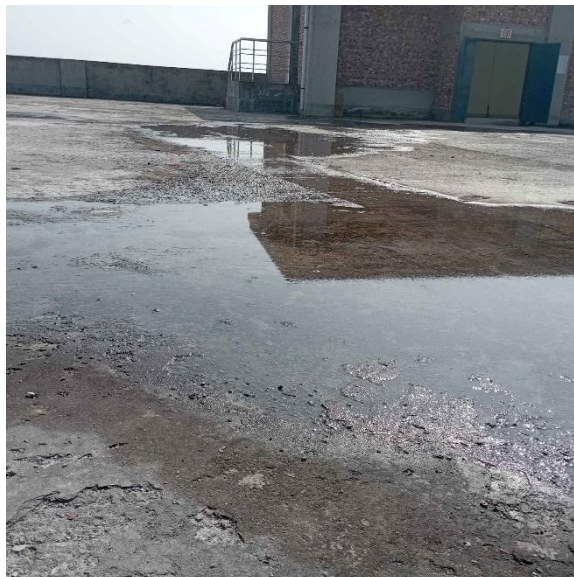
Observation 2: Water ponding on roof slab (Finished Goods Storage Building).

Description: Water ponding was found on the roof slab. The building engineer is required to improve the drainage system on the roof slab.

2.		Carry out the suggested remedial works.	within 6 months
3.	Water ponding on roof slab (Finished Goods Storage Building)	The building engineer is required to improve the drainage system on the roof slab.	within 6 months

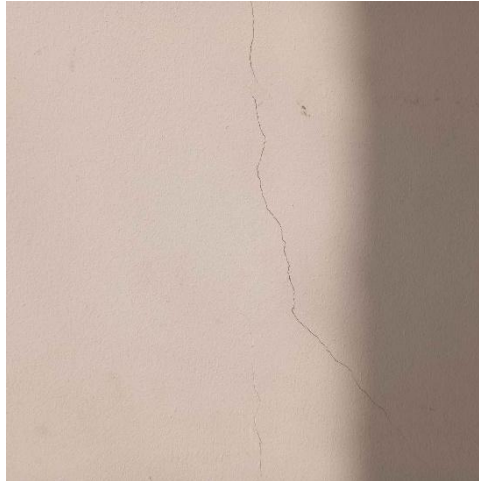
Observation 3: Crack on brick wall surface (Finished Goods Storage Building).

Description: A crack was found on the brick wall surface at the south stair. The building engineer is required to check the reason of crack and repair it with suitable method.

4.	Crack on brick wall surface (Finished Goods Storage Building)	The building engineer is required to check the reason of the crack and repair it with suitable method.	within 6 weeks

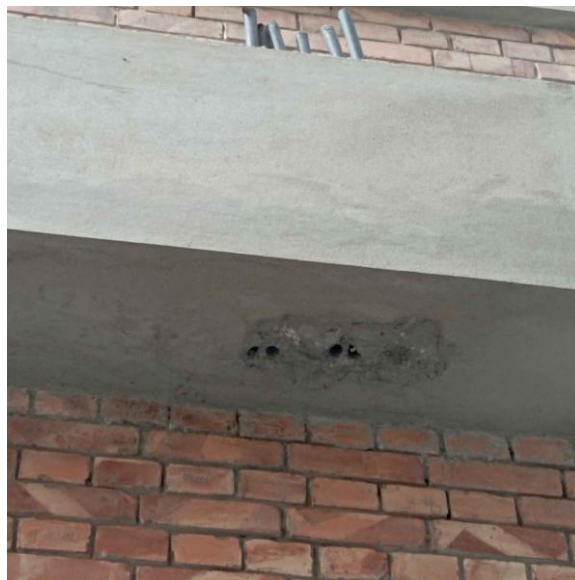
Observation 4: Holes on floor beam (Finished Goods Storage Building).

Description: Holes were observed on the floor beam (periphery south side). The building engineer is required to check the effect of holes and if required repair the hole with a suitable method.

5.	Holes on floor beam (Finished Goods Storage Building)	The building engineer is required to check the effect of holes and if required repair the hole with a suitable method.	within 6 weeks

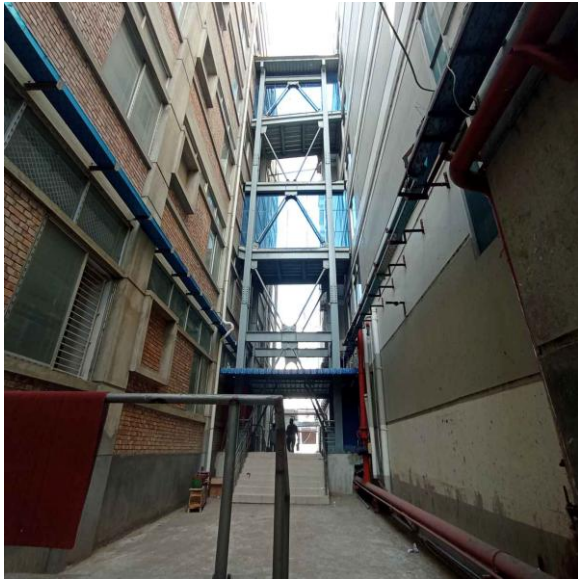
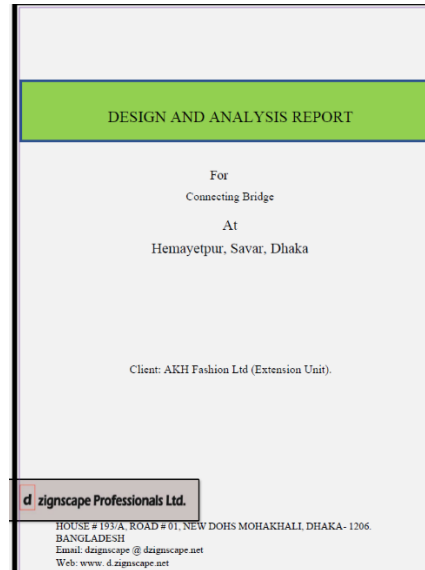
Observation 5: Lack of information in the design report. (Connecting bridge).

Description: The framing system is not defined (OMRF/IMRF/SMRF). No connection adequacy check is included. Also, the foundation adequacy check is not provided properly. The building engineer is required to update the design report and submit it to RSC for review.

6.	Lack of information in the design report. (Connecting bridge)	The building engineer is required to update the design report and submit it to RSC for review against lateral forces.	within 6 weeks

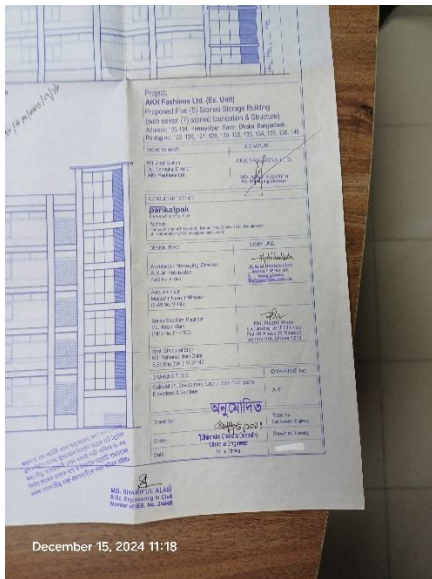
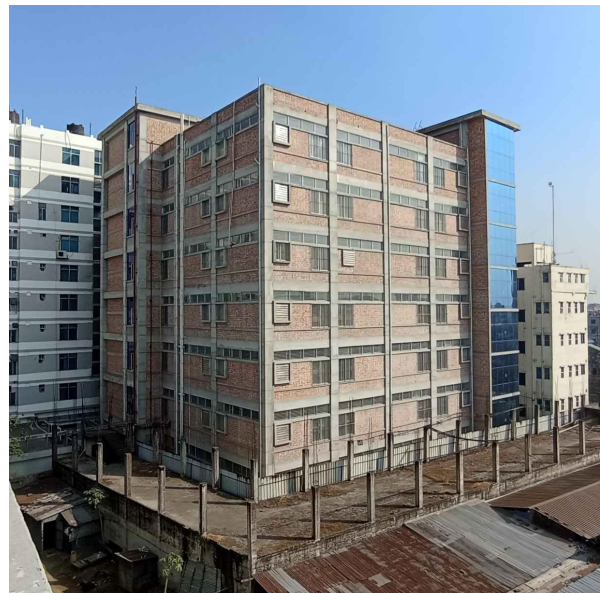
Observation 6: Updated building permit from local authority not available. (Finished Goods Storage Building).

Description: During the inspection, a building permit from the local authority was available for a 5-storied building (with a proposed 7-storied foundation & structure). However, the building was found 7-storied. The factory authority is required to collect updated building permits from the local authority for existing conditions.

7.		Carry out the suggested remedial works.	within 6 months
8.	Updated building permits from the local authority not available. (Finished Goods Storage Building)	The factory authority is required to collect updated building permits from the local authority for existing conditions.	within 6 months
