# Aliza Fashion Ltd (Extension)

Chaydana, National University, Gazipur-1704.

19 December 2024

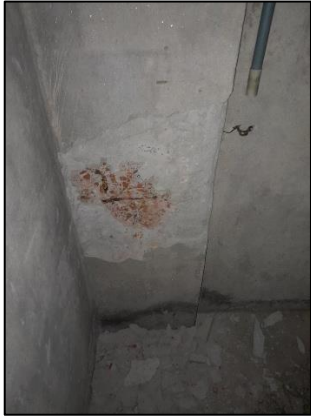
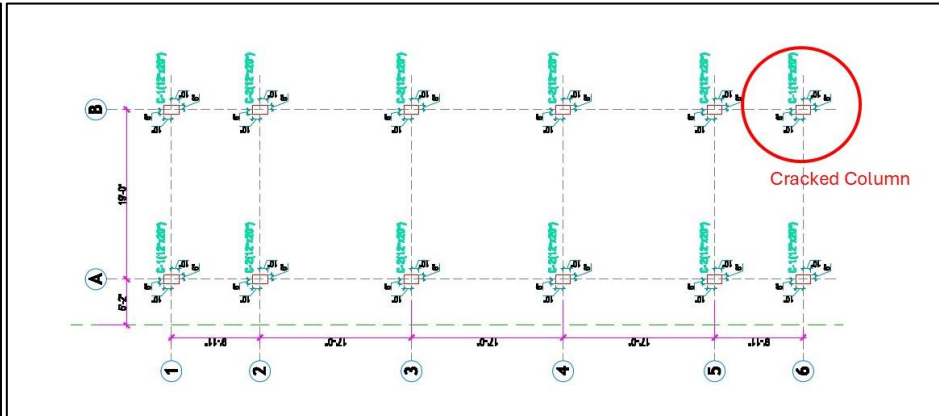
### Observation-01: Crack in the ground floor column. (Aliza Boiler Building)

**Description:** A crack was identified on the peripheral reinforced concrete column (Grid B-6) on the ground floor. The factory must immediately engage a structural consultant to investigate the identified cracks. The building engineer is required to prepare the investigation report with a detailed repair methodology and submit it to RSC for review.

| Item No | Observation | Action Plan | Timeline |
|---|---|---|---|
| 1. | Crack in the ground floor column. (Aliza Boiler Building) | The factory must immediately engage a structural consultant to investigate the identified cracks. | within 6 weeks |
| 2. | | Any necessary safety measures suggested by the consultant must be implemented immediately to ensure safety. | within 6 weeks |
| 3. | | The investigation report, along with a detailed repair methodology, must be submitted to RSC. | within 6 weeks |
| 4. | | The required remediation work must be completed after receiving acceptance from RSC. Pictorial evidence of the work progress should be shared with RSC. | within 6 months |

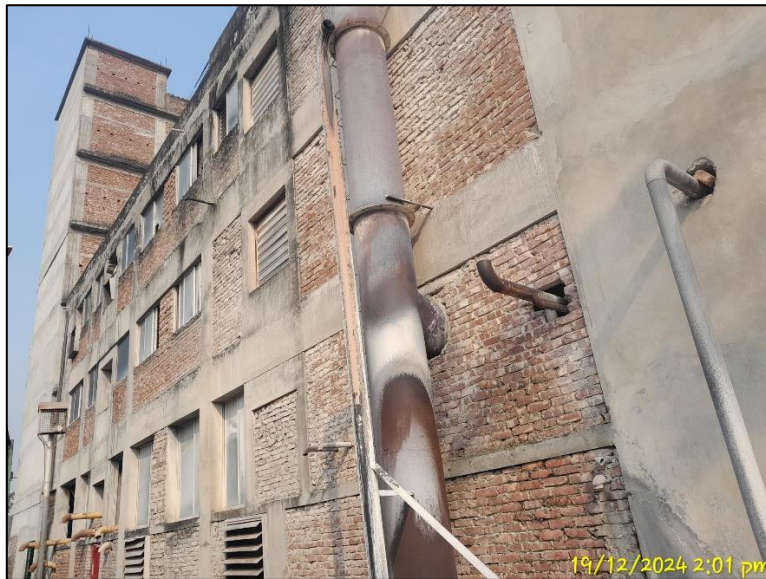
### Observation-02: Absence of design documents. (Aliza Boiler Building)

**Description:** As per BNBC, every building or structure designed shall have its design documents prepared following the provision of Section 1.9.1. The design document shall include a design report, and a set of structural drawings, which shall be prepared in compliance with section 1.9.1.1 and section 1.9.1.2 as per BNBC. At the time of inspection, the design report was not available which is required to be prepared in compliance with section 1.9.1.1 (part 6, BNBC).

| Item No | Observation | Action Plan | Timeline |
|---|---|---|---|
| 5. | Absence of design documents. (Aliza Boiler Building) | The building engineer is required to prepare the design documents in accordance with BNBC 1.9.1 and submit them to the RSC for review. | within 6 weeks |

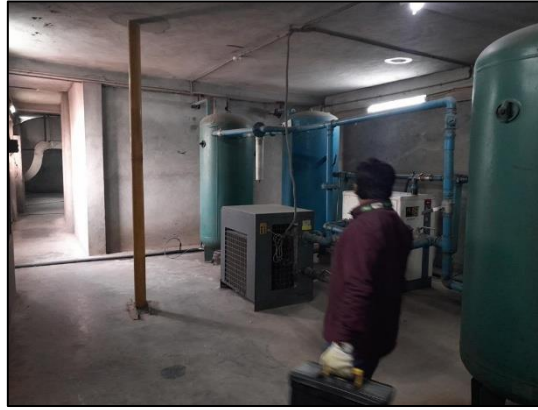
**Observation-03:** Lack of load management plan. (Aliza Boiler Building)

**Description:** During inspection, the load plan was not found posted. The building engineer is required to prepare the load plan & post the load plan on every floor.

| Item No | Observation | Action Plan | Timeline |
|---|---|---|---|
| 6. | Lack of load management plan. (Aliza Boiler Building) | The building engineer is required to prepare the load plan & implement management program (posting, marking, maintaining) | within 6 weeks |

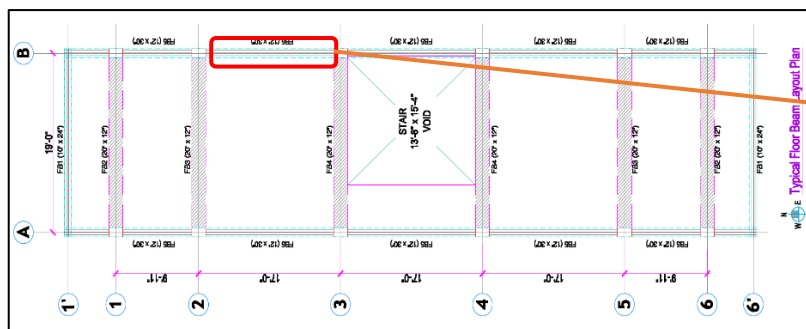
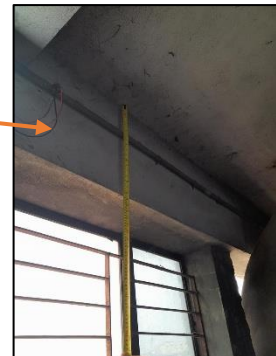
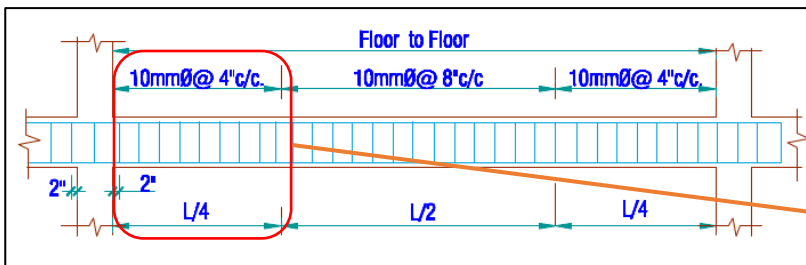
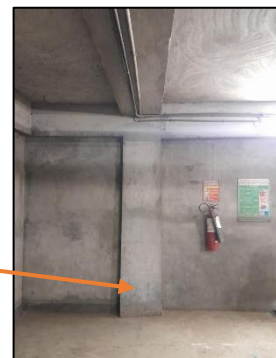
**Observation-04:** Discrepancy in as-built drawing. (Aliza Boiler Building)

**Description:** During the inspection, column tie spacing was found 150 mm instead of 100 mm. Also, the periphery beam FB-5 was found 300X500 mm whereas it was mentioned as 300X750 mm in the as-built drawing. The building engineer is required to update the as-built drawing which reflects the on-site condition.

| Item No | Observation | Action Plan | Timeline |
|---|---|---|---|
| 7. | Discrepancy in as-built drawing. (Aliza Boiler Building) | The building engineer is required to update the as-built drawing which reflects the on-site condition. | within 6 weeks |

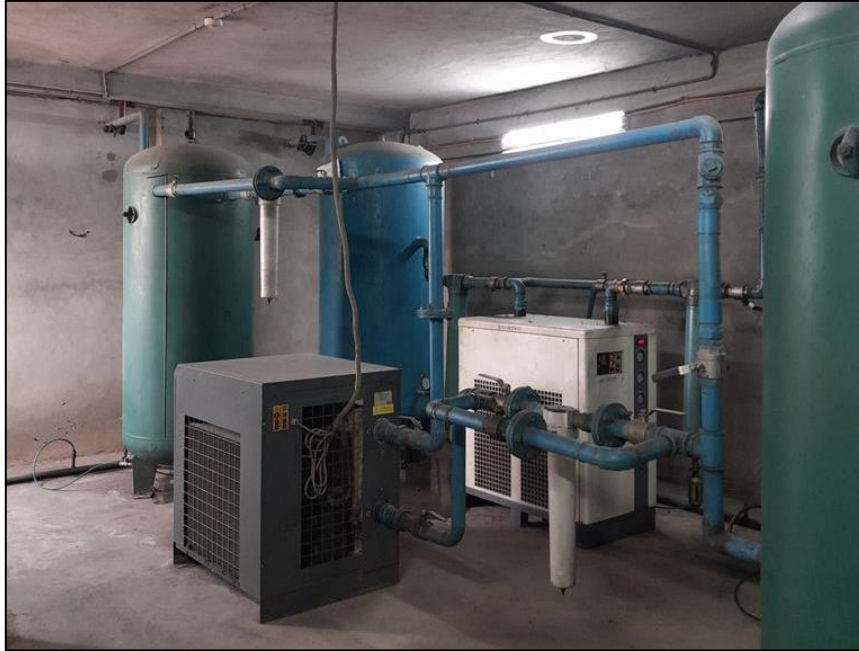
**Observation-05:** Vibration on the 1<sup>st</sup> and 2<sup>nd</sup> floor. (Aliza Boiler Building)

**Description:** During the inspection, floor vibration was observed on the 1<sup>st</sup> and 2<sup>nd</sup> floors. The building engineer is required to remediate the floor vibration by installing the rubber pad under the compressor machine.

| Item No | Observation | Action Plan | Timeline |
|---|---|---|---|
| 8. | Vibration on the 1 <sup>st</sup> and 2 <sup>nd</sup> floor. (Aliza Boiler Building) | The building engineer is required to remediate the floor vibration by installing the rubber pad under the compressor machine. | within 6 weeks |

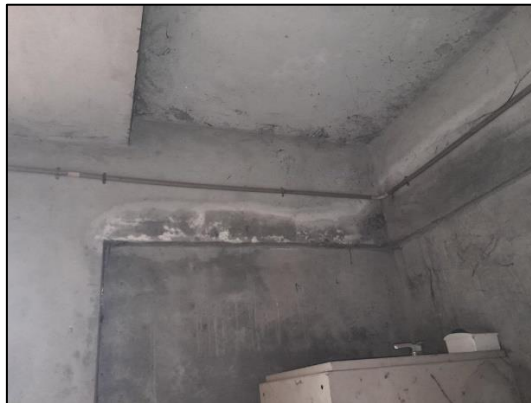
**Observation-06:** Dampness found on beam. (Aliza Boiler Building)

**Description:** During inspection, dampness was found on the 2<sup>nd</sup> floor beam. The building engineer is required to repair dampness with a suitable method.

| Item No | Observation | Action Plan | Timeline |
|---|---|---|---|
| 9. | Dampness found on beam. (Aliza Boiler Building) | The building engineer is required to seal the source of water and repair dampness with a suitable method. | within 6 weeks |

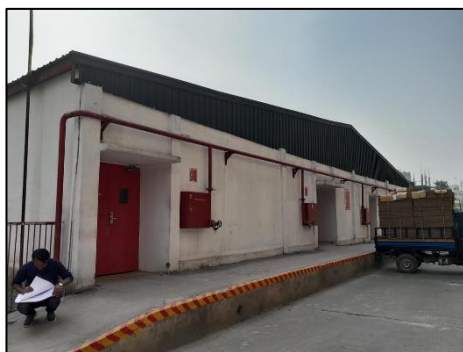
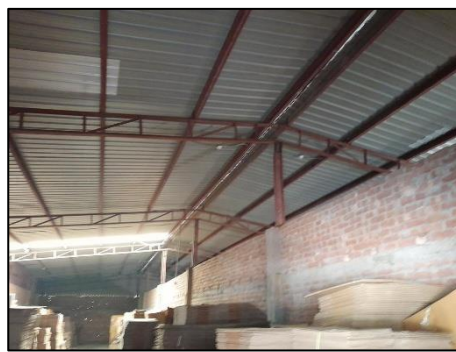
**Observation-07: Lack of lateral stability and inadequate member size. (Jute & Empty Cartoon Shed)**

**Description:** During the inspection, load transfer media along the long direction was found missing. Also, member sizes & their connections were found to be inadequate. The building engineer is required to check the connection and member adequacy and propose remediation accordingly.

| Item No | Observation | Action Plan | Timeline |
|---|---|---|---|
| 10. | Lack of lateral stability and inadequate member size. (Jute & Empty Cartoon Shed) | The building engineer is required to check the connection and member adequacy and propose remediation accordingly. | within 6 weeks |

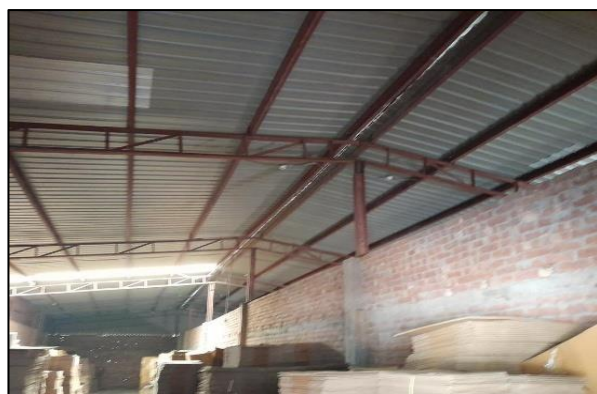
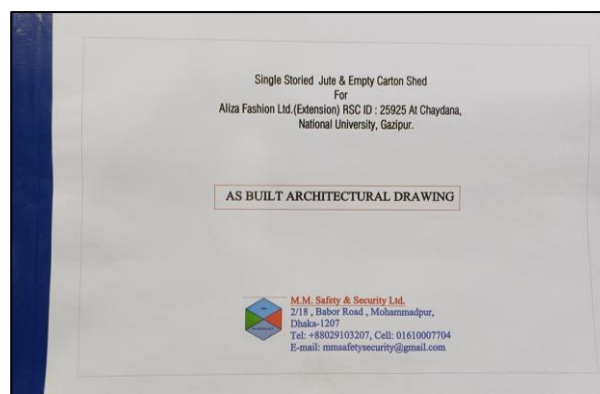
**Observation-08: Discrepancy in the as-built drawing. (Jute & Empty Cartoon Shed)**

**Description:** During inspection, the as-built drawing was not matched with the on-site condition. Moreover, the as-built drawing was incomplete. The building engineer is required to update the as-built drawing which reflects the credible on-site condition.

| Item No | Observation | Action Plan | Timeline |
|---|---|---|---|
| 11. | Discrepancy in the as-built drawing. (Jute & Empty Cartoon Shed) | The building engineer is required to update the as-built drawing which reflects the credible on-site condition. | within 6 weeks |

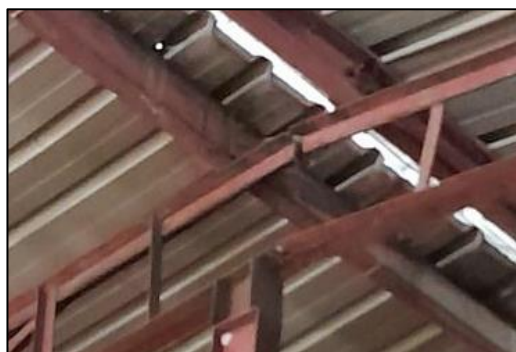
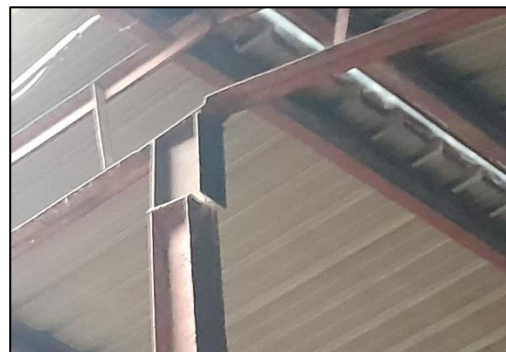
**Observation-09: Discontinued steel column & truss member. (Jute & Empty Cartoon Shed)**

**Description:** During the inspection, a discontinued steel column & truss was found on-site. The building engineer is required to check the member's adequacy & propose remediation.

| Item No | Observation | Action Plan | Timeline |
|---|---|---|---|
| 12. | Discontinued steel column & truss member. (Jute & Empty Cartoon Shed) | The building engineer is required to check the roof truss/member adequacy & propose proper remediation. | within 6 weeks |

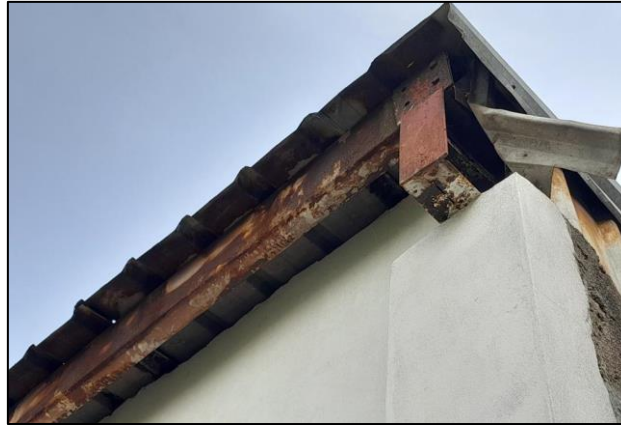
**Observation-10:** Corrosion on steel member. (Jute & Empty Cartoon Shed)

**Description:** During the inspection, corrosion was found in the steel member. The building engineer is required to remove the corrosion and provide anti corrosive coating to the steel members.

| 13. | Corrosion on steel member.<br>(Jute & Empty Cartoon Shed) | The building engineer is required to repair corrosion with a suitable method. | within 6 weeks |

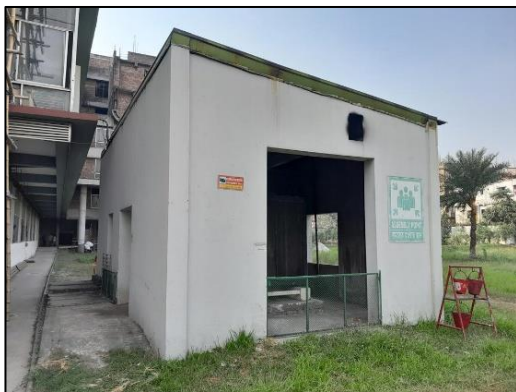
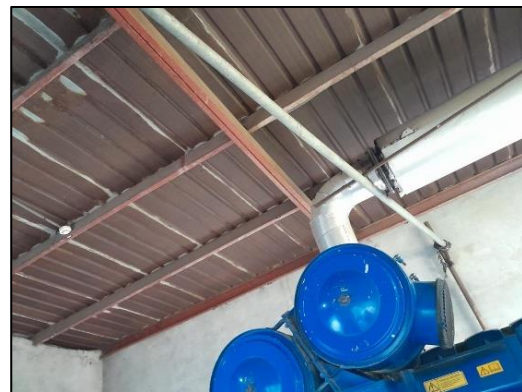
**Observation-11:** Lack of lateral stability and inadequate member size. (Aliza Generator Shed)

**Description:** Lack of lateral stability system observed in the shed. The building engineer is required to prepare a safety check report according to the Accord Building Standard to address this issue.

| 14. | Lack of lateral stability and inadequate member size.<br>(Aliza Generator Shed) | The building engineer is required to prepare a safety check report according to the Accord Building Standard to address this issue. | within 6 weeks |

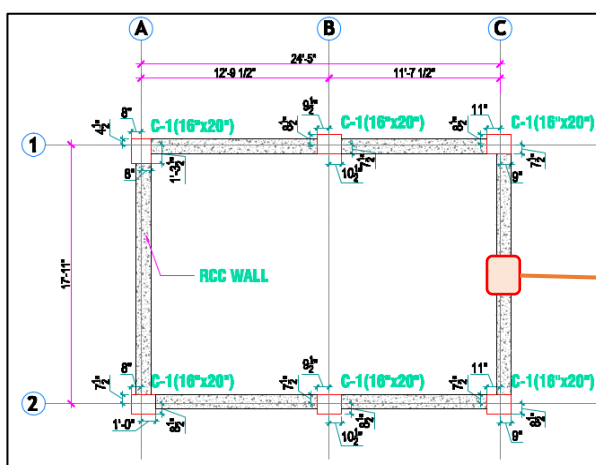
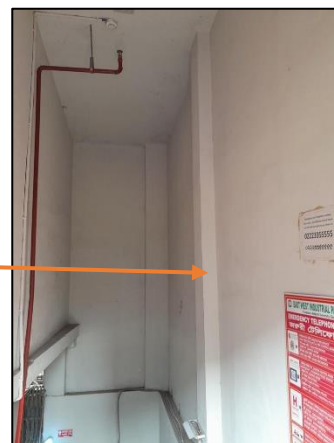
**Observation-12:** Discrepancy in as-built drawing. (Fire Pump House)

**Description:** An extra RC column (250X250 mm) was found on grid-C. The building engineer is required to update the as-built drawing which reflects the credible on-site condition.

| 15. | Discrepancy in as-built drawing. (Fire Pump House) | The building engineer is required to update the as-built drawing which reflects the credible on-site condition. | within 6 weeks |

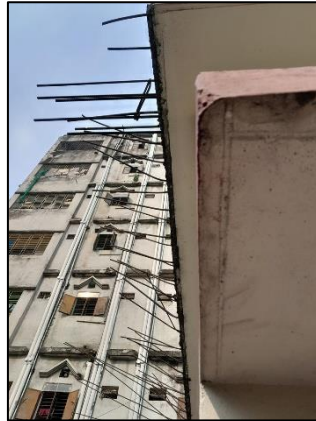
**Observation-13:** Exposed rebar. (Fire Pump House)

**Description:** During inspection, the exposed rebar was found on the roof slab. The building engineer is required to apply anti-rust proof coating on exposed rebar.

| 16. | Exposed rebar. (Fire Pump House) | The building engineer is required to apply anti-rust proof coating on exposed rebar. | within 6 weeks |

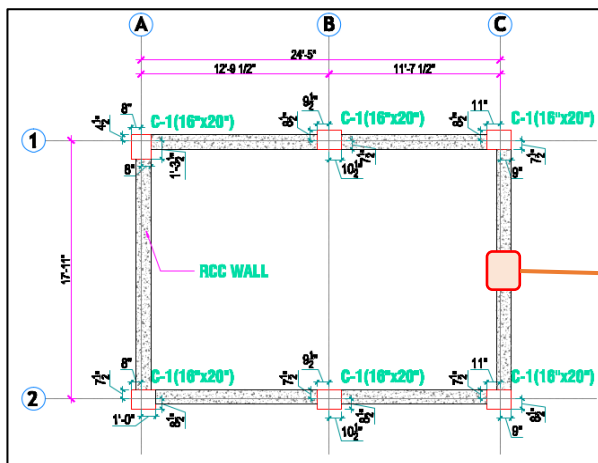
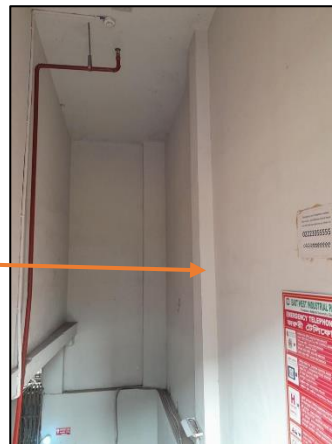
**Observation-14:** A slender column was found. (Fire Pump House)

**Description:** An extra RC column (250X250 mm) was found on grid-C. The length of the column is 4.0 m in height. The building engineer is required to check the slenderness effect of the column & propose remediation accordingly.

| 17. | A slender column was found.<br>(Fire Pump House) | The building engineer is required to check the slenderness effect of the column & propose remediation. | within 6 weeks |
