# TM Jeans Ltd

12 November 2024

## 2. Observation

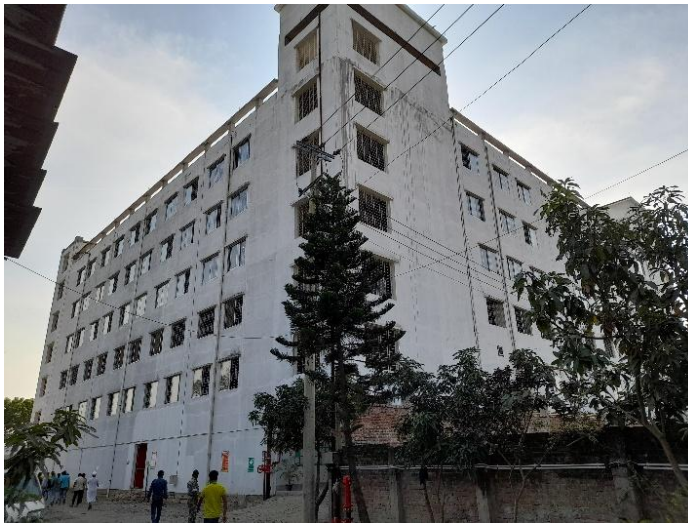
### Observation-01: Lack of Engineering Assessment report. (Building 1: Production Building)

**Description:** During the inspection, only fourteen concrete cylinder test reports were available for the production building. Among the cylinder test reports: seven sets from the foundation, two sets from the column, two sets from the Slab and three sets from the Beam. The provided number of cylinder test reports does not meet the requirement of frequency of test as per BNBC-2020: Part-6: Section 5.12.2. In FEA model 4000psi concrete strength has been considered for column and 3500 psi for the beam & slab.

The building engineer is required to provide the adequate number of existing cylinder strength data test reports otherwise verify the in-situ concrete strength by taking at least four numbers of concrete cores from the lower tier of columns. Also, concrete cores need to be taken from the beam and slab at least four numbers based on concrete type.

As per BNBC, every building or structure designed shall have its design documents prepared in accordance with the provision of Section 1.9.1. The design document shall include a design report, and a set of structural drawings, which shall be prepared in compliance with section 1.9.1.1 and section 1.9.1.2 as per BNBC.

However, the building engineer is required to prepare a full set of Engineering Assessment (EA) documents considering the capacity of structural members, floor use, in-situ material strength, and actual site condition.

| Item No. | Observation | Action Plan | Timeline |
|---|---|---|---|
| 1 | Lack of Engineering Assessment report.<br>(Building 1: Production Building) | The building engineer is required to prepare the Engineering Assessment (EA) based on design/in-situ material strength. Submit EA to RSC for further review. | within 6 weeks |
| 2 | Lack of Engineering Assessment report.<br>(Building 1: Production Building) | Provide the adequate number of existing cylinder strength data test reports otherwise verify in-situ concrete strength from column, beam and slab by taking at least 4 cores from each. | within 6 weeks |
| 3 | Lack of Engineering Assessment report.<br>(Building 1: Production Building) | Carry out remedial work if required. | within 6 months |

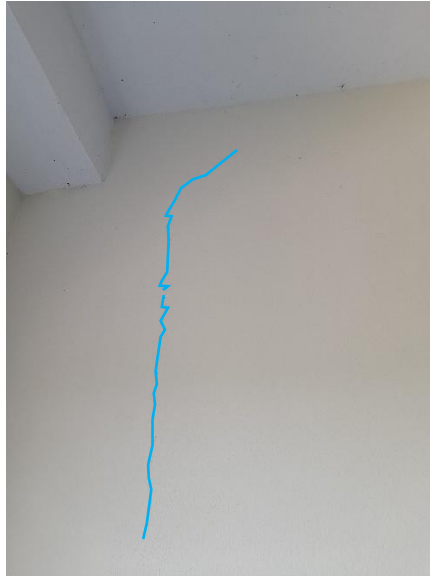
**Observation-02:** Cracks in masonry wall. (Building 1: Production Building)

**Description:** Cracks in masonry walls were observed at stair case. The building engineer is required to identify the reason for the cracks and repair with suitable method.

| Item No. | Observation | Action Plan | Timeline |
|---|---|---|---|
| 4 | Cracks in masonry wall.<br>(Building 1: Production Building) | The building engineer is required to identify the reason for the cracks and repair with suitable method. | within 6 weeks |

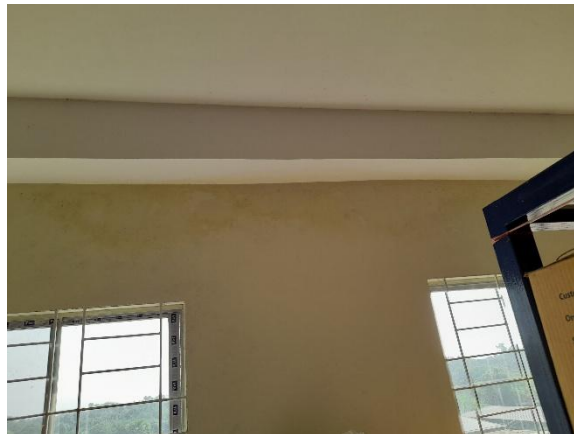
**Observation-03:** Dampness in the brick wall. (Building 1: Production Building)

**Description:** During the inspection, dampness was observed on the brick wall. The building engineer is required to seal the source of water and repair the damp areas with a suitable method.

| Item No. | Observation | Action Plan | Timeline |
|---|---|---|---|
| 5 | Dampness in the brick wall.<br>(Building 1: Production Building) | The building engineer is required to seal the source of water and repair the damp areas with a suitable method. | within 6 weeks |

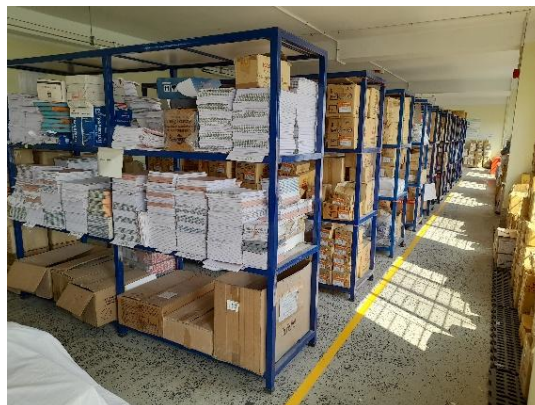
**Observation-04:** Non-structural elements were not found anchored or braced.  
(Building 1: Production Building).

**Description:** Steel racks were found unbraced and not anchored. Building engineer is required to anchor or brace the non-structural elements.

| Item No. | Observation | Action Plan | Timeline |
|---|---|---|---|
| 6 | Non-structural elements were not found anchored or braced<br>(Building 1: Production Building). | Building engineer is required to anchor or brace all the non-structural elements (steel racks) | within 6 weeks |

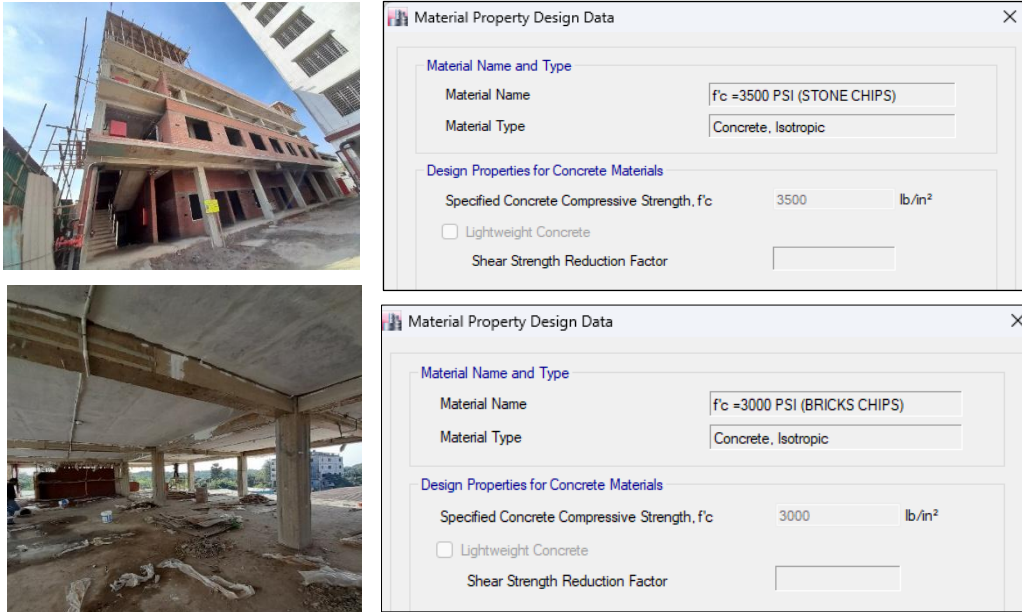
**Observation-05:** Lack of Engineering Assessment report. (Building 2: Medical, Childcare & Dining Building).

**Description:** During the inspection only one sets of concrete cylinder test report from footing was available for Building-2. The provided number of cylinder test reports does not meet the requirement of test frequency as per BNBC-2020: Part-6: Section 5.12.2. In FEA model 3500 psi concrete strength has been considered for the column and 3000 psi for the beam & slab.

The building engineer is required to provide the adequate number of existing cylinder strength data test reports otherwise verify the in-situ concrete strength by taking at least four numbers of concrete cores from the lower tier of columns. Also, concrete cores need to be taken from the beam and slab at least four numbers based on concrete type.

As per BNBC, every building or structure designed shall have its design documents prepared in accordance with the provision of Section 1.9.1. The design document shall include a design report, and a set of structural drawings, which shall be prepared in compliance with section 1.9.1.1 and section 1.9.1.2 as per BNBC.

However, the building engineer is required to prepare a full set of Engineering Assessment (EA) documents considering the capacity of structural members, floor use, in-situ material strength, and actual site condition.

| Item No. | Observation | Action Plan | Timeline |
|---|---|---|---|
| 7 | Lack of Engineering Assessment report. (Building 2: Medical, Childcare & Dining Building) | The building engineer is required to prepare the Engineering Assessment (EA) based on design/in-situ material strength. Submit EA to RSC for further review. | within 6 weeks |
| 8 | Lack of Engineering Assessment report. (Building 2: Medical, Childcare & Dining Building) | Provide the adequate number of existing cylinder strength data test reports otherwise verify in-situ concrete strength from column, beam and slab by taking at least 4 cores from each. | within 6 weeks |
| 9 | Lack of Engineering Assessment report. (Building 2: Medical, Childcare & Dining Building) | Carry out remedial work if required. | within 6 months |

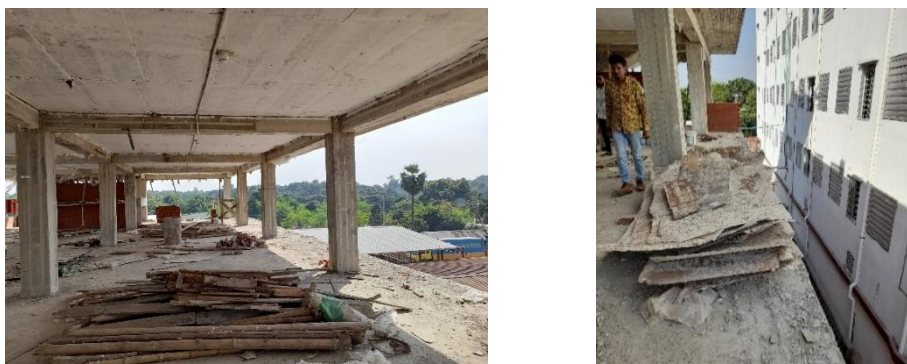
**Observation-06:** Falling hazard risk on 2<sup>nd</sup> floor. (Building 2: Medical, Childcare & Dining Building)

**Description** Railings/barriers were missing at 2<sup>nd</sup> floor level. Also the construction materials was found stored at edge of the slab that may cause serious injuries if fall down. The building engineer is required to provide railing/barrier at 2<sup>nd</sup> floor.

| Item No. | Observation | Action Plan | Timeline |
|---|---|---|---|
| 10 | Falling hazard risk on 2nd floor.<br>(Building 2: Medical, Childcare & Dining Building) | The building engineer is required to provide railing/barrier at 2 <sup>nd</sup> floor. | within 6 weeks |

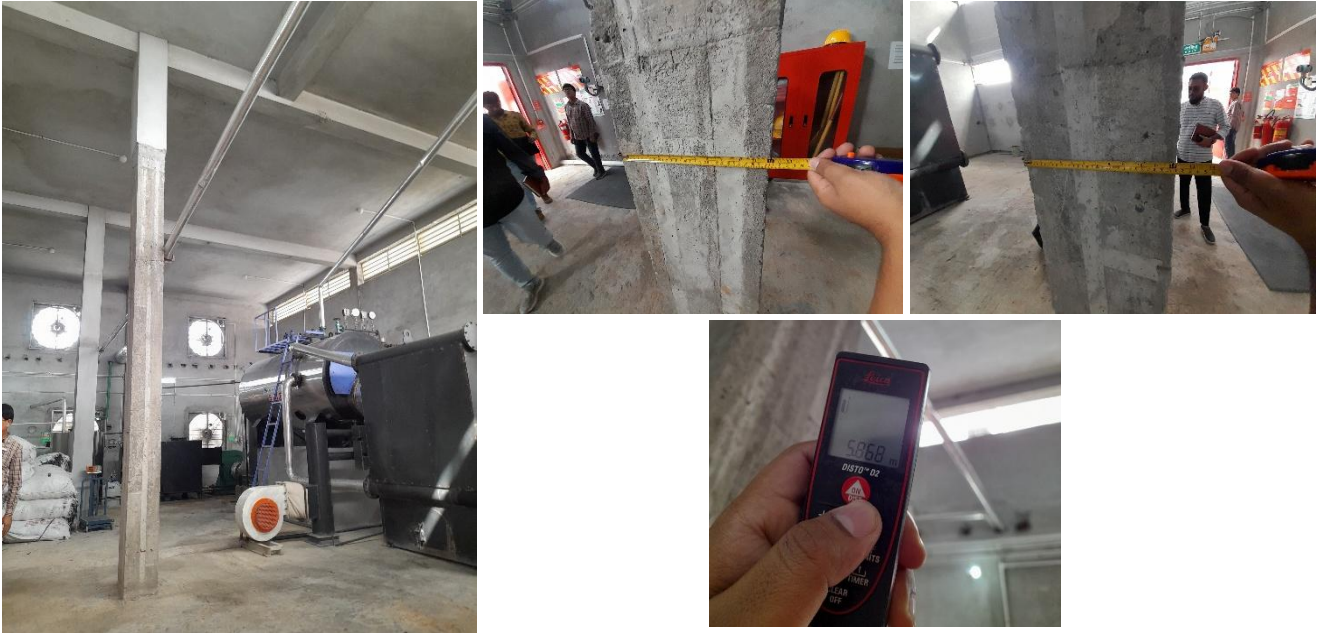
**Observation-07:** Column seems to be slender (Building 3: Utility Building)

**Description:** Ground floor columns are 5.86 m in length and 300X300 mm in size. The  $KL/r = 33.83$ ; indicates that the columns are slender. So, the building engineer is required to check the adequacy of the column for the slenderness.

Also, the building engineer is required to prepare a full set of Engineering Assessment (EA) for the structure.

| 11 | Column seems to be slender (Building 3: Utility Building) | The building engineer is required to prepare the Engineering Assessment (EA) document for the structure and submit to RSC for review. | within 6 weeks |
| 12 | Column seems to be slender (Building 3: Utility Building) | Carry out remedial work if required. | within 6 months |

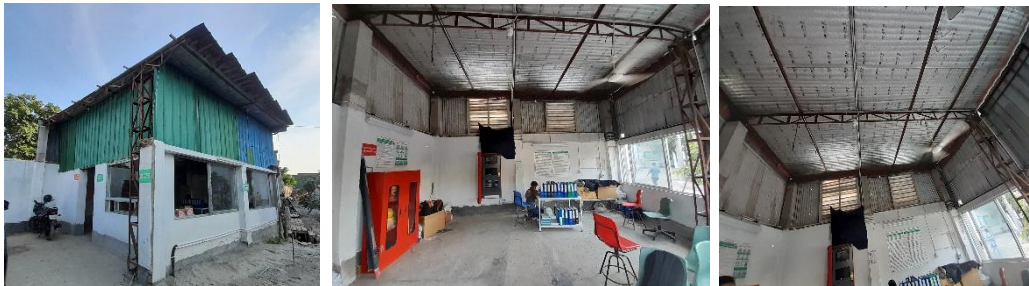
**Observation-08:** Lack of as-built drawing. (Building 4: Security Post)

**Description:** This is a single-storied steel truss roof structure supported by RC column and steel lattice column. The as-built drawings were not available for the structure. The building engineer is required to survey the whole structure and prepare accurate as-built drawing.

| 13 | Lack of as-built drawing. (Building 4: Security Post) | The building engineer is required to survey the full structure and update the as-built drawings. | within 6 weeks |

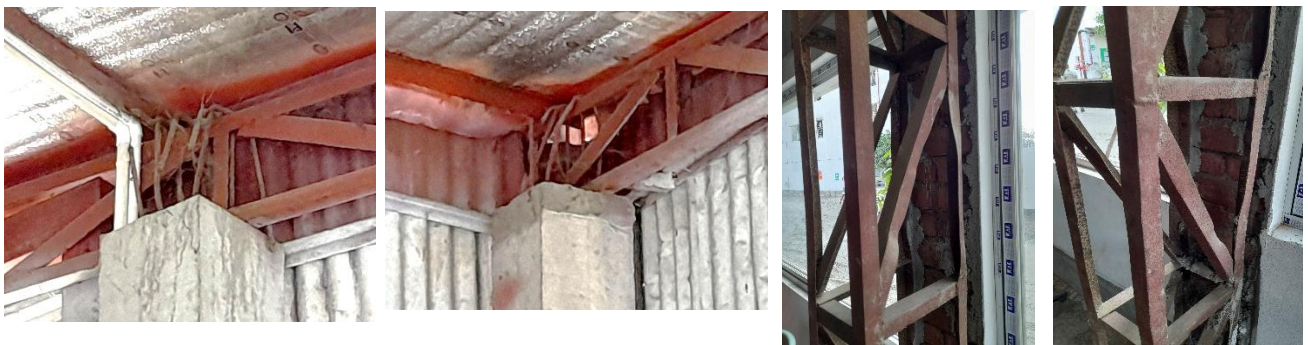
**Observation-09:** Non-engineered connection and distorted members. (Building 4: Security Post)

**Description:** The connection between the RC column and truss found to be non-engineered. Also distorted member of the lattice column was found. Building engineer is required to develop engineered connection and check the adequacy of lattice column. Submit required calculations and remedial drawing to RSC as part of Safety Check Report.

| 14 | Non-engineered connection and distorted members. (Building 4: Security Post) | Building engineer is required to develop engineered connection and check the adequacy of lattice column. Submit required calculations and remedial drawing to RSC as part of Safety Check Report. | within 6 weeks |

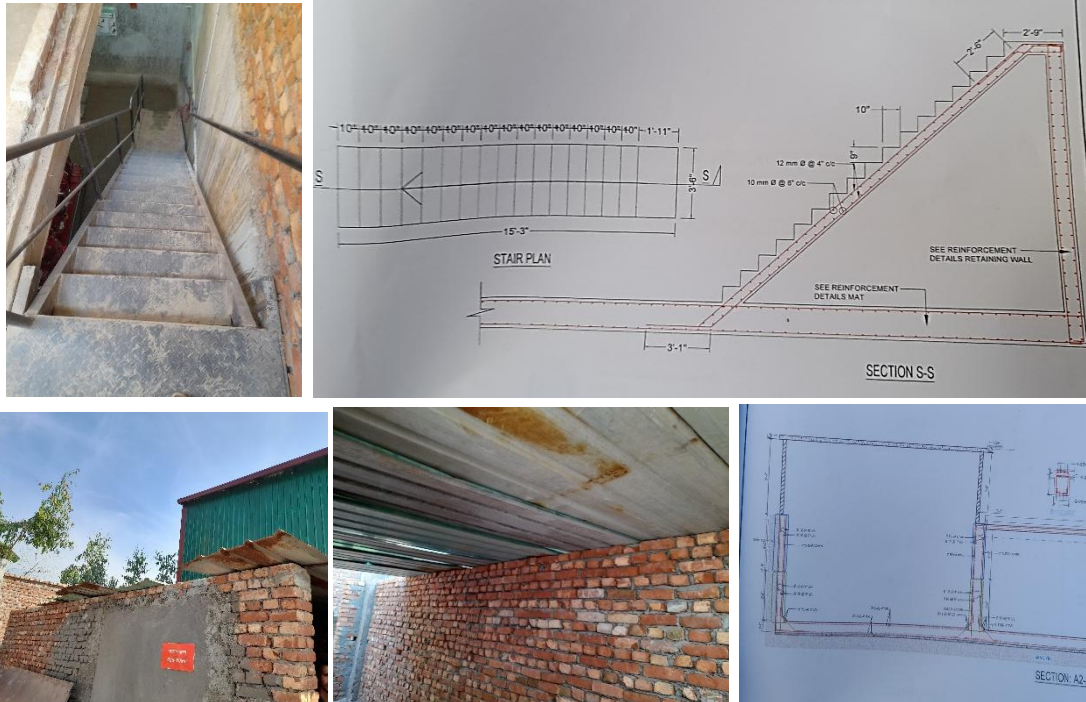
**Observation-10: Mismatch in provided as-built drawing. (Building 5: Fire Pump Room)**

**Description:** During the inspection, steel stair was found at fire pump room. But in the provided as-built drawing, RC stair has been shown. Also RC roof slab has been shown in drawing but light weight steel roof was found. The building engineer is required to update the full set of as built drawing.

| 15 | Mismatch in provided as-built drawing. (Building 5: Fire Pump Room) | The building engineer is required to survey the full structure and update the as-built drawings. | within 6 weeks |

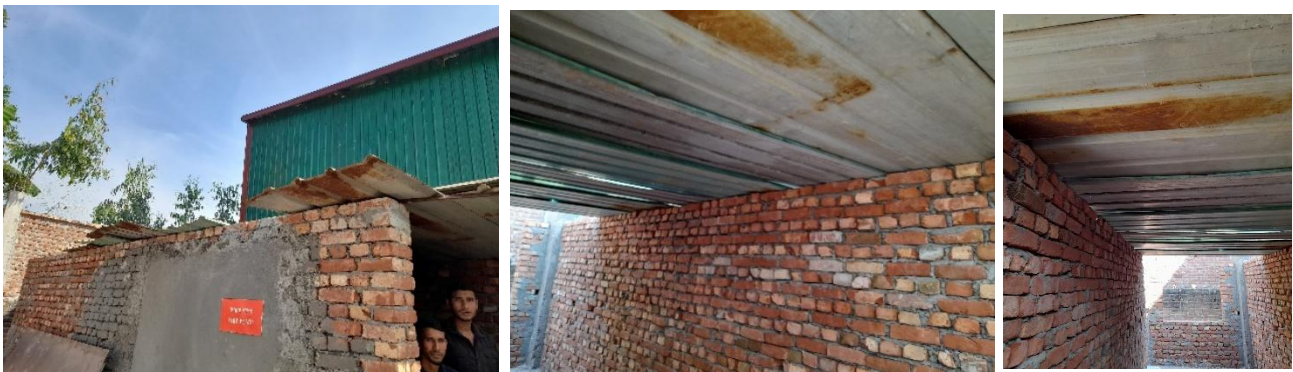
**Observation-11: Light-weight non-engineered steel roof (Building 5: Fire Pump Room)**

**Description:** The steel roof of the fire pump room is non-engineered shed. Also lack of connection with the brick wall. Building engineer is required to re-place the shed with engineered shed and develop proper connection. Check the adequacy of the steel shed and connection against the uplift capacity. Submit required calculations and remedial drawing for the steel shed to RSC as part of Safety Check Report.

| 16 | Light-weight non-engineered steel roof (Building 5: Fire Pump Room) | The building engineer is required to replace the shed with an engineered shed and develop the proper connection. Check the adequacy of the steel shed and connection uplift. Submit required calculations and remedial drawings to RSC as part of the Safety Check Report. | within 6 weeks |

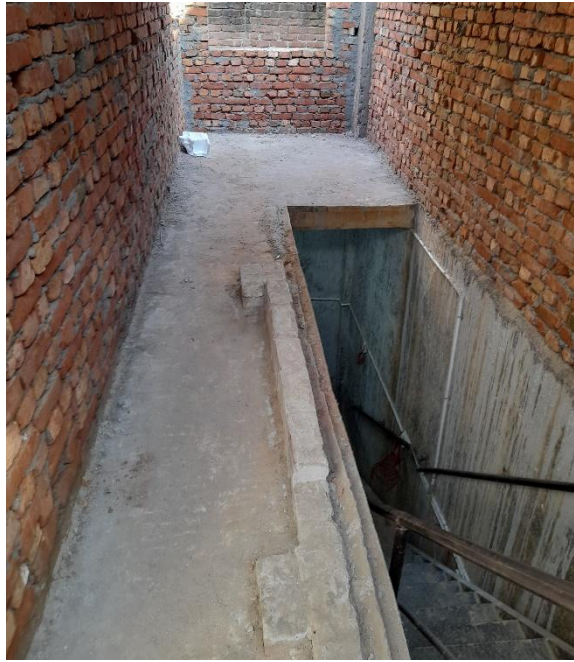
**Observation-12:** Falling hazard risk (Building 5: Fire Pump Room)

**Description:** During inspection, falling hazard risk was found in the fire pump room. Building engineer is required to provide barrier to mitigate the falling hazard.

| 17 | Falling hazard risk (Building 5: Fire Pump Room) | The building engineer is required to provide the railing/barrier to mitigate the falling hazard. | within 6 weeks |
