# Columbia Apparels Ltd - Extension

228/1 Tin Sharak, Joydevpur

6 November 2024

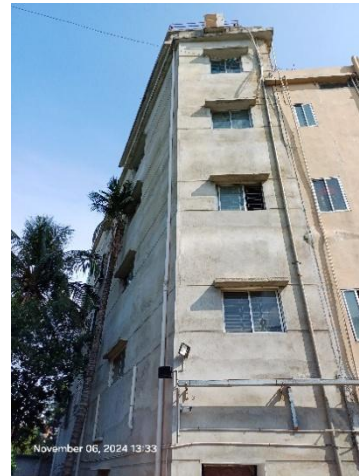
**Observation-1:** Building permit from local authority not available. (Factory Building (Extended Portion) and Fabric Warehouse)

**Description:** During the inspection, a building permit from the local authority was not available for the Factory Building (Extended Portion) and Fabric Warehouse. The factory authority is required to collect building permits from the local authority.

| Observation | Action Plan | Timeline |
|---|---|---|
| Building permit from local authority not available. (Factory Building (Extended Portion) and Fabric Warehouse) | The factory authority is required to collect building permits from the local authority. | within 6 months |

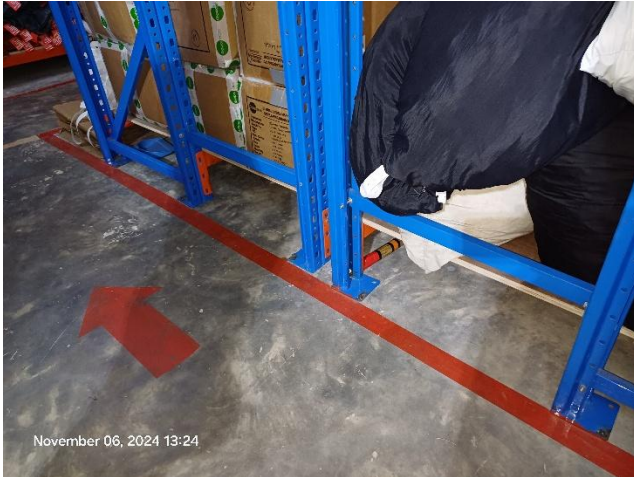
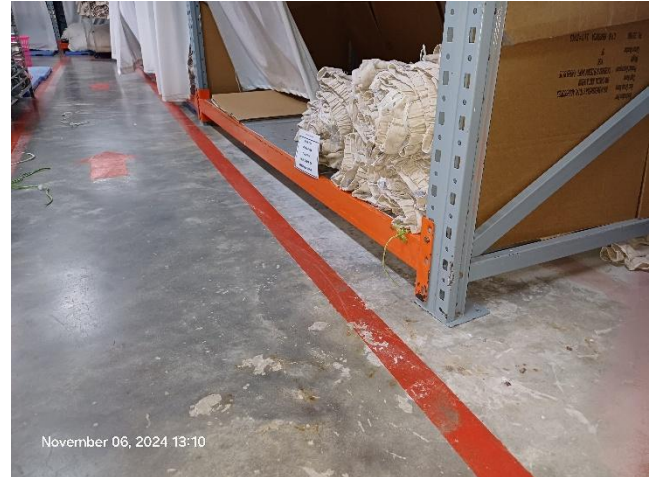
Unbraced racks on the floor

**Description:** Non-structural elements suspended from, attached to, or resting atop the structure shall be adequately anchored and braced to resist earthquake forces. Factory is required to brace/anchor all non-structural elements (storage racks).

| Observation | Action Plan | Timeline |
|---|---|---|
| Non-structural elements found unbraced/not anchored. (Factory Building (Extended Portion)) | Factory is required to brace/anchor all non-structural elements. | within 6 weeks |

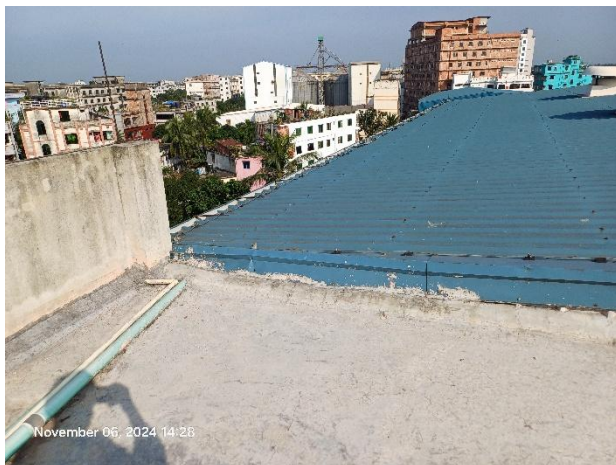
Roof of factory building

**Description:** Railing/parapet was not provided in the stair and roof, which may cause falling hazard. The factory is required to provide railing/barriers to avoid possible falling hazards.

| Observation | Action Plan | Timeline |
|---|---|---|
| Falling Hazard. (Factory Building (Extended Portion) and STP) | The factory is required to provide railing/barriers to avoid possible falling hazards. | within 6 weeks |

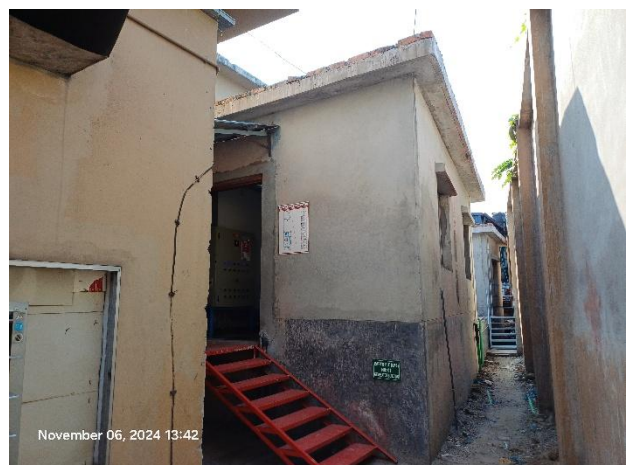
Stair of STP

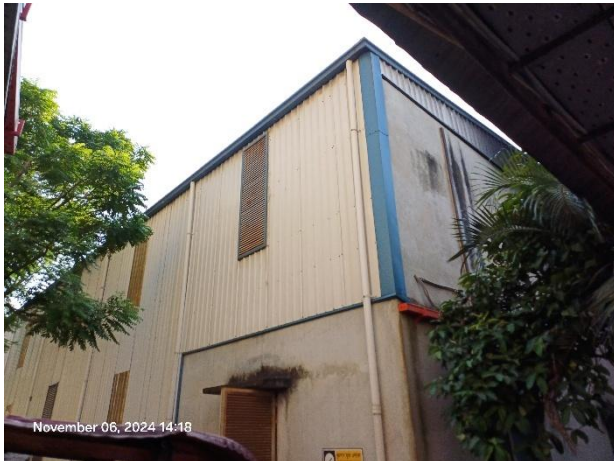
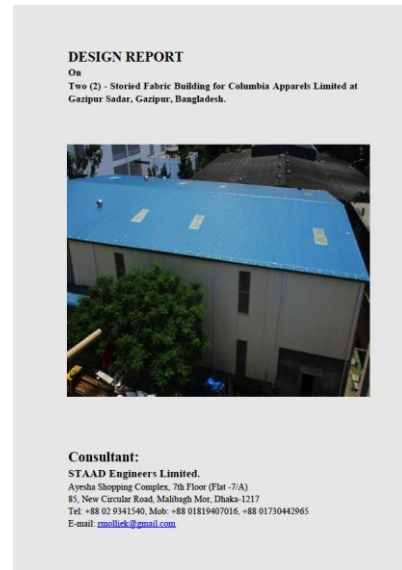
**Observation-5:** Lack of information in the design report. (Fabric Warehouse)

**Description:** A design report was available for the fabric warehouse. However, the adequacy checks of different structural members (foundation, column, beam, rafter) were not provided properly (comparison of demand and capacity for each element), and the steel member connection check was not incorporated into the design report.

The building engineer is required to incorporate an adequacy check of all structural members and steel member connections in the design report in compliance with section 1.9.1 (part-6, BNBC) and submit it to the RSC for review.

| Observation | Action Plan | Timeline |
|---|---|---|
| Lack of information in the design report. (Fabric Warehouse) | Building engineer is required to incorporate an adequacy check of all structural members, and steel members connections in the design report in compliance with section 1.9.1 (part-6, BNBC) and submit it to the RSC for review. | within 6 weeks |
| | Carry out the suggested remedial works. | within 6 months |

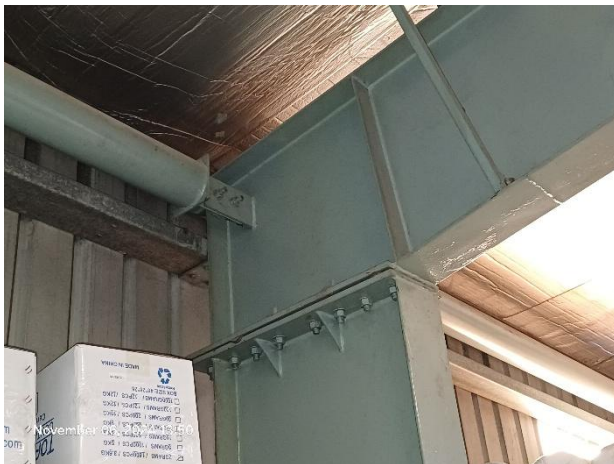
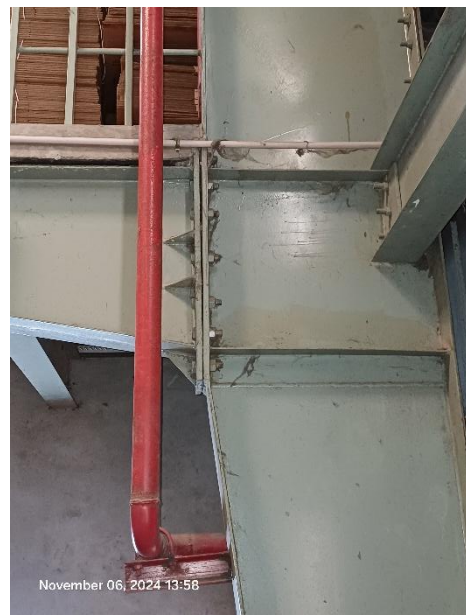
**Observation-6:** Connection gap. (Fabric Warehouse)

**Description:** Connection gaps were observed in the steel joint. The building engineer is required to identify the locations and carry out suitable remedial works.

| Observation | Action Plan | Timeline |
|---|---|---|
| Connection gap. (Fabric Warehouse) | Building engineer is required to identify the locations and carry out suitable remedial works. | within 6 weeks |
