Nkk Knitwear Ltd. (Extension)

KUTUBAIL, FATULLAH, NARAYANGANJ, DHAKA, Bangladesh
(23.642571, 90.487552)
5 November 2024

1. Building information

Building-3 (New Production Building) is an eight-storied (B+G+7) RC building with an underground fire pump room and water reservoir.

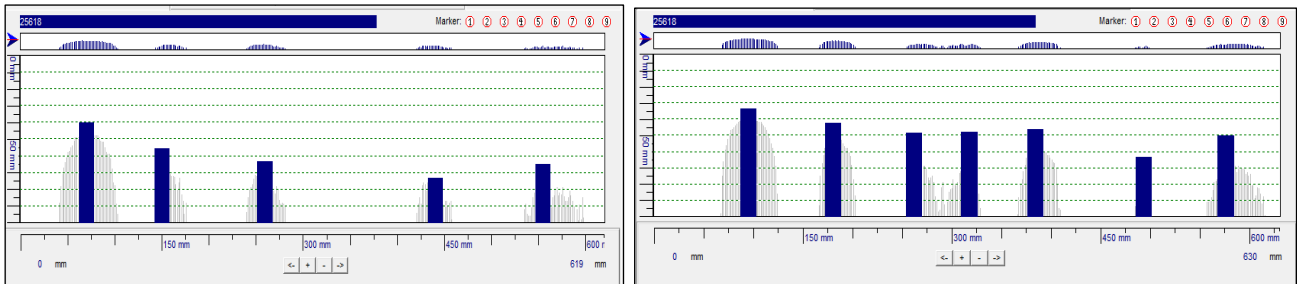
Column schedule in as-built drawing

A total of 20 nos of rebars were found from the ferro-scan

Description: During inspection, the number of rebars was found mismatched for the C1 column at grid B/2 on the 4th floor. In the as-built drawing, the total number of rebar has been provided 24 nos (7X7). But, from the ferro-scanning, total 20 nos (5X7) of the re-bar was found. Building engineer is required to survey the whole structure and prepare accurate as-built drawings.

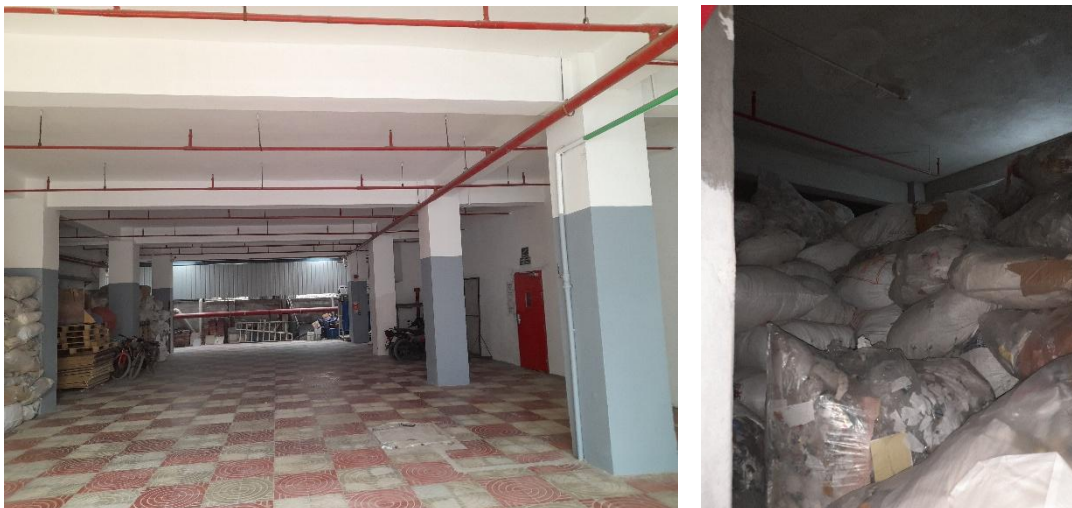
Load plan of suspended ground floor slab

Description: During the inspection, jhut storage was found on the ground floor suspended slab over the underground water reservoir. Also, the storage is uncontrolled. Load limit marking has not been provided in the storage area.

The building engineer is required to produce load plan for the ground floor suspended slab and provide load limit marking at the storage area.

6	Lack of load plan and load management program. (Building-3)	Implement the floor load management plan.	within 6 months
7	Lack of Building permit from the local authority (Building-3)	Factory is required to avail of the permit drawing for the building from the local authority.	within 6 months
8	Exposed re-bar at the roof. (Building-3)	The building engineer is required to provide anti-corrosive coating in the rebar to prevent corrosion.	within 6 months

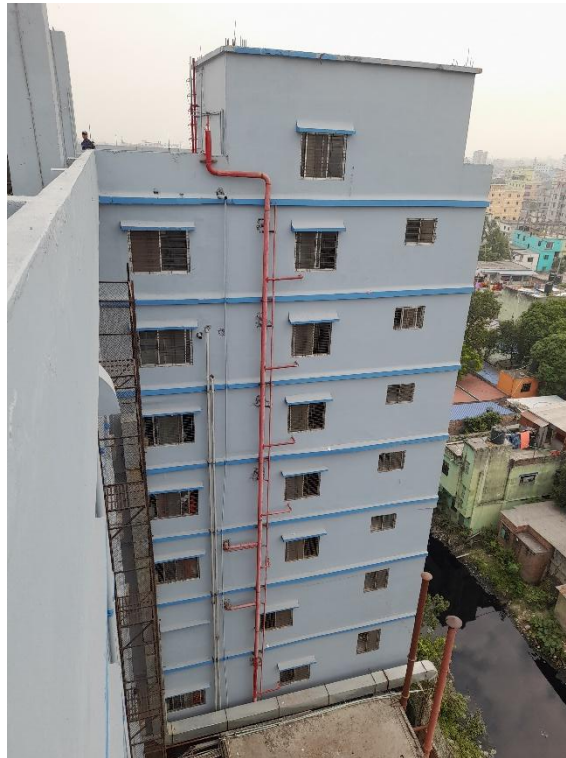
Description: The factory building did not have a permit from any local authority. Factory is required to avail the permit drawing for the building from the local authority.

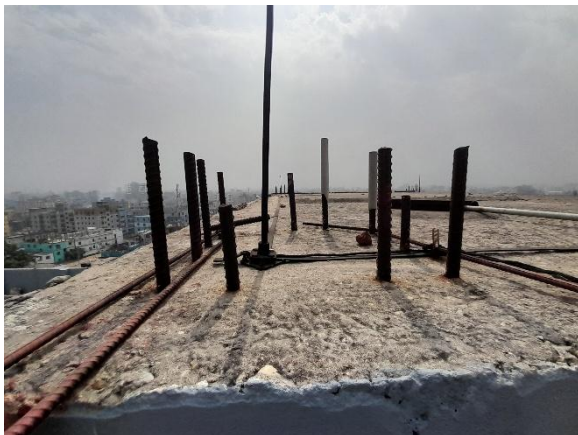
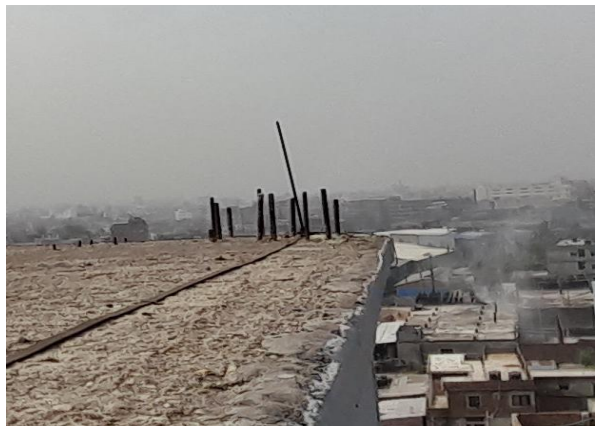
Observation-5: Exposed re-bar at the roof. (Building-3)

Description: Exposed re-bar was found at stair top. The building engineer is required to provide anti-corrosive coating in rebar to prevent corrosion.
