# FAKIR KNITWEARS LTD. (Extension - 2)

KAYEMPUR, FATULLAH, NARAYANGANJ

22 December 2024

## Structural Inspection Report

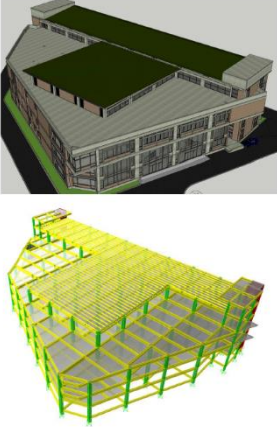
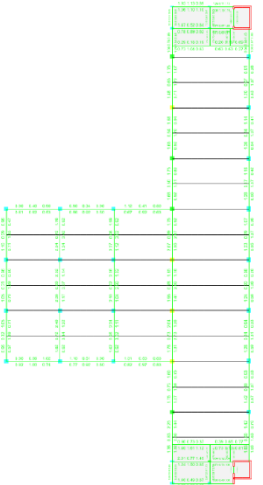
### Observation 01: Inconsistency in the design report [Building-12 (All Over Printing Building)]

**Description:** The prepared design report did not include steel connection design and member adequacy checks. Irregularity checks were missing in the report. Moreover, the steel pipe material test report was not available during the inspection. The building engineer is required to verify in-situ steel material strength and include all necessary checks in the design report in compliance with BNBC (part-6, section 1.9.1) requirements. Submit the revised design documents to the RSC for detailed review against lateral forces.

| SL | Observation | Action Plan | Timeline |
|---|---|---|---|
| 1. | Inconsistency in the design report [Building-12 (All Over Printing Building)] | The building engineer is required to verify in-situ steel material strength and include all necessary checks in the design report in compliance with BNBC (part-6, section 1.9.1) requirements. Submit the revised design documents to the RSC for detailed review against lateral forces. | within 6 weeks |
| 2. | | Carry out suggested remedial works if required. | within 6 months |

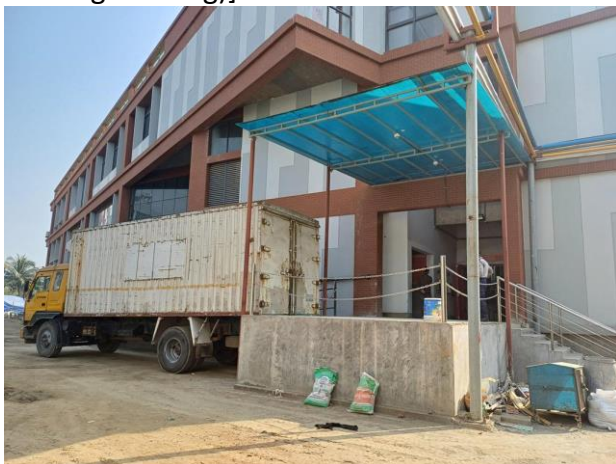
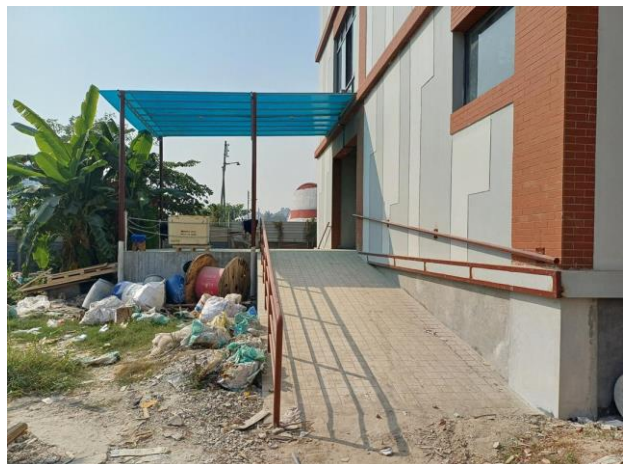
### Observation 02: Lack of as-built drawings for the loading-unloading sheds [Building-12 (All Over Printing Building)]

**Description:** Loading-unloading sheds were not shown in the drawings. The building engineer is required to survey the structure and prepare as-built drawings with connection details.

| SL | Observation | Action Plan | Timeline |
|---|---|---|---|
| 3. | Lack of as-built drawings for the loading-unloading sheds [Building-12 (All Over Printing Building)] | The building engineer is required to survey the structure and prepare as-built drawings with connection details. | within 6 weeks |

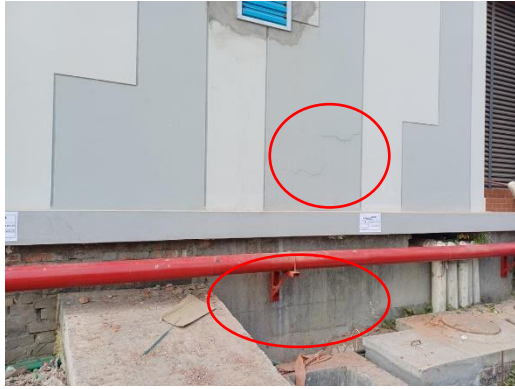
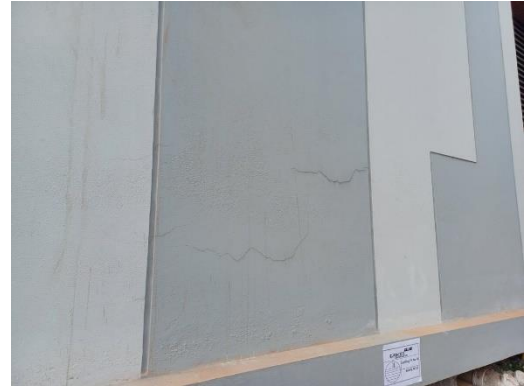
**Observation 03:** Cracks in ground floor brick wall. [Building-12 (All Over Printing Building)]

**Description:** Cracks were found in the ground floor brick wall. The building engineer is required to identify the reason for the crack and repair it with a suitable method.

| SL | Observation | Action Plan | Timeline |
|---|---|---|---|
| 4. | Cracks in ground floor brick wall. [Building-12 (All Over Printing Building)] | The building engineer is required to identify the reason for the crack and repair it with a suitable method. | within 6 weeks |

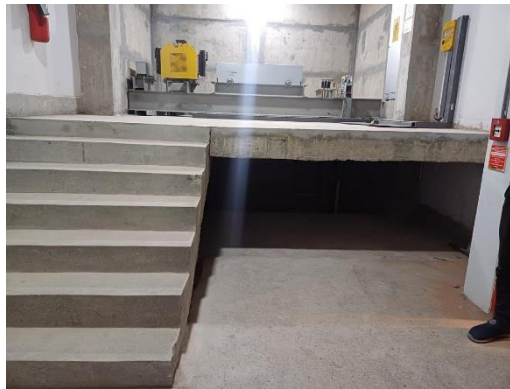
**Observation 04:** Falling hazard in the lift machine platform. [Building-12 (All Over Printing Building)]

**Description:** Lack of railing/barrier was observed in the elevated lift machine platform. The building engineer is required to provide railing/barrier to prevent the falling hazard.

| SL | Observation | Action Plan | Timeline |
|---|---|---|---|
| 5. | Falling hazard in the lift machine platform. [Building-12 (All Over Printing Building)] | The building engineer is required to provide railing/barrier to prevent the falling hazard. | within 6 weeks |

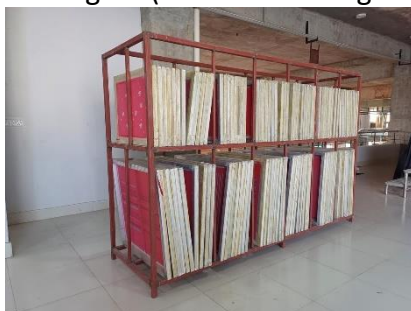
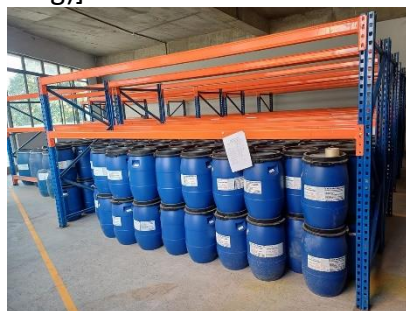
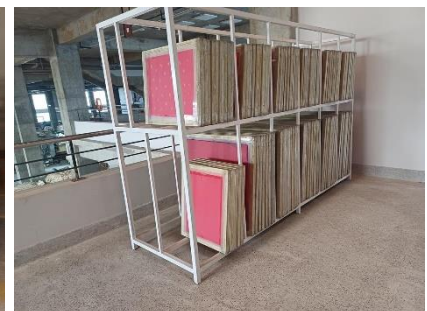
**Observation 05:** Lack of anchorage/bracing for non-structural elements including storage racks. [Building-12 (All Over Printing Building)]

**Description:** Lack of anchorage/bracing was observed for film/storage racks. Provide anchorage/bracing to the storage racks.

| SL | Observation | Action Plan | Timeline |
|---|---|---|---|
| 6. | Lack of anchorage/bracing for non-structural elements including storage racks. [Building-12 (All Over Printing Building)] | Provide anchorage/bracing to the film/storage racks. | within 6 months |

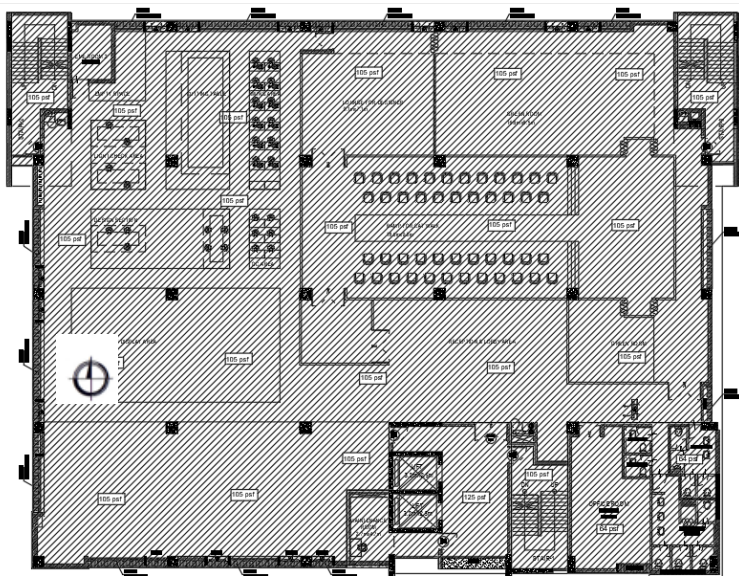
4<sup>th</sup> floor load plan-Studio (105 psf)

**Observation-06: Inconsistencies in as-built drawing. (Building-13 (New Printing Building))**

**Description:** During the inspection, store (125 psf) was found on the 4<sup>th</sup> floor but in the load plan it was mentioned as studio (105 psf). The building engineer is required to update the as-built drawing according to site conditions, revise the load plan as per BNBC requirements and check the design accordingly.

| SL | Observation | Action Plan | Timeline |
|---|---|---|---|
| 7. | Inconsistencies in as-built drawing. (Building-13 (New Printing Building)) | The building engineer is required to update the as-built drawing according to the as-built condition, revise the load plan as per BNBC requirements. | within 6 weeks |

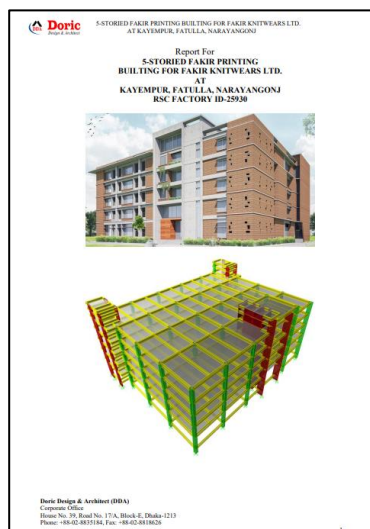
**Observation-07: Inconsistencies in design report. (Building-13 (New Printing Building))**

**Description:** During the inspection, a design report was found on site for this structure where Intermediate moment resisting frame (IMRF) is considered but no details calculation was provided to justify IMRF, concrete strength calculations (as per BNBC) for cylinder test report was not provided, pile capacity considered 100 ton for the foundation which was not found in soil test report, and serviceability check not found also. The building engineer is required to revise the design report as per BNBC requirements and check the design accordingly.

| SL | Observation | Action Plan | Timeline |
|---|---|---|---|
| 8. | Inconsistencies in design report. (Building-13 (New Printing Building)) | The building engineer is required to revise the design report as per as-built drawing, floor load plan, in-situ concrete strength following BNBC requirements and submit to the RSC for review. | within 6 weeks |
| 9. | | Carry out suggested remedial works if required. | within 6 months |

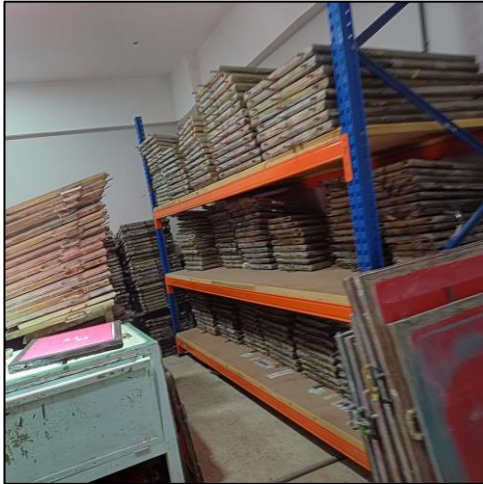
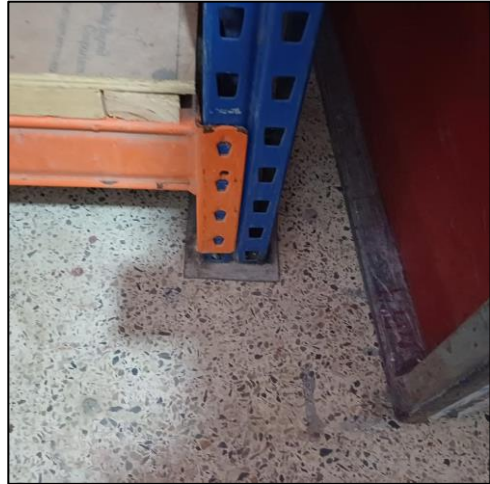
**Observation-08:** Lack of anchorage of non-structural elements. (Building-13 (New Printing Building))

**Description:** During the inspection, storage rack was not found anchored/braced. The building engineer is required to anchor/brace all the non-structural elements.

| SL | Observation | Action Plan | Timeline |
|---|---|---|---|
| 10. | Lack of anchorage of non-structural elements. (Building-13 (New Printing Building)) | The building engineer is required to anchor/brace all the non-structural elements. | within 6 months |

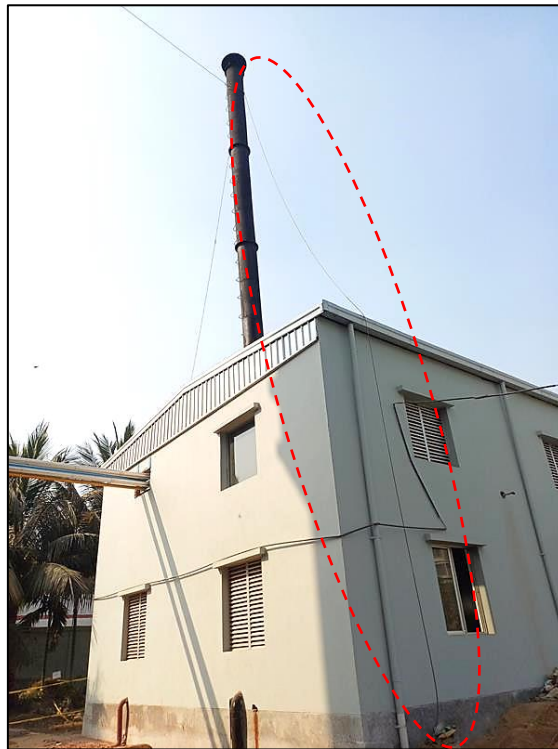
**Observation-09:** Lateral bracing removed from tall chimney. (Shed-21 (New Boiler Shed))

**Description:** Due to construction work the lateral bracing of the chimney of the New Boiler Shed has been removed. The building engineer is required to re-install the bracing to make the chimney stable.

| SL | Observation | Action Plan | Timeline |
|---|---|---|---|
| 11. | Lateral bracing removed from tall chimney. (Shed-21 (New Boiler Shed)) | The building engineer is required to re-install the bracing to make the chimney stable. | within 6 weeks |
