# Mawna Fashions LTD. (EXTENSION)

Tepirbari, Sreepur, Gazipur.

18 December 2024

Single Storied Shed

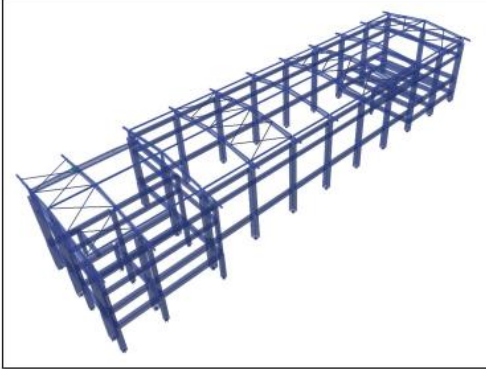
| Observation-1: Overstressed structural members. | |
| <p><b>Description:</b> Overstressed member observed by the analysis of the DEA report. Retrofitting is also suggested in the DEA report.</p> <p>In the DEA report the <math>f_y</math> of the MS plate is considered 345 MPa but the test report is not provided in the report. Also, concrete strength is considered below the design strength of concrete 27.5 MPa.</p> <p>Building engineer is required to review the design load and structural member stress. Submit the EA report to the RSC for further review.</p> | |

| Item No. | Observation | Action Plan | Timeline |
|---|---|---|---|
| 1. | Overstressed structural members. | Building engineer is required to review the design load and structural member stress. Submit the EA report to the RSC for further review | within 6 weeks |
| 2. | | Building engineer is required to use the concrete cylinder strength data and calculate 5.12.1 to use the design strength.<br>&<br>Use minimum MS plate grade otherwise carry out tensile strength test. | within 6 weeks |
| 3. | | Implement remediation work where required. | within 6 months |

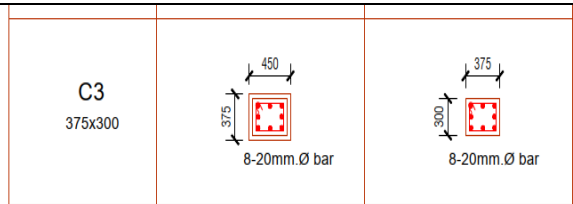
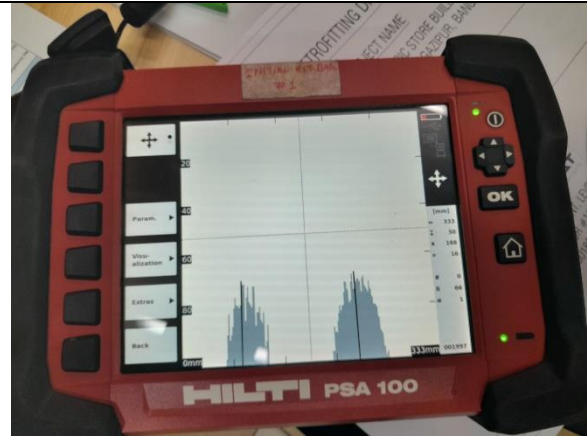
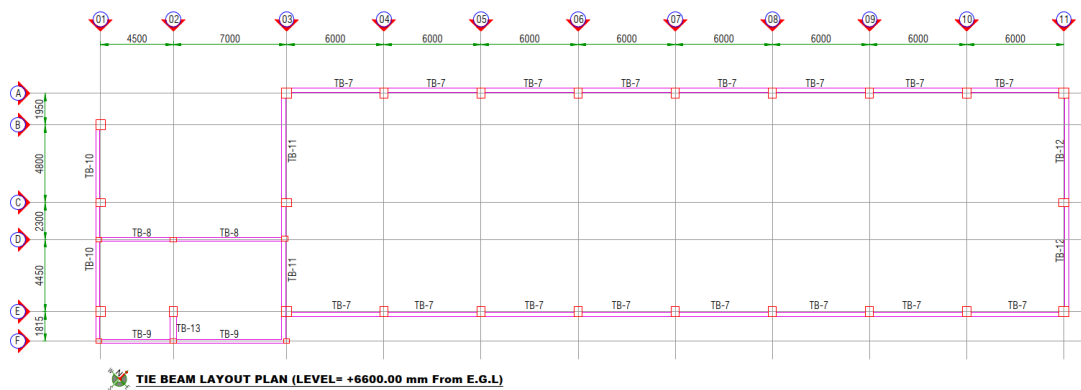
### Observation 2: Lack of information and mismatch in as-built drawing.

**Description:** The amount of rebar of the C3 column was found 6 instead of 8. Grid-wise sectional details missing in long-direction grids.

Building engineer is required to confirm all types of column rebar by ferro scanning or strip cutting update the drawing and prepare a detailed accurate structural drawing.

| Item No. | Observation | Action Plan | Timeline |
|---|---|---|---|
| 4. | Lack of information and mismatch in as-built drawing. | The building engineer is required to survey the structure and update the as-built drawing. | within 6 weeks |

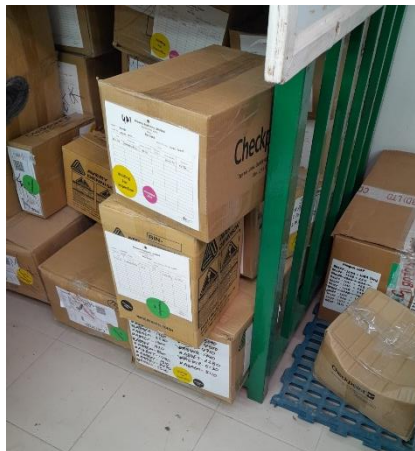
### Observation-3: Unbraced storage racks.

**Description:** Unbraced storage racks were observed. The building engineer is required to provide anchorage/bracing to the storage racks to protect them from falling hazards.

| Item No. | Observation | Action Plan | Timeline |
|---|---|---|---|
| 5. | Unbraced storage racks. | The building engineer is required to survey the structure and update the as-built drawing. | within 6 months |
