# Square Denims Limited (Garments Unit) (Extension)

Dubaliapara, Zamirdia, Bhaluka, Mymensingh

26 December 2024

## Structural Inspection Report

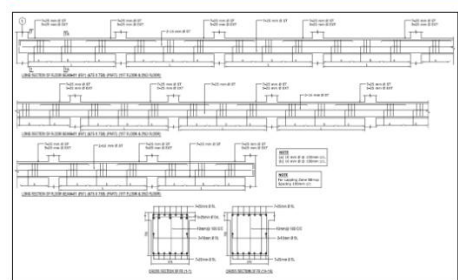
Figure 3.1-7: Typical long section and x-section of Beam for SDC D (SMRF)

From figure 3.1-7 it is shown that provided long rebar-

The minimum positive rebars are  $7-25\text{mm}=5.33\text{in}^2$  which is greater than one-half of the maximum  $7-25\text{mm}+5-25\text{mm}=1/2*9.13=4.565\text{in}^2$ .

The minimum long rebar at any section is also  $7-25\text{mm}=5.33\text{in}^2$  which is greater than  $1/4*9.13=2.2825\text{in}^2$  which satisfies the design criteria of SMRF shown in Figure 3.1-5.

From Figure 3.1-7 it is shown that provided stirrups spacing at hoop zone =  $10\text{mm}@100^\circ\text{c}$  and at midzone =  $10\text{mm}@100^\circ\text{c}$ .

**Description:** The building engineer has prepared the design report based on Special Reinforced Concrete Moment Frames (SMF). However, several key detailing checks have not been adequately addressed in the report as per BNBC 2020 Part VI, Section 8.3.

The building engineer must ensure the check in compliance with all SMF detailing requirements outlined in BNBC 2020 Sections 8.3.4, 8.3.5, 8.3.7, 8.3.8, and 8.3.11. These checks should be verified and incorporated into the design report to ensure full alignment with the code provisions.

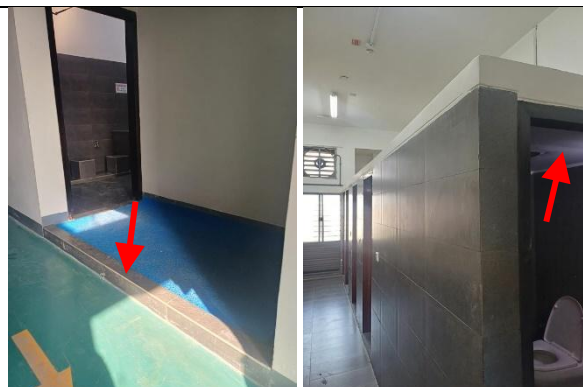
### Observation-2: Lack of information in as-built drawing (Building-3 Washing Building).

**Description:** During inspection, floor raises, and false ceiling were found in the toilet zone which were not mentioned in the drawing. The building engineer is required to survey the structure and update the accurate as-built drawing as per actual site condition.

2.		Carry out remedial work if required.	within 6 months
3.	Lack of information in as-built drawing (Building-3)	The building engineer is required to survey the whole structure and update the as-built drawing reflecting actual site condition.	within 6 weeks

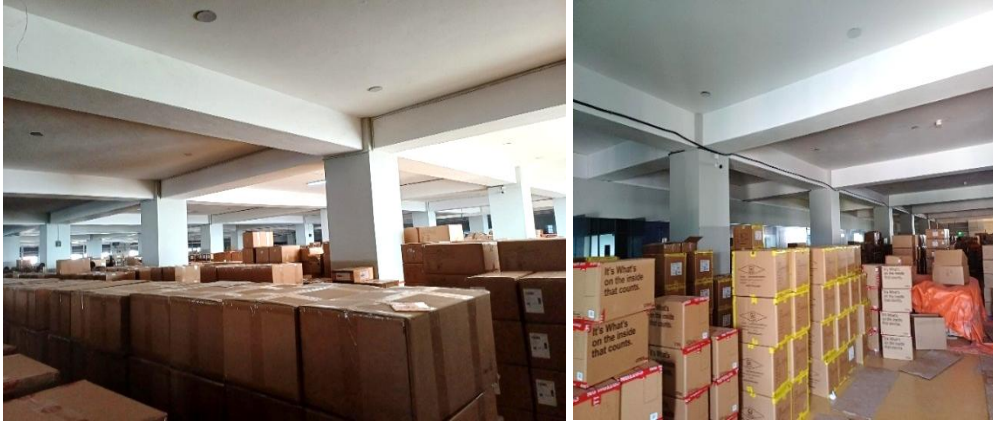
**Observation-3:** Lack of height marking in the storage area (Building-3 Washing Building).

**Description:** Load restriction height marking was not provided in the storage areas. The factory is required to provide load restriction height marking in the storage areas as per the floor loading capacity and compliance requirement.

4.	Lack of height marking in the storage area (Building-3).	The factory is required to provide load restriction height marking in the storage areas as per the floor loading capacity and compliance requirement.	within 6 weeks

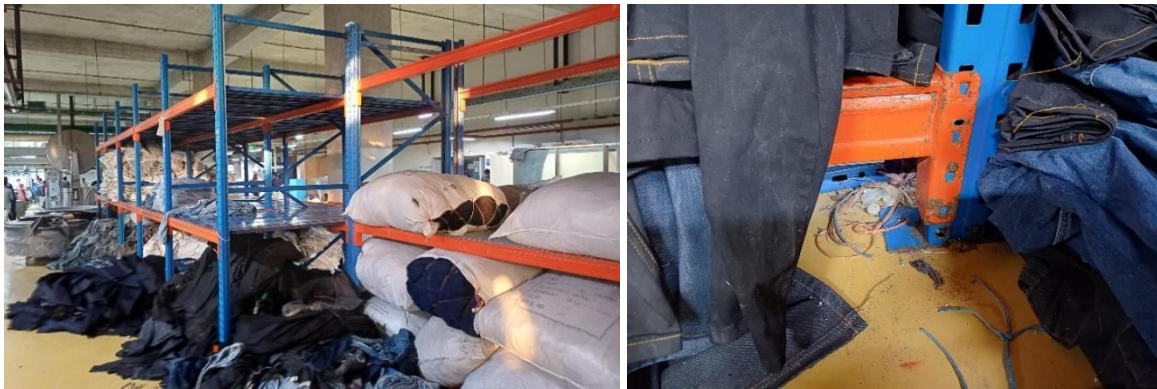
**Observation-4:** Lack of anchorage of the non-structural elements (Building-3 Washing Building).

**Description:** The anchorage of ground floor storage rack was missing. Non-structural elements suspended from, attached to, or resting atop the structure shall be adequately anchored and braced to resist earthquake forces. The factory is required to brace/anchor all storage racks.

5.	Anchorage of the non-structural elements (Building-3).	The factory is required to brace/anchor all storage racks.	within 6 months
6.	Possible falling hazard at the loading-unloading zone (Building-3).	The factory is required to install appropriate safety barriers or railings to mitigate the risk of falling and ensure compliance with safety standards.	within 6 weeks

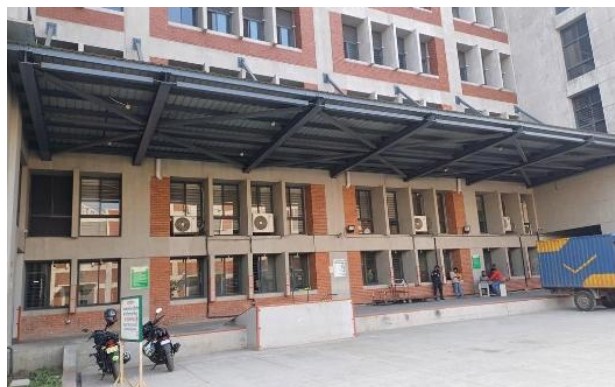
**Observation-5:** Possible falling hazard at the loading-unloading zone (Building-3 Washing Building).

**Description:** During the inspection, it was noted that the elevated loading-unloading platform lacked railings or barriers at its edges, creating a potential falling hazard. The factory is required to install appropriate safety barriers or railings to mitigate the risk of falls and ensure compliance with safety standards.

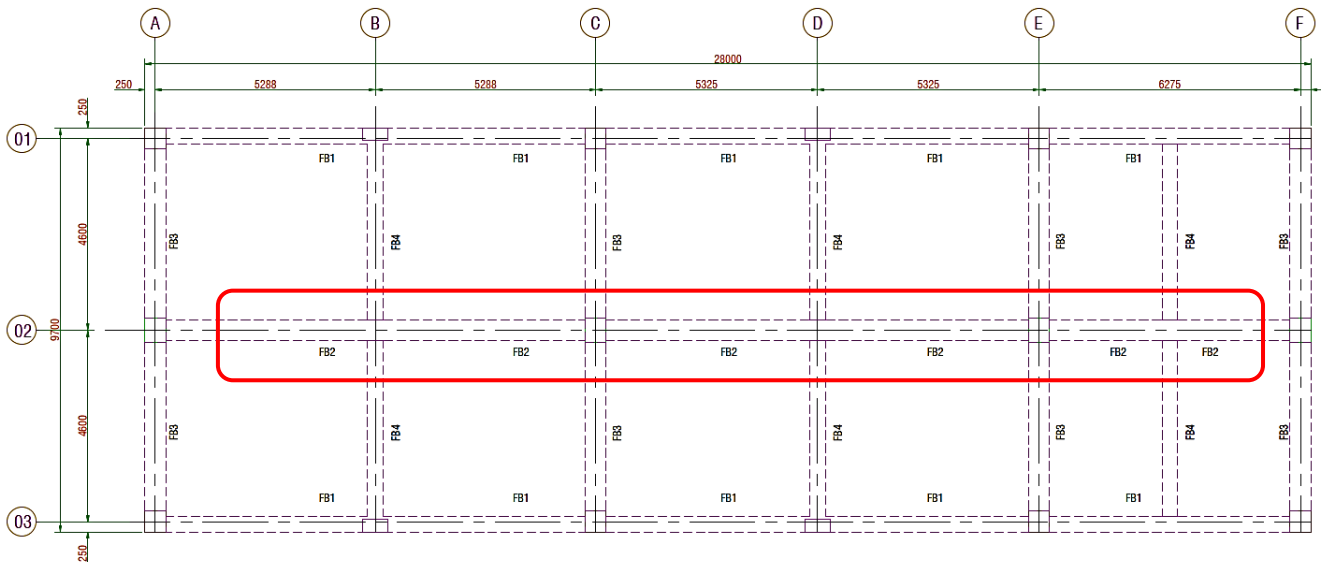
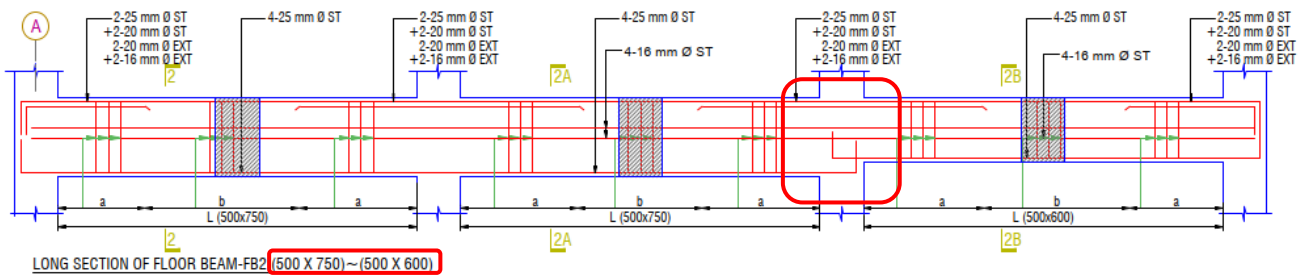
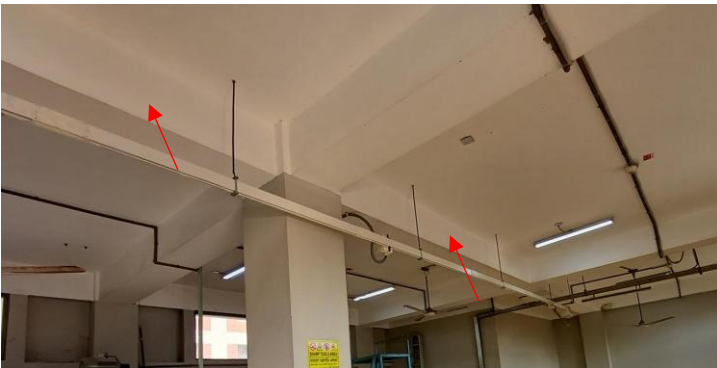
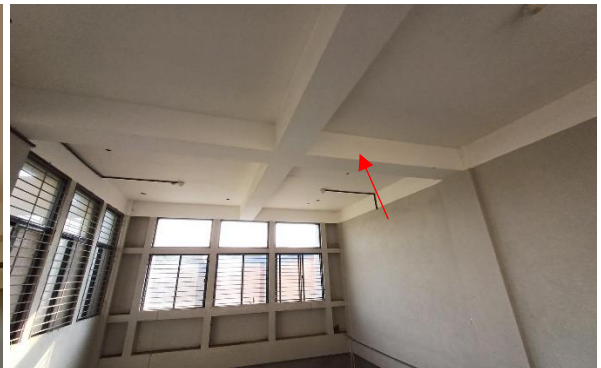
**Observation-7: Mismatch between as-built drawing and onsite condition (Process Water Tank).**

**Description:** During inspection, mismatch was found between the provided as-built drawing and actual site condition. The depth of the roof beam FB2 was found 500 X 600 instead of (500 X 750) in two spans. The building engineer is required to survey the structure and update the accurate as-built drawing as per actual site condition.

8.		Carry out remedial work if required.	within 6 months
9.	Mismatch between as-built drawing and onsite condition (Process Water Tank).	The building engineer is required to survey the structure and update the accurate as-built drawing as per actual site condition.	within 6 weeks

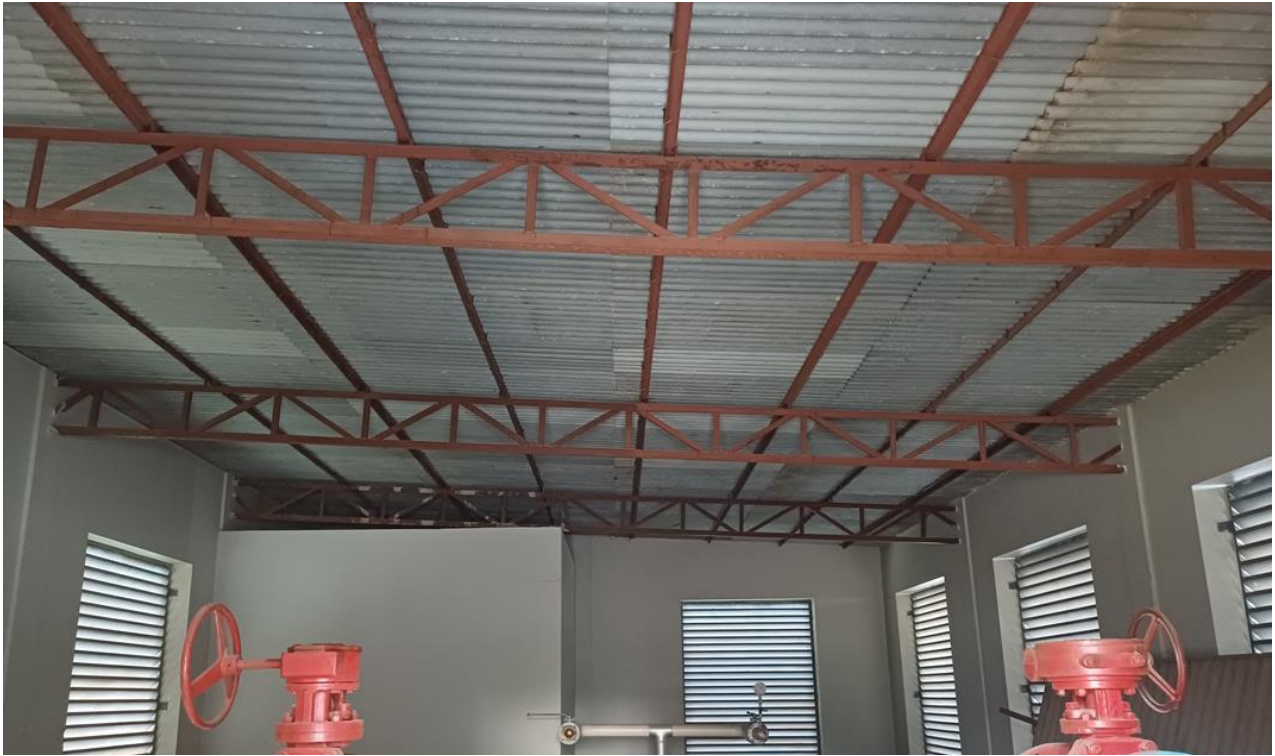
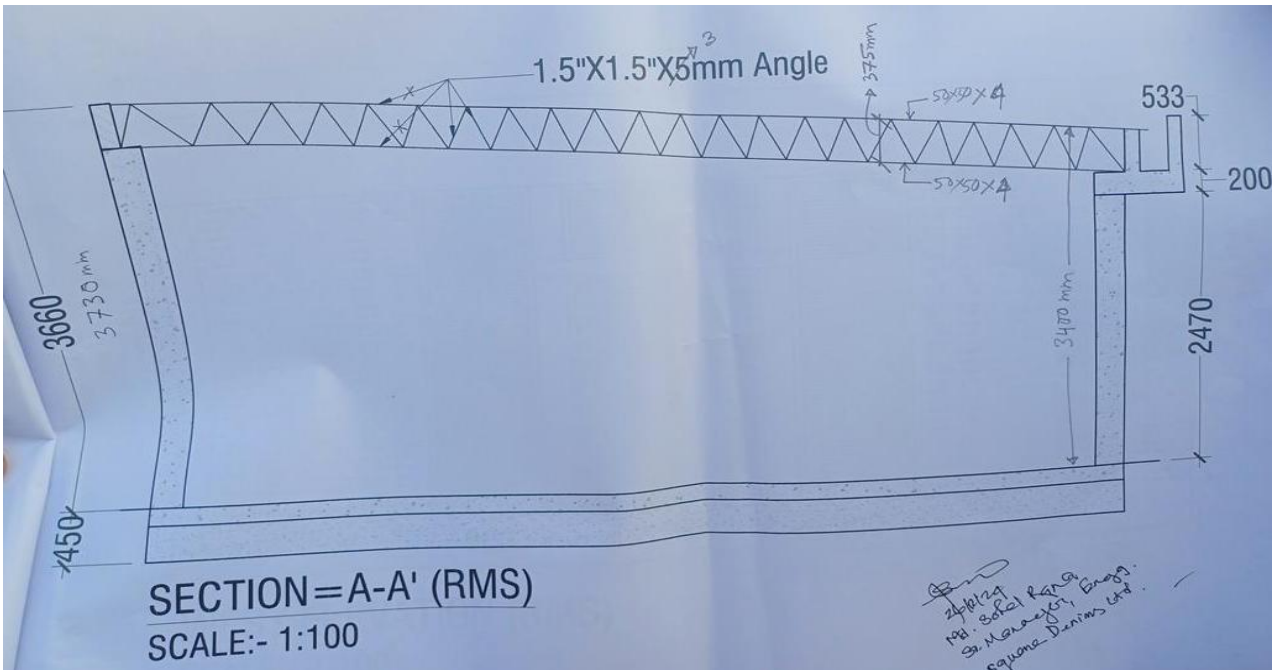
**Observation-8:** Mismatch and lack of information in provided drawing (RMS).

**Description:** During inspection, mismatch and lack of information were observed between the provided drawing and actual site condition. The size of truss member differed with provided drawing- top and bottom chords found L-50x50x4 instead of L-38x38x4. The elevation heights were measured as 3.73 m & 3.4 m, where drawing shown 3.6 m and 3.2 m respectively. Additionally, the drawings lacked information on the truss depth and vertical chord dimensions, foundation, and RC columns were inaccurately shown as masonry columns in the provided drawing.

The building engineer is required to survey the whole structure and prepare accurate as-built drawing as per actual site condition.

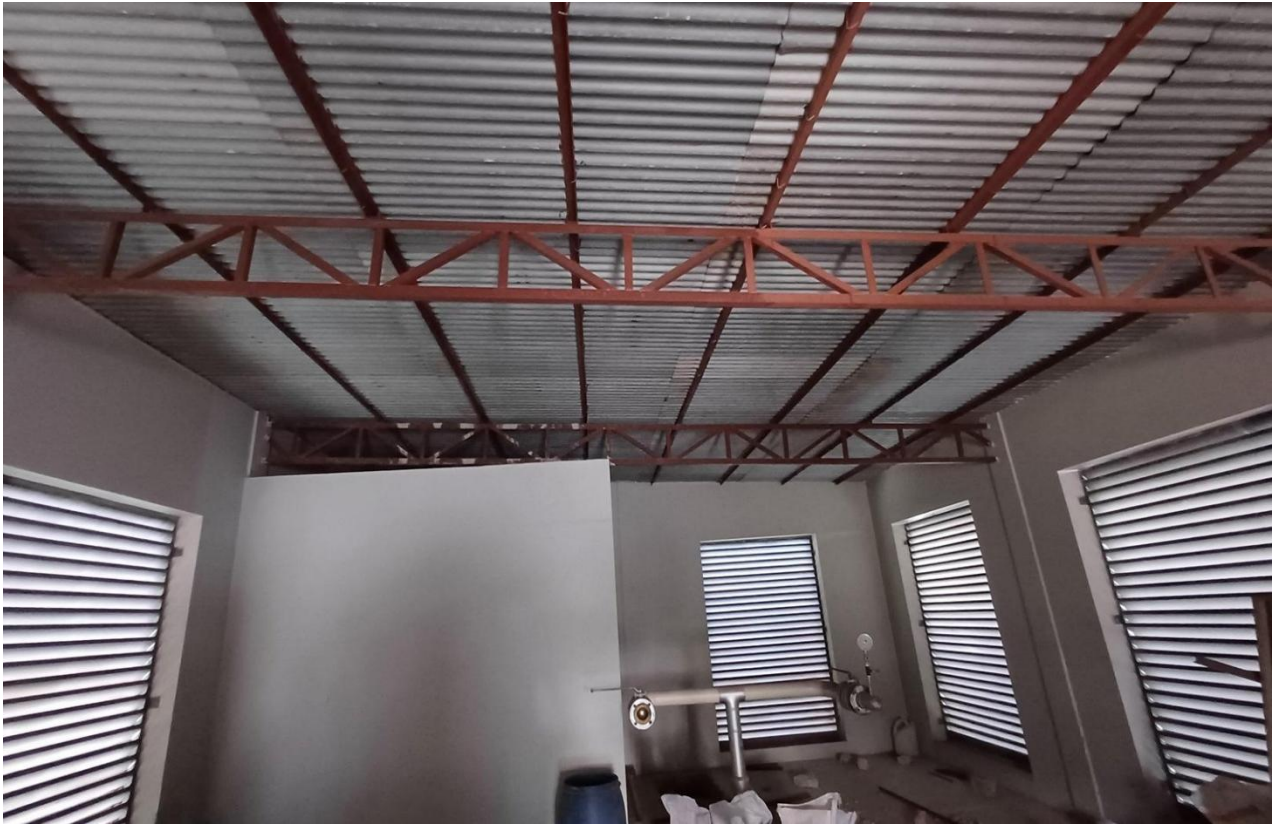
**Observation-9:** Absence of bracing system (RMS Shed).

**Description:** Roof truss system observed along the north-south direction. No bracing or strut member observed in the east-west direction.

The building engineer is required to suggest adequate size of roof bracing and strut member. Submit the design of bracing system as part of safety check report to RSC for review.
