Sterling Designs Limited (Extension)

10 November 2024

Structural Inspection Report

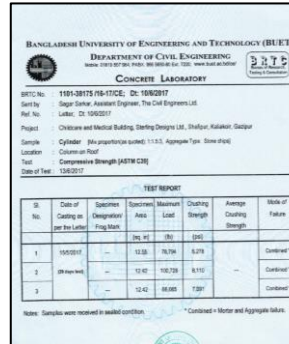
Concrete strength consideration in design report for Building-2 & 3

Description: During the inspection, concrete cylinder test report- (1 set from column for Building-2), (1 set from column, 1 set from beam & slab for Building-3,) were available. However, in the design reports of Building 2 & 3, f'_c was considered 24.14 MPa without any justification. The building engineer is required to take the necessary concrete cores to confirm the concrete strength. Update the analysis & design report based on in-situ material strength and submit to RSC for review.

Item No.	Observation	Action Plan	Timeline
1.	Lack of material test report (Building-02).	Verify in-situ concrete strength either by 100 mm diameter cores or existing credible cylinder test reports.	within 6 weeks

2.		The building engineer is required to revise the design report based on the in-situ material strength, the actual framing system, and proper design parameters. Submit the revised design documents to RSC for review.	within 6 weeks

5.	Lack of material test report. (Building-03).	Verify in-situ concrete strength either by 100 mm diameter cores or existing credible cylinder test reports.	within 6 weeks

6.		The building engineer is required to revise the design report based on the in-situ material strength, the actual framing system, and proper design parameters. Submit the revised design documents to RSC for review.	within 6 weeks

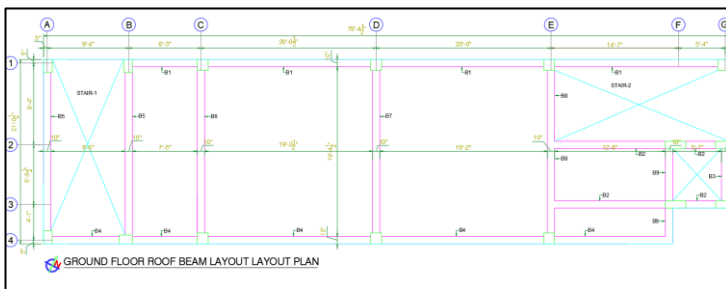
Typical floor beam layout

Description: In the structural drawing, structural details of ground floor tie beam were not available. The building engineer is required to survey the structure and update the as-built drawing.

3.		Carry out the suggested remedial if works.	within 6 months
4.	Missing information in as-built drawing (Building-02).	The building engineer is required to survey the structure and update the as-built drawing.	within 6 weeks

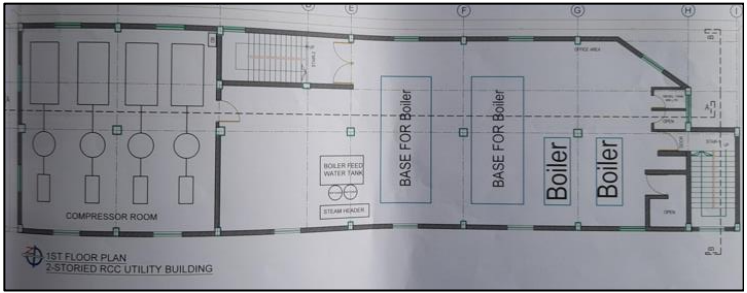
Typical floor beam layout

Description: In the as-built architectural drawing, build-up thickness was not shown for base of boiler in 1st floor. The building engineer is required to survey the structure and update the as-built drawing.

7.		Carry out the suggested remedial if works.	within 6 months
8.	Missing information in as-built drawing (Building-03).	The building engineer is required to survey the structure and update the as-built drawing.	within 6 weeks

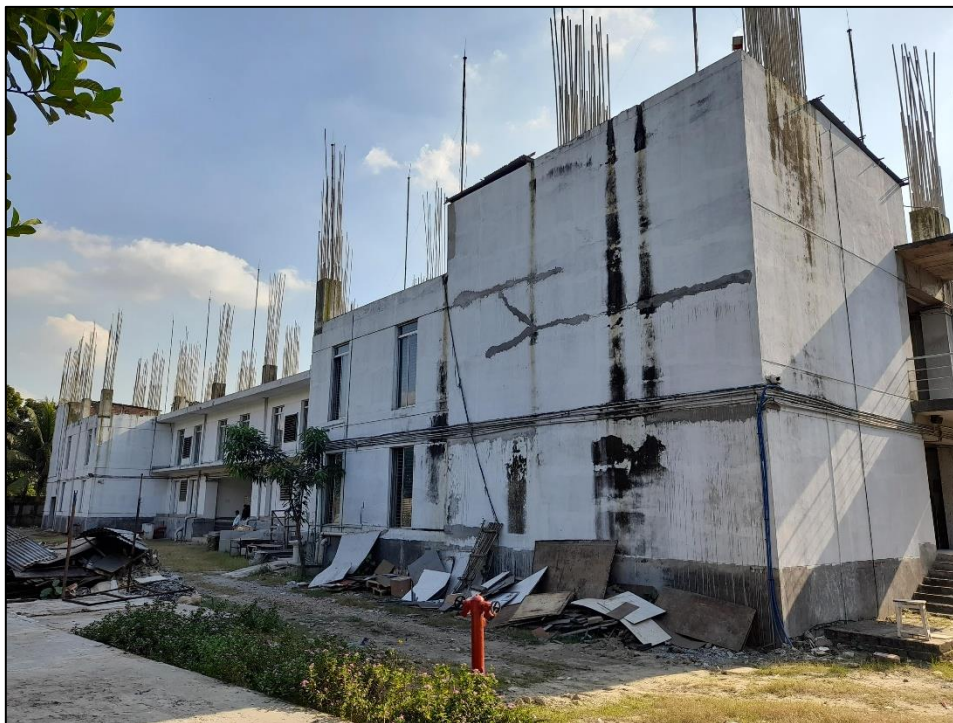
Observation 4: Lack of design report (Building-04).

Description: As per BNBC, every building or structure designed shall have its design documents prepared in accordance with the provision of Section 1.9.1. The design document shall include a design report, and a set of structural drawings, which shall be prepared in compliance with section 1.9.1.1 and section 1.9.1.2 as per BNBC. At the time of inspection, the design report was not available. The building engineer is required to prepare a design report in compliance with BNBC 1.9.1

9.	Lack of design report (Building-04).	The building engineer is required to prepare a design report in compliance with BNBC 1.9.1 and submit to the RSC for review.	within 6 weeks

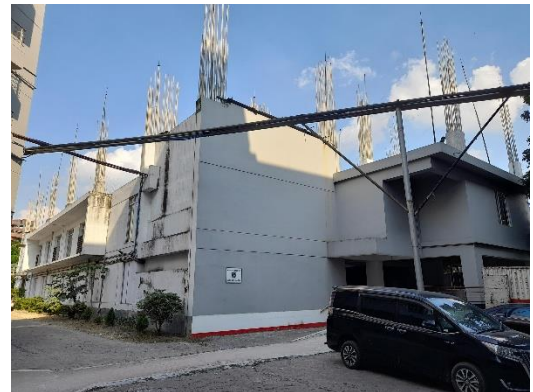
Permit for 10 storied building

Existing single storied with mezzanine

Description: The building has permit drawings for 10 storied with one basement. The building is constructed up to single storied with a mezzanine. The roof columns are extended for possible vertical extension in future. The building engineer is required to prepare a Detail Engineering Assessment (DEA) for the proposed building prior to conducting any vertical extension.

10.		Carry out suggested remedial works if required.	within 6 months
11.	Possible vertical extension (Building-04).	Factory engineers are required to prepare a Detail Engineering Assessment (DEA) report prior conducting any vertical extension and submit to RSC for review.	within 6 weeks

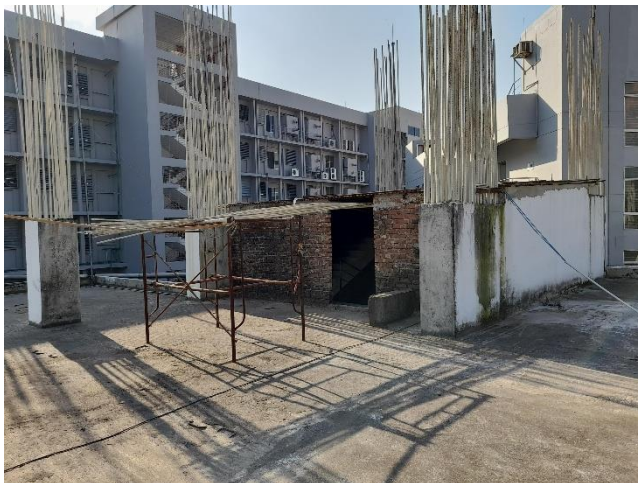
Steel truss roofing system

Description: During inspection no structural connection was observed between the steel roof supporting the angle of staircase and supporting masonry wall. The building engineer is required to check the connection adequacy for uplift forces as part of EA and suggest remedial actions.

12.		Carry out the suggested remedial if requires.	within 6 months
13.	Lack of structural connection (Building-04).	Factory engineers are required to check the connection adequacy for uplift forces. Implement remediation work if required.	within 6 weeks

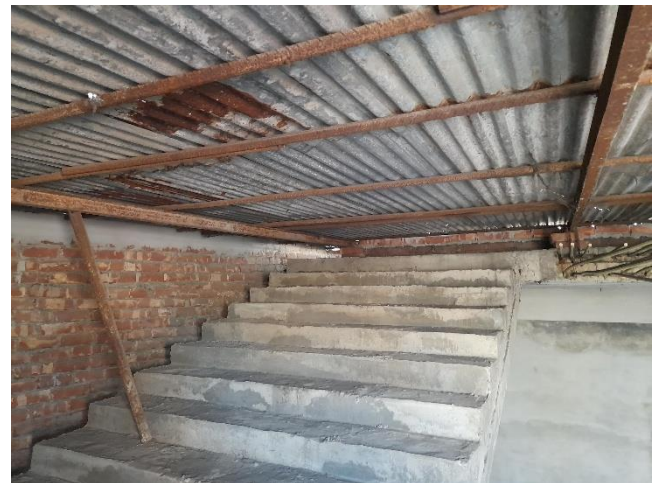
Truss angle rested on masonry wall

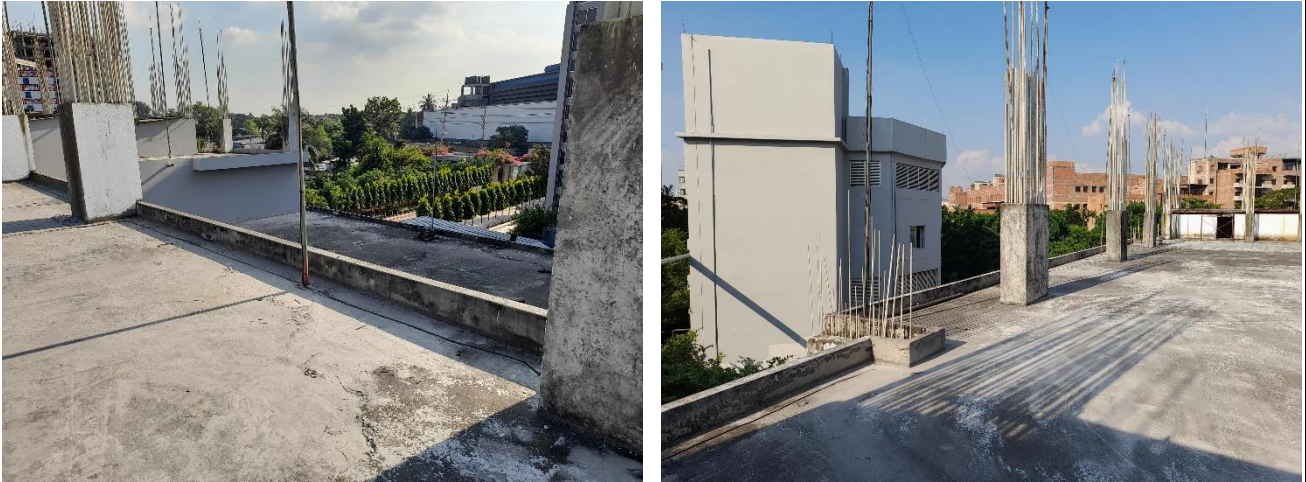
Observation-7: Falling hazard on the roof (Building-04).

Description: A lack of fall protection barrier/parapet wall/railing was found on roof. The building engineer is required to provide a fall protection barrier for the open roof/floor and for all openings.

14.	Falling hazard on the roof and 5 th floor. (Building-04).	The building engineer is required to provide a fall protection barrier to the roof/floor and all openings.	within 6 weeks
