# INITIAL FIRE SAFETY INSPECTION REPORT

**SQ Birichina Ltd Unit 2 - Extension (previously SQ Colblanc Limited)**

**RSC ID: 25621**

**Date: 31-Oct-2024**

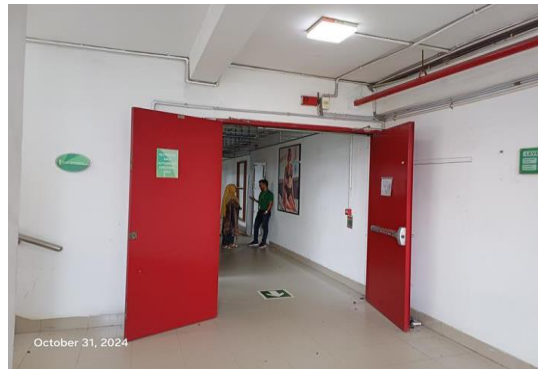
| SI No. | Category | Findings | Required Action | Remediation Time Frame |
|---|---|---|---|---|
| F-1 | Means of Egress | <p>The south-west exit stairs are not separated from work areas and other spaces on each floor by fire rated construction at extended office building.</p> <p>Newly installed fire doors (south-west) manual and certificate need to be kept on-site. Fire doors should be interfaced with FACP.</p> | <p>Provide minimum 1-hr rated doors for buildings with 3 or fewer stories and 1.5-hr fire rated doors for buildings that are 4 or more stories. Seal all unprotected openings to separate the exit stairs from work areas and other building spaces on all floor levels.</p> <p>Ensure that the fire doors are self-closing and positive latching and that they are provided with fire exit (panic) hardware where serving production floors. Provide credible documents and certificates for fire rated doors. If fire doors are required to be held open for functional reasons, provide automatic closing devices tied to the fire alarm system.</p> | Within 3 months |

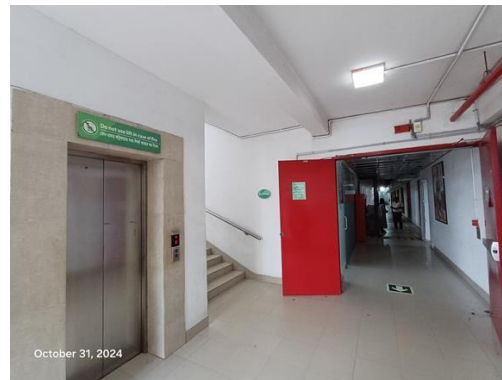
| SI No. | Category | Findings | Required Action | Remediation Time Frame |
|---|---|---|---|---|
| F-2 | Fire Rated Construction | Elevator shafts are directly open into south-west exit stair enclosure. | Modify the elevator shaft as per RSC Technical Guideline (Standard) V1-6.14.3. An exit stairway shall not be built around a lift shaft unless both of them are located in a smoke proof enclosure and made of a material with fire resistance rating required for the type of construction of smoke proof enclosure. So, rearrange the facility to provide separate enclosure for lifts. If not possible anyway then provide a minimum 2-hr fire- rated elevator shaft with listed fire rated lift landing door to separate from each floor level.) | Within 3 months |

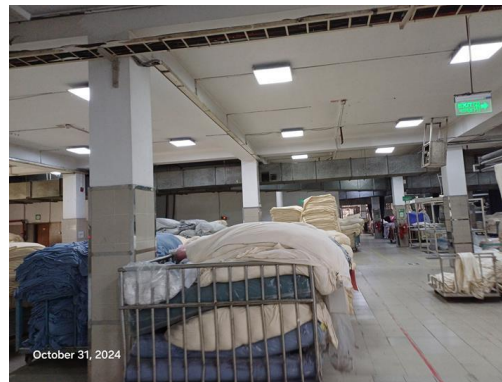
| SI No. | Category | Findings | Required Action | Remediation Time Frame |
|---|---|---|---|---|
| F-3 | Fire Rated Construction | Areas used for combustible storage are not separated by fire rated construction on the ground floor. | <p>Separate the dedicated storage rooms by minimum 1-hr fire-rated construction. Provide 0.75 hr. fire rated door and seal all penetrations and openings by 0.75 hr. (45 Minutes) fire rated fire rated barrier construction.</p> <p>Where separate storage rooms are not feasible, provide defined storage areas and limit the storage arrangement as follows:</p> <ul style="list-style-type: none"> <li>- Maximum height of 2.45m (8ft.) , maximum area of 23m<sup>2</sup> (250 ft<sup>2</sup>) and 3m (10ft.) clear distance from adjacent another unenclosed combustible storage.</li> <li>- If the building/floor is sprinkler protected: maximum height of 3.66m (12ft.) and maximum area of 93m<sup>2</sup> (1000 ft<sup>2</sup>).</li> <li>-In process storage shall be limited to 10 percent of the building area of the story in which they occur.</li> </ul> | Within 3 months |

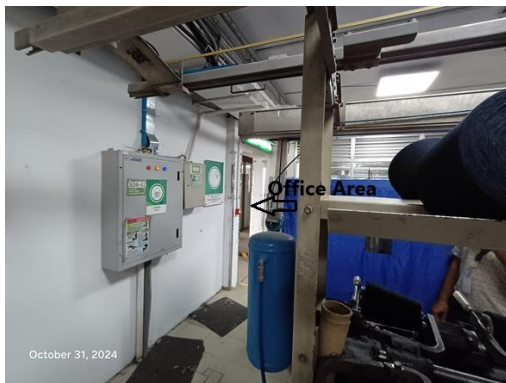
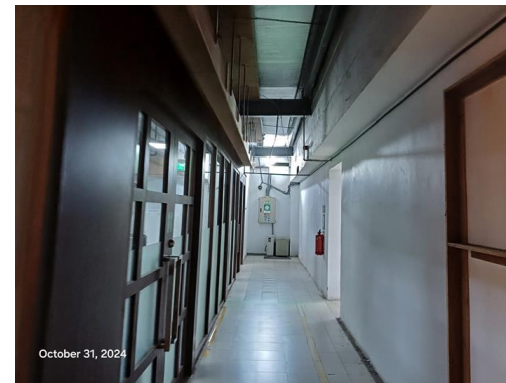
| SI No. | Category | Findings | Required Action | Remediation Time Frame |
|---|---|---|---|---|
| F-4 | Fire Rated Construction | Office area located at 1st floor is not separated from winding section. | <p>Ensure the office area fire separated by minimum 3-hr fire rated construction barrier with only occupancies with G and H following table 3.2.1 of BNBC-2006.</p> <p>Or, ensure that the office area is incidental to adjacent winding section having an area less than 10% in accordance to section 3.4.2 of RSC Technical Guideline.</p> | Within 3 months |

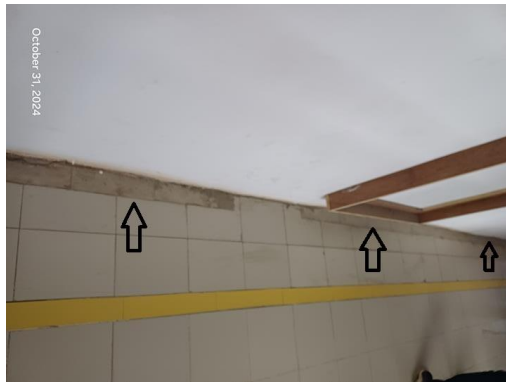
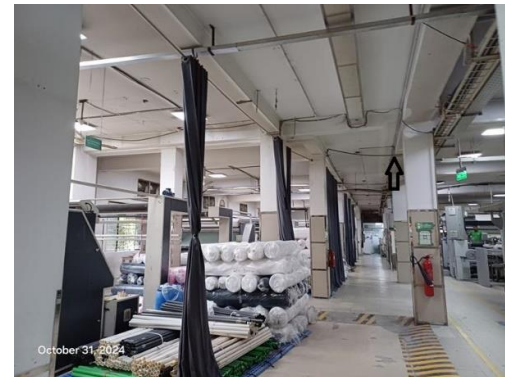
| SI No. | Category | Findings | Required Action | Remediation Time Frame |
|---|---|---|---|---|
| F-5 | Fire Rated Construction | Unsealed penetrations and openings are located in the fire-rated floor/ceiling assemblies due to expansion joint located at 1st floor slab of extended office building. | <p>Provide a minimum 2-hr fire rated shaft to separate the utility risers from each floor level or seal all penetrations and openings in floors/ceiling assemblies by 3-hr fire rated listed/certified materials. The installation of such fire rated materials shall be following certified design.</p> <p>Submit the proposed drawing/design to RSC for review. Once reviewed, install passive fire protection as per reviewed design.</p> | Within 3 months |

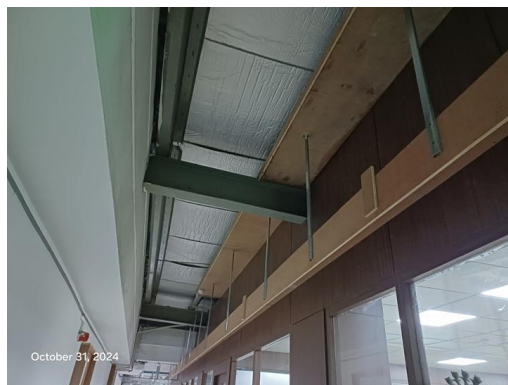
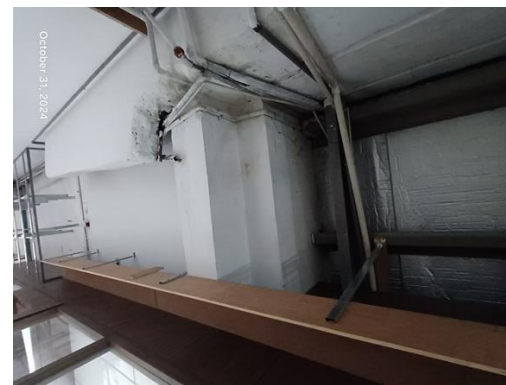
| SI No. | Category | Findings | Required Action | Remediation Time Frame |
|---|---|---|---|---|
| F-6 | Fire Rated Construction | The main structural elements (Rafter & Purlin on 1st floor roof) of the building are constructed by steel which is non-rated and were found in exposed condition without any fire protection. <b>(Interim Structure).</b> | Assess the steel part of building as per BNBC-2020. Submit the design philosophy and drawing and design to RSC for review. Once reviewed, according to requirement, install passive fire protection as per reviewed design. | Design within 2 months, installation/modification on within 4 months |

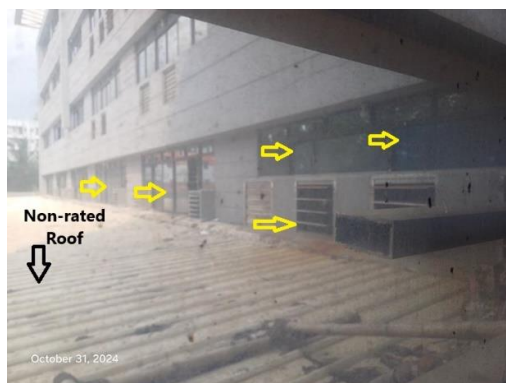
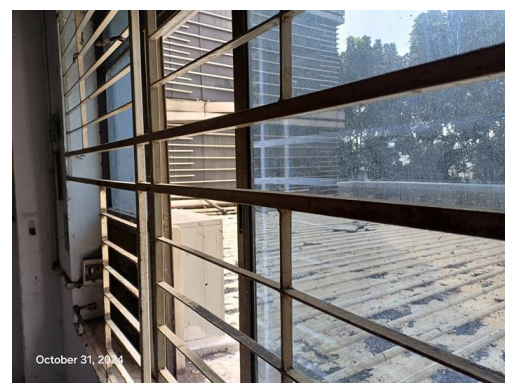
| SI No. | Category | Findings | Required Action | Remediation Time Frame |
|---|---|---|---|---|
| F-7 | Fire Rated Construction | Floor to floor separation is not ensured as the extended office building has non-rated structure on 1st floor roof and 6 storied production building has openings without any fire protection on 2nd floor. | Provide a minimum 3-hr fire resistance rating in floors/ceiling assemblies by applying listed/certified materials. The installation of such fire rated materials shall be following certified design. Or, seal the opening adjacent to shed on 2nd floor by fire rated construction. | Within 3 months |

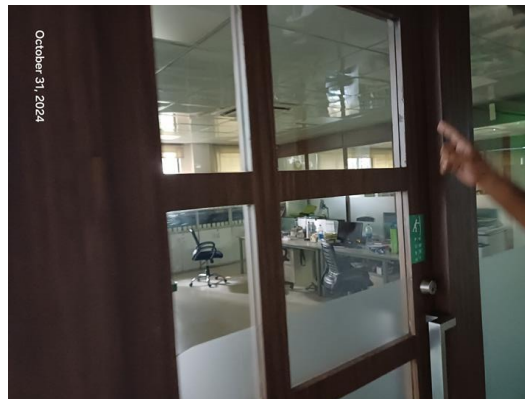
| SI No. | Category | Findings | Required Action | Remediation Time Frame |
|---|---|---|---|---|
| F-8 | Means of egress | Egress doors and gates with locking features are provided at office rooms located at 1st floor of extended office building. | <p>Remove locking features from all egress doors and gates. If locks are required for security reasons, utilize special door locking features complying with NFPA 101 and RSC standard 6.8.2.</p> <p>Or, integrate the locking devices with FACP in such a way that upon triggering alarm all door locking mechanism released.</p> | Within 1 month |

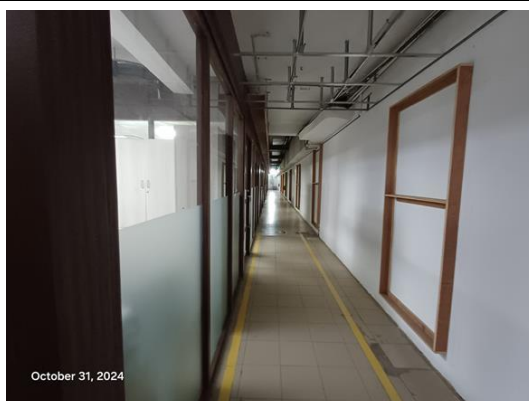
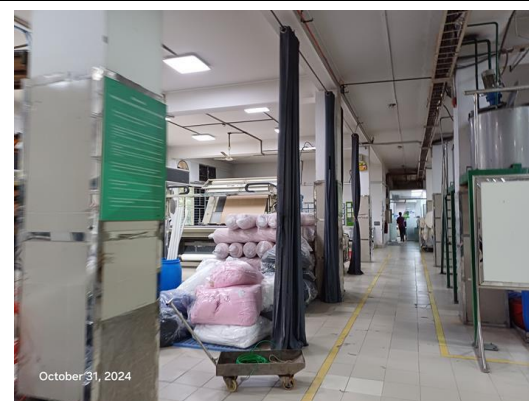
| SI No. | Category | Findings | Required Action | Remediation Time Frame |
|---|---|---|---|---|
| F-9 | Emergency Lighting | Based on the number and location of emergency lights observed, adequate illumination levels are not anticipated along egress routes and at exit stairs on all floors.<br>Location: Corridor of office on 1st floor, aisles on ground floor | Test the emergency lighting system on each floor and provide additional emergency fixtures to supply adequate illumination along the means of egress. Provide a minimum illumination of 10 lux at the floor level within exit stairs and along exit discharge paths and a minimum 2.5 lux along exit access aisles. | Within 1 month |

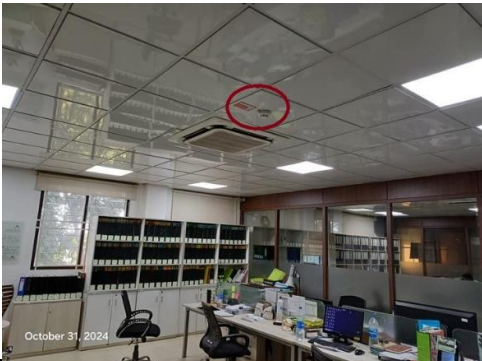
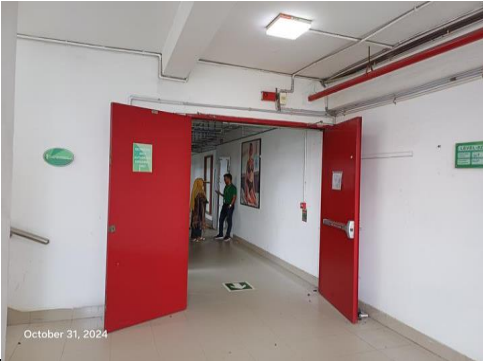
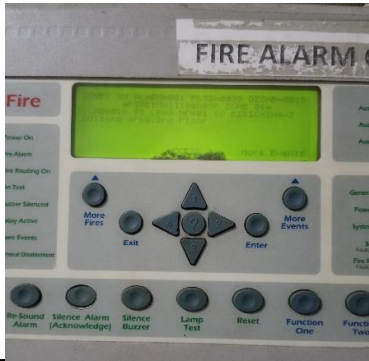
| SI No. | Category | Findings | Required Action | Remediation Time Frame |
|---|---|---|---|---|
| F-12 | Fire Alarm & Detection System (FADS) | SQ Birichina Ltd Unit 2 - Extension [ID-25621] and SQ Birichina Ltd Unit 2 (previously SQ Colblanc Limited) [ID- 12229] are in single fire compartment. All the buildings have been provided with addressable fire alarm and detection system. In extension office building centralized fire alarm and detection system (FACP- "KENTEC", Loop-6 used for extension office building) installation work is almost in finished level which required details review & verification. | Submit as-built drawings, testing records, equipment certification and other relevant documentation to the RSC for review and approval. Modification (if required) shall have to done as per the reviewed design and NFPA- 72. Upon approval & modification (if required) the factory shall inform RSC to conduct final testing and commissioning verification of the system for final acceptance. | Design within 2 months, installation/modification on within 4 months |

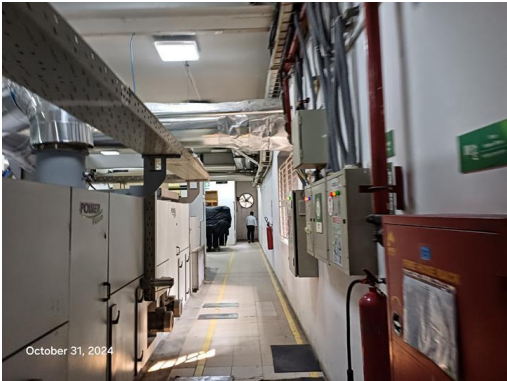
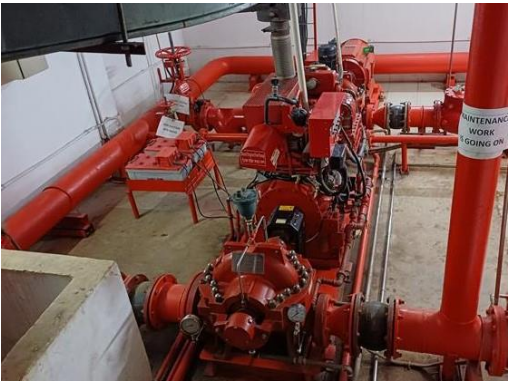
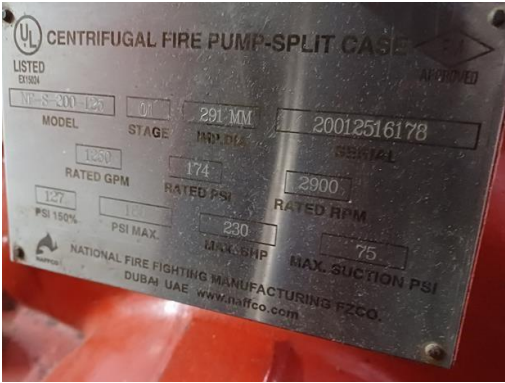
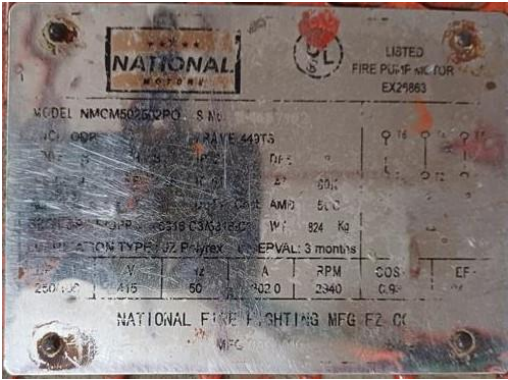
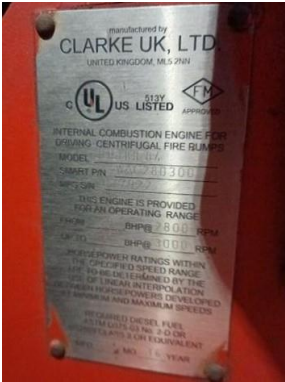
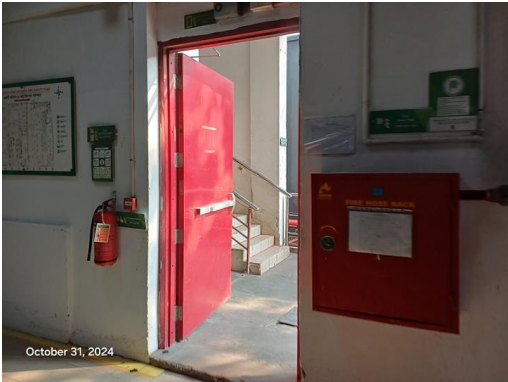
| SI No. | Category | Findings | Required Action | Remediation Time Frame |
|---|---|---|---|---|
| F-14 | Fire Protection System | <p>Height of the highest occupied floor level of the extended office building is 4.57 m (15.0 feet). But, SQ Birichina Ltd Unit 2 - Extension [ID-25621] and SQ Birichina Ltd Unit 2 (previously SQ Colblanc Limited) [ID- 12229] are in single fire compartment. and height of occupied floor of 6 storied main production building is more than 10.0m.</p> <p>According to the height of the highest occupiable floor class III standpipe system is required.</p> | <p>Submit the as-built standpipe system, fire pump and water supply system drawing to RSC for review. Once reviewed, install or modify the standpipe system throughout the building in accordance with RSC standard and NFPA 14,20,22 and 24.</p> <p>After installation the owner shall contact the RSC for witness of conducting the final acceptance testing of the standpipe system, fire pump and water supply system.</p> | Design within 2 months, installation/modification on within 4 months |
