# Knittex Industries Limited (Extension)

Plot: 247-252, Baimile, Konabari, Gazipur

1 January 2025

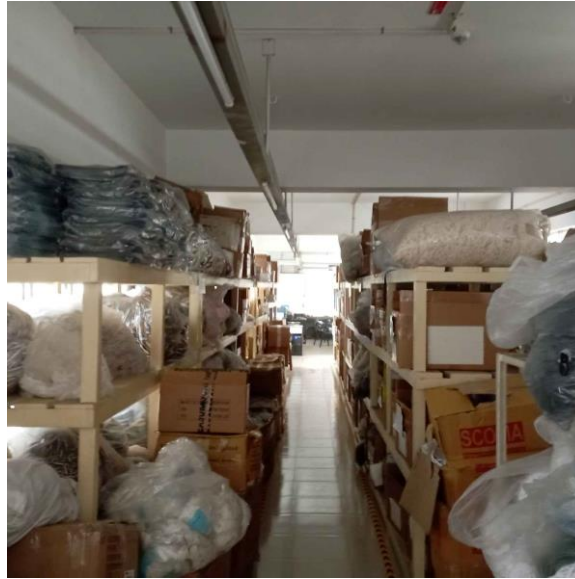
**Observation-5:** Nonstructural elements found not anchored/braced (Building 02 & 03).

**Description:** Nonstructural elements (storage racks) were found not anchored/braced. The building engineer is required to anchor/brace all nonstructural elements within the factory.

8.		Also, repair the crack on the beam using a suitable method.	within 6 weeks
9.	Nonstructural elements found not anchored/braced (Building 02 & 03).	The building engineer is required to anchor/brace all nonstructural elements within the factory.	within 6 months

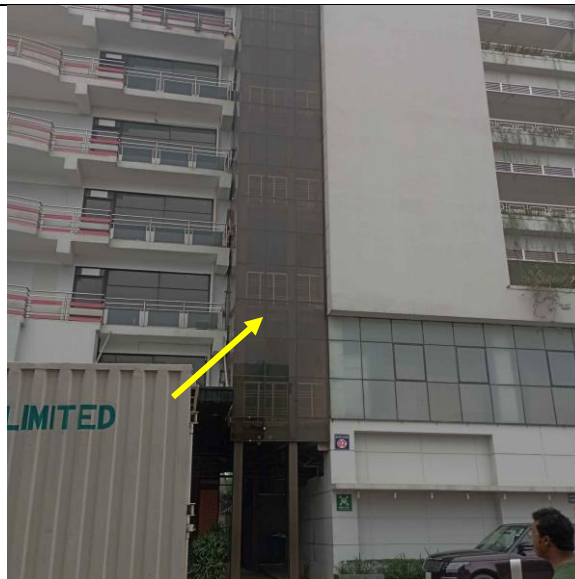
**Observation 6:** Lack of design report (Connecting bridge).

**Description:** As per BNBC, every building or structure designed shall have its design documents prepared by the provision of Section 1.9.1. The design document shall include a design report, and a set of structural drawings, which shall be prepared in compliance with section 1.9.1.1 and section 1.9.1.2 as per BNBC. At the time of inspection, the design report was not available, which is required to be prepared in compliance with section 1.9.1.1 (part 6, BNBC).

10.		The building engineer is required to prepare a design report in compliance with section 1.9.1.1 (part 6, BNBC).	within 6 weeks
11.	Lack of design report (Connecting bridge).	Implement remediation work if required.	within 6 months
12.	Corrosion on steel members (Connecting bridge).	The building engineer is required to provide rust-proof paint on steel members.	within 6 weeks
13.		The building engineer is required to check the column for slenderness ratio and incorporate it in the design report.	within 6 weeks
14.	The column appears to be slender (Building 6).	Implement remediation work if required.	within 6 months

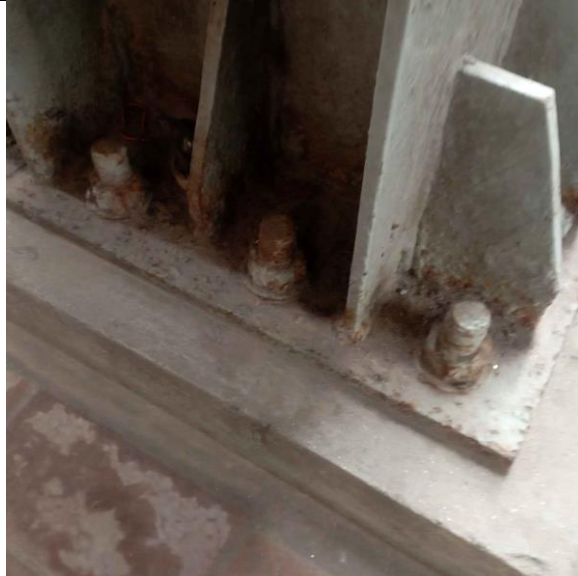
**Observation 7:** Corrosion on steel members (Connecting bridge).

**Description:** Corrosion was observed on steel members at the connecting bridge. The building engineer is required to provide rust-proof paint on steel members.

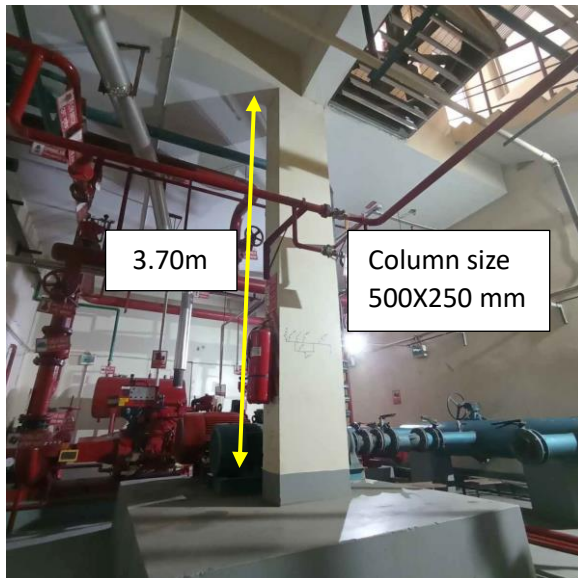
**Observation 8:** The column appears to be slender (Building 6).

**Description:** The column appears to be slender due to high unsupported length. The building engineer is required to check the column for slenderness ratio and incorporate it in the design report.
