ASWAD COMPOSITE MILLS LTD. (U-2) (EXTENSION)

Kabirpur, Ashulia, Savar
(24.010700, 90.247947)

5 December 2024

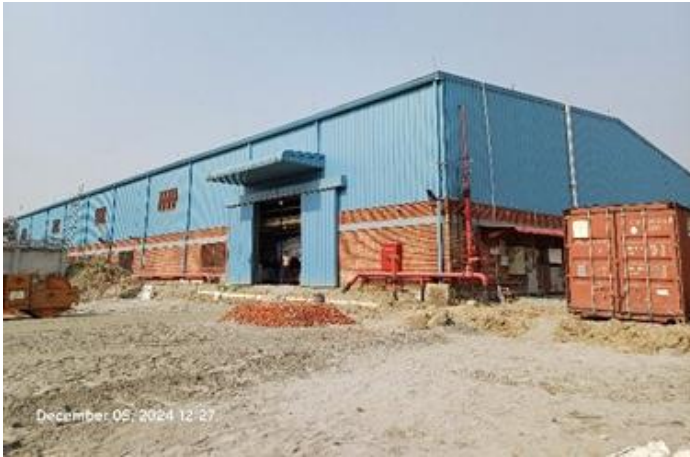
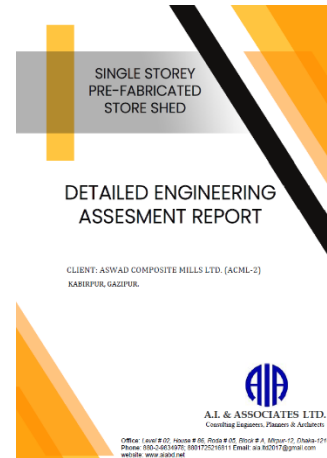
Observation-1: Lack of information in design documents. (Single-Storeyed Prefabricated Shed)

Description: A DEA report was available for the shed. The connection adequacy of structural members (Column-rafter, rafter-rafter etc.) was not incorporated in the report. The building engineer is required to check the connection adequacy of all types of connections and incorporate them in the design report. Submit revised design documents to the RSC for detailed review against lateral forces.

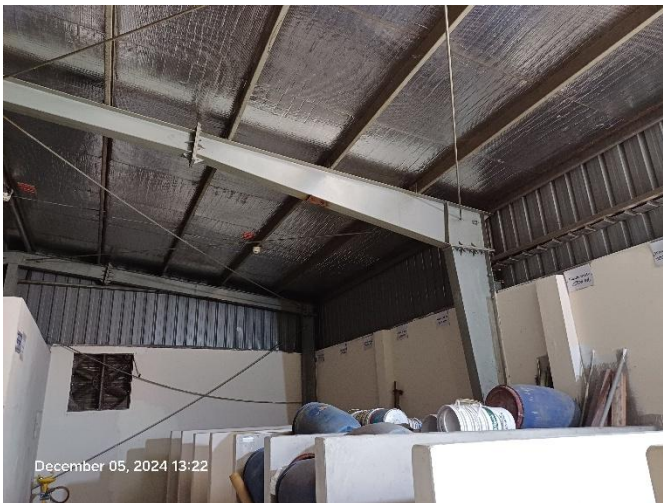
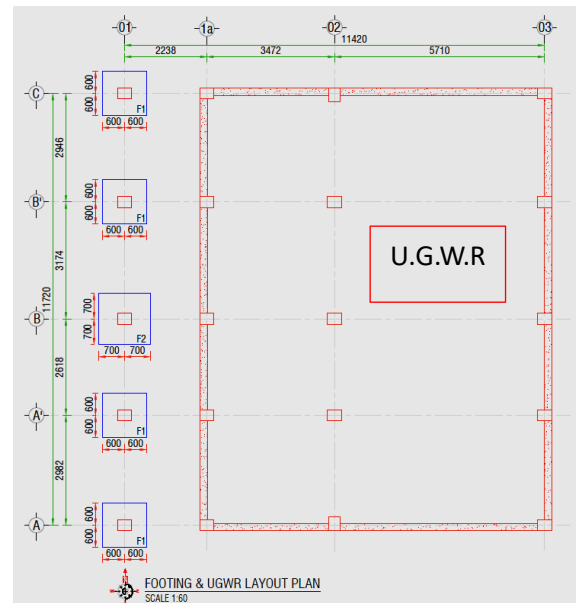
Observation-2: Lack of lateral stability. (Wastage Shed)

Description: Lateral load transfer media compression struts were missing along the long direction at the ridge/eave. So, the lateral stability system of the structure is incomplete. Also, the shed rests on the top slab of the underground water reservoir. However, no load plan was prepared for the suspended slab. The building engineer is required to prepare design documents (considering lateral stability) following section 1.9.1 (part-6, BNBC) and submit to the RSC for detailed review. Also, produce and actively manage a loading plan for suspended floor plate.

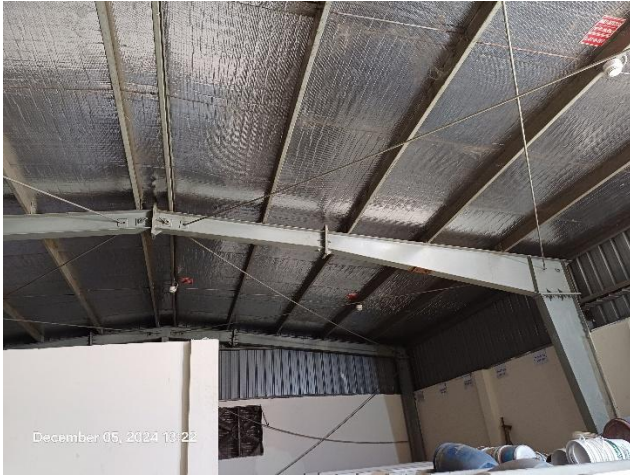
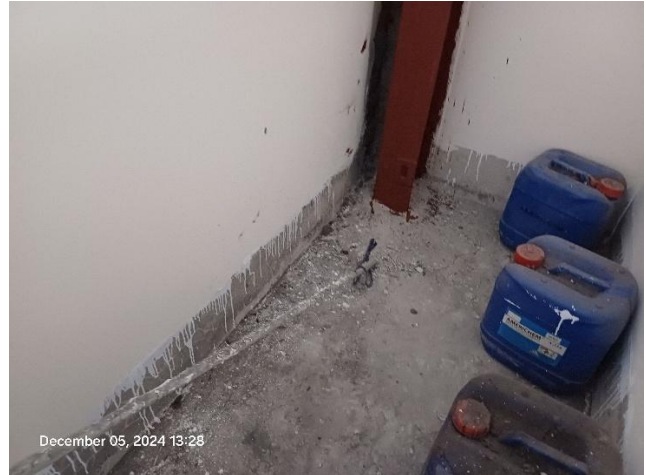
Observation-3: Disconnected wall bracing. (Wastage Shed)

Description: A disconnected wall bracing was found on the south side of the shed. The factory mentioned that it was disconnected for maintenance work. However, the building engineer is required to reinstall the disconnected bracing.

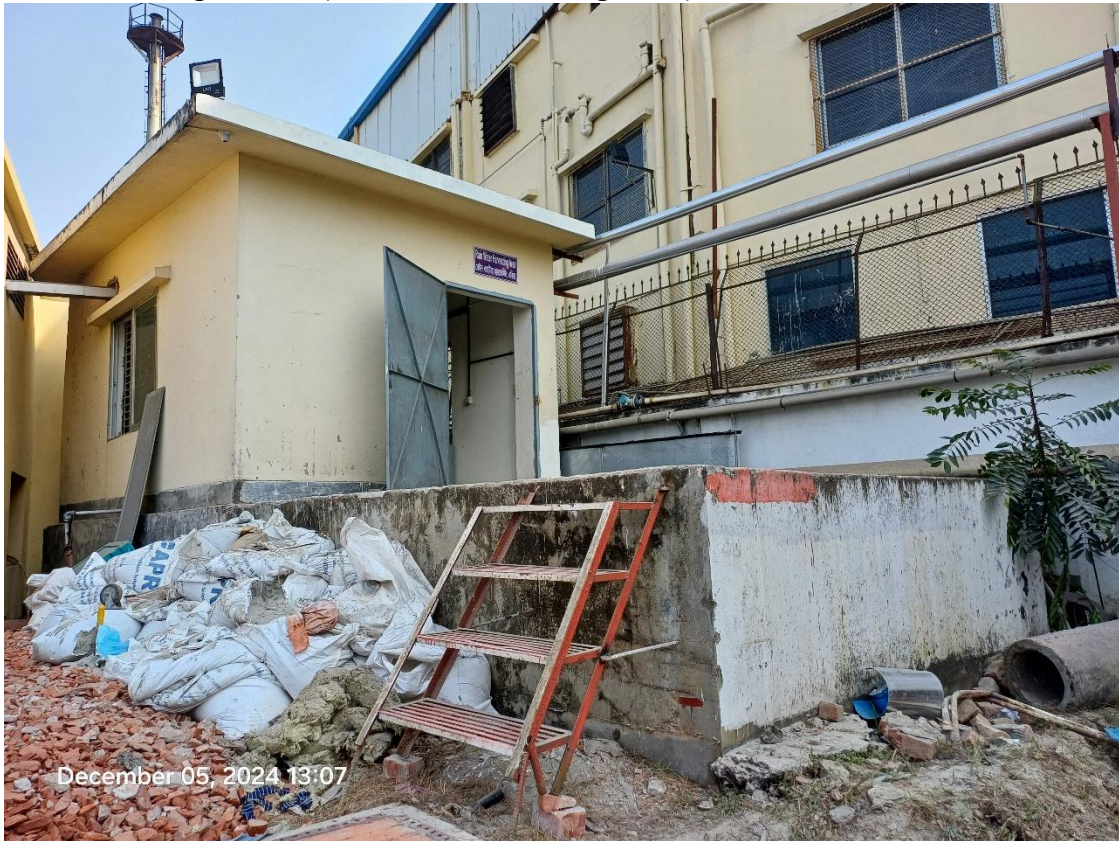
Observation-4: Falling Hazard. (Rainwater Harvesting Plant)

Description: Railing was not provided for the stair and elevated platform which may cause falling hazards. The factory is required to provide a railing to avoid possible falling hazards.

7	Falling Hazard. (Rainwater Harvesting Plant)	The factory is required to provide a railing/barrier to avoid possible falling hazards.	within 6 weeks
