Soorty Textiles (BD) Ltd. (Extension -2)

Plot # 241-242, Cumilla EPZ, Cumilla, Bangladesh

24 December 2024

1. Building Information

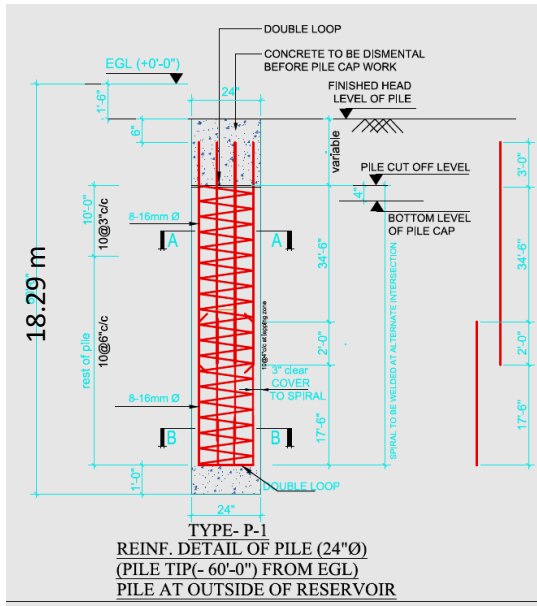
Sectional details of P1

Observation-1: Inconsistencies in the design report. (Production Building)

Description: As-built drawings showed two types of pile P1 (length 18.29m) and P2 (length 15.85m). But in design report, the capacity used to check pile capacity is 285 kip (each pile). Also, for SMRF consideration joint shear check was missing in the design report as per BNBC.

The building engineer is required to address the issues mentioned and revise the design report and submit the revised design documents to the RSC for review.

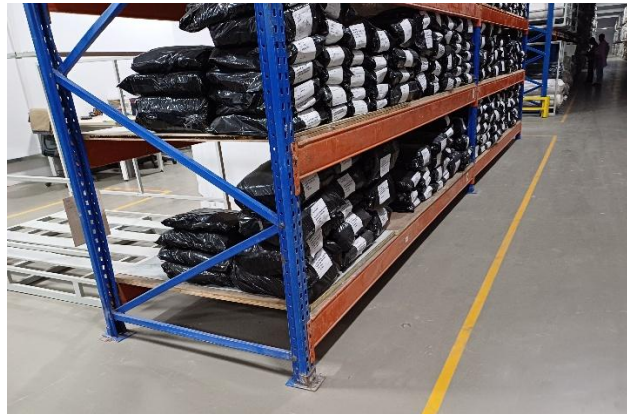
Observation-2: Unbraced storage racks on different floors. (Production Building)

Description: Unbraced storage racks were observed on different floors. The building engineer is required to provide anchorage/bracing to the storage racks to protect them from falling hazards.

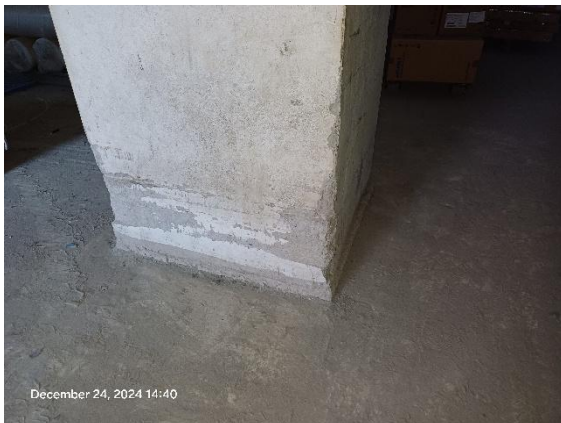
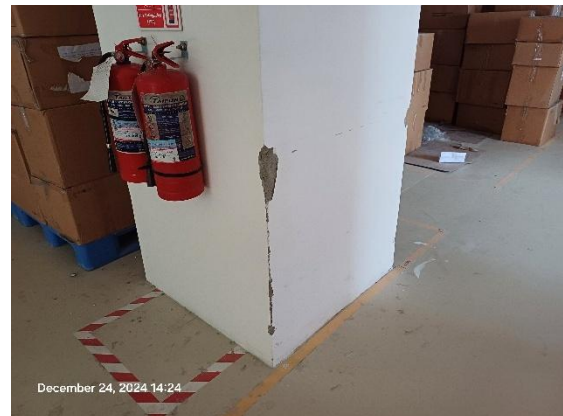
Observation-3: Column Susceptible to trolley impact. (Production Building)

Description: Columns are susceptible to trolley impact on different floor levels. Building engineer is required to take necessary action to prevent the trolley impact with the columns.

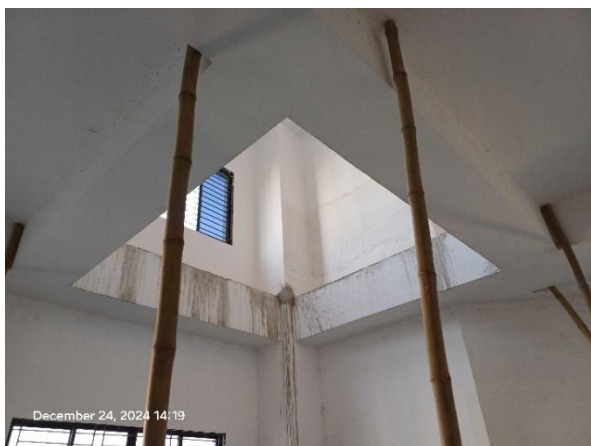
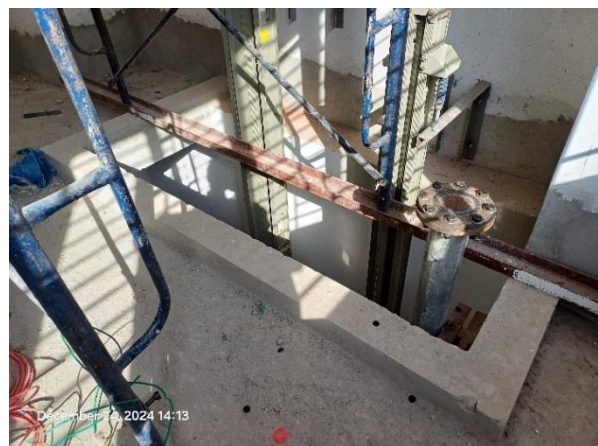
Observation 4: Falling Hazard through slab opening (Production Building).

Description: Falling hazard was observed through the slab opening in the spiral conveyor room and electrical room. The building engineer is required to take necessary measures to avoid possible falling hazards.

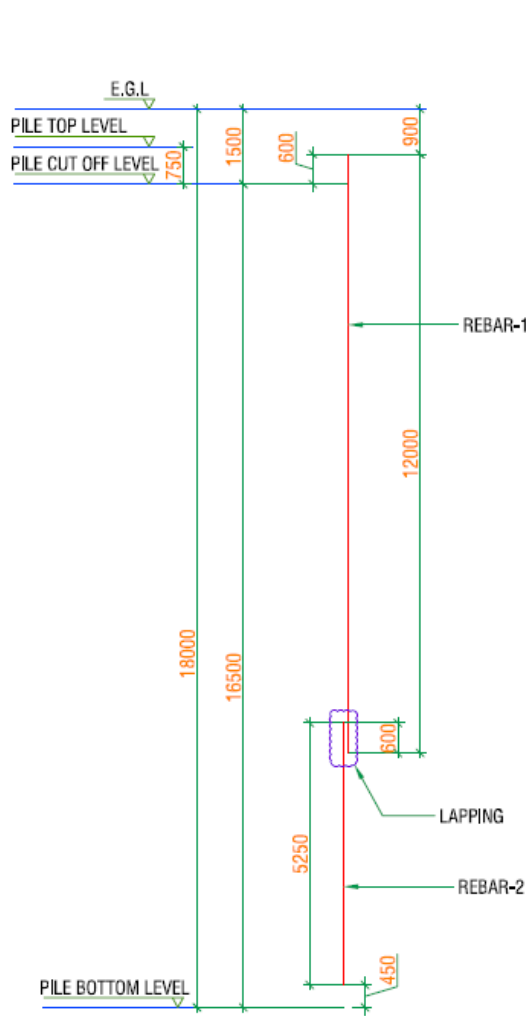
REBAR CUTTING DETAIL FOR PILE

Observation-5: Inconsistencies in the design report. (Service Building -A)

Description: The as-built drawings showed the pile length from EGL as 18m, but in the design report, it was considered 15.24m. Also, 8 no's 16mm bar was provided in the pile as per the as-built drawing, but the calculation shows 7 no's 16mm rebar. However, the pile requirement is more than one in the joint label '7', but the final pile number is one.

The building engineer is required to address the issues mentioned, revise the design report, and submit the revised design documents to the RSC for review.

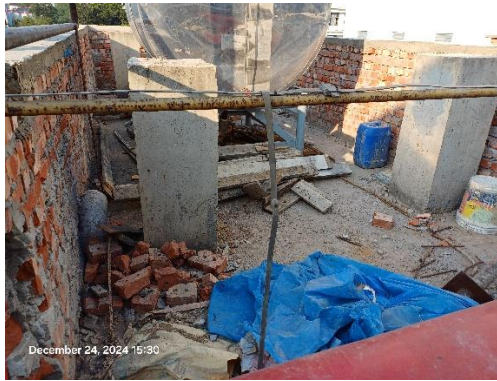
Observation-6: Construction materials on the roof level. (Service Building -A)

Description: Construction materials were found on the roof level. The building engineer is required to remove all kinds of construction materials from the roof.

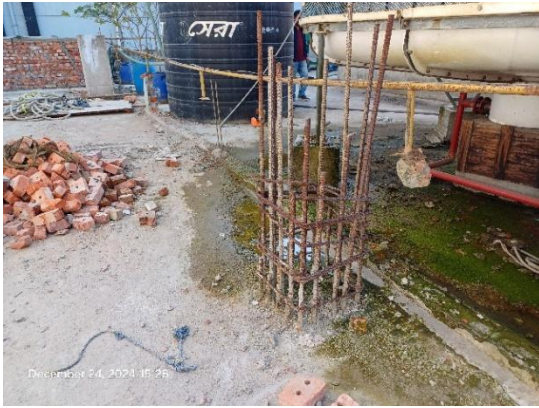
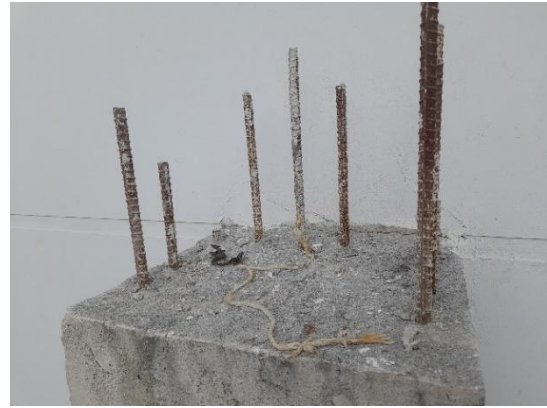
Observation-8: Exposed re-bar on the roof level. (Service Building -B)

Description: Exposed re-bar was observed on the roof, which is prone to corrosion. The building engineer is required to provide anti-corrosive coating on the exposed rebar.

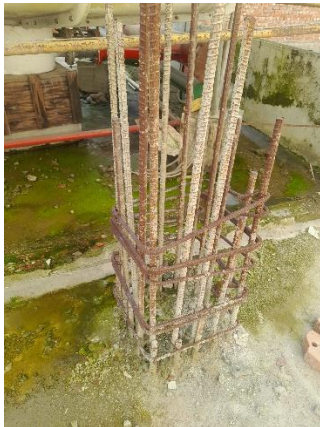
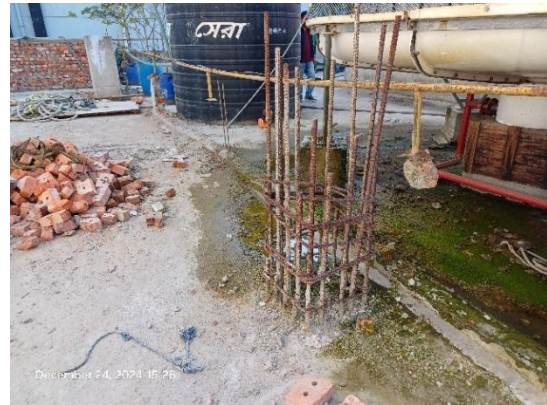
Observation-9: Standing water and dampness on the roof. (Service Building -B)

Description: Standing water and dampness were observed on the roof. Building engineer is required to improve the drainage system on the roof and repair the dampness with a suitable method.

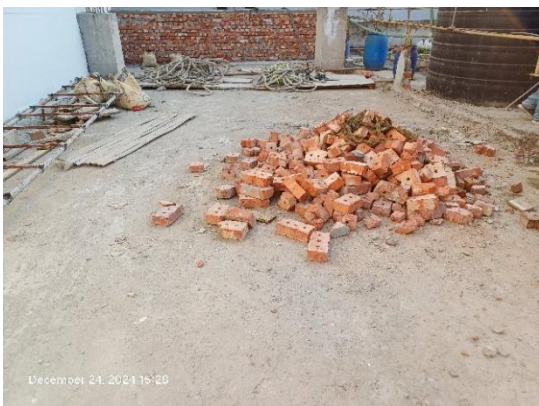
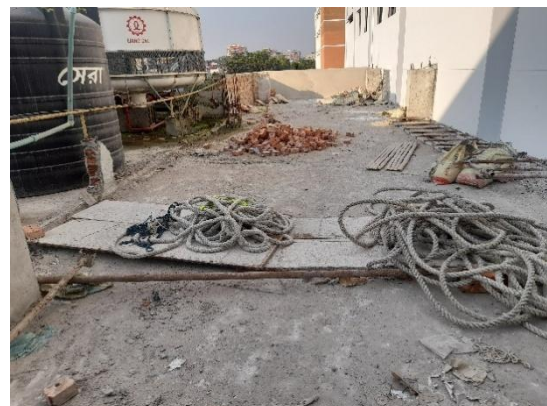
Observation-10: Construction materials on the roof level. (Service Building -B)

Description: Construction materials were found on the roof level. Building engineer is required to remove all kinds of construction materials from the roof.

13	Construction materials on the roof level. (Service Building -B)	Building engineer is required to remove all kinds of construction materials from the roof.	within 6 weeks

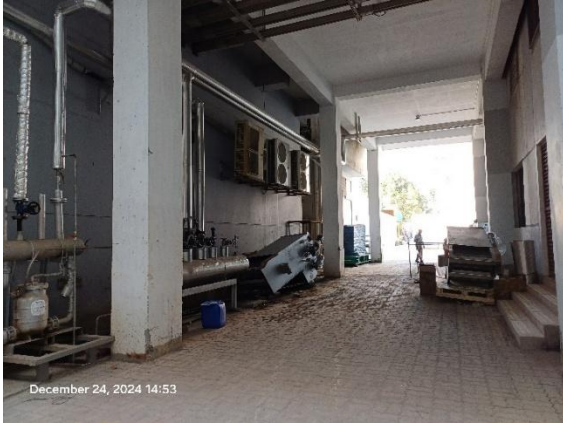
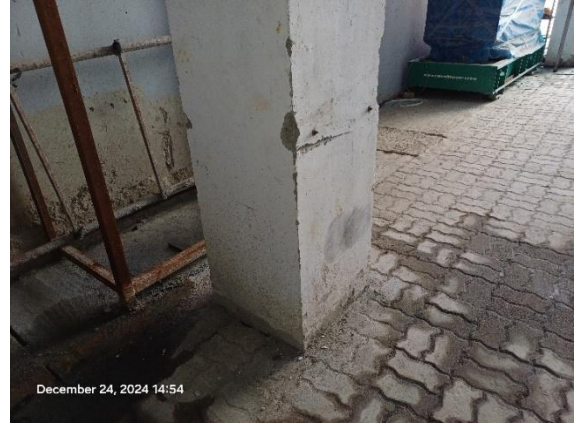
Observation-11: Column susceptible to vehicle impact. (Service Building -B)

Description: The ground floor of this building is part of an internal road. So, columns in the ground floor area are susceptible to vehicle impact. The building engineer is required to provide separate barriers around the column to prevent vehicle impact.

14	Column susceptible to vehicle impact. (Service Building -B)	The building engineer is required to provide separate barriers around the column to prevent vehicle impact.	within 6 weeks
----	---	---	----------------
