# Snowtex Outer Wear Ltd (Extension)

Plot#65/3, Lakuria para, Dhamrai, Dhaka, Bangladesh

12 January 2025

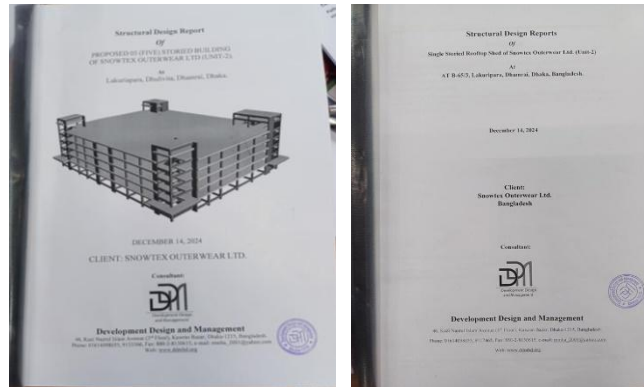
### Observation-1: Design report needs to be reviewed against lateral forces. [Building-10 (Unit-2)]

**Description:** The building engineer has prepared the design report based on BNBC code. Submit design documents to the RSC for detail review against lateral forces.

| Item No | Observation | Action Plan | Timeline |
|---|---|---|---|
| 1. | Design report needs to be reviewed against lateral forces. [Building-10 (Unit-2)] | The building engineer is required to submit design documents to the RSC for detailed review against lateral forces. | within 6 weeks |
| 2. | | Carry out remedial work if required. | within 6 months |

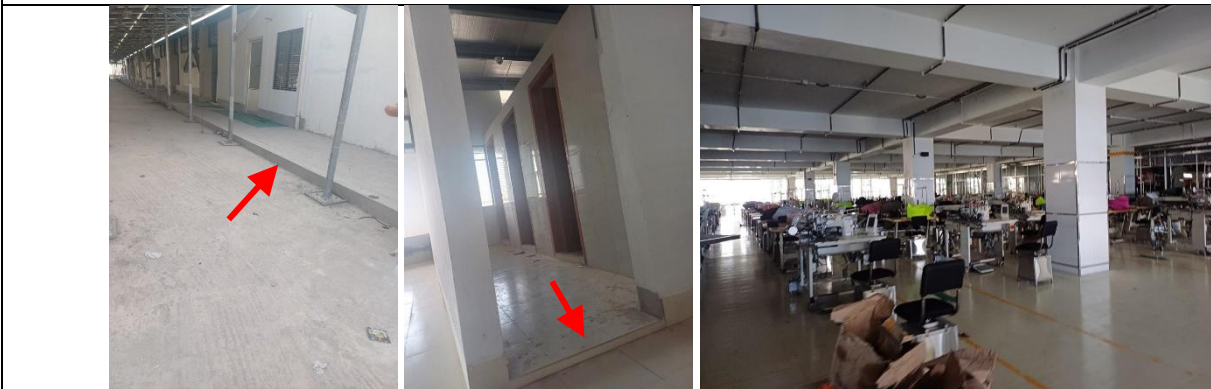
### Observation-2: Mismatch between as-built drawing and on-site condition. [Building-10 (Unit-2)]

**Description:** During inspection, floor raise (150 mm for rooftop shed platform & 75 mm for toilet zone) was found which was not mentioned in the drawing. Also, top floor was mentioned as vacant, but some idle machineries were found on site. The building engineer is required to survey the structure and update the accurate as-built drawing as per actual site condition.

| Item No | Observation | Action Plan | Timeline |
|---|---|---|---|
| 3. | Mismatch between as-built drawing and on-site condition. [Building-10 (Unit-2)] | The building engineer is required to survey the structure and update the accurate as-built drawing as per actual site condition. | within 6 weeks |

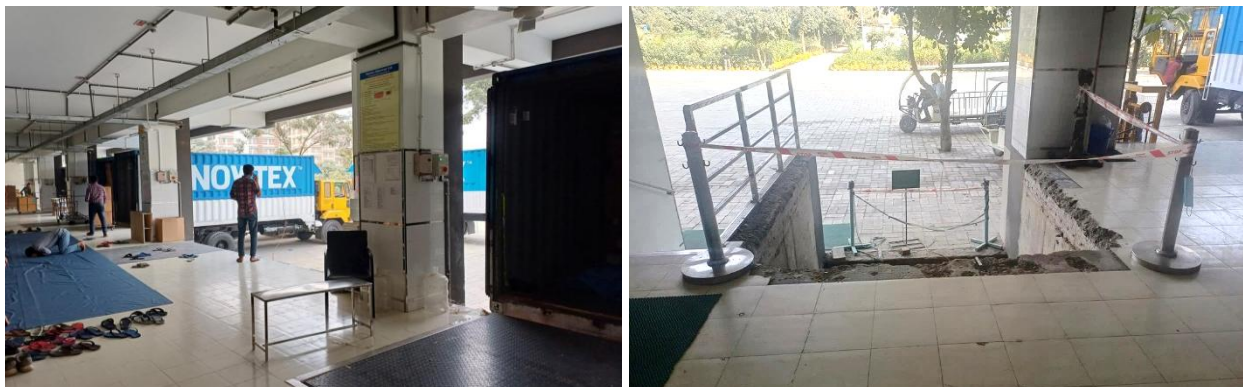
### Observation-3: Potential falling hazard at the loading-unloading zone. [Building-10 (Unit-2)]

**Description:** During the inspection, it was noted that the elevated loading-unloading platform lacked railings or barriers at its edges, creating a potential falling hazard. The factory is required to install appropriate safety barriers or railings to mitigate the risk of falls and ensure compliance with safety standards.

| Item No | Observation | Action Plan | Timeline |
|---|---|---|---|
| 4. | Potential falling hazard at the loading-unloading zone. [Building-10 (Unit-2)] | The building engineer is required to install appropriate safety barriers or railings to mitigate the risk of falls and ensure compliance with safety standards. | within 6 weeks |

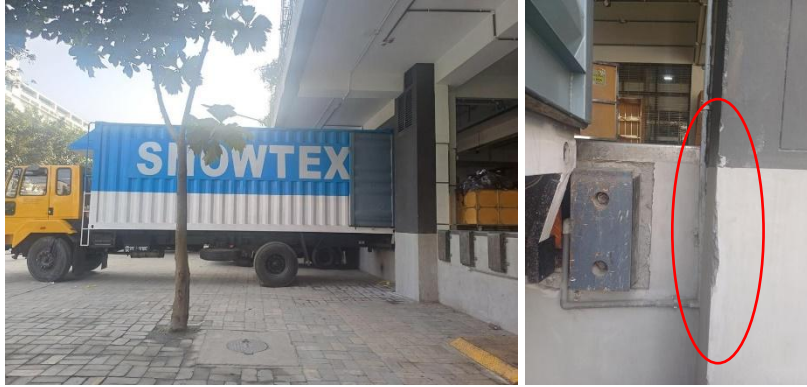
**Observation-4:** Ground floor column susceptible to vehicle impact. [Building-10 (Unit-2)]

**Description:** The ground floor columns were susceptible to vehicle impact. The building engineer is required to provide separate barriers around the columns to avoid impact from the vehicles.

| Item No | Observation | Action Plan | Timeline |
|---|---|---|---|
| 5. | Ground floor column susceptible to vehicle impact. [Building-10 (Unit-2)] | The building engineer is required to provide separate barriers around the columns to avoid impact from the vehicles. | within 6 weeks |

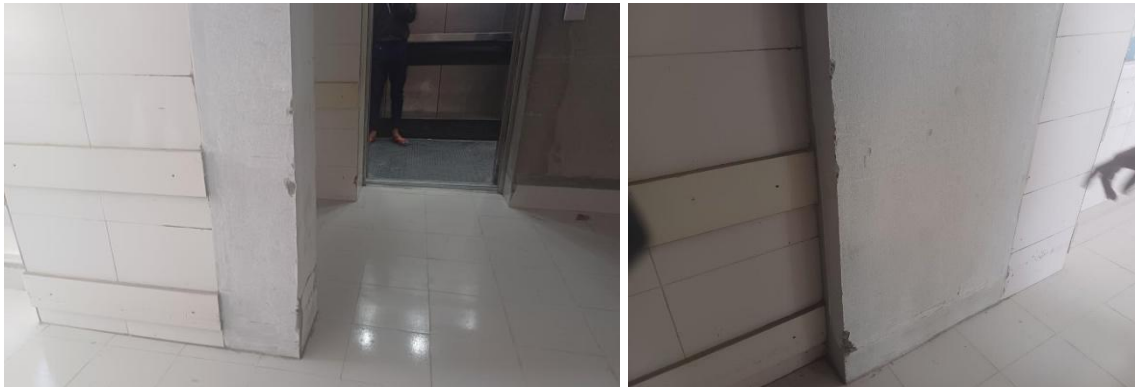
**Observation-5:** Trolley impact on columns surface. [Building-10 (Unit-2)]

**Description:** The cover of floor columns was damaged due to trolley impact. The building engineer is required to provide column/wall guard to protect the trolley impact.

| Item No | Observation | Action Plan | Timeline |
|---|---|---|---|
| 6. | Trolley impact on columns surface (Unit-2). | The building engineer is required to provide column/wall guard to protect the trolley impact. | within 6 weeks |

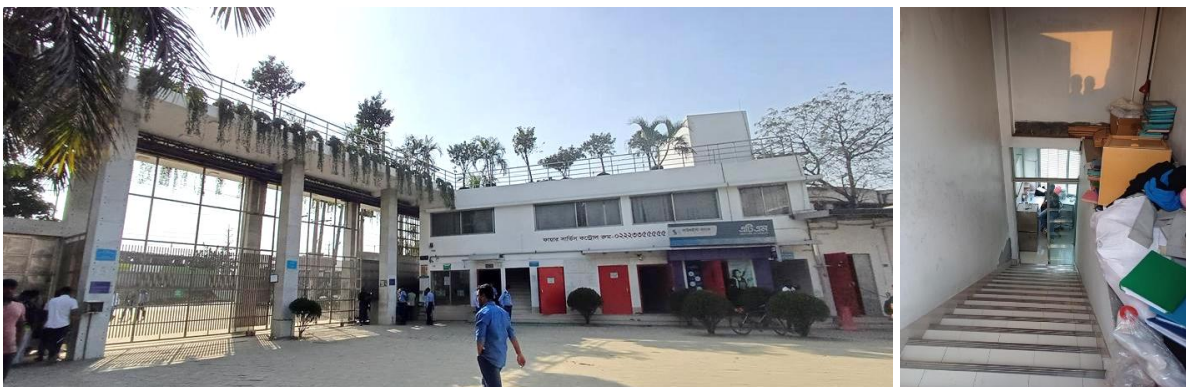
**Observation-6:** Lack of design report. [Building-3 (Security Childcare & Medical)]

**Description:** There was no design report for the building. The building engineer is required to prepare necessary design documents including design report, as-built drawings, floor load plan following BNBC section 1.9.1. Include the one-way stair slab adequacy check in the design report. Submit the design documents to the RSC for review.

| Item No | Observation | Action Plan | Timeline |
|---|---|---|---|
| 7. | Lack of design report. [Building-3 (Security Childcare & Medical)] | The building engineer is required to prepare necessary design documents including design report, as-built drawings, floor load plan following BNBC section 1.9.1. Include the one-way stair slab adequacy check in the design report. Submit the design documents to the RSC for review. | within 6 weeks |
| 8. | | Carry out remedial work if required. | within 6 months |

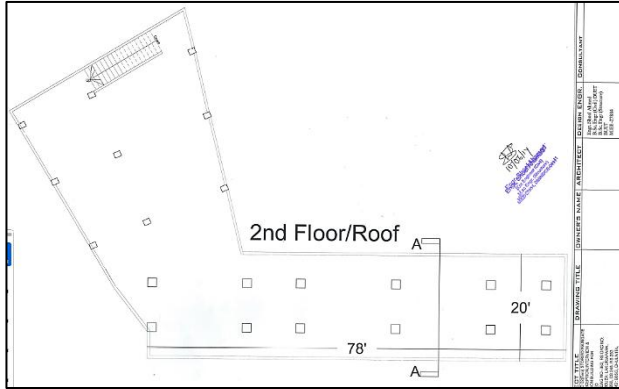
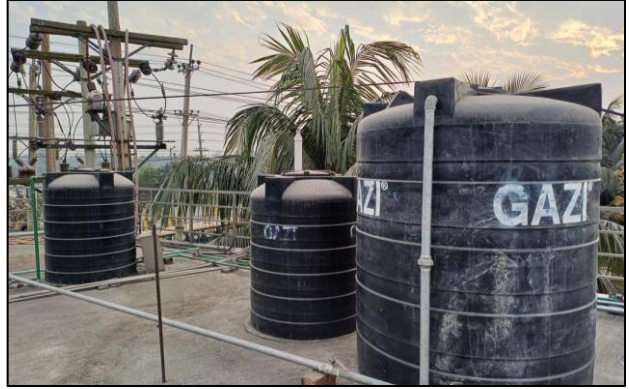
**Observation-7:** Lack of information in the as-built drawing.

**Description:** 3 water tanks were observed on the roof which were not shown in the drawing. The building engineer is required to survey the structure and update the accurate as-built drawing as per actual site condition.

| Item No | Observation | Action Plan | Timeline |
|---|---|---|---|
| 9. | Lack of information in the as-built drawing. [Building-3 (Security Childcare & Medical)] | The building engineer is required to survey the structure and update the accurate as-built drawing as per actual site condition. | within 6 weeks |

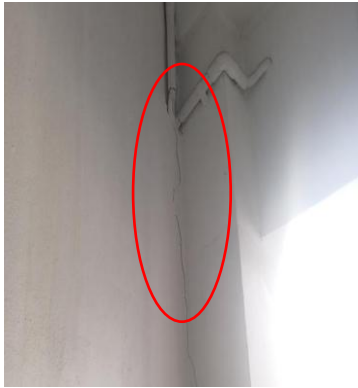
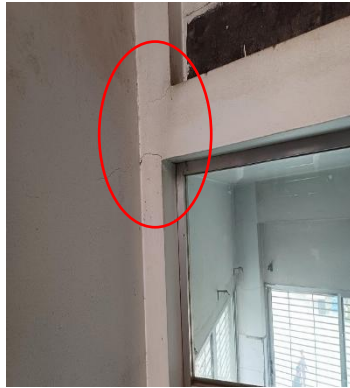
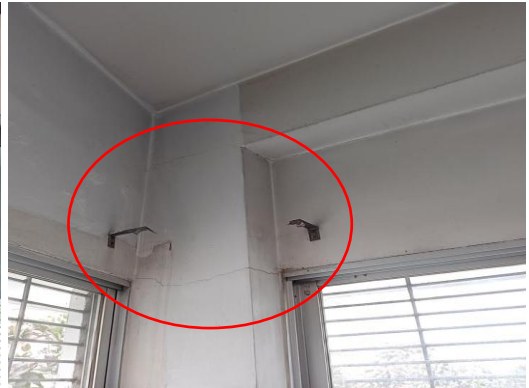
**Observation-8:** Crack in brick wall. [Building-3 (Security Childcare & Medical)]

**Description:** Several cracks in brick walls were observed in the cantilever stair portion of the building. The building engineer is required to investigate the reason for the crack and repair the cracks following suitable repair methodology.

| Item No | Observation | Action Plan | Timeline |
|---|---|---|---|
| 10. | Crack in brick wall. [Building-3 (Security Childcare & Medical)] | The building engineer is required to investigate the reason for the crack and repair the cracks following suitable repair methodology. | within 6 weeks |

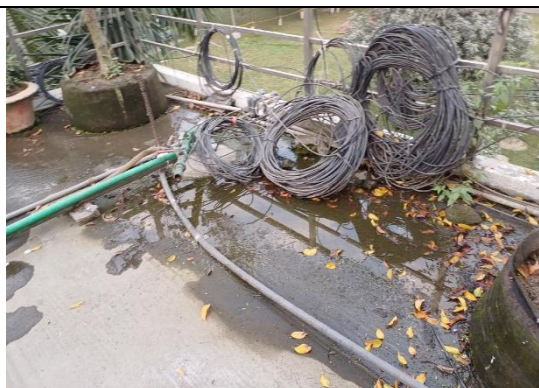
**Observation-9:** Lack of drainage system on the roof. [Building-3 (Security Childcare & Medical)]

**Description:** Water ponding was observed on the roof. The building engineer is required to improve the roof drainage system with proper slope and an adequate number of water outlets.

| Item No | Observation | Action Plan | Timeline |
|---|---|---|---|
| 11. | Lack of drainage system on the roof. [Building-3 (Security Childcare & Medical)] | The building engineer is required to improve the roof drainage system with proper slope and an adequate number of water outlets. | within 6 months |

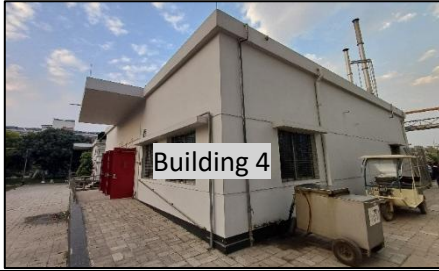
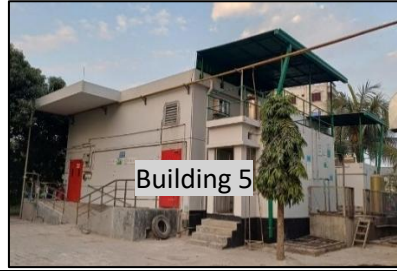
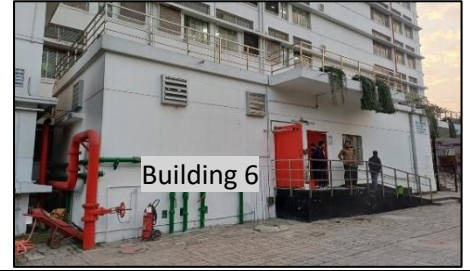
**Observation-10:** Cantilevered canopy missing in the as-built drawings of Building-4 (Compressor & Boiler), Building-5 (Chemical Store), and Building-6 (Fire Pump room).

**Description:** Canopy details were missing in the as-built drawings of Building-4 (Compressor & Boiler), Building-5 (Chemical Store), and Building-6 (Fire Pump room). The building engineer is required to survey the structure and update the accurate as-built drawing as per actual site condition.

| Item No | Observation | Action Plan | Timeline |
|---|---|---|---|
| 12. | Cantilever canopy missing in the as-built drawings of Building-4 (Compressor & Boiler), Building-5 (Chemical Store), and Building-6 (Fire Pump room) | The building engineer is required to survey the structure and update the accurate as-built drawing as per actual site condition. | within 6 weeks |

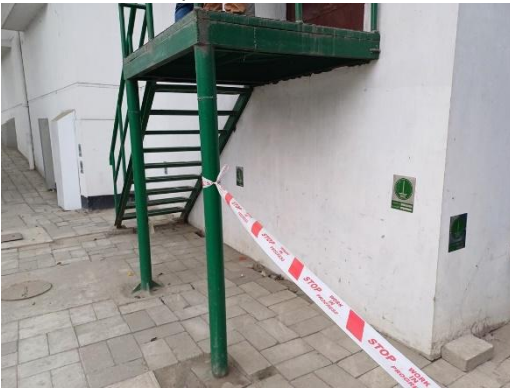
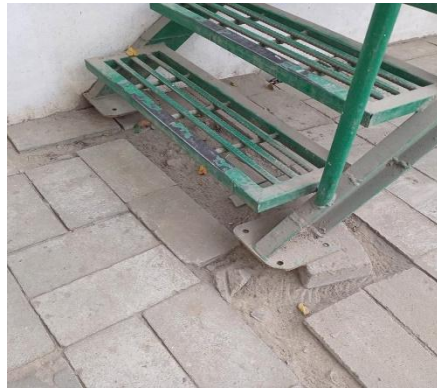
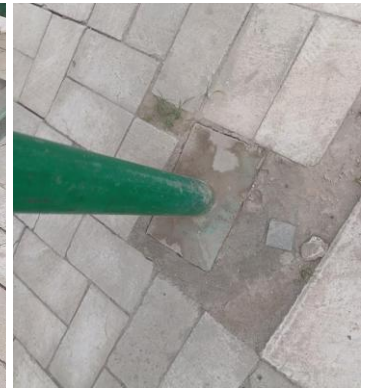
**Observation-11:** Lack of foundation and anchorage for external steel stairs adjacent to Building-7 (33 KV Substation).

**Description:** Lack of foundation and anchorage was observed for the external steel stair. The building engineer is required to provide required anchorage and prepare as-built drawings.

| 13. | Lack of foundation and anchorage for external steel stairs adjacent to Building-7 (33 KV Substation). | The building engineer is required to provide required foundation, anchorage, and prepare as-built drawings. | within 6 weeks |

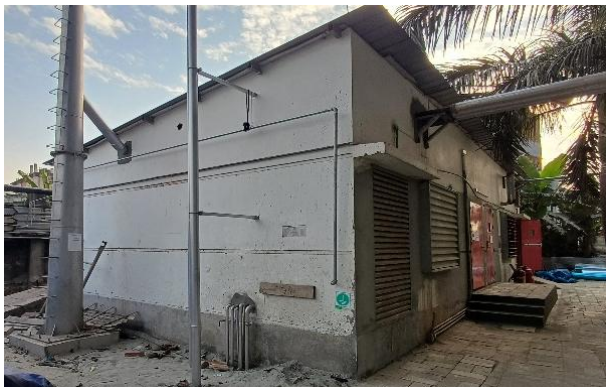
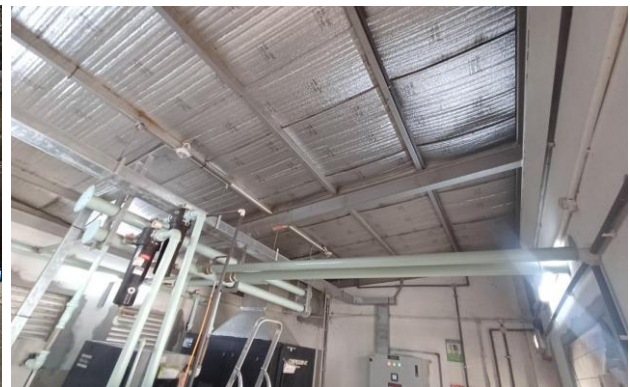
**Observation-12:** Lack of connection detail in the as-built drawings for Building-8 (Compressor Shed).

**Description:** The connection between frames and purlins was not shown in the drawing. The building engineer is required to survey the structure and update the accurate as-built drawing as per actual site condition.

| 14. | Lack of connection detail in the as-built drawings for Building-8 (Compressor Shed). | The building engineer is required to survey the structure and update the accurate as-built drawing as per actual site condition. | within 6 weeks |

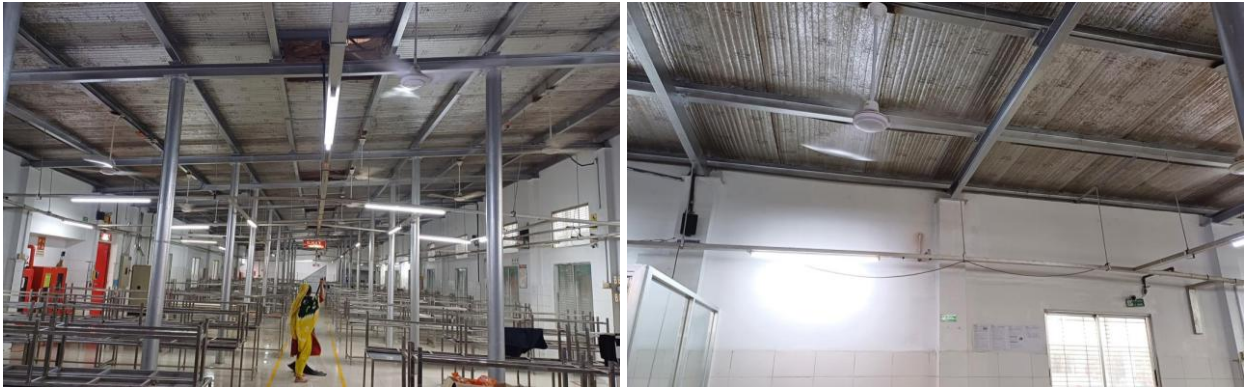
**Observation-13:** Lack lateral load transfer media (bracing & strut) in the Shed-1 (Dining Shed).

**Description:** Lack of bracing system along the long direction of the shed was observed. The building engineer is required to check the lateral stability system (bracing & strut) of the shed and prepare an Engineering Assessment (EA) report with proper remedial actions.

| 15. | Lack lateral load transfer media (bracing & strut) in the Shed-1 (Dining Shed). | The building engineer is required to check the lateral stability system (bracing & strut) of the shed and prepare an Engineering Assessment (EA) report with proper remedial actions. | within 6 weeks |
| 16. | | Carry out necessary remedial works | within 6 months |

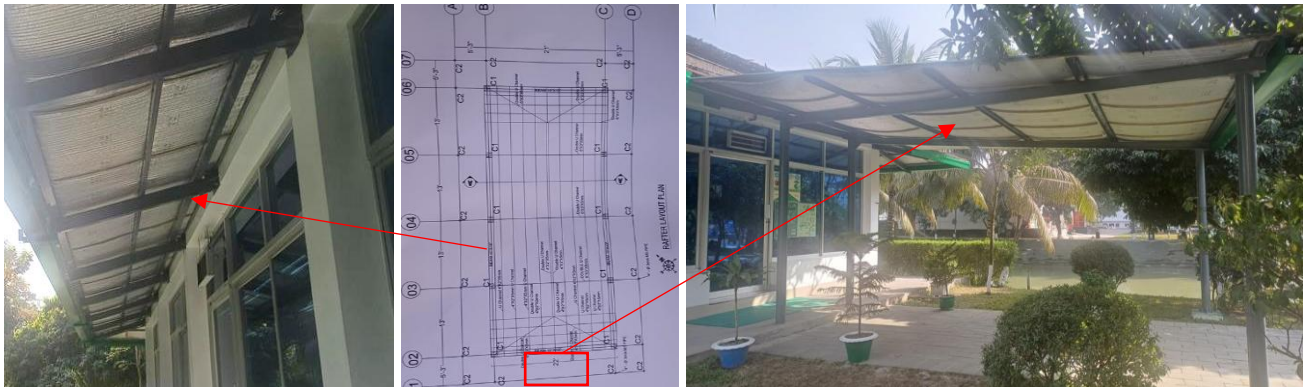
**Observation-14:** Mismatch between drawing and onsite conditions for the Shed-3 (Training Centre).

**Description:** The front steel canopy area and the peripheral cantilever beams were not shown in the as-built drawings. The building engineer is required to survey the structure and prepare accurate as-built drawings with connection details.

| 17. | Mismatch between drawing and onsite conditions for the Shed-3 (Training Centre). | The building engineer is required to survey the structure and update accurate as-built drawing with connection details. | within 6 weeks |

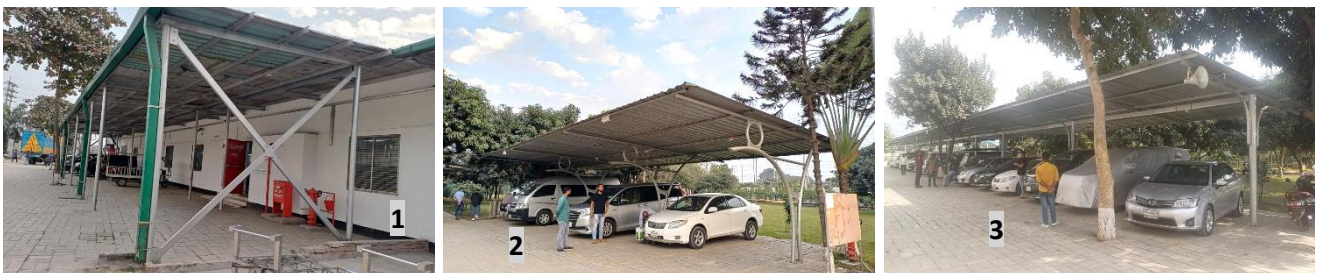
**Observation-15:** Lack of as-built drawings for the Car Parking Shed-1, 2, & 3

**Description:** There were no documents for the parking sheds. The building engineer is required to survey the structure and prepare the accurate as-built drawings with connection details.

| 18. | Lack of as-built drawings for the Car Parking Shed-1, 2, & 3. | The building engineer is required to survey the structure and prepare accurate as-built drawings with connection details. | within 6 weeks |
