# GOLDEN STITCH DESIGN LTD

Rajaghat, Rajfulbaria, Savar, Dhaka-1347, Bangladesh  
(23.813915 N, 90.257765 E)  
24<sup>th</sup> November 2015

# Observations

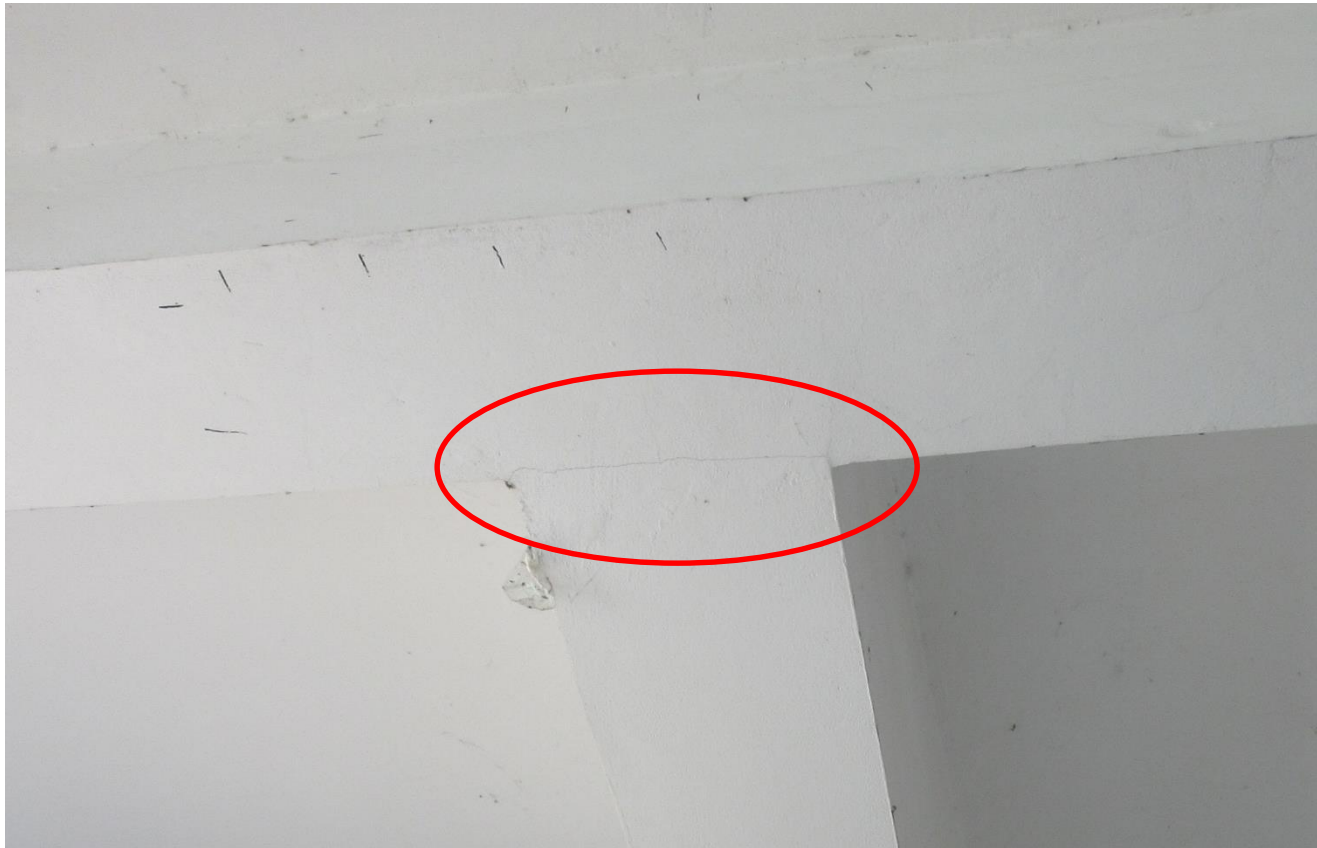
# Hairline Cracks at Beam to Beam Connection – Building 1

**Cracks observed at the same beam-to-beam connection region  
at 3<sup>rd</sup> and 2<sup>nd</sup> floors.**

| Item No. | Observation | Recommended Action Plan | Recommended Timeline |
|---|---|---|---|
| 3 | Hairline Crack at a Beam-to-Beam Joint in Building 1 | Hairline cracks at beam-to-beam joint in 2nd and 3rd floors to be monitored. | 6-months |
| 4 | Hairline Crack at a Beam-to-Beam Joint in Building 1 | Necessary repair actions to be taken. | 6-months |

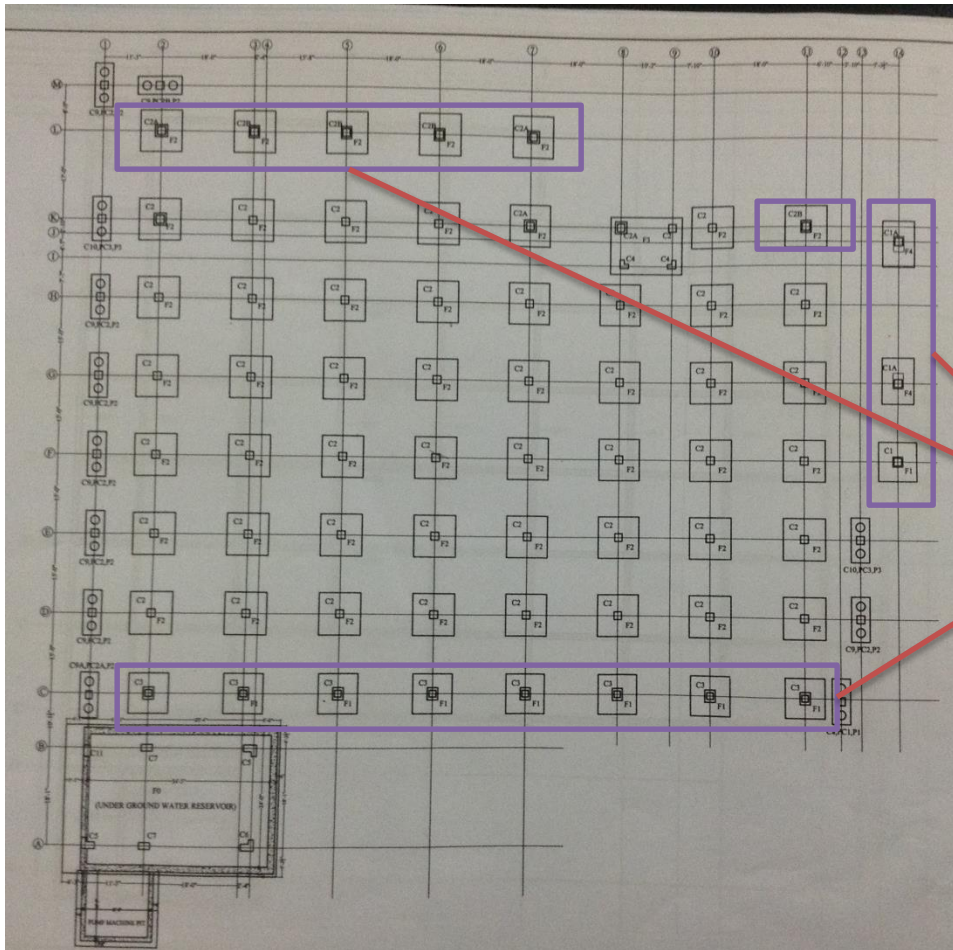
# **Jacketed Columns are not Connected to the Foundations – Building 1**

Existing edge columns were retrofitted by jacking at the first two floors, however the jacket parts are not connected to the foundations, but resting on grade beams.

| Item No. | Observation | Recommended Action Plan | Recommended Timeline |
|---|---|---|---|
| 1 | Grade Beams and Slab Supporting Jacketed Columns | Jacketed columns at East and West sides of Building 1 are sitting on grade beams and slab and transferring the loads to these members instead of foundations. Grade beam and slab capacity to be checked and necessary actions to be taken. | 6-months |

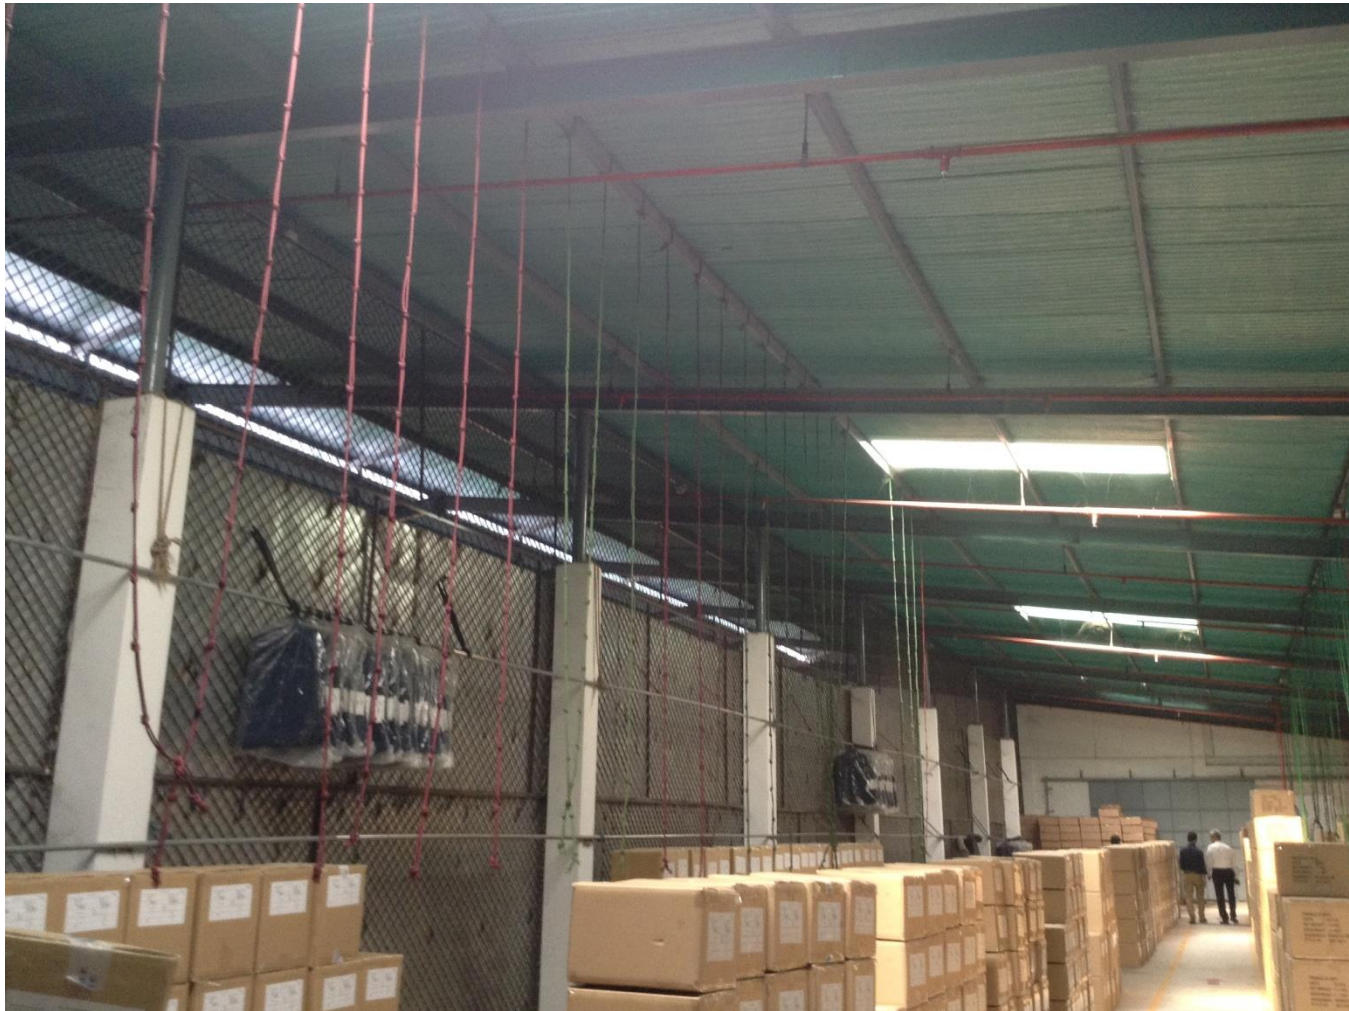
# Stability of the Warehouse Steel Structure

**There is no horizontal bracing at roof level nor vertical bracing between columns which raise concern on the stability of the structure.**

| Item No. | Observation | Recommended Action Plan | Recommended Timeline |
|---|---|---|---|
| 2 | Lack of Stability to structural system in the Warehouse | Structural system of the Warehouse to be assessed and necessary bracing to be provided for stability. (We were told that this is in progress at the moment) | 6-months |

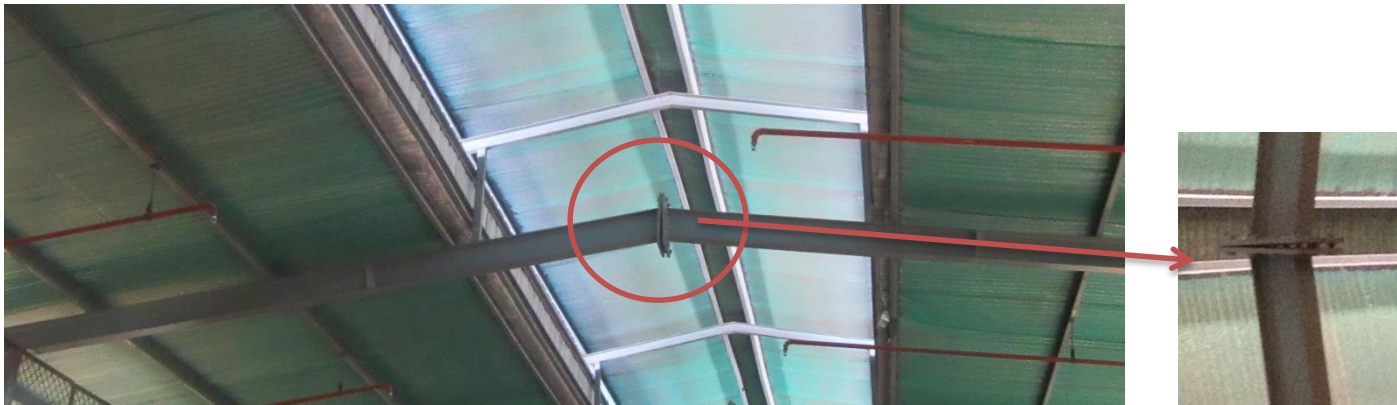
# Connections at Warehouse Steel Structure

**At some joint locations of the roof beams there exist gap between the end plates.**
