Intex Link Garments (BD) Limited

Plot No. A 54-55, BSCIC Industrial Estate, Kalurghat(Extn), Chittagong
(22.380857 N, 91.864550 E)

29th November 2015

Observations

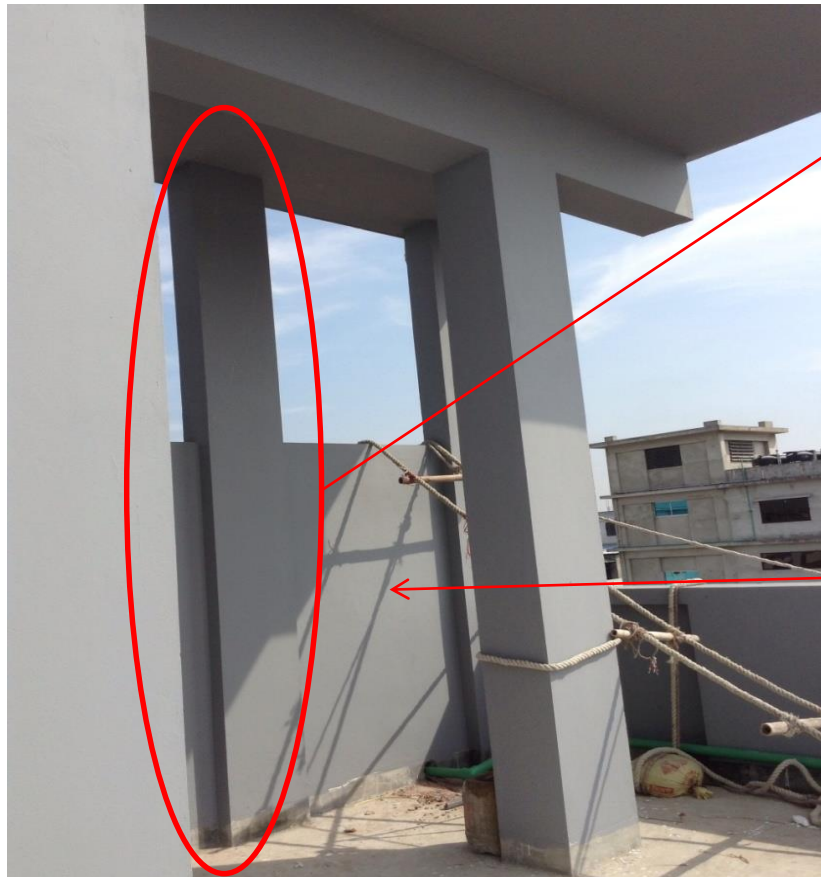
**Extension to Lift Machine Room roof slab
not shown on drawings and supported by
unrestrained brickwork**

4.28m high brick piers

2.4m high brick wall

An extension to the Lift Machine Room slab supported on one side by two 4.28m high brick piers, partially restrained by a 2.4m high brick wall. No obvious lateral restraint to brick panel on NE edge of main roof slab

Item No.	Observation	Recommended Action Plan	Recommended Timeline
1	Extension to Lift Machine Room roof slab not shown on drawings and supported by unrestrained brickwork	Building Engineer to assess whether lateral restraint has been provided to the brick panel in the NE corner of the roof slab	6-weeks
2	Extension to Lift Machine Room roof slab not shown on drawings and supported by unrestrained brickwork	Provide lateral restraint to brick panel if necessary	6-months
3	Extension to Lift Machine Room roof slab not shown on drawings and supported by unrestrained brickwork	Revise drawings to show extension of LMR roof slab and supporting structure	6-months
4	Brick stub columns under the water reservoir bearing on main slab	Building Engineer to assess loading on the roof slab from brick stub columns under the water reservoir, and the capacity of the beams and slabs to resist that loading	6-weeks
5	Brick stub columns under the water reservoir bearing on main slab	Adjust loading by removing stub columns or strengthen the beam and slab structure if necessary to accommodate anticipated loading	6-months

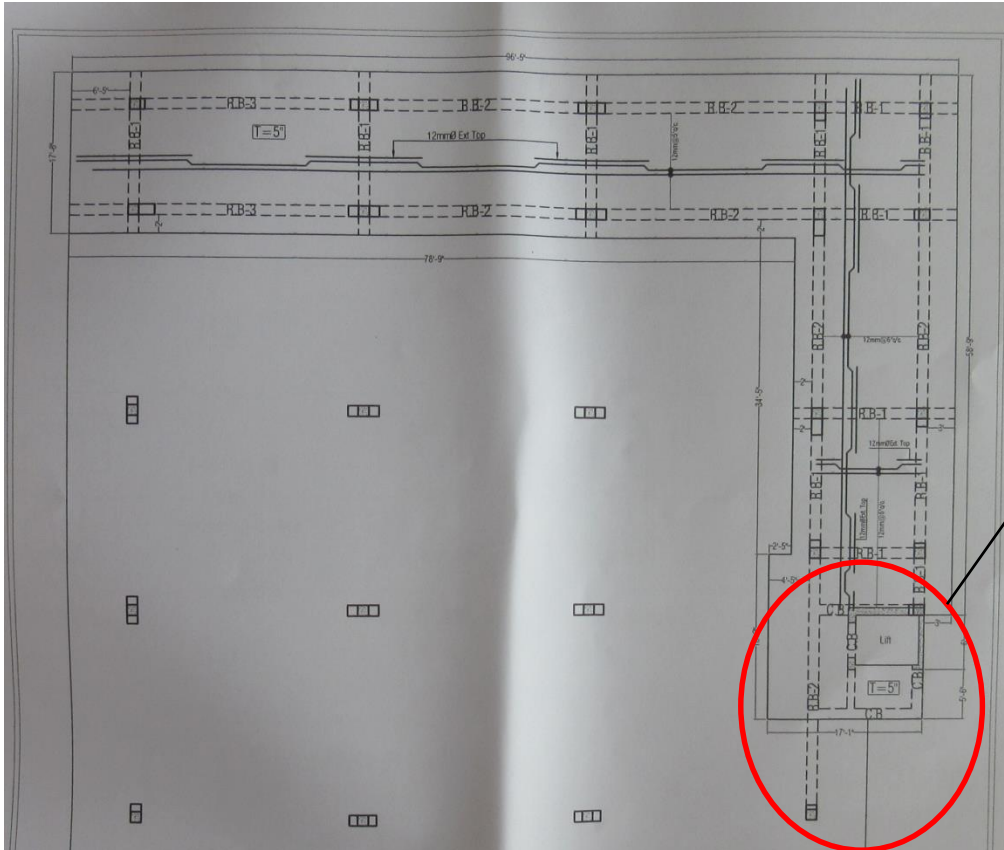
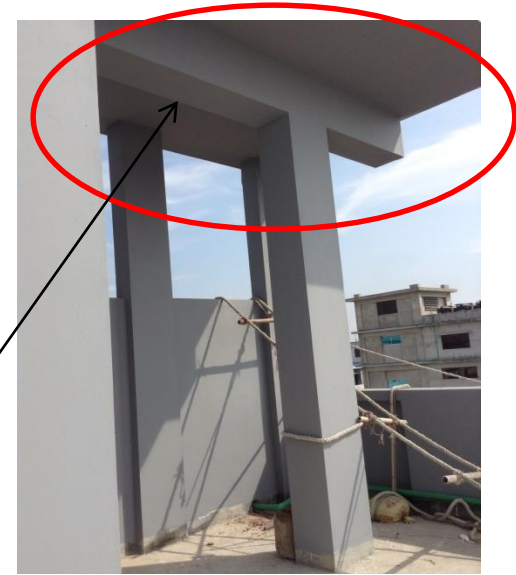
The extended portion of lift machine room top slab is not shown on drawings

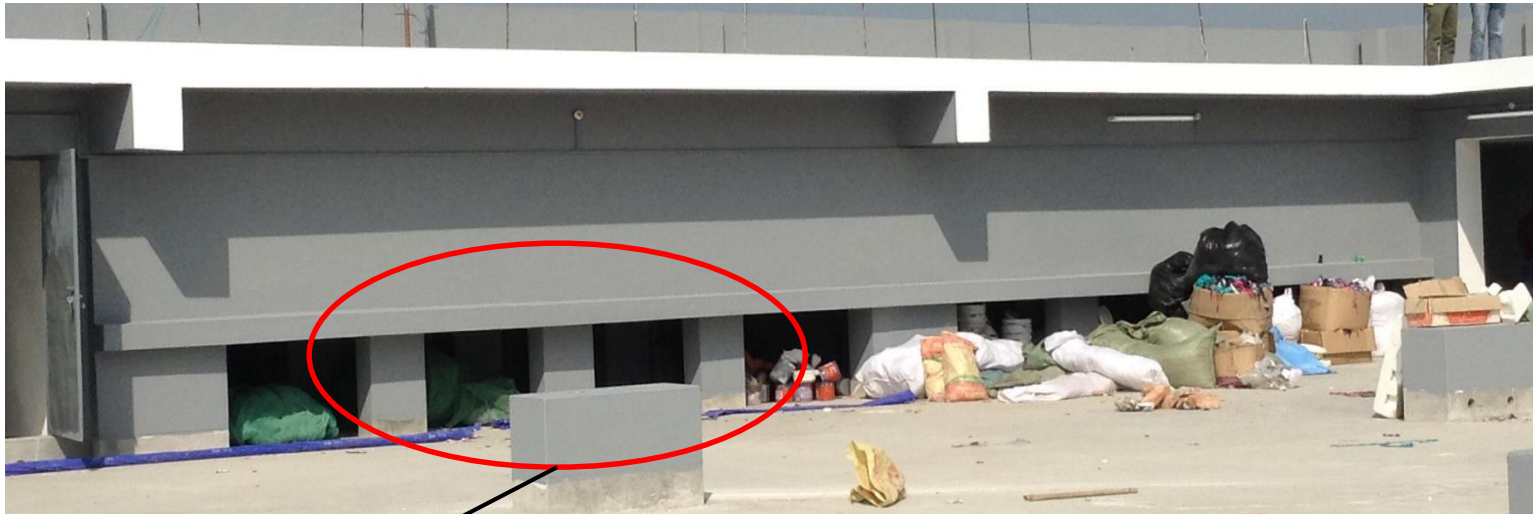
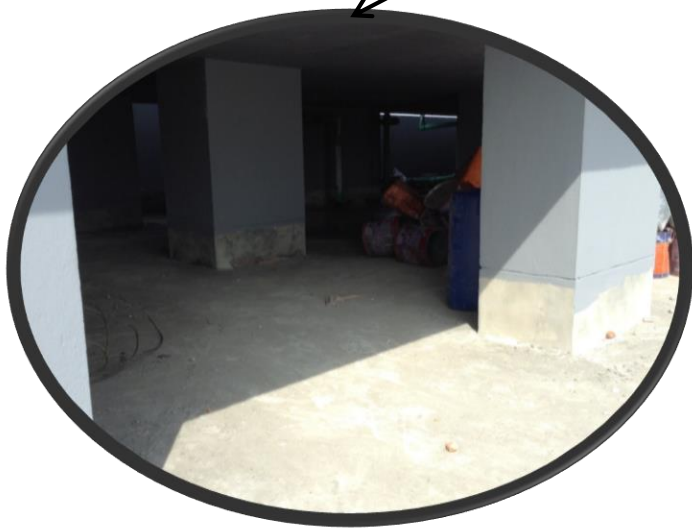
Brick stub columns under the water reservoir bearing on main slab

Brick stub columns under over head water reservoir
1 row of 3 stub columns/span under reservoir support walls; 3 rows/span under reservoir floor slab

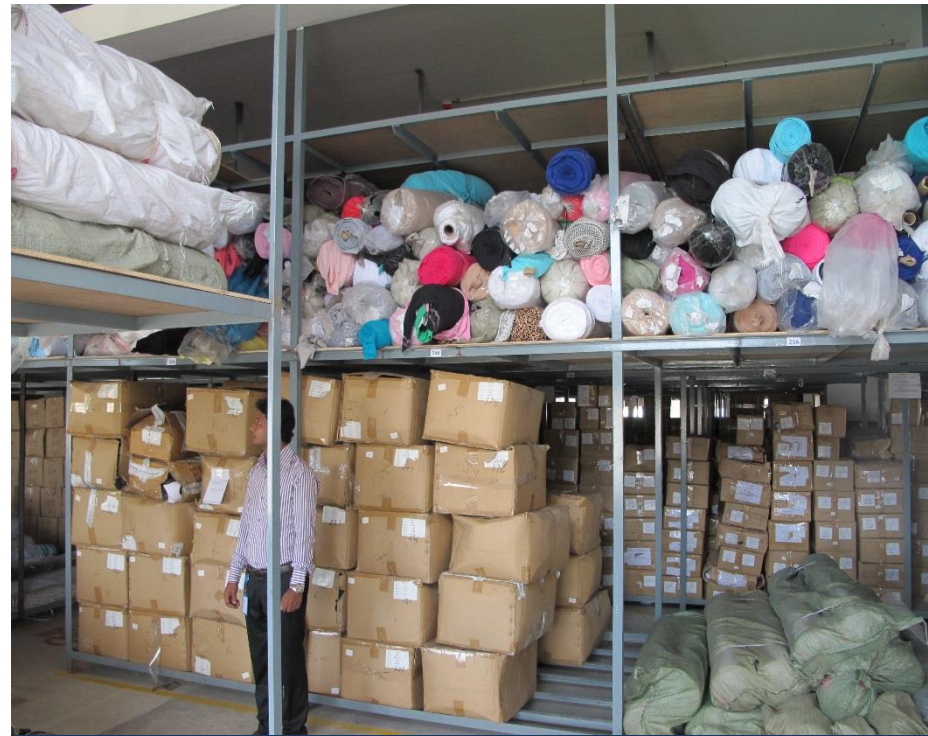
3-level storage racks observed over full floor area 5th Floor. Estimated loading for area fully packed (boxed lower level, material rolls upper level) approximately 120psf No storage observed on 3rd (top) rack level; management told us that this level would not be used for storage

Item No.	Observation	Recommended Action Plan	Recommended Timeline
6	High loading in Storage area 5th Floor	Building Engineer to assess loading on the 5th Floor slab and the capacity of the floor structure to accommodate that loading	6-weeks
7	High loading in Storage area 5th Floor	Provide Load Plan indicating the maximum storage load that can be accommodated by the 5th Floor structure	6-months
8	High loading in Storage area 5th Floor	Adjust racking system if necessary to avoid overloading	6-months
9	High loading in Storage area 5th Floor	Post notices on 5th Floor indicating maximum storage height or loads	6-months
10	Discrepancies between drawings and lack of structural drawings for Building 2	Provide as-built drawings that reflect the actual architectural and structural layouts and sections	6-months
11	Discrepancies between drawings and lack of structural drawings for Building 2	Provide structural drawings for Building 2	6-months
