# SAIHAM KNIT COMPOSITE LTD. (Extension 2)

Saiham Nagar, Noyapara, Madhabpur, Hobigonj

16 January 2025

## 1. Building Information

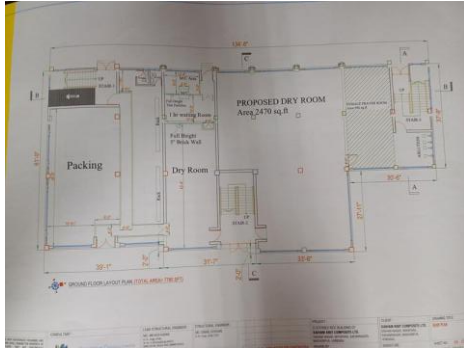
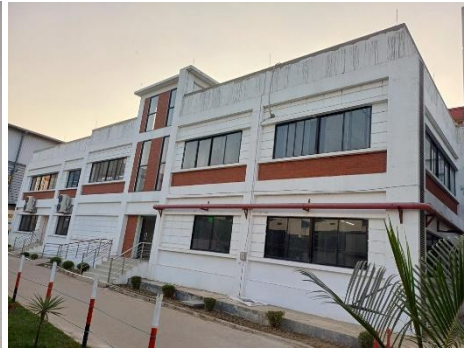
**Observation-1:** Design report needs to be reviewed against lateral forces (Locker Building).

**Description:** The prepared design report needs to be reviewed against lateral forces. Submit the design report to the RSC for detailed review.

| Item No | Observation | Action Plan | Timeline |
|---|---|---|---|
| 1. | Design report needs to be reviewed against lateral forces (Locker Building). | The building engineer is required to revise the design report and submit it to RSC for review against lateral forces. | within 6 weeks |

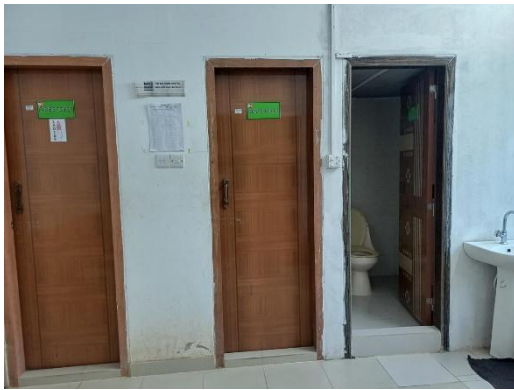
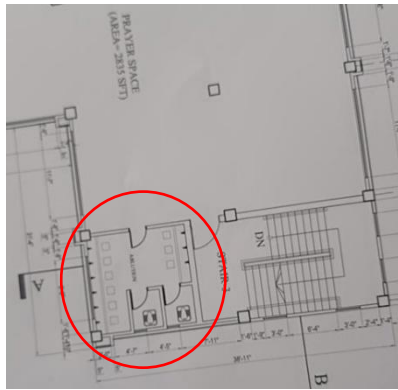
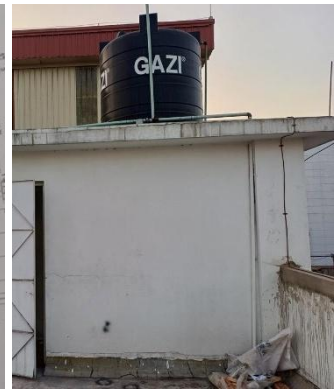
**Observation-2:** Mismatch between drawing & onsite condition (Locker Building).

**Description:** The floor rise, and toilet zone brick wall layout didn't match with drawing. Also, the rooftop PVC tank wasn't shown in the drawing. The building engineer is required to update the drawing based on the as-constructed structure.

| Item No | Observation | Action Plan | Timeline |
|---|---|---|---|
| 3. | Mismatch between drawing & onsite condition (Locker Building). | The building engineer is required to update the drawing to the as-constructed status. | within 6 weeks |

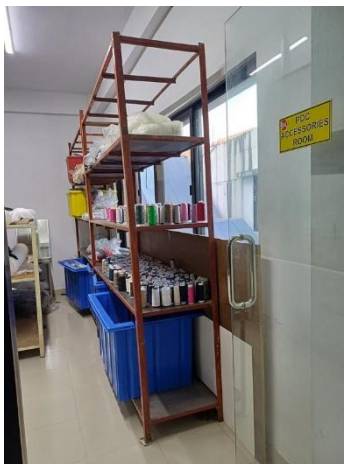
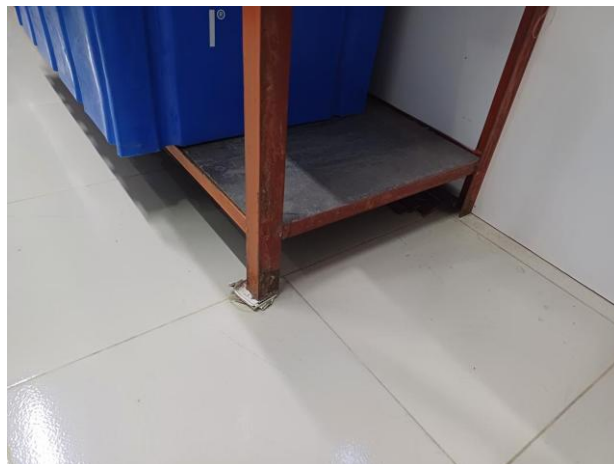
**Observation-3:** Lack of anchorage to the storage racks (Locker Building).

**Description:** Lack of anchorage/brace was observed for the storage racks. The building engineer is required to anchor/brace all the non-structural elements within the building.

| Item No | Observation | Action Plan | Timeline |
|---|---|---|---|
| 4. | Lack of anchorage to the storage racks (Locker Building). | The building engineer is required to anchor/brace all the non-structural elements within the building. | within 6 months |

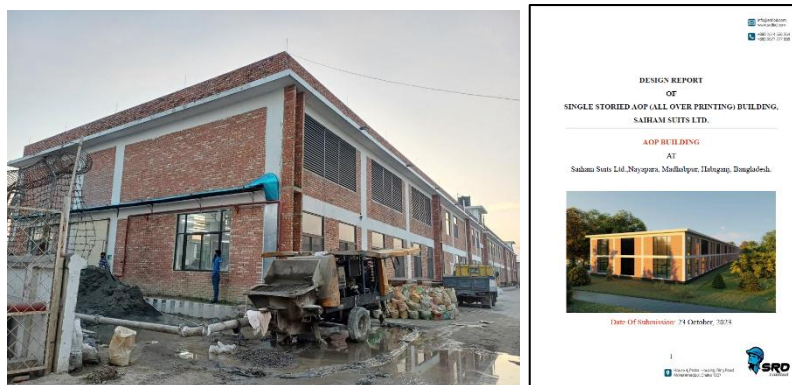
**Observation-5:** Design report needs to be reviewed against lateral forces (AOP Building).

**Description:** The design report prepared needs to be reviewed against lateral forces. Submit the design report to the RSC for detailed review.

| Item No | Observation | Action Plan | Timeline |
|---|---|---|---|
| 7. | Design report needs to be reviewed against lateral forces (AOP Building). | The building engineer is required to revise the design report and submit it to RSC for review against lateral forces. | within 6 weeks |

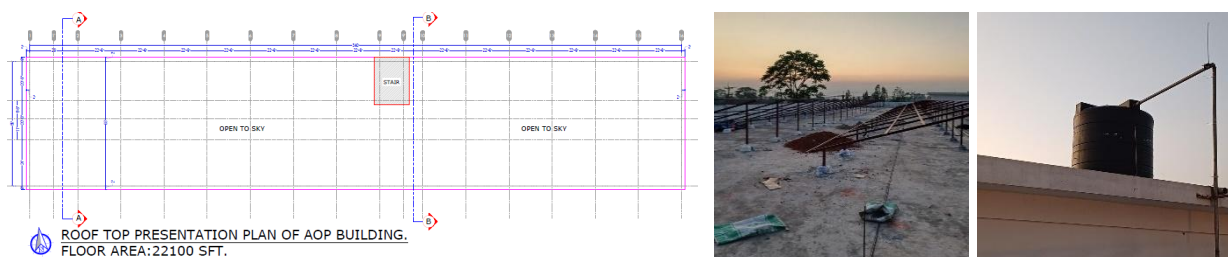
**Observation-6:** Mismatch between drawing & onsite condition (AOP Building).

**Description:** The rooftop PVC tank and solar panels weren't shown in the architectural drawing. The building engineer is required to update the drawing based on the as-constructed structure.

| Item No | Observation | Action Plan | Timeline |
|---|---|---|---|
| 9. | Mismatch between drawing & onsite condition (AOP Building). | The building engineer is required to update the drawing to the as-constructed status. | within 6 weeks |

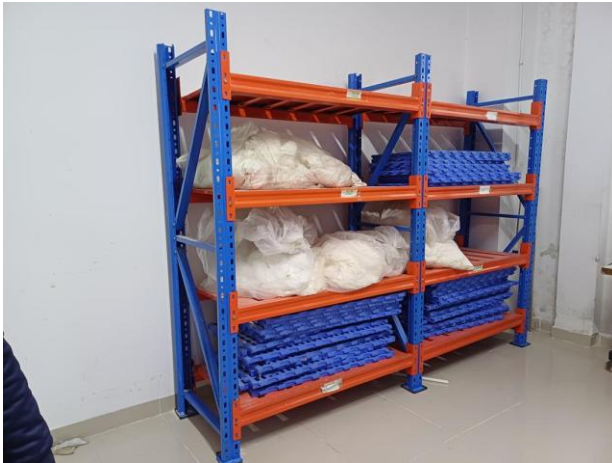
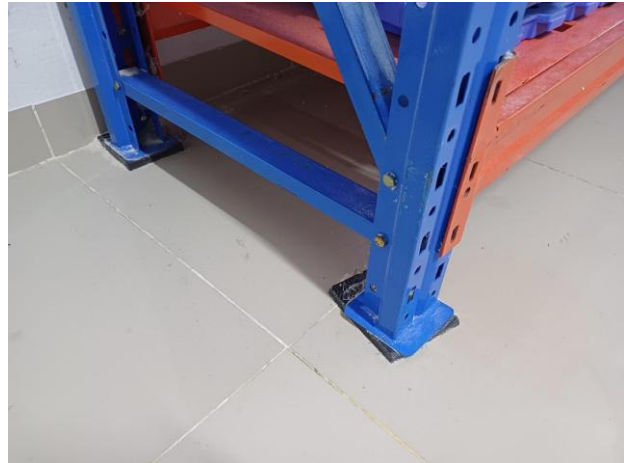
**Observation-7:** Lack of anchorage to the storage racks (AOP Building).

**Description:** Lack of anchorage/brace observed for the storage racks. The building engineer is required to anchor/brace all the non-structural elements within the building.

| Item No | Observation | Action Plan | Timeline |
|---|---|---|---|
| 10. | Lack of anchorage to the storage racks (AOP Building). | The building engineer is required to anchor/brace all the non-structural elements within the building. | within 6 months |

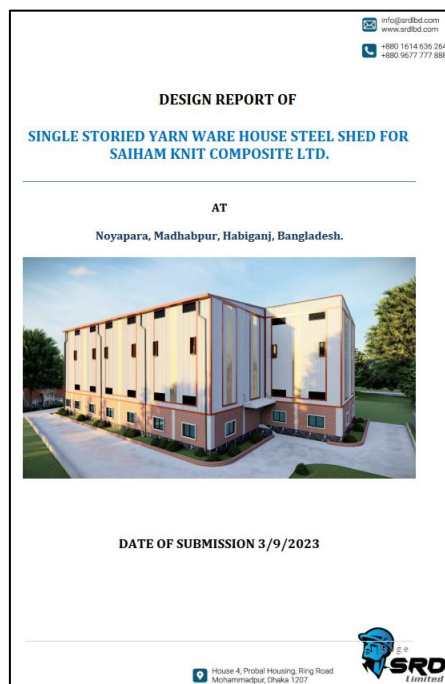
**Observation-8:** Design report needs to be reviewed against lateral forces (Yarn Warehouse).

**Description:** The design report prepared needs to be reviewed against lateral forces. Submit the design report to the RSC for detailed review.

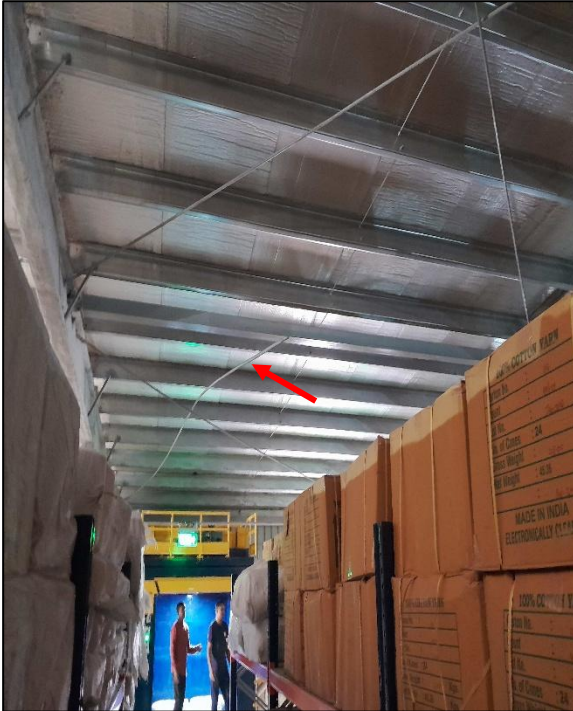
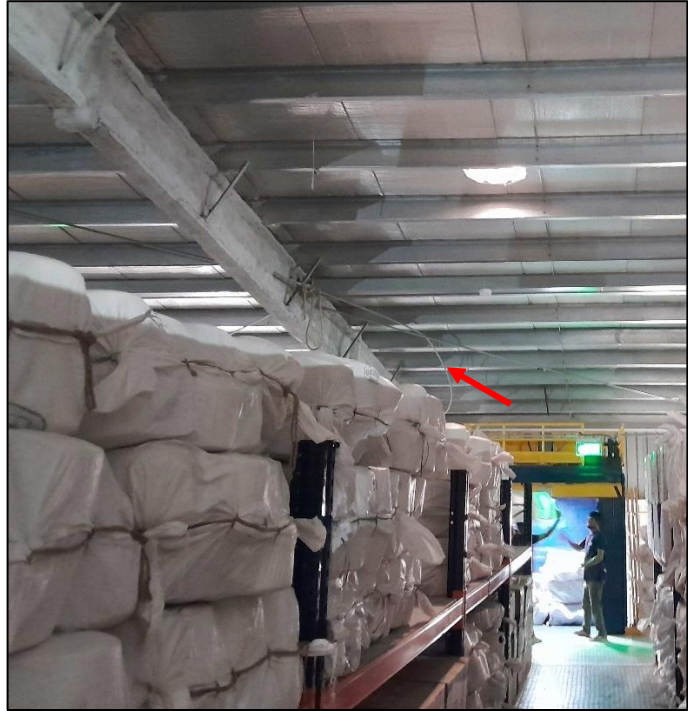
**Observation-9:** Disconnected roof bracing (Yarn Warehouse).

**Description:** During the inspection, disconnected roof bracings were observed at several locations. The factory is required to connect all the roof bracings appropriately.

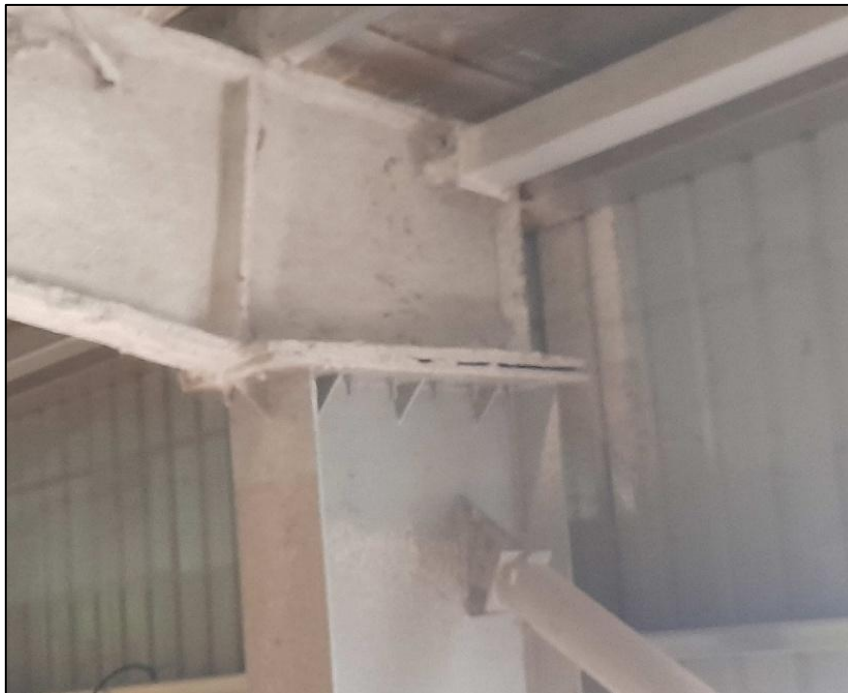
**Observation-10:** Connection gap on steel plates (Yarn Warehouse).

**Description:** During the inspection, connection gaps were observed in rafter-column joints. The factory is required to tighten up the connection joints or fill the connection gap with shim plate if required.

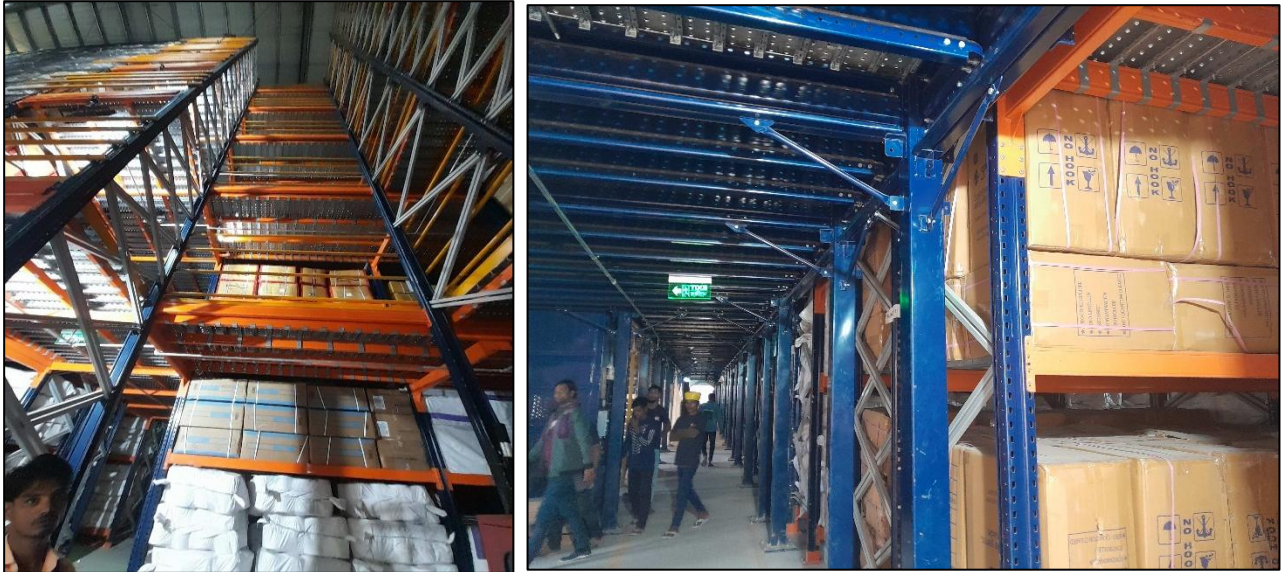
**Observation-11: Long-height storage racks (Yarn Warehouse).**

**Description:** During the inspection, approximately 15m high free-standing, self-supported storage racks were found in the building. However, no design report was available. The building engineer is required to prepare an Engineering Assessment (EA) report to confirm the stability of the storage racks.

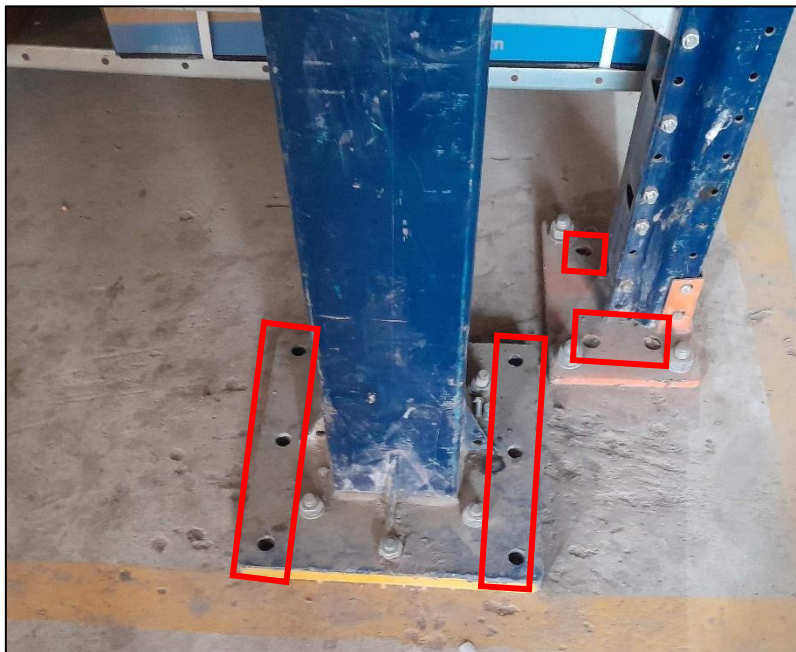
**Observation-12: Inadequate Rack anchorage (Yarn Warehouse).**

**Description:** During the inspection, long height storage racks were found partially anchored. The factory has not anchored all proposed points. The factory is required to anchor adequately all proposed points.

| Item No | Observation | Action Plan | Timeline |
|---|---|---|---|
| 26. | Inadequate Rack anchorage (Yarn Warehouse). | The factory is required to anchor adequately all proposed points. | within 6 weeks |

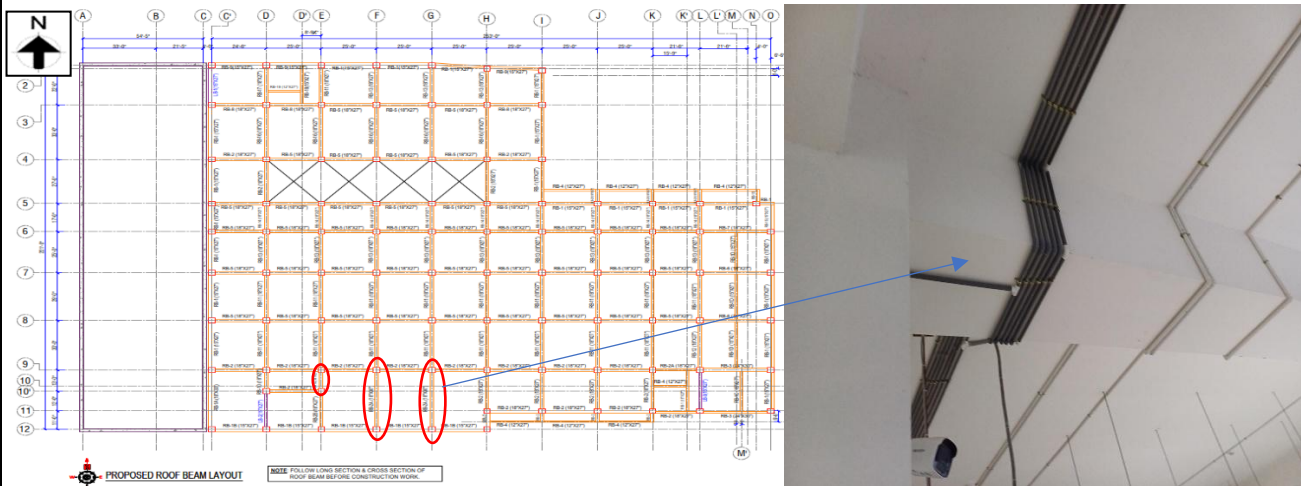
Mentioned roof beam width 600mm instead of 450mm as per the provided drawing.

**Description:** During the inspection, discrepancies and lack of information were observed between the provided drawing and on-site conditions. The building engineer is required to survey the whole structure and update the drawing reflecting actual on-site condition.

| Item No | Observation | Action Plan | Timeline |
|---|---|---|---|
| 15. | Discrepancy and lack of information in provided drawing (Dyeing Building). | The building engineer is required to survey the whole structure and update the drawing reflecting actual on-site condition. | within 6 weeks |

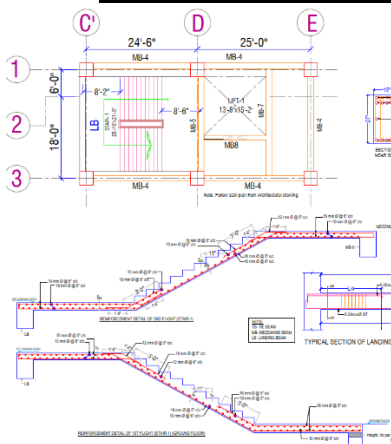
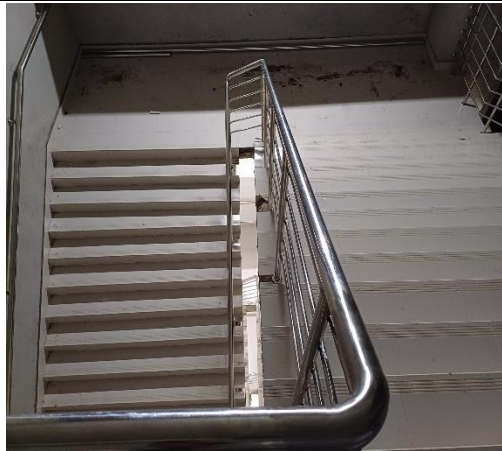
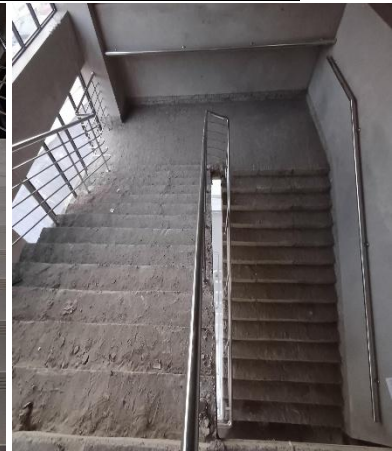
14 no's stair tread found instead of 10 no's in the one flight. Also, mentioned tread riser size mismatching as mentioned in the drawing.

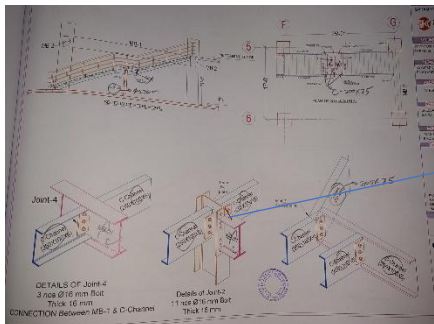
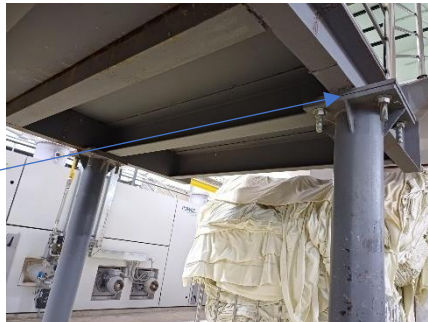
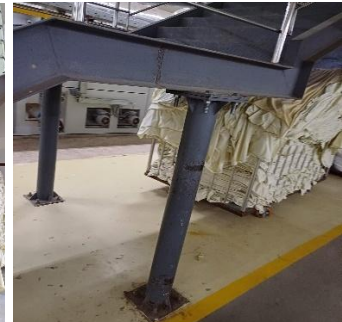
Pipe section and c-channel found instead of I-section. Also, connection detail mismatches.

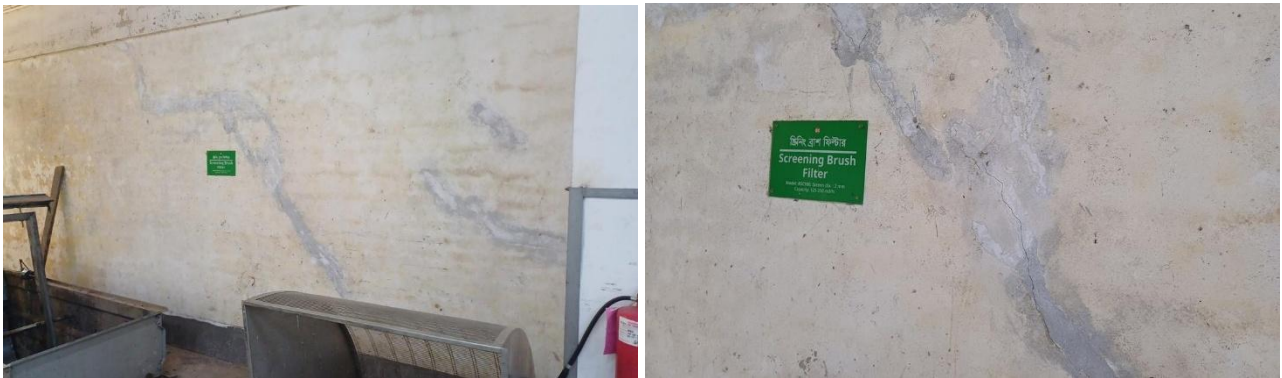
**Observation-16: Crack on brick wall (Dyeing Building).**

**Description:** During the inspection, brick wall cracks were observed on the ground floor peripheral wall. The factory is required to repair the cracks as per the recommendation of the building engineer.

| Item No | Observation | Action Plan | Timeline |
|---|---|---|---|
| 17. | Crack on brick wall (Dyeing Building). | The factory is required to repair the cracks as per the recommendation of the building engineer. | within 6 months |

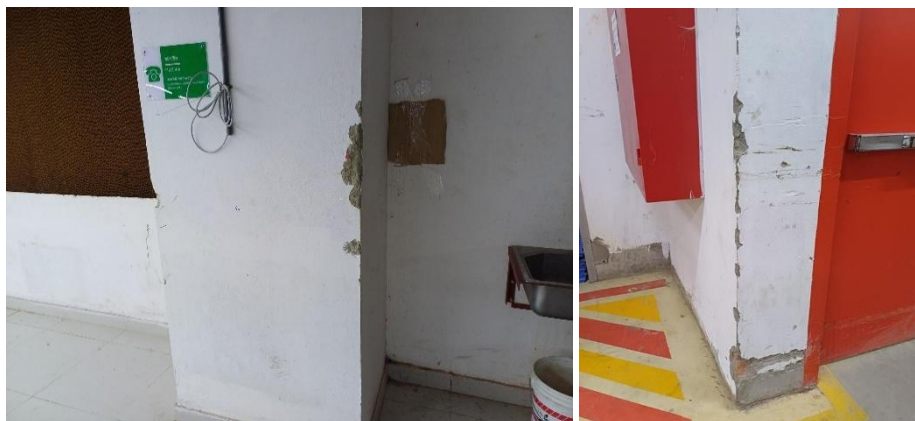
**Observation-17: Trolley impact on column surface (Dyeing Building).**

**Description:** The cover of floor columns was damaged due to trolley impact. The building engineer is required to provide column/wall guard to protect from trolley impact.

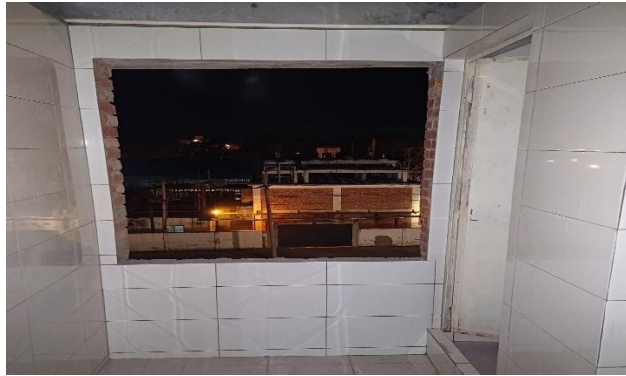
**Observation-18:** Possible falling hazard (Dyeing Building).

**Description:** During the inspection, it was noted that toilet zone peripheral lacked barriers at its edges, creating a potential falling hazard. The factory is required to install appropriate safety barriers to mitigate the risk of falls and ensure compliance with safety standards.

| Item No | Observation | Action Plan | Timeline |
|---|---|---|---|
| 19. | Possible falling hazard (Dyeing Building). | The factory is required to install appropriate safety barriers to mitigate the risk of falls and ensure compliance with safety standards. | within 6 weeks |

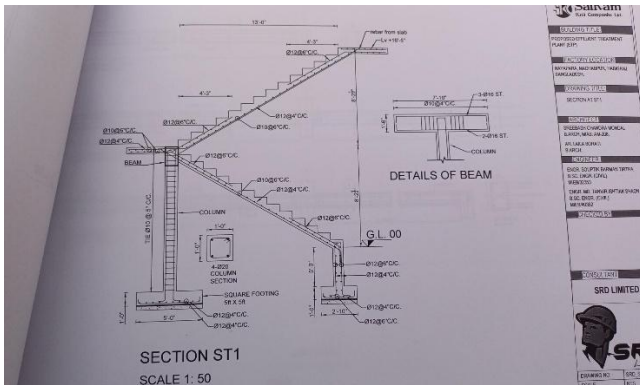
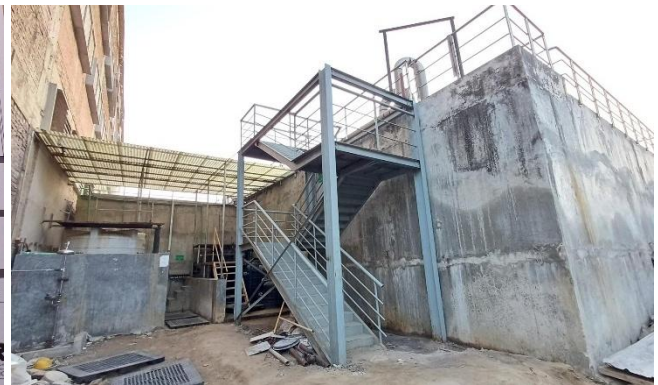
Steel stair found instead of RC stair as per the provided drawing

**Description:** During the inspection, discrepancies and lack of information were observed between the provided drawing and on-site conditions. The building engineer is required to survey the whole structure and update the drawing reflecting actual on-site condition.

| Item No | Observation | Action Plan | Timeline |
|---|---|---|---|
| 27. | Mismatch and lack of information in provided drawing (ETP-3). | The building engineer is required to survey the whole structure and update the drawing reflecting actual on-site condition. | within 6 weeks |

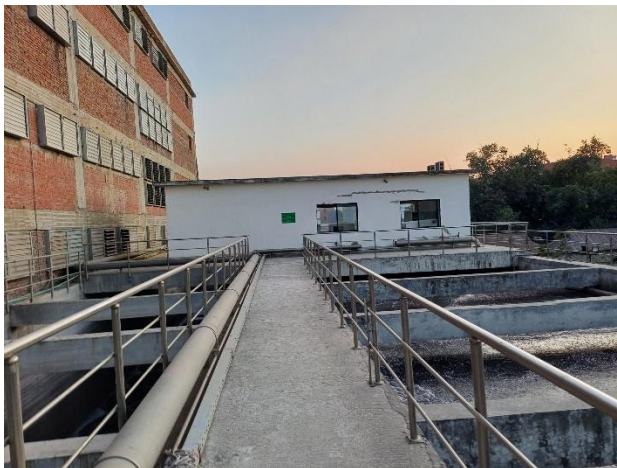
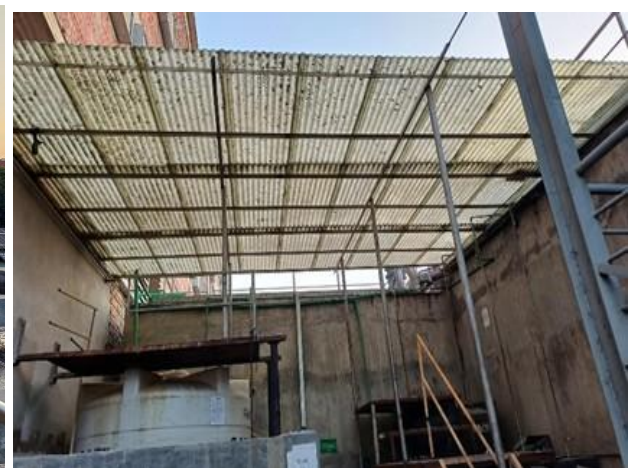
ETP roof top lab room & steel roof structural details were not shown in the provided drawing

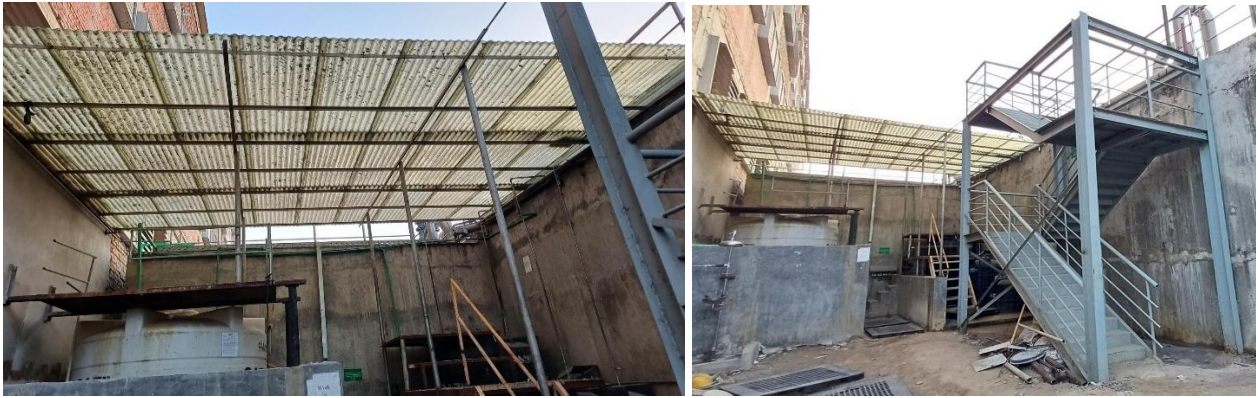
**Observation-20:** Inadequate steel roof and stair (ETP-3).

**Description:** The size of steel roof members was observed inadequate to resist the vertical and lateral loading for the mentioned structure. The building engineer is required to suggest adequate size of steel members, develop adequate connection for the structure. Submit the adequacy check calculation and remedial drawing to RSC as part of safety check report.

| Item No | Observation | Action Plan | Timeline |
|---|---|---|---|
| 28. | Inadequate steel roof and stair (ETP-3). | The building engineer is required to suggest adequate size of steel members, develop adequate connections for the structures. Submit the adequacy check calculation and remedial drawing as part of safety check report. | within 6 weeks |

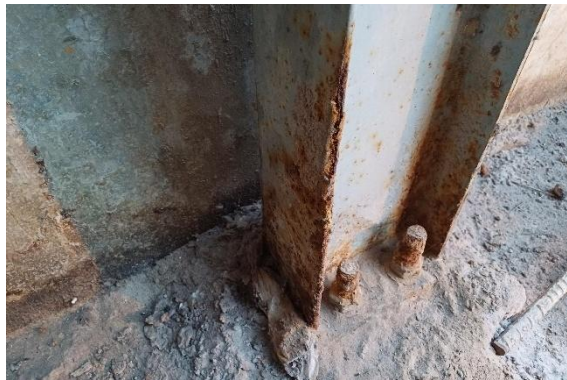
**Observation-21:** Corrosion on steel member (ETP-3).

**Description:** During the inspection, corrosion was observed on the steel column. The factory is required to repair/replace the corroded member and apply anti-corrosive coating.

| Item No | Observation | Action Plan | Timeline |
|---|---|---|---|
| 30. | Corrosion on steel member (ETP-3). | The factory is required to repair/replace the corroded member and apply anti-corrosive coating. | within 6 weeks |

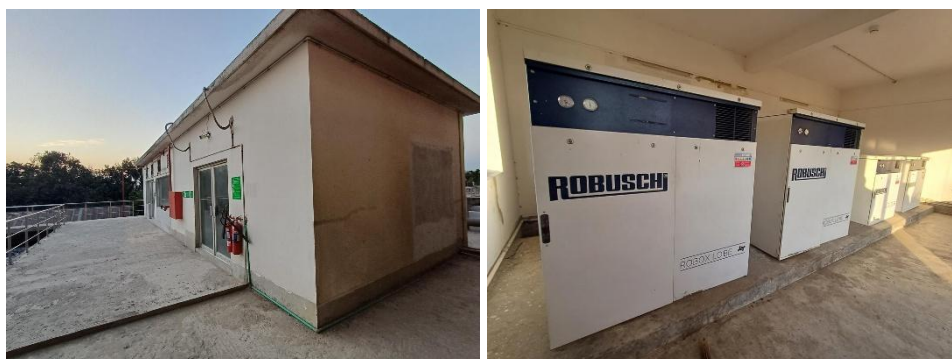
**Observation-22:** Vibration in lab room supporting slab (ETP-3).

**Description:** During the inspection, vibration was felt on the ETP lab room supporting slab. The building engineer is required to check the reason for the vibration, check the slab adequacy subject to imposed loading & vibration and suggest proper remedial/damping methodology.

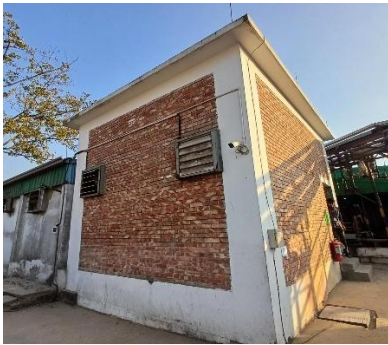
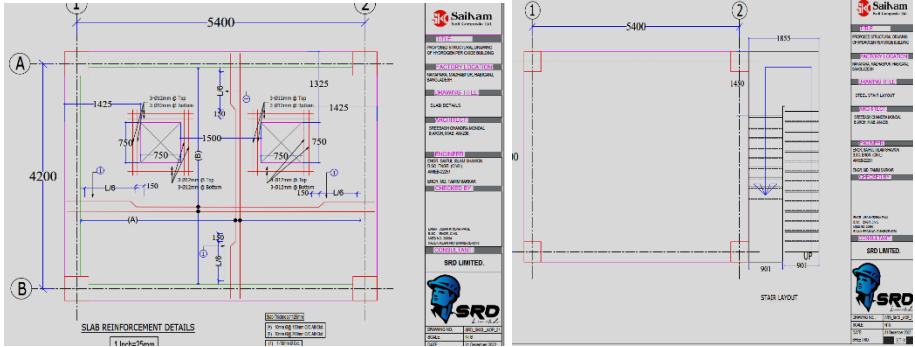
**Observation-23:** Lack of information in provided drawing (Hydrogen Peroxide Building).

Cantilever slab on peripheries has not been shown, and the proposed stair has not been constructed.

**Description:** During the inspection, lack of information was observed between the provided drawing and on-site conditions. The building engineer is required to survey the whole structure and prepare as-built drawing reflecting actual on-site condition.

| Item No | Observation | Action Plan | Timeline |
|---|---|---|---|
| 33. | Lack of information in provided drawing (Hydrogen Peroxide Building). | The building engineer is required to survey the whole structure and prepare as-built drawing reflecting actual on-site condition. | within 6 weeks |

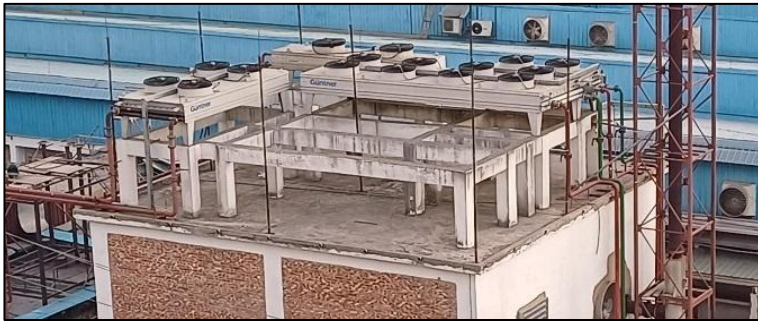
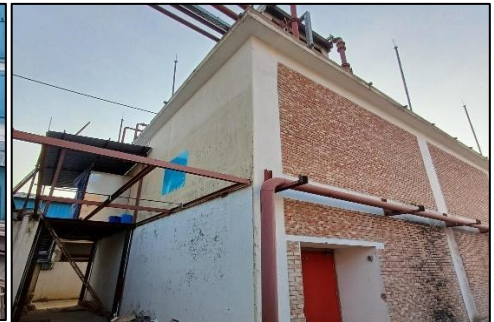
**Observation-24:** Lack of information in provided drawing (New Generator).

Roof top RC frames and details and two-story steel platform are not shown in the provided drawing

**Description:** During the inspection, lack of information was observed between the provided drawing and on-site conditions. The building engineer is required to survey the whole structure and prepare as-built drawing reflecting actual on-site condition.

| Item No | Observation | Action Plan | Timeline |
|---|---|---|---|
| 34. | Lack of information in provided drawing (New Generator). | The building engineer is required to survey the whole structure and prepare as-built drawing reflecting actual on-site condition. | within 6 weeks |

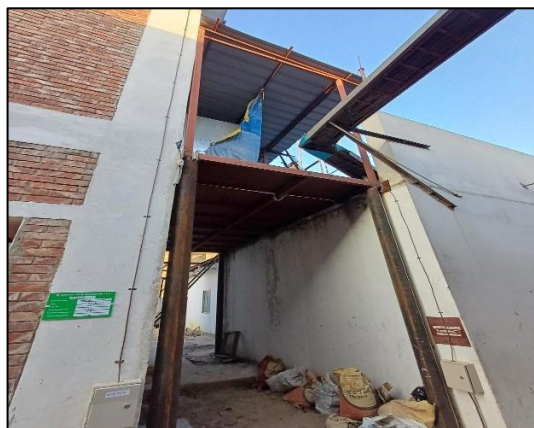
**Observation-25:** Inadequate steel member sizes (New Generator).

**Description:** The size of steel members was observed to be inadequate to resist the vertical and lateral loading for the mentioned structure. The building engineer is required to suggest adequate size of steel members, develop the adequate connection for the structure. Submit the adequacy check calculation and remedial drawing as part of safety check report.

| Item No | Observation | Action Plan | Timeline |
|---|---|---|---|
| 35. | Inadequate steel member sizes (New Generator). | The building engineer is required to suggest adequate size of steel members, develop adequate connections for the structures. Submit the adequacy check calculation and remedial drawing as part of safety check report. | within 6 weeks |

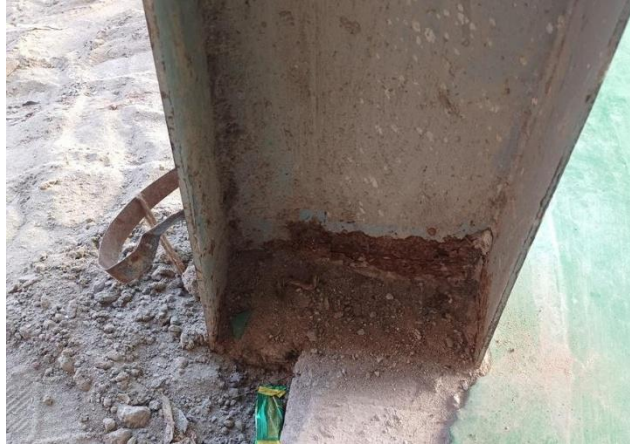
**Observation-26:** Corrosion on steel member (Connecting Bridge).

**Description:** During the inspection, corrosion was observed on the steel column. The factory is required to repair/replace the corroded member and apply anti-corrosive coating.

| Item No | Observation | Action Plan | Timeline |
|---|---|---|---|
| 37. | Corrosion on steel member (Connecting Bridge). | The factory is required to repair/replace the corroded member and apply anti-corrosive coating. | within 6 weeks |

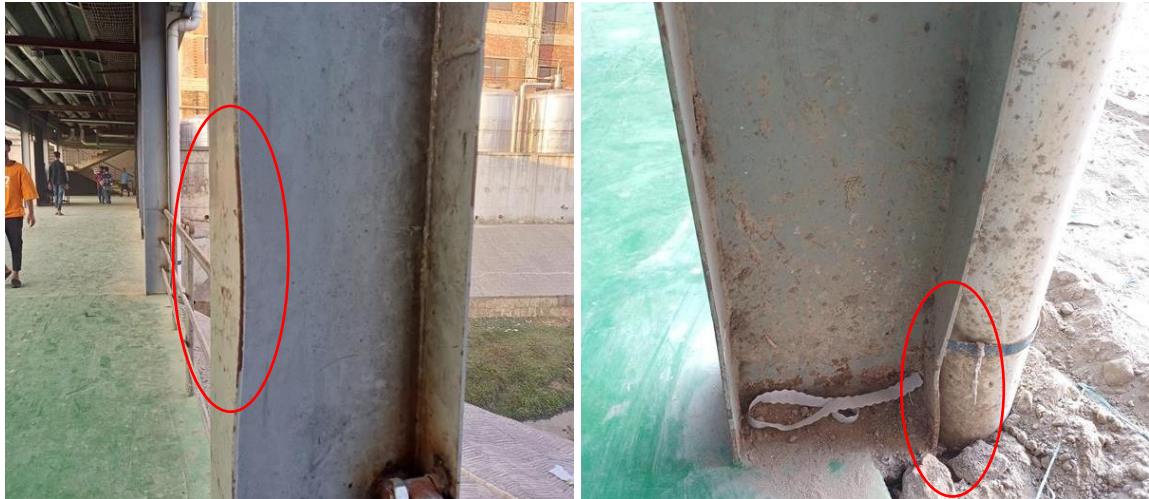
**Observation-27:** Distorted steel column (Connecting Bridge).

**Description:** During the inspection, distorted steel column flange was observed in several locations. The building engineer is required to repair the damaged steel column flange with suitable method.

| Item No | Observation | Action Plan | Timeline |
|---|---|---|---|
| 38. | Distorted steel column (Connecting Bridge). | The building engineer is required to repair the damaged steel column flange with suitable method. | within 6 weeks |
