# INITIAL FIRE SAFETY INSPECTION REPORT

**FAKIR KNITWEARS LTD. (Extension - 2)**

**RSC ID: 25930**

**Date: 22 December, 2024**

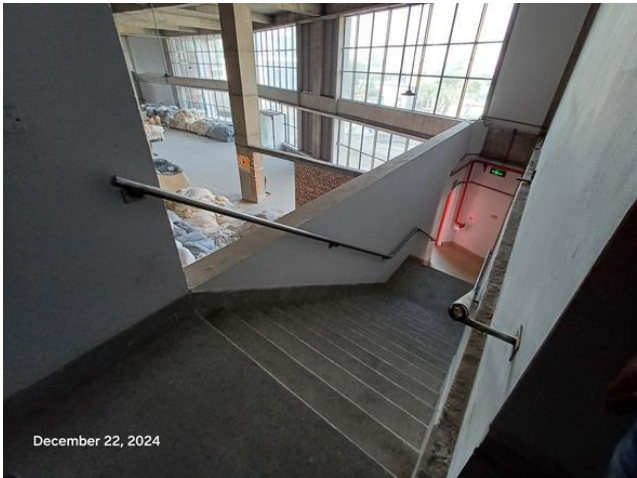
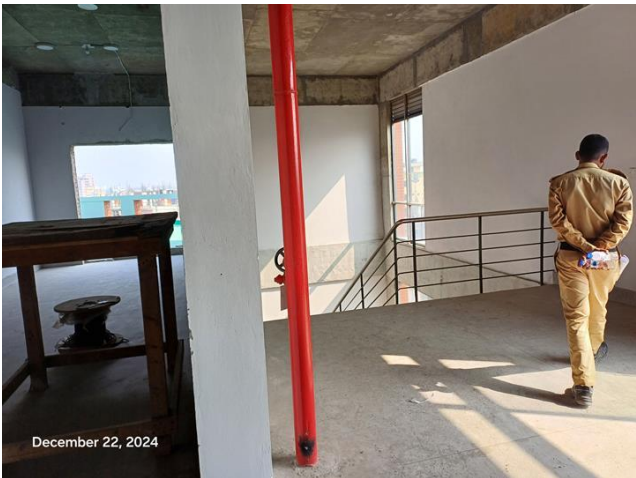
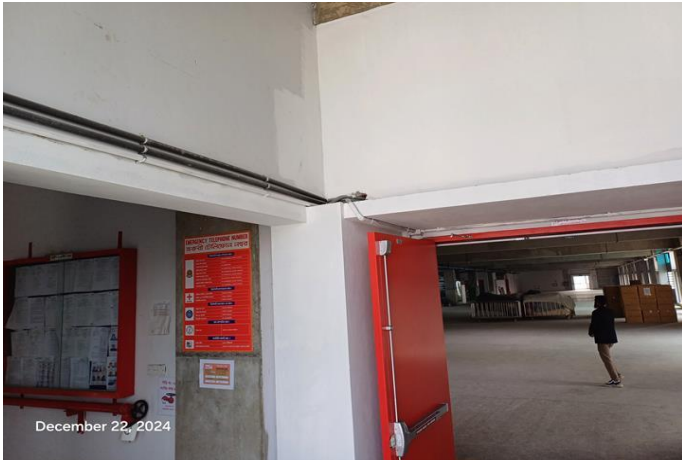
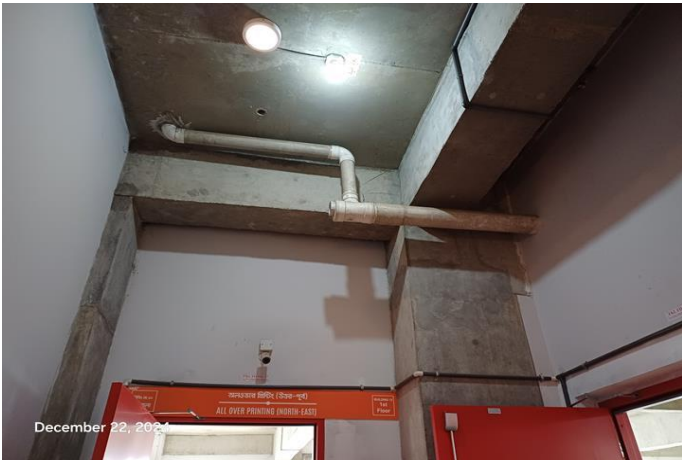
| Sl No. | Category | Findings | Required Action | Remediation Time Frame |
|---|---|---|---|---|
| F1 | Means of egress | <p>The exit stair enclosures are not separated from work areas and other spaces on each floor by fire-rated construction (N-E Exit enclosure-2 on Ground floor, N-W Exit enclosure-1 on 2nd floor and S-W exit enclosure-4 on 2nd floor).</p> <p>Penetrations through ceiling is also observed at 1st floor S-E Staircase-3.</p> <p>Fire rated doors are not interfaced yet with FACP (Installation on-going).<br/>Location: Building-12</p> | <p>Provide minimum 2-hr fire rated construction for buildings 4 storied or more and 1-hr for up to 3 storied. Seal all unprotected openings to separate the exit stairs from work areas and other spaces on all floor levels by 90 minutes for 2 hr. construction and 60 minutes for 1-hr construction.</p> <p>Ensure that the fire-rated doors are self-closing and positive latching and that they are provided with fire exit (panic) hardware where serving production floors. If fire-rated doors are required to be held open for functional reasons, provide automatic closing devices tied to the fire alarm system.</p> | Within 3 months |

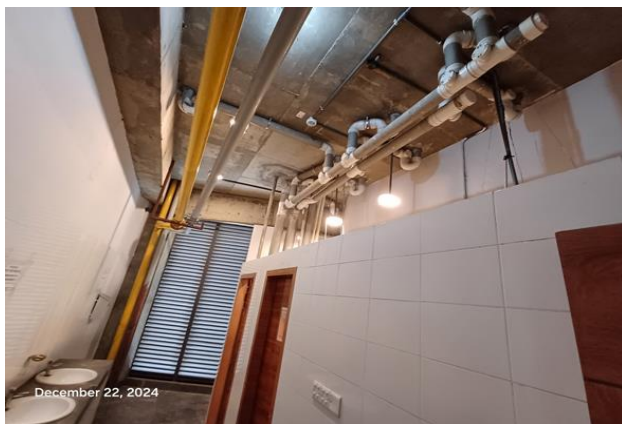
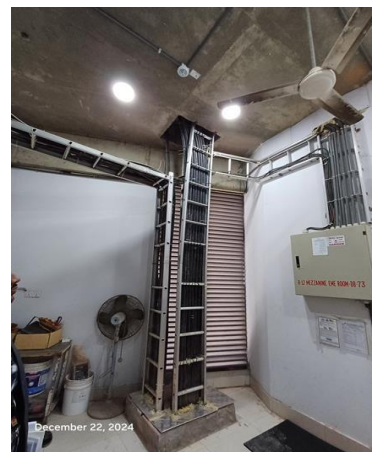
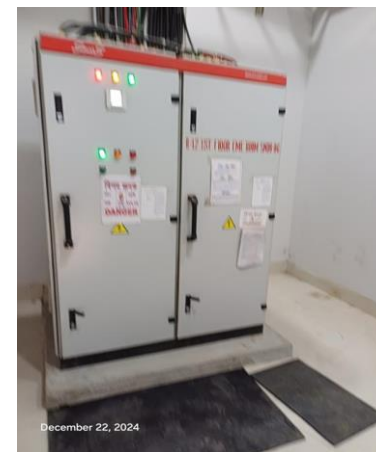
| SI No. | Category | Findings | Required Action | Remediation Time Frame |
|---|---|---|---|---|
| F2 | Fire Rated Construction | <p>Penetrations through floor/ceiling assemblies (Both electrical riser and plumbing pipes) are found unsealed.</p> <p><b>Location(s):</b> Building-12, 1st &amp; Mezzanine Floor</p> | <p>Provide a minimum 2-hr fire-rated shaft to separate the utility risers from each floor level or seal all penetrations and openings in floors/ceiling assemblies by 3-hr fire-rated listed/certified materials. The installation of such fire-rated materials shall be following certified design.</p> | Within 3 months |

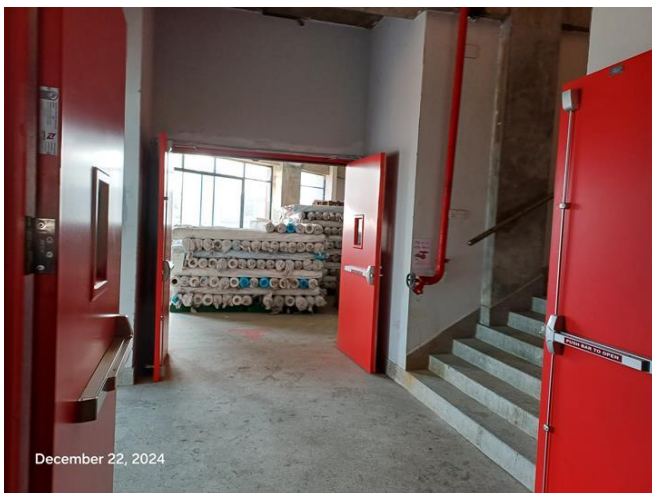
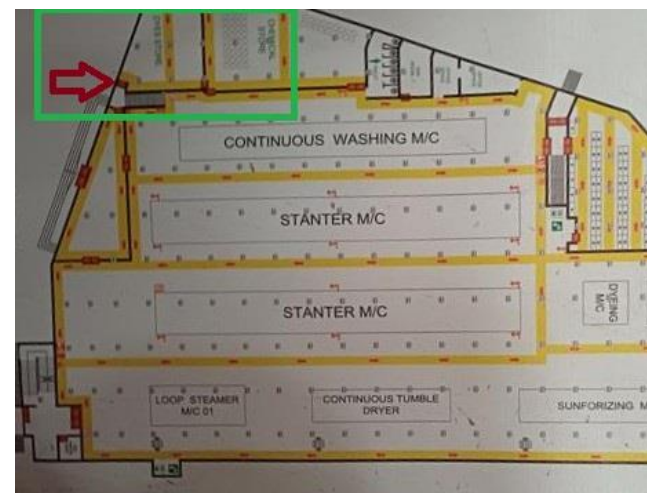
| SI No. | Category | Findings | Required Action | Remediation Time Frame |
|---|---|---|---|---|
| F3 | Means of egress | Ground Floor fabrics storage room and chemical store discharges directly into South-east exit enclosure-3 and North-east exit enclosure-2 on ground floor. | Openings from exit enclosure to storage room spaces shall be provided with a vestibule with fire rated construction and openings. Provide a 1.5 hr. fire rated door on the exit stair side and a 1-hr. fire rated door on the Store room side. Ensure that the fire rating of the vestibule construction matches that of the exit stair enclosure. | Within 3 months |

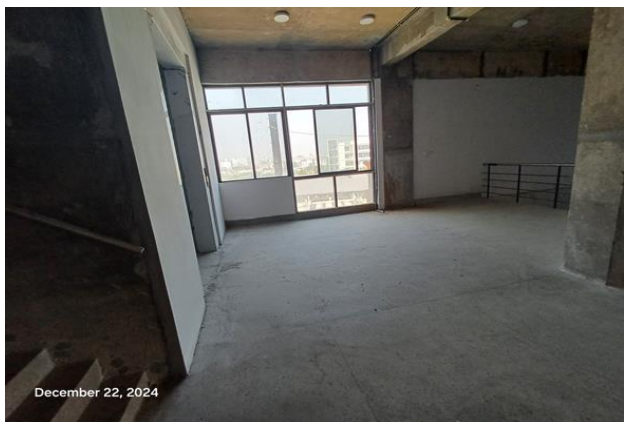
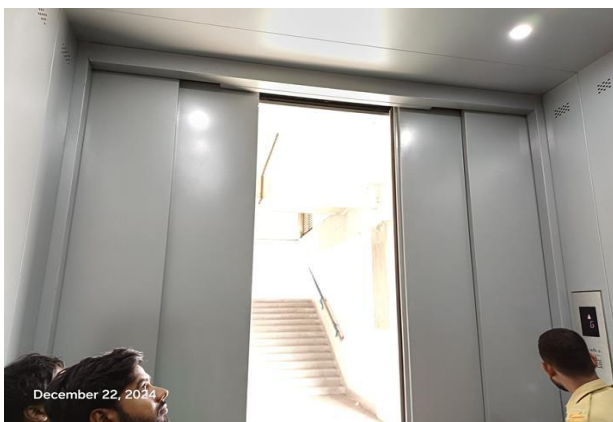
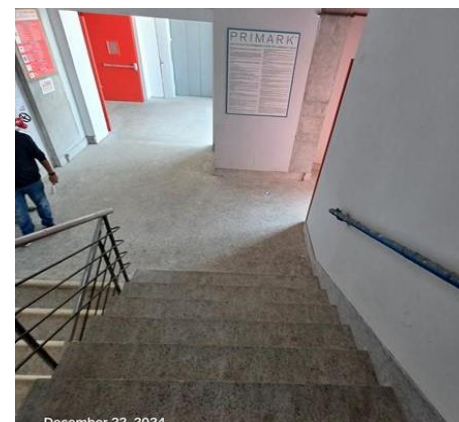
| SI No. | Category | Findings | Required Action | Remediation Time Frame |
|---|---|---|---|---|
| F4 | Means of Egress | Elevator shafts are directly open into North-west exit stair enclosure-1 and South-west exit enclosure-4. | Modify the elevator shaft as per RSC Technical Guideline (Standard) V1-6.14.3. An exit stairway shall not be built around a lift shaft unless both of them are located in a smoke proof enclosure and made of a material with fire resistance rating required for the type of construction of smoke proof enclosure. So, rearrange the facility to provide separate enclosure for lifts. If not possible anyway then provide a minimum 2-hr fire- rated elevator shaft with listed fire rated lift landing door to separate from each floor level.) | Within 3 months |

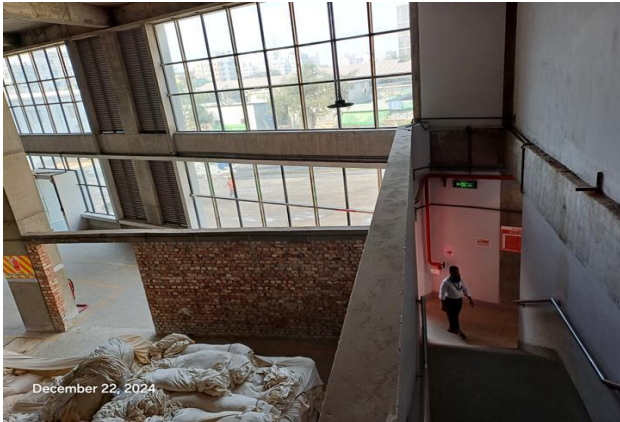
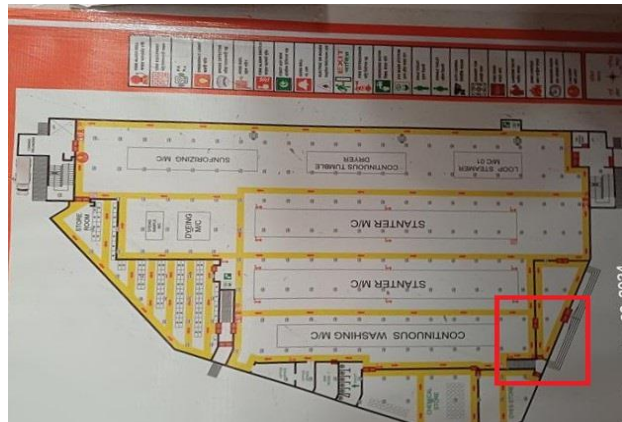
| SI No. | Category | Findings | Required Action | Remediation Time Frame |
|---|---|---|---|---|
| F5 | Means of Egress | North-East Exit Stair-2 discharge the occupant inside the building on the ground floor. | <p>A maximum of 50 percent of the number and capacity of the exit enclosures can discharge through areas on the level of exit discharge where all of the following are met:</p> <p>(1) Automatic sprinkler protection is provided throughout the level of exit discharge or portion of the level of discharge where separated from non sprinklered portions of the floor by fire barriers with the same fire resistance rating as the exit enclosure.</p> <p>(2) The interior discharge is not through a storage or hazardous occupancy.</p> <p>(3) The entire area of the level of exit discharge is separated from areas below by construction having a fire resistance rating not less than that required for the exit enclosure.</p> <p>(4) The way to the exterior shall be free and unobstructed and shall be readily visible and identifiable from the point of discharge of the interior exit.</p> | Within 3 months |

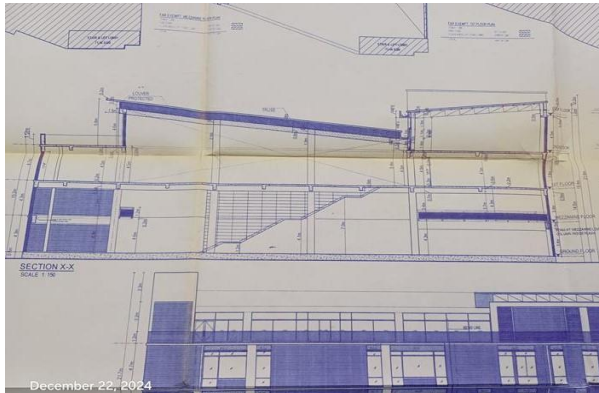
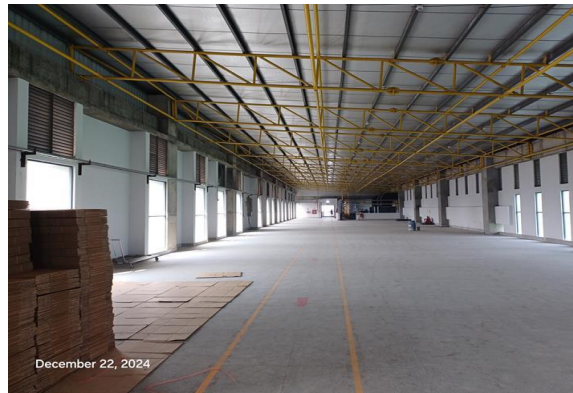
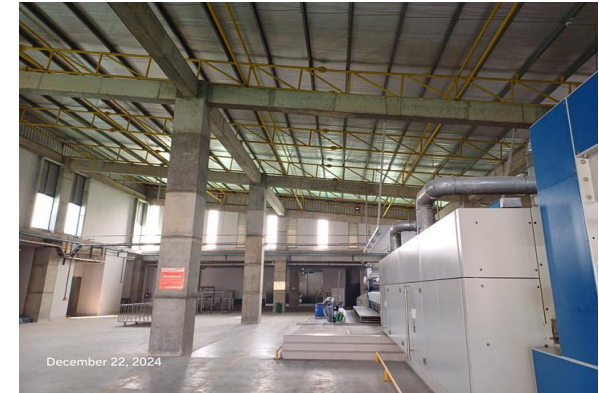
| SI No. | Category | Findings | Required Action | Remediation Time Frame |
|---|---|---|---|---|
| F6 | Fire Rated Construction | The main structural elements of the building (2nd floor roof and partially 1st floor roof) are constructed by steel which are non-rated and are found in exposed condition without any fire protection. | <p>The construction type shall confirm to be in accordance with BNBC 2020 Part-3, Table 3.1.7. Ensure fire resistive rated construction following Table 3.3.1 (a) Part 3 Section-3, Table 3.2.2 and Table 3.2.3 Part 3 Section 2 and Table 4.1.1 from BNBC 2020 Part 4 Section 1. Provide design philosophy to determine the construction type as per BNBC 2020. If any construction rating requires, Consult a qualified fire protection engineer to achieve the require fire rating.</p> <p>Factory shall ensure that, all the design, datasheet, certificate, and the design-philosophy has been reviewed from the RSC prior to install the passive fire protection system.</p> | Design Review within 2 month and installation within 4 months. |

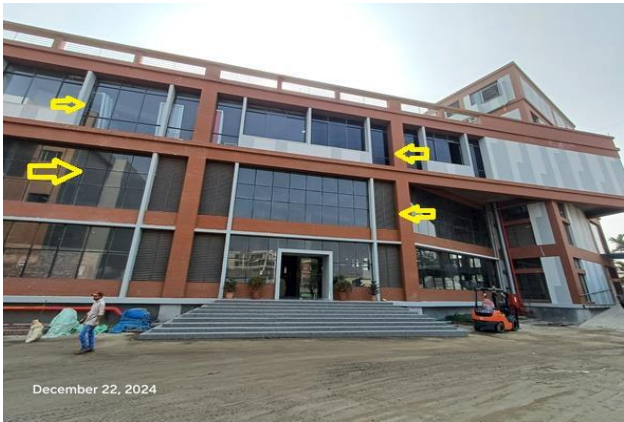
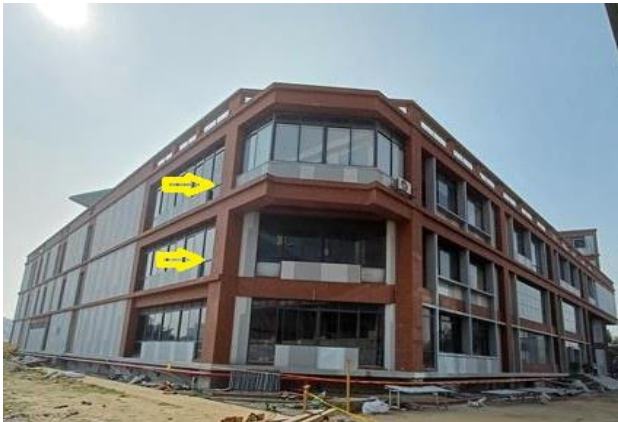
| SI No. | Category | Findings | Required Action | Remediation Time Frame |
|---|---|---|---|---|
| F7 | Fire Rated Construction | Opening in exterior wall is within 1.50m on ground and 1st floor and there is not horizontal projection for flame barrier. | Openings in the exterior wall in two consecutive floors lying within 1.5 m laterally shall be separated with a flame barrier projecting at least 75 cm from the external face of the exterior wall. The flame barrier shall have a fire resistance rating of not less than three-fourths hour. as per BNBC-2006<br>3.1.7.2 Exterior Walls | Within 3 months |

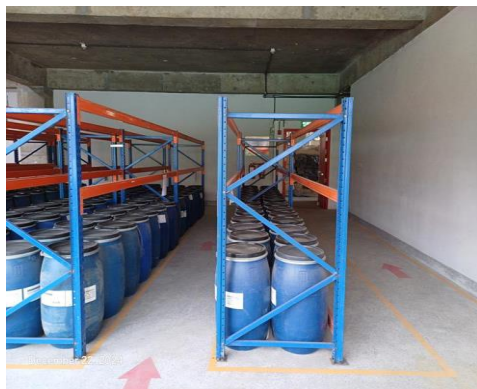
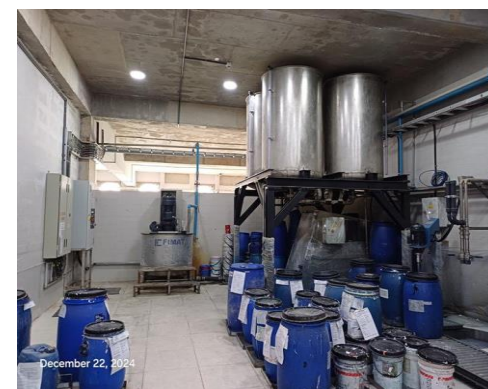
| SI No. | Category | Findings | Required Action | Remediation Time Frame |
|---|---|---|---|---|
| F8 | Fire Rated Construction | <p>Chemical storage room is not properly separated by fire-rated construction from surrounding occupancy. Location: On ground floor of building-12.</p> <p>Rooms used for subchemical storage is also not separated by fire rated construction from printing section on 1st floor .</p> | <p>Either separate the chemical storage room by 4-hr fire rated construction. Seal all penetrations and protect the openings to maintain the required fire separations for 4-hrs. Opening is not permitted for 4- hrs fire rated separation. Keep 16-points SDS of all chemicals in the storage area. Note: Construction type shall be Type-1 and separation shall be as per Table 3.2.1 of BNBC-2006.</p> <p>Or, Limit the chemical contain less than the exempt quantities as specified in Table 3.2.7 BNBC 2006.</p> | Within 3 months |

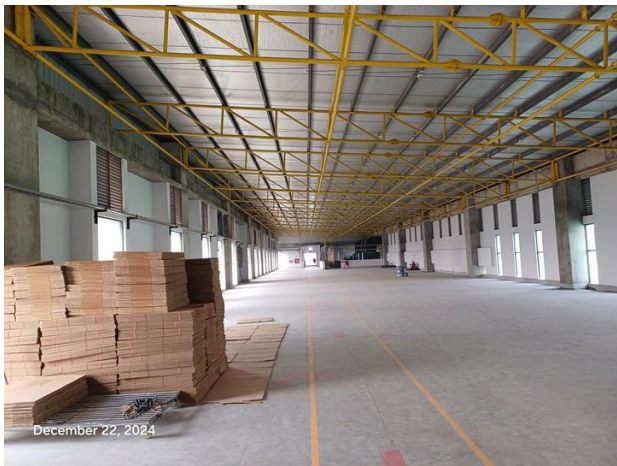
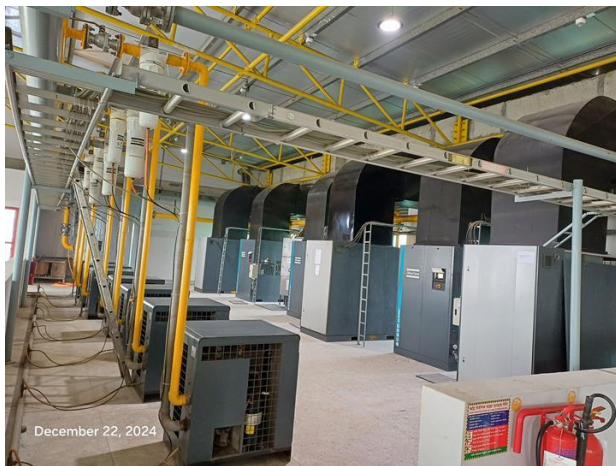
| SI No. | Category | Findings | Required Action | Remediation Time Frame |
|---|---|---|---|---|
| F9 | Fire Rated Construction | <p>The compressor room is not separated by fire rated construction from surrounding occupancy.</p> <p><b>Location(s):</b> Building-12, 2nd floor</p> | Any room or space housing boilers or other heat producing equipment shall be separated from other occupancies by a minimum 1 hour construction or by a minimum spatial separation of 3 m (10 ft) where located exterior to the building. | Within 3 months |

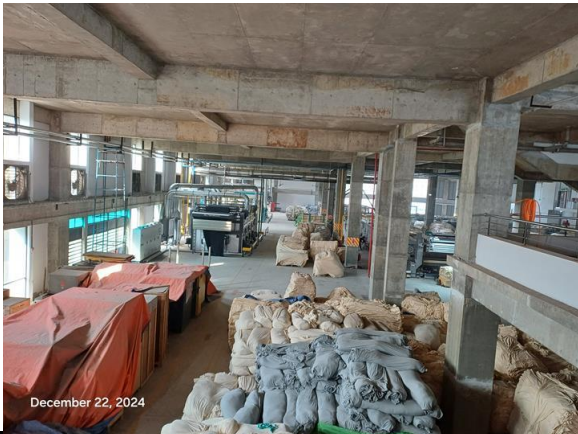
| SI No. | Category | Findings | Required Action | Remediation Time Frame |
|---|---|---|---|---|
| F-11 | Fire Alarm & Detection system | <p>Automatic fire alarm and detection system is being installed which requires detailed review to confirm compliance with NFPA 72 and The RSC Technical Guidelines (Standard).</p> <p>Location: Building-12</p> | <p>Submit the fire alarm system design to RSC for review. Once the design is reviewed, install and modify the fire detection and alarm system throughout the buildings in accordance with review comment, RSC Technical Guidelines (Standard) and NFPA 72. After installation the owner shall conduct internal testing and commissioning and then contact the RSC for witness of final acceptance testing. Also inspect, test and maintain the fire alarm system, and keep written records on-site, in accordance with Table-14.3.1 of NFPA 72.</p> | <p>Design Review within 2 months and installation/modification within 4 months</p> |

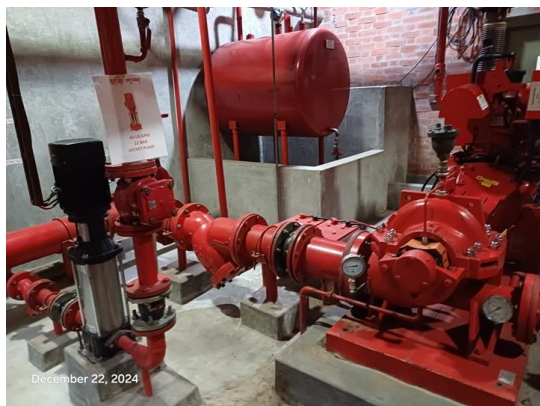
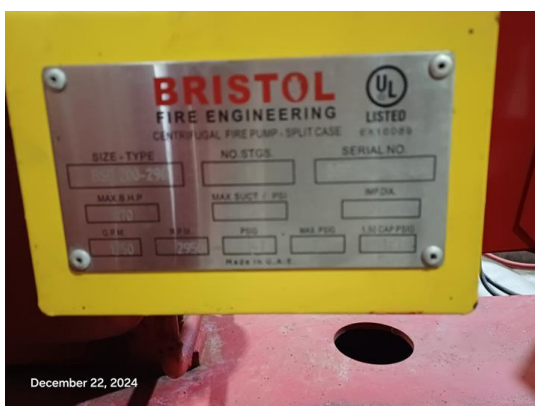
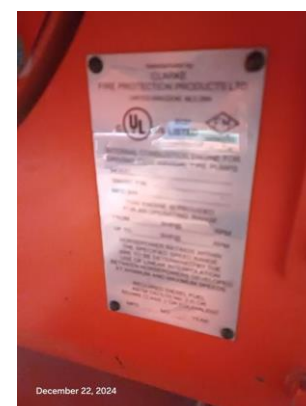
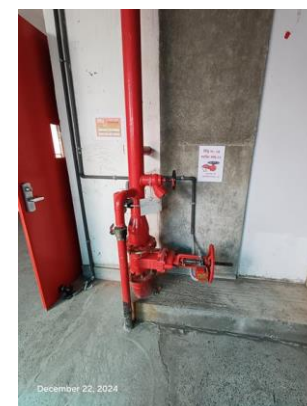
| SI No. | Category | Findings | Required Action | Remediation Time Frame |
|---|---|---|---|---|
| F-13 | Fire Protection System (Standpipe ) | A Standpipe system is found to be installed in the factory, which is required to be reviewed and verified.<br>Location: Building-12. | Submit the standpipe system drawing to RSC for review.<br>Once reviewed, install or modify the standpipe system throughout the building in accordance with RSC standard and NFPA 14,20,22 and 24.<br>Upon approval & modification (if required) the factory shall inform RSC to conduct final testing and commissioning verification of the system for final acceptance. | Design Review within 2 months and installation/modification within 4 months |

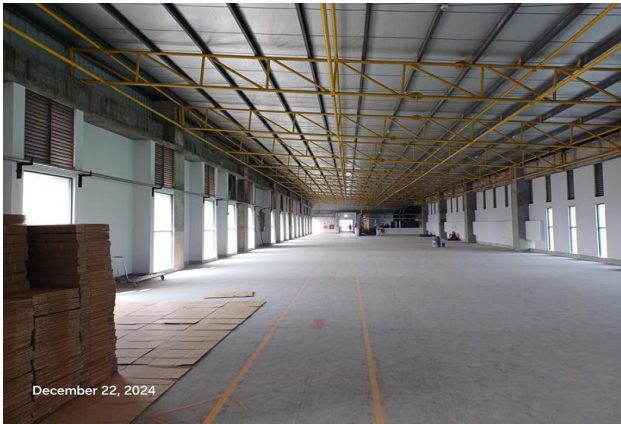
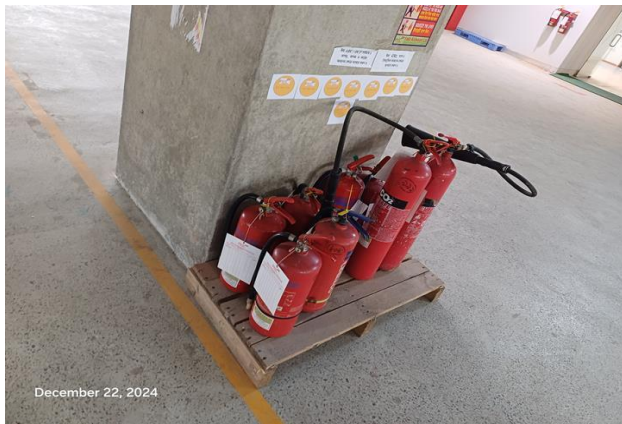
| SI No. | Category | Findings | Required Action | Remediation Time Frame |
|---|---|---|---|---|
| F-16 | Fire Rated Construction | Portable fire extinguisher are not installed inside 2nd floor unoccupied area. Few installed portable fire extinguishers are not mounted properly.<br>Location: Building-12 | Portable fire extinguishers shall be installed throughout all new, interim, and existing facilities in accordance with BNBC 2020 and NFPA 10. Extinguishers shall be placed so that maximum travel distance to the nearest unit shall not exceed 30 m (100 ft). Fire extinguishers having a gross weight not exceeding 18.14 kg (40 lb) shall be installed so that the top of the fire extinguisher is not more than 1.53 m (5 ft) above the floor (NFPA 10 6.1.3.8). The clearance between the bottom of the hand portable fire extinguisher and the floor be less than 4 in. (102 mm). | Within 3 months |

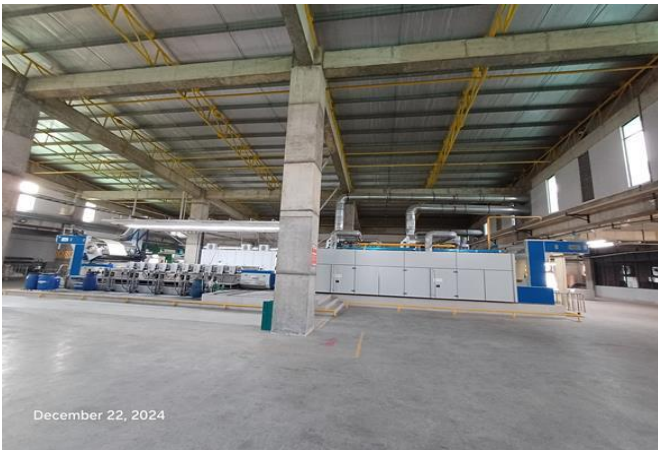
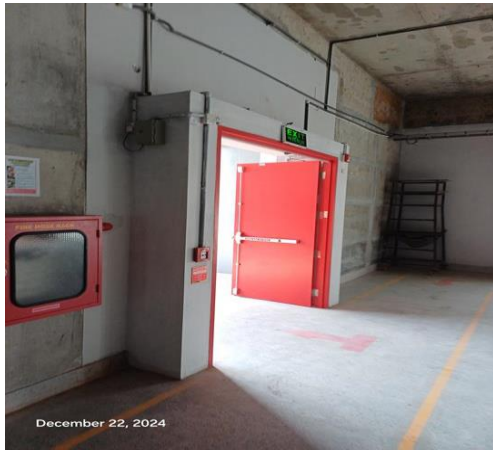
| SI No. | Category | Findings | Required Action | Remediation Time Frame |
|---|---|---|---|---|
| F-18 | Emergency Lighting | Directional signage is not provided along the path of egress where there is a change in the direction for the path of travel. Exit sign is provided only in exit. But, a few has less illumination level.<br><br>Location: All floors, Building-12 | Provide exit signs above all building exits to the exterior, all doors to the exit stairs and along all paths of travel where a change of direction is not obvious. Lighted exit signs shall be provided with either battery backup or uninterruptable power supply systems and shall be continuously illuminated. | Within 1 month |

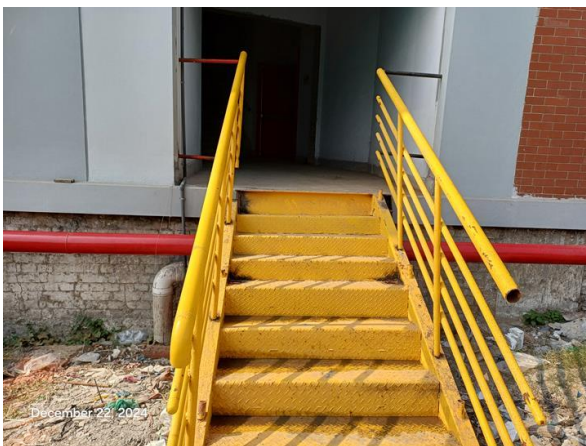
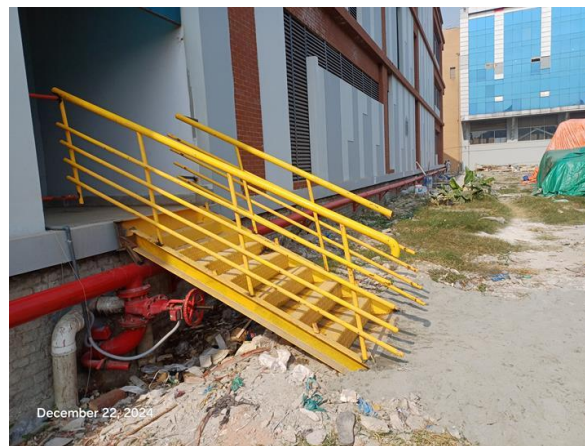
| SI No. | Category | Findings | Required Action | Remediation Time Frame |
|---|---|---|---|---|
| F-21 | Means of Egress | <p>Width of stair is less than 60 inches.<br/>Location: discharge of south-east staircase- 3 (temporary Steel stair).</p> <p>Note that all four staircase has sufficient width</p> | Construct stair in discharge in such a way that it shall have a minimum width of 1.5 m (60 in.) for all industrial occupancies. | Within 3 months |

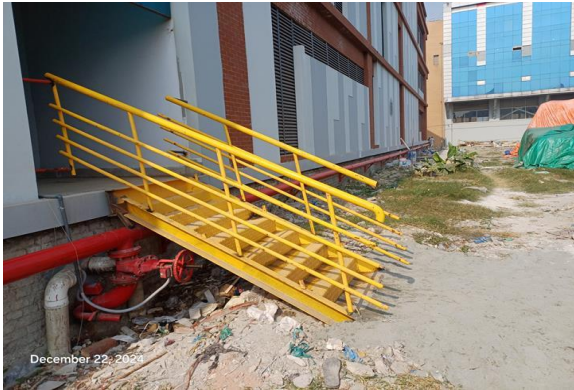
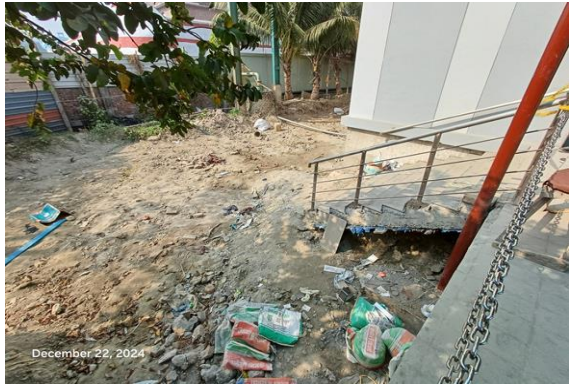
| SI No. | Category | Findings | Required Action | Remediation Time Frame |
|---|---|---|---|---|
| F-22 | Means of Egress | South and east side exit discharge path are unusable & abrupt changes of elevation in the walking surface have been found. | Provide an even level walking surface in exit discharge in accordance with 6.3.4 of RSC Technical Guidelines (Standard). | Within 1 month |

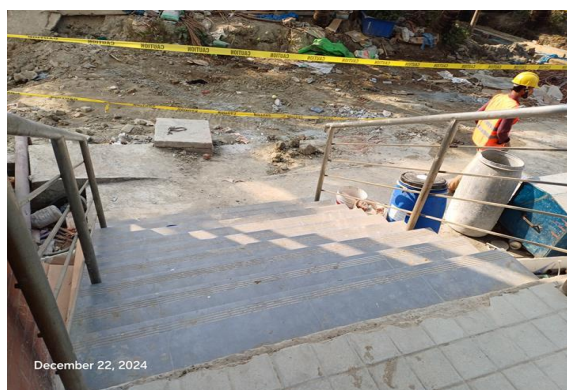
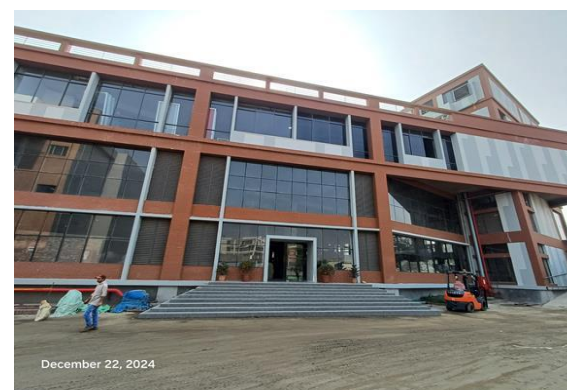
| SI No. | Category | Findings | Required Action | Remediation Time Frame |
|---|---|---|---|---|
| F-23 | Means of Egress | Handrails are not provided on both sides of the exit stairs on the 3rd floor.<br>Intermediate handrail is not provided in discharge stairs more than 2.2m wide.<br>Location: South-west & North-west stair discharge | Both side handrails should be provided to all stairs.<br>Intermediate handrail need to be provided in stairs wider than 2.20m. Handrails shall have a minimum height of 865 mm (34 in.) and a maximum height of 965 mm (38 in.) as measured from the leading edge of the tread. | Within 1 month |

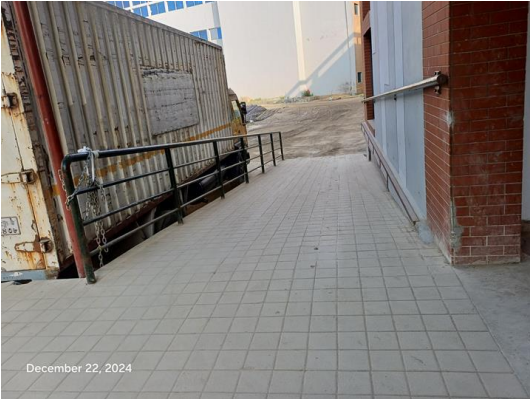
| SI No. | Category | Findings | Required Action | Remediation Time Frame |
|---|---|---|---|---|
| F-24 | Means of Egress | North-west Stair-1 discharge is provided with a ramp steeper than 1:12. | Ensure ramps shall not have a running slope greater than 1 in 12 (8 percent). | Within 3 months |

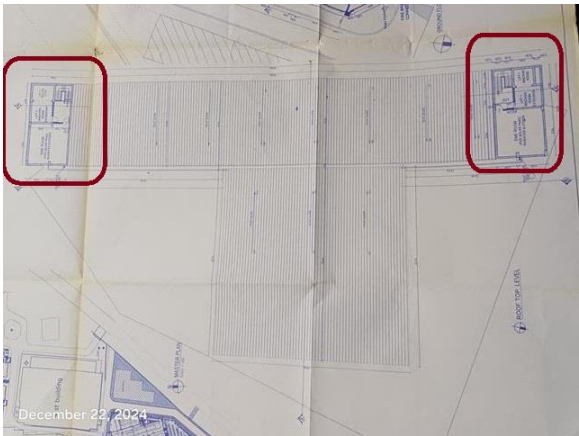
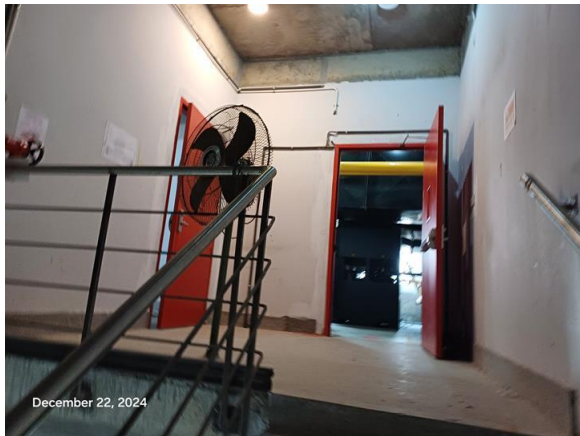
| SI No. | Category | Findings | Required Action | Remediation Time Frame |
|---|---|---|---|---|
| F-26 | Means of Egress | On 3rd floor, compressor room, lift machine room and unoccupied rooms at south-west and north-west part is provided with single exit stair. | The number of means of egress from any floor, story or portion thereof shall not be less than 2 except where a single exit is permitted by RSC guidelines 6.6.2, a single means of egress is permitted by RSC guidelines 6.6.5 or where a greater number is required by RSC guidelines 6.6.3. | Within 3 months |

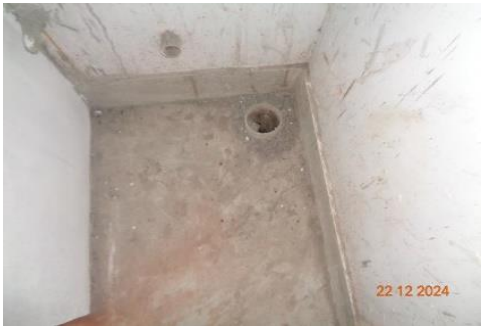
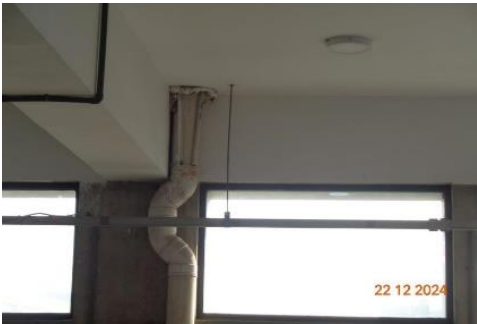
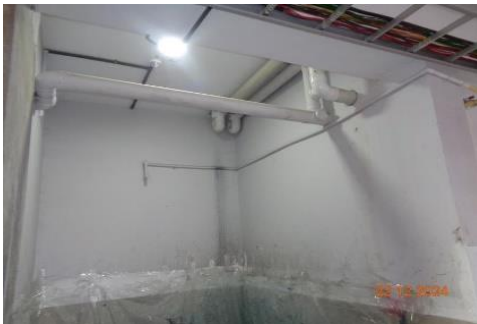
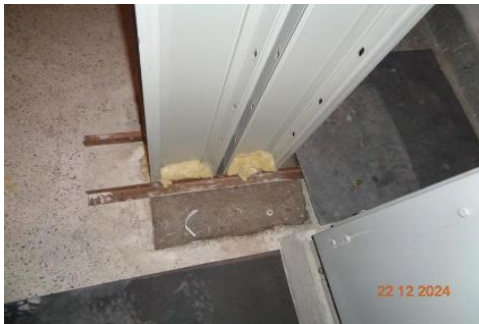
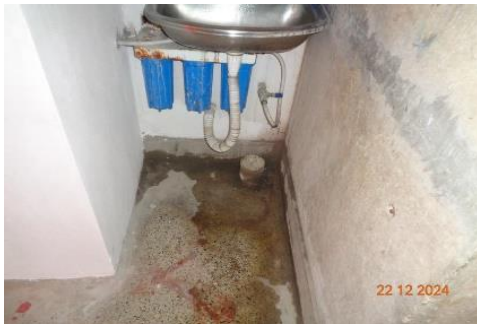
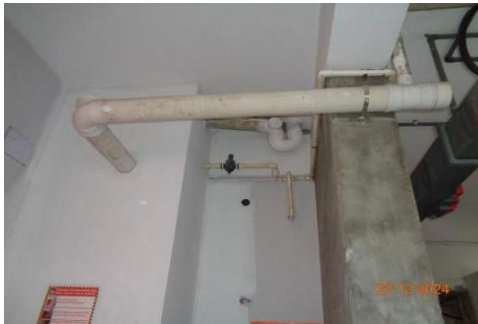
| SI No. | Category | Findings | Required Action | Remediation Time Frame |
|---|---|---|---|---|
| F-27 | Fire Rated Construction | <p>Penetrations through floor/ceiling assemblies are found unsealed.</p> <p><b>Location(s):</b> Building-13; Drinking water drain line, rain water drainage pipe, plumbing pipe on toilet area &amp; BBT etc.</p> | <p>Provide a minimum 2-hr fire-rated shaft to separate the utility risers from each floor level ,</p> <p>OR ,</p> <p>seal all penetrations and openings in floors/ceiling assemblies by 3-hr fire-rated listed/certified materials. The installation of such fire-rated materials shall be following certified design.</p> | Within 3 months |

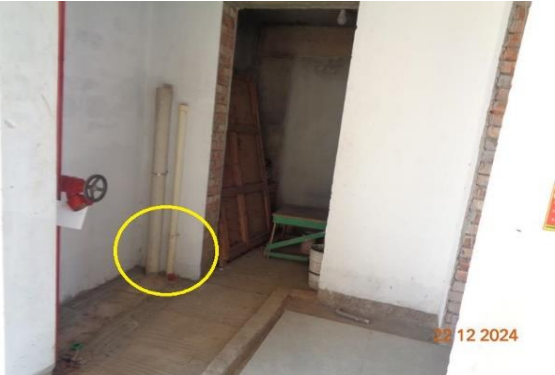
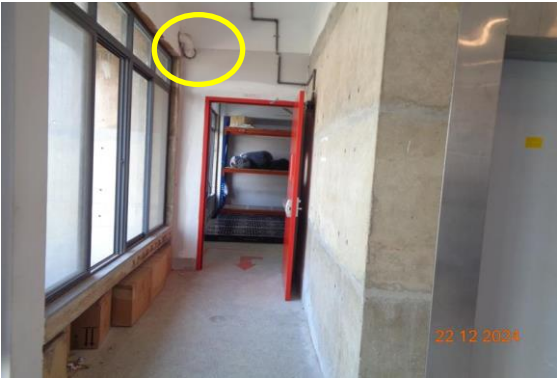
| SI No. | Category | Findings | Required Action | Remediation Time Frame |
|---|---|---|---|---|
| F-28 | Means of Egress | <p>The exit stair enclosures are not separated from work areas due to plumbing pipe connected with floor areas, which doesn't meet clause 6.14.4 (RSC Technical Guidelines)</p> <p>Location: Building-13</p> | <p>Provide minimum 2-hr fire rated construction for buildings 4 storied or more and 1-hr for up to 3 storied. Seal all unprotected openings to separate the exit stairs from work areas and other spaces on all floor levels by 90 minutes for 2 hr. construction and 60 minutes for 1-hr construction. Penetrations into and through an exit enclosure shall be prohibited with the exception of required exit doors, sprinkler piping, standpipes, electrical raceway for fire alarm equipment, and electrical conduit serving the exit enclosure.</p> <p>If fire-rated doors are required to be held open for functional reasons, provide automatic closing devices tied to the fire alarm system.</p> | Within 3 months |

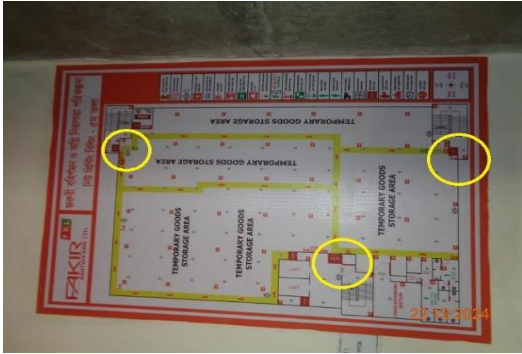
| SI No. | Category | Findings | Required Action | Remediation Time Frame |
|---|---|---|---|---|
| F-29 | Means of Egress | <p>Storage room discharges directly into exit stair enclosure without vestibules.</p> <p>Location: Building-13 ; All stairs at 4th floor, 3rd Floor stair-01 cut panel store</p> | <p>Openings from the exit enclosure to the storage room, shall be provided with a vestibule with fire-rated construction and openings.</p> <p>Provide a 1.5 hr. fire-rated door on the exit stair side and a 1 hr. fire-rated door on the store side. Ensure that the fire rating of the vestibule construction matches that of the exit stair enclosure.</p> <p>The minimum width for vestibules shall not be less than 1.1m and length 1.8m.</p> | Within 3 months |

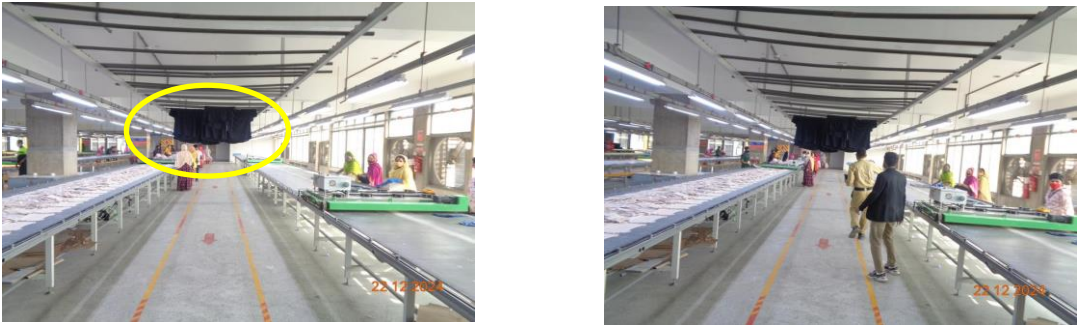
| SI No. | Category | Findings | Required Action | Remediation Time Frame |
|---|---|---|---|---|
| F-31 | Means of Egress | Headroom measured less than the 80 inch.<br>(available 66 inch)<br><br>Location: Building-13 ; 2nd & 3rd floor above aisles | All means of egress shall have a minimum ceiling height of 2.3 m (7 ft 6 in.) with projections from the ceiling not less than 2.03 m (6 ft 8 in.). The minimum ceiling height shall be maintained for at least 2/3 of the space or room as long as the remaining area shall be not less than 2.03 m (6 ft 8 in.). Headroom on stairs shall not be less than 2.03 m (6 ft 8 in.). | Within 1 month |

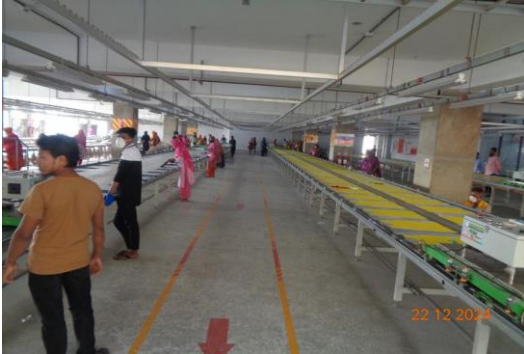
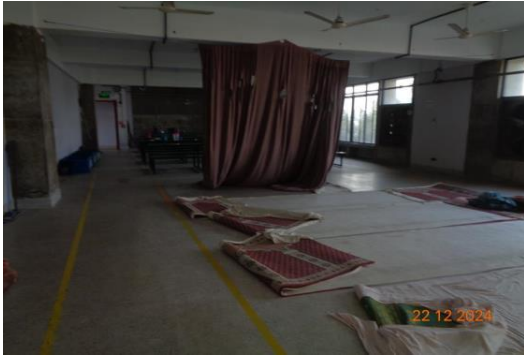
| SI No. | Category | Findings | Required Action | Remediation Time Frame |
|---|---|---|---|---|
| F-32 | Emergency Lighting | Based on the number and location of emergency lights observed, adequate illumination levels are not anticipated along egress routes and at exit stairs on all floors.<br>Location: Building-13 | Test the emergency lighting system on each floor and provide additional emergency fixtures to supply adequate illumination along the means of egress. Provide a minimum illumination of 10 lux at the floor level within exit stairs and along exit discharge paths and a minimum 2.5 lux along exit access aisles. | Within 1 month |

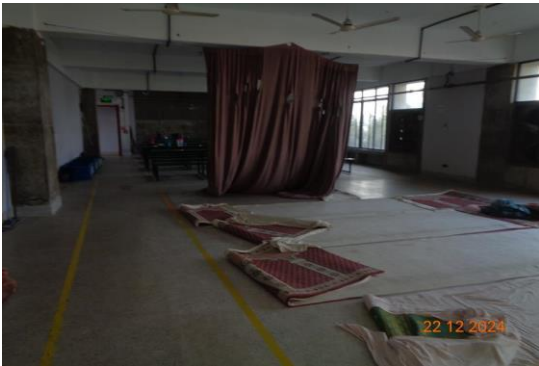
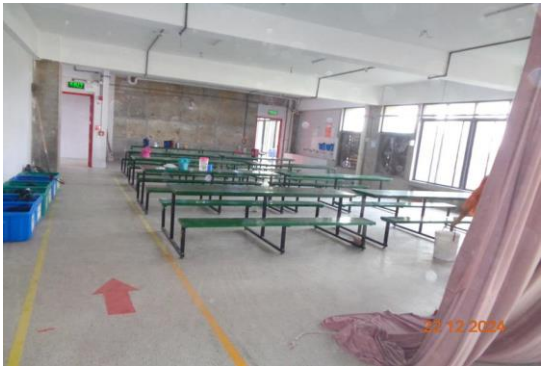
| SI No. | Category | Findings | Required Action | Remediation Time Frame |
|---|---|---|---|---|
| F-34 | Means of Egress | <p>Dinning area doesn't have required direct exits leading directly to the street or leading to a corridor or open space.</p> <p><b>Location:</b> Building-13 1st floor</p> | Assemblies of Occupancy E4 shall have at least two means of exits leading directly to the street or leading to a corridor or open space having access to exits in two independent and different direction. (3.21.3-BNBC-2006). | Within 3 months |

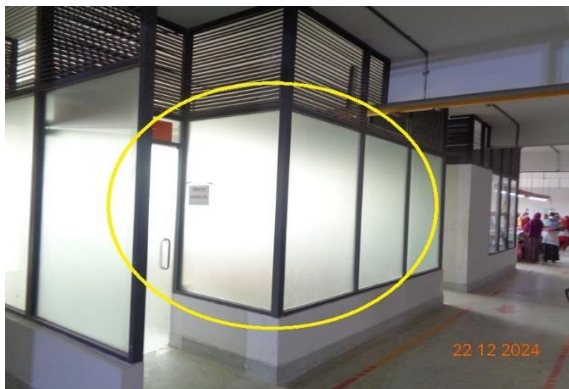
| SI No. | Category | Findings | Required Action | Remediation Time Frame |
|---|---|---|---|---|
| F-35 | Fire Rated Construction | Female prayer room is not separated from adjacent floor are(Chemical store, production occupancy etc. ) by fire rated construction.<br>Location: Building-13 , 1st floor | Separate the prayer area (assembly occupancy) by a minimum 2-hr fire-rated construction having required direct access to exit stair or safe location. Seal and/or protected all openings to maintain the required fire separations. | Within 3 months |

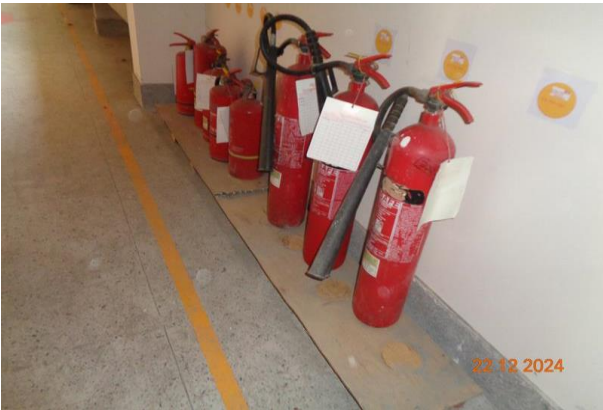
| SI No. | Category | Findings | Required Action | Remediation Time Frame |
|---|---|---|---|---|
| F-40 | Fire Protection System | <p>Fire extinguisher has been placed on a wood shelf where adequate clearance doesn't found between bottom of portable fire extinguisher and the floor.</p> <p>Location: Building-13</p> | <p>Portable fire extinguishers shall be installed throughout all new, interim, and existing facilities in accordance with BNBC 2020 and NFPA 10. Extinguishers shall be placed so that maximum travel distance to the nearest unit shall not exceed 30 m (100 ft). Fire extinguishers having a gross weight not exceeding 18.14 kg (40 lb) shall be installed so that the top of the fire extinguisher is not more than 1.53 m (5 ft) above the floor (NFPA 10 6.1.3.8). The clearance between the bottom of the hand portable fire extinguisher and the floor be less than 4 in. (102 mm).</p> | Within 1 month |

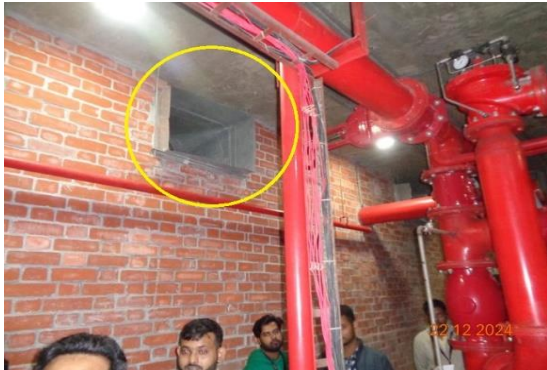
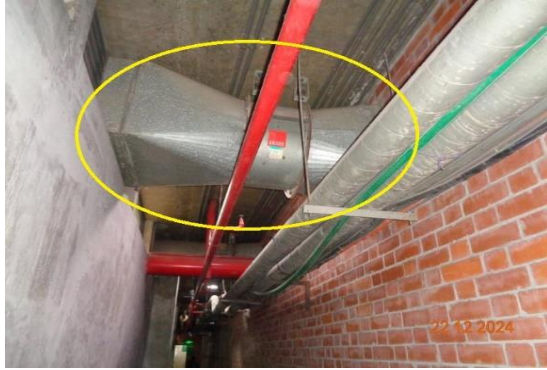
| SI No. | Category | Findings | Required Action | Remediation Time Frame |
|---|---|---|---|---|
| F-44 | Fire Rated Construction | The fire pump room is not provided with adequate fire separation from adjacent occupancy due to non-rated duct. | <p>Provide fire pump room with 2 hr. rated fire separation when not sprinklered and 1 hr. rated fire separation when provided with automatic sprinklers, in accordance with NFPA 20.</p> <p>In the case exterior it shall be 50 ft away from another occupancy.</p> | Within 3 months |
