# Natural Denim Ltd(Extension)

532, Tongabari, Ashulia, Savar, Dhaka

19 January 2025

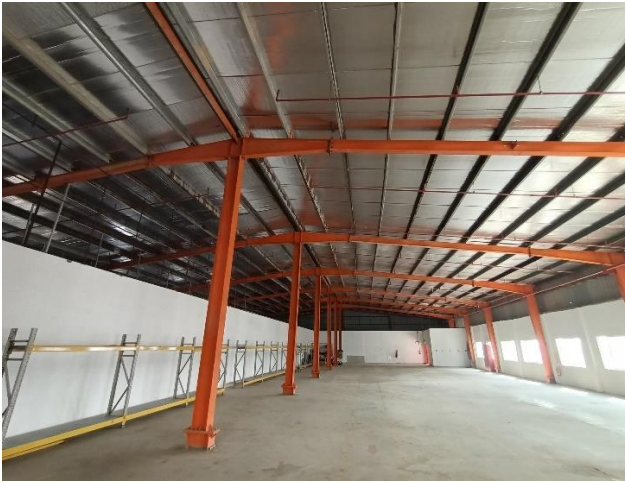
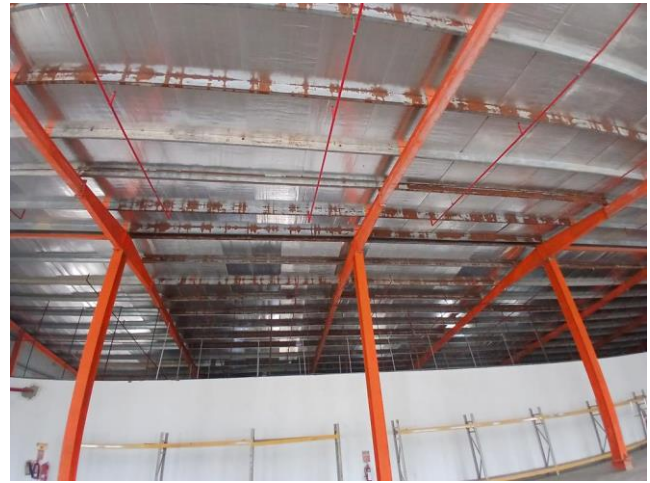
### Observation-01: Lack of lateral stability. (Washing Building)

**Description:** Lateral Load transfer media along the long direction was found discontinues at roof. The building engineer is required to carry out an Engineering Assessment (EA) to check the lateral stability of the structure and suggest proper remedial measures.

| Item No | Observation | Action Plan | Timeline |
|---|---|---|---|
| 1. | Lack of lateral stability. (Washing Building) | The building engineer is required to carry out Engineering Assessment (EA) to check the lateral stability of the structure and suggest proper remedial measures. | within 6 weeks |
| 2. | Lack of lateral stability. (Washing Building) | Carry out the suggested remedial work if required. | within 6 months |

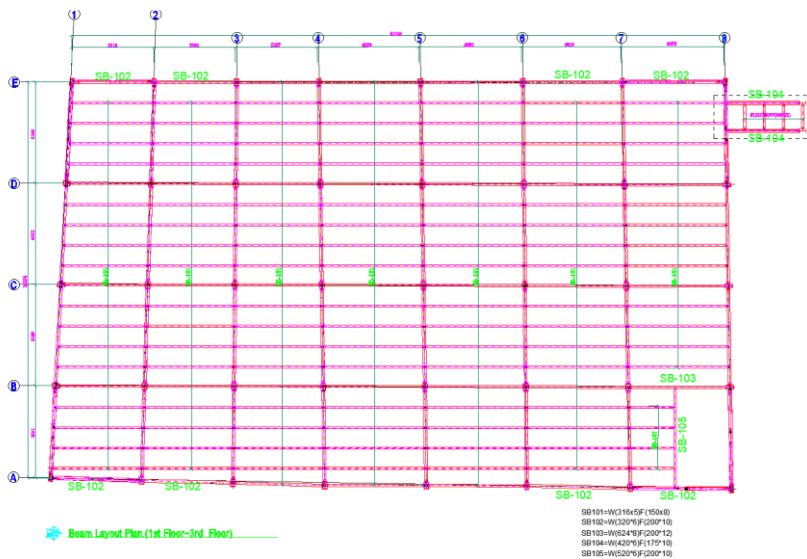
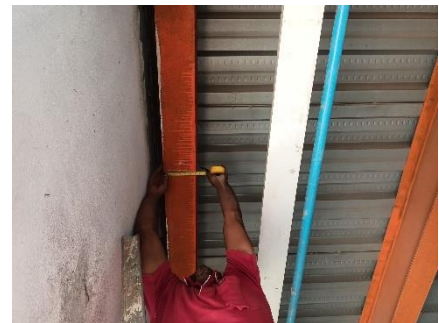
### Observation-02: Discrepancy in as-built drawing. (Washing Building)

SB101=W(316x5)F(150x8)  
SB102=W(320\*6)F(200\*10)  
SB103=W(624\*8)F(200\*12)  
SB104=W(420\*6)F(175\*10)  
SB105=W(520\*6)F(200\*10)

**Description:** Flange width of SB 102 was found 150 mm instead of 200 mm. Alos, connection details of the steel structure were not found in the provided drawings. The building engineer is required to survey the whole structure and prepare a full set of as-built drawings which reflects the on-site condition.

| Item No | Observation | Action Plan | Timeline |
|---|---|---|---|
| 3. | Discrepancy in as-built drawing. (Washing Building) | The building engineer is required to update the as-built drawing which reflects the on-site condition. | within 6 weeks |

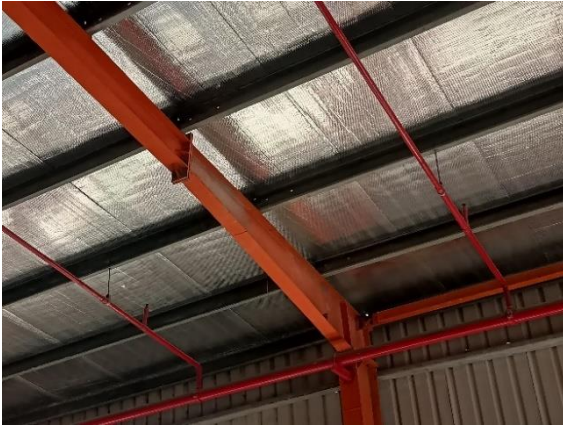
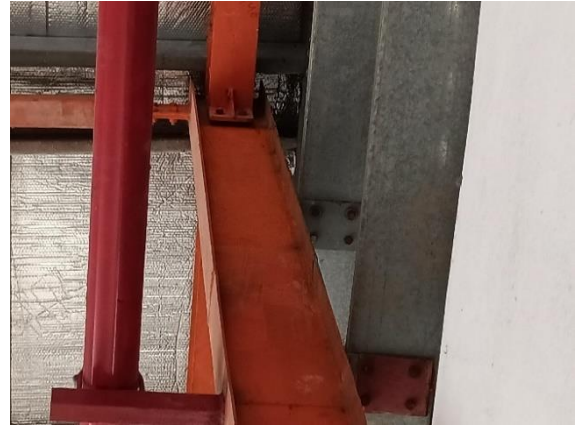
**Observation-03: Bolt missing and connection gap. (Washing Building)**

**Description:** Bolt missing and connection gap were found in the Knitting Shed. The building engineer is required to repair the gap with a suitable method. Also, install missing bolts where necessary.

| Item No | Observation | Action Plan | Timeline |
|---|---|---|---|
| 4. | Bolt missing and connection gap. (Washing Building) | The building engineer is required to repair the gap with a suitable method. | within 6 weeks |
| 5. | Bolt missing and connection gap. (Washing Building) | Install missing bolts where necessary. | within 6 weeks |

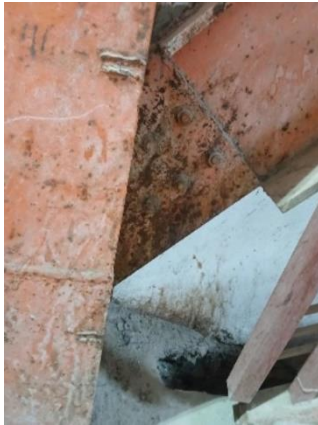
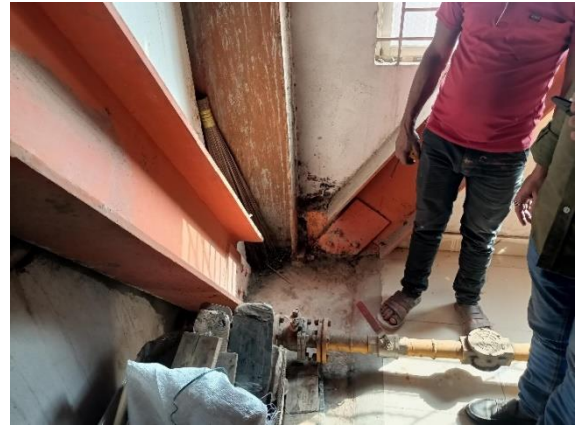
**Observation-04: Corrosion on steel member. (Washing Building)**

**Description:** Corrosion was found in the steel member. The building engineer is required to remove the corrosion and provide anti corrosive coating to the steel members.

| Item No | Observation | Action Plan | Timeline |
|---|---|---|---|
| 6. | Corrosion on steel member. (Washing Building) | The building engineer is required to remove the corrosion and provide anti corrosive coating to the steel members. | within 6 weeks |

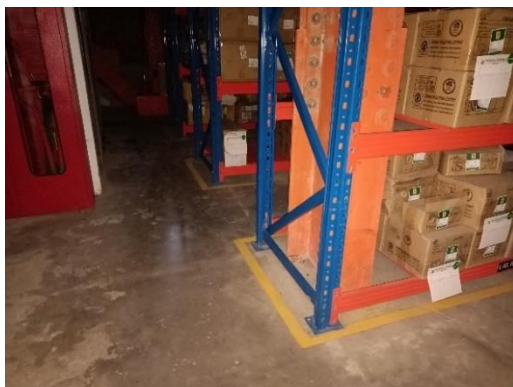
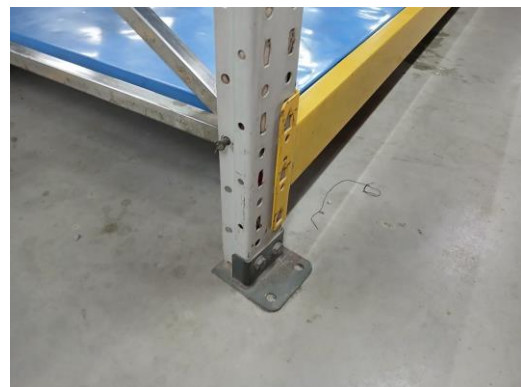
**Observation-05: Non-structural elements not anchored or braced. (Washing Building)**

**Description:** Non-structural elements (PVC tank and Racks) were found on different floors of the building. Which were not properly anchored or braced. Building engineer is required to anchor or brace all non-structural elements to avoid falling hazard during earthquake or any lateral loading.

| Item No | Observation | Action Plan | Timeline |
|---|---|---|---|
| 7. | Non-structural elements not anchored or braced. (Washing Building) | The building engineer is required to anchor or brace all non-structural elements to avoid falling hazard during earthquake or any lateral loading. | within 6 months |

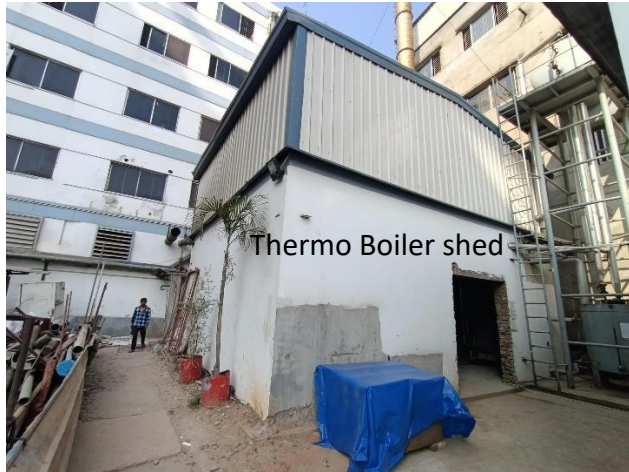
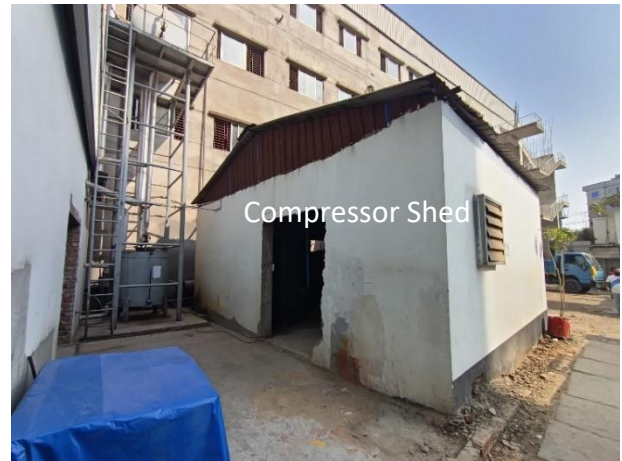
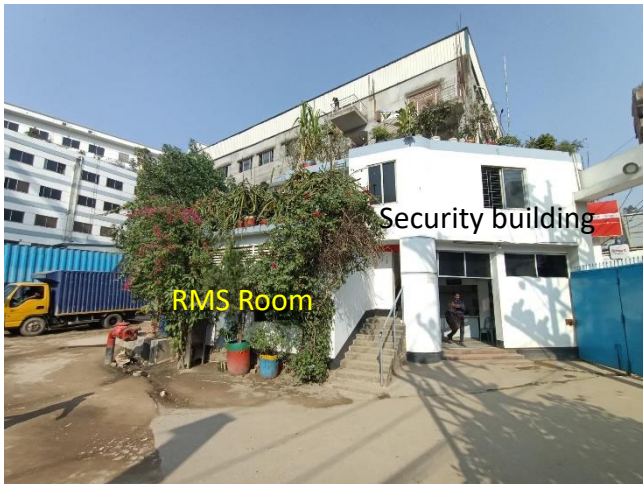
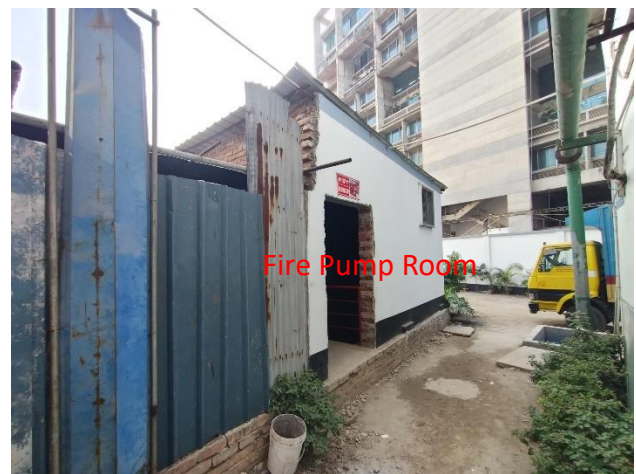
**Observation-06:** Lack of as-built drawings (Thermo Boiler shed, Compressor Shed, Fire Pump Room, Security building, RMS room)

**Description:** As-built structural & architectural drawings were not available for these structures. Only sub-structural details were available for the Fire pump Room. The building engineer is required to prepare full set of as-built drawing with complete structural and architectural details.

| Item No | Observation | Action Plan | Timeline |
|---|---|---|---|
| 8. | Lack of as-built drawings (Thermo Boiler shed, Compressor Shed, Fire Pump Room, Security building, RMS room) | The building engineer is required to prepare a full set of as-built drawing with complete structural details. | within 6 weeks |

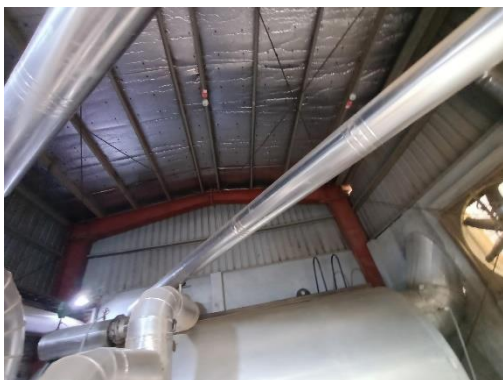
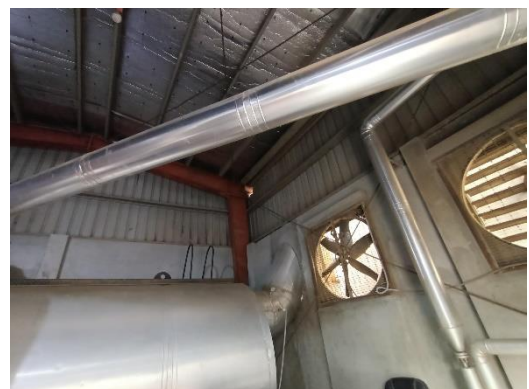
**Observation-07:** Lack of lateral stability. (Thermo Boiler shed)

**Description:** Lack of lateral stability system observed in the shed. Also, existing bracings were found untighten. The building engineer is required to prepare a safety check report according to the Accord Building Standard to address this issue.

| Item No | Observation | Action Plan | Timeline |
|---|---|---|---|
| 9. | Lack of lateral stability. (Thermo Boiler shed) | The building engineer is required to prepare a safety check report according to the Accord Building Standard to ensure the basic level of safety of the structure. | within 6 weeks |
| 10. | Lack of lateral stability. (Thermo Boiler shed) | Carry out the suggested remedial work if required. | within 6 months |

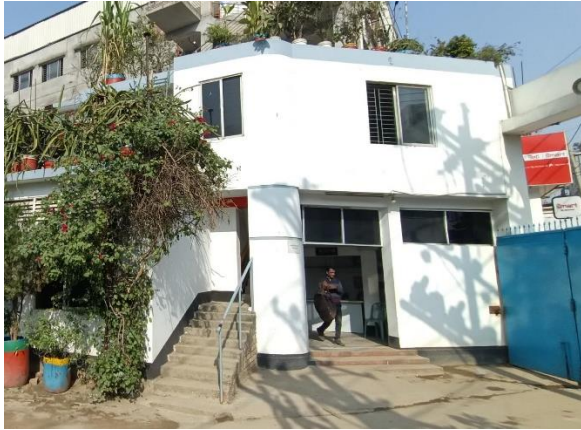
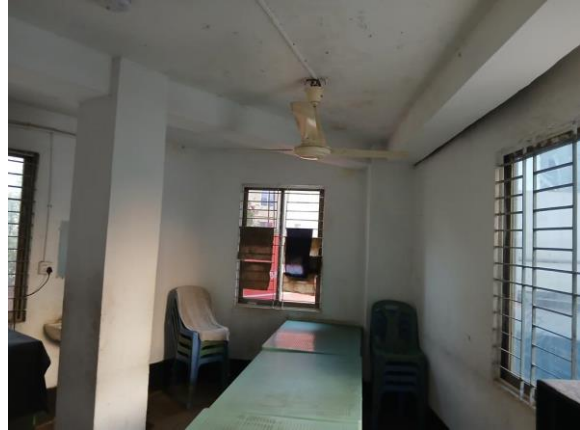
**Observation-08:** Absence of design documents. (Security Building)

**Description:** As per BNBC, every building or structure designed shall have its design documents prepared following the provision of Section 1.9.1. The design document shall include a design report, and a set of structural drawings, which shall be prepared in compliance with section 1.9.1.1 and section 1.9.1.2 as per BNBC. At the time of inspection, the design report was not available which is required to be prepared in compliance with section 1.9.1.1 (part 6, BNBC).

| Item No | Observation | Action Plan | Timeline |
|---|---|---|---|
| 11. | Absence of design documents. (Security Building) | Prepare design report for the structure as per 1.9.1 BNBC. | within 6 weeks |
| 12. | Absence of design documents. (Security Building) | Implement the recommendations of the design report. | within 6 months |
| 13. | Absence of design documents. (Security Building) | Implement floor load plan. | within 6 months |

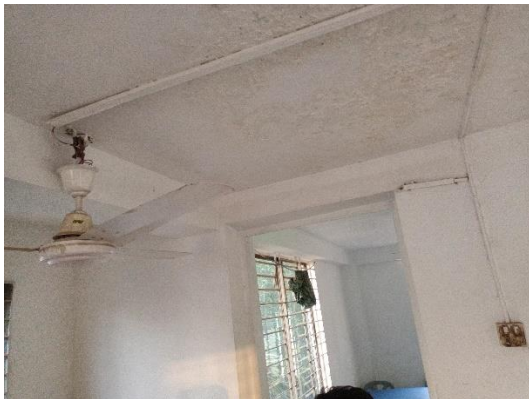
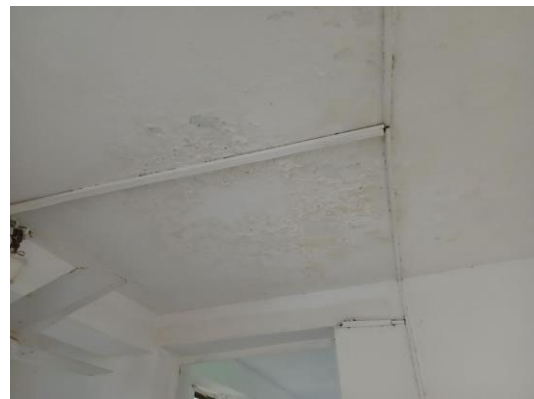
**Observation-09:** Dampness found on slab soffit. (Security Building)

**Description:** Dampness was found on the 1<sup>st</sup> floor roof slab soffit. The building engineer is required to repair dampness with a suitable method.

| 14. | Dampness found on slab soffit. (Security Building) | Investigate the damp portion and repair accordingly. | within 6 weeks |

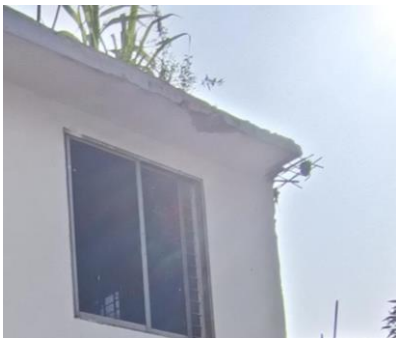
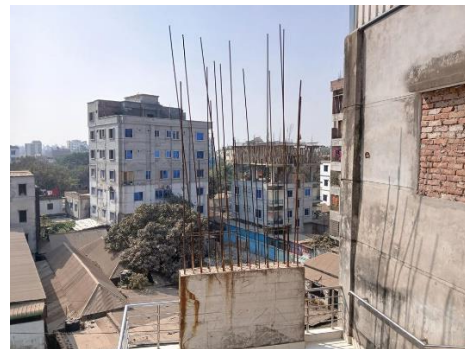
**Observation-10:** Exposed rebar on partial roof. (External Stair and Security Building)

**Description:** During inspection, the exposed rebar was found on the roof slab. The building engineer is required to apply anti-rust proof coating on exposed rebar.

| 15. | Exposed rebar on partial roof. (External Stair and Security Building) | The building engineer is required to apply anti-rust proof coating on exposed rebar. | within 6 months |
