# Euro Knitwear Limited (Unit-2)

159, Ojarpara, Mollah Market, National University-1704, Gacha, Gazipur City Corp; Gazipur  
(23.958650, 90.364458)  
9 January 2025

## 1. Building Information

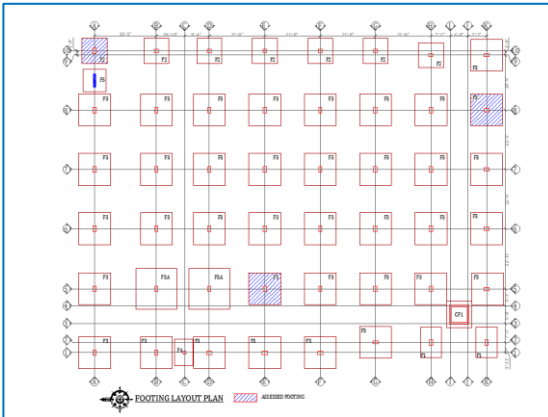
### Observation-01: Stress in the foundation exceeds normal design limit. (Production Building)

**Description:** Cursory calculation indicates the internal footings are stressed above the normal design limit for bearing capacity. We considered the observed live load 3 kPa for typical floor. Also, the ultimate bearing capacity of the soil was considered 2.5 ksf, as per soil test report. The building engineer is required to carry out Engineering Assessment (EA) to review the design, load and foundation stresses.

| Item No | Observation | Action Plan | Timeline |
|---|---|---|---|
| 1. | Stress in the foundation exceeds normal design limit. (Production Building) | The building engineer is required to carry out Engineering Assessment (EA) to review the design, load and foundation stresses. | within 6 weeks |
| 2. | Stress in the foundation exceeds normal design limit. (Production Building) | Produce and actively manage a loading plan for all floor plates within the factory, considering floor, column, and foundation capacity. | within 6 weeks |
| 3. | Stress in the foundation exceeds normal design limit. (Production Building) | Carry out the suggested remedial work if required. | within 6 months |

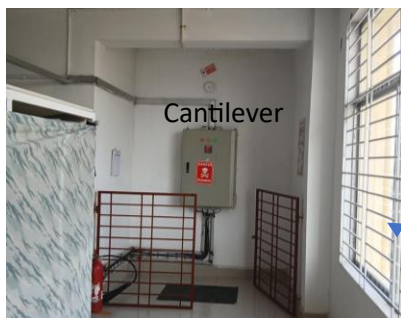
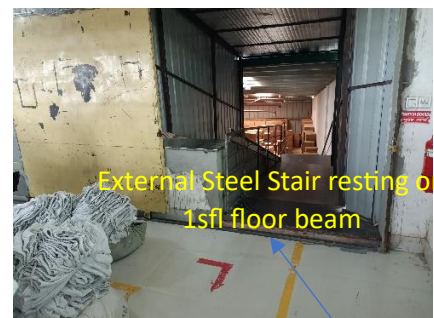
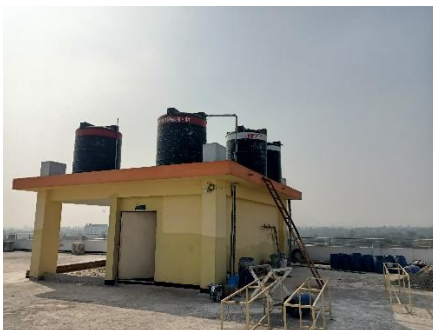
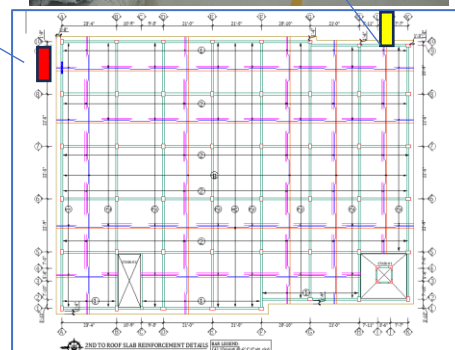
### Observation-02: Discrepancy in as-built drawing. (Production Building)

**Description:** Floor layouts are not fully matched with the as-built condition. Cantilever portion at North-east corner not shown in the structural slab layout. Also, an external steel stair landing is resting on the 1<sup>st</sup> floor beam which is not shown in the drawings. Moreover, 4 nos of undocumented PVC tank (3000L each) were found in the stair top. The building engineer is required to update the as-built drawing which reflects the on-site condition.

| Item No | Observation | Action Plan | Timeline |
|---|---|---|---|
| 4. | Discrepancy in as-built drawing. (Production Building) | The building engineer is required to update the as-built drawing which reflects the on-site condition. | within 6 weeks |

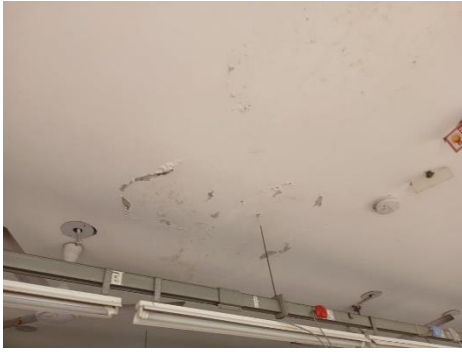
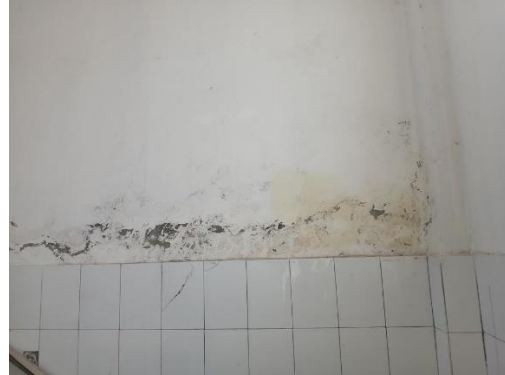
**Observation-03:** Dampness in the slab and walls. (Production Building)

**Description:** Dampness was found in the floor slab and walls. Building Engineer is required to investigate the damped portion and repair accordingly

| Item No | Observation | Action Plan | Timeline |
|---|---|---|---|
| 5. | Dampness in the slab and walls. (Production Building) | Building Engineer is required to investigate the damped portion and repair accordingly | within 6 weeks |

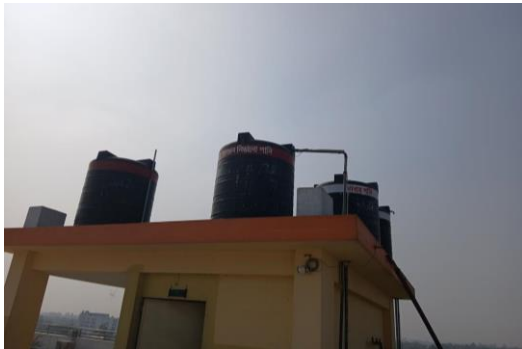
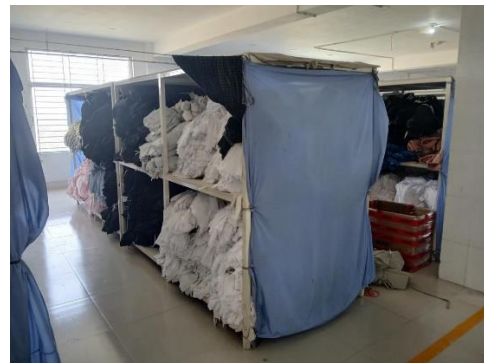
**Observation-04:** Non-structural elements not anchored or braced. (All structures)

**Description:** Non-structural elements (PVC tank and Racks) were found on different floors of the building. Which were not properly anchored or braced. Building engineer is required to anchor or brace all non-structural elements to avoid falling hazard during earthquake or any lateral loading.

| Item No | Observation | Action Plan | Timeline |
|---|---|---|---|
| 6. | Non-structural elements not anchored or braced. (All structures) | Building engineer is required to anchor or brace all non-structural elements to avoid falling hazard during earthquake or any lateral loading. | within 6 weeks |

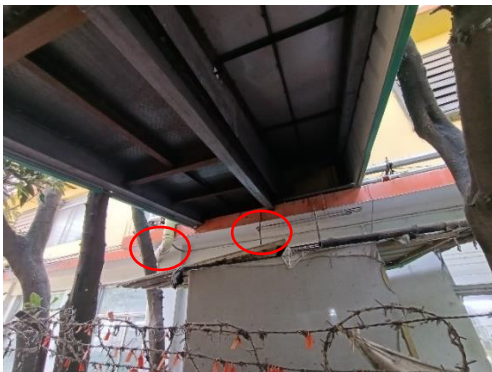
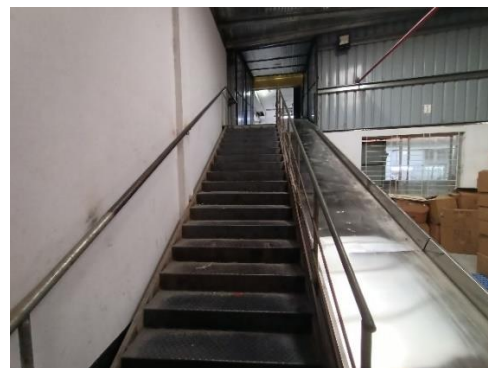
**Observation-05:** Inadequate connection at external steel stairs. (Production Building)

**Description:** An external steel stair was found in between Production Building and Fabric Godown Shed. The landing of the stair was resting on the 1<sup>st</sup> floor beam of the Production Building at East. Stair landing beam was poorly welded with anchored rebar of the Cornish of the Production Building. The building engineer is required to check the connection adequacy and provide separate support system for the external steel stair.

| Item No | Observation | Action Plan | Timeline |
|---|---|---|---|
| 7. | Inadequate connection at external steel stair. (Production Building) | The building engineer is required check the connection adequacy and also provide separate support system for the external steel stair. | within 6 weeks |

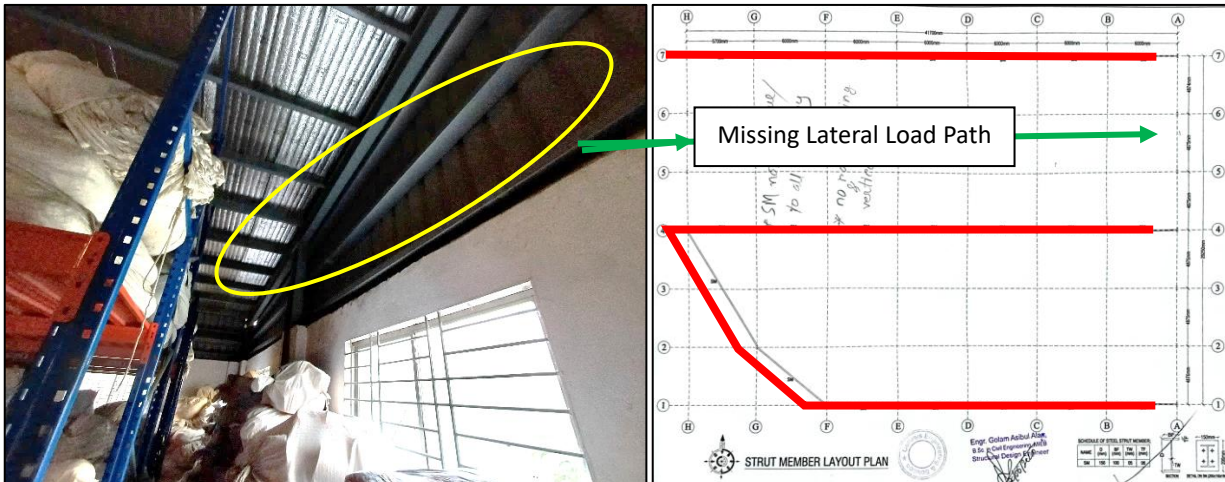
**Observation-06:** Incomplete lateral load path. (Grey Fabric Store)

**Description:** During inspection, the lateral load path was found missing along Grid-A and Grid-H (shown by green arrow). The building engineer is required to check the lateral stability system of the shed.

| Item No | Observation | Action Plan | Timeline |
|---|---|---|---|
| 8. | Incomplete lateral load path. (Grey Fabric Store) | The building engineer is required to check the lateral stability system of the shed. | within 6 weeks |
| 9. | Incomplete lateral load path. (Grey Fabric Store) | Carry out the suggested remedial work if required. | within 6 months |

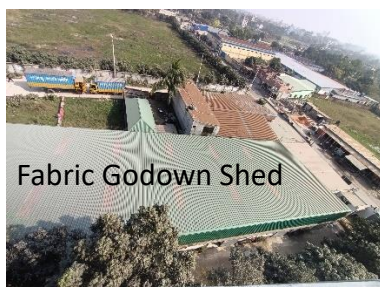
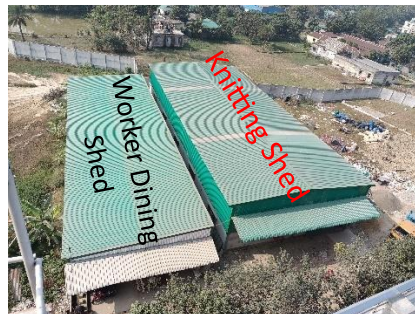
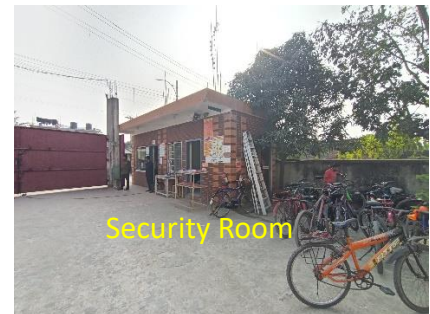
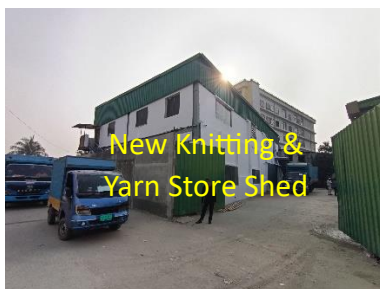
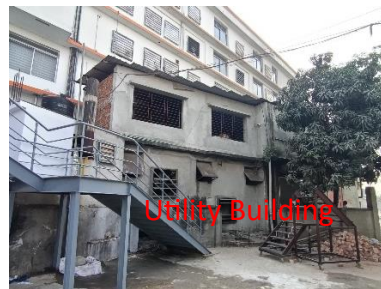
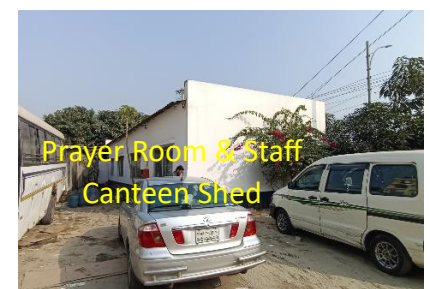
**Observation-07:** Incomplete as-built drawings (Fabric Godown Shed, New Knitting & Yarn Store Shed, Knitting Shed, Worker Dining Shed, Prayer Room & Staff Canteen Shed, Utility Building, Security Room)

**Description:** As-built structural & architectural drawings were not available for these structures. Only a layout plan was found during the inspection. The building engineer is required to prepare full set of as-built drawing with complete structural details.

| Item No | Observation | Action Plan | Timeline |
|---|---|---|---|
| 10. | Incomplete as-built drawings (Fabric Godown Shed, New Knitting & Yarn Store Shed, Knitting Shed, Worker Dining Shed, Prayer Room & Staff Canteen Shed, Utility Building, Security Room) | Building engineer is required to prepare full set of as-built drawing with complete structural details. | within 6 weeks |

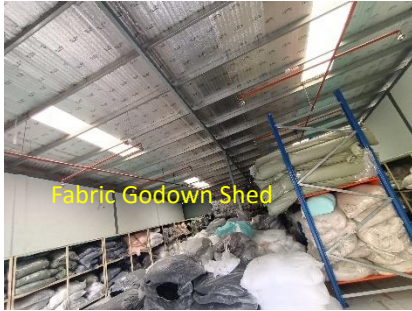
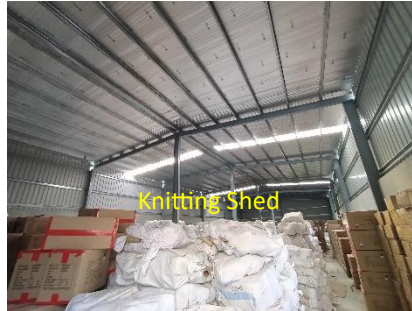
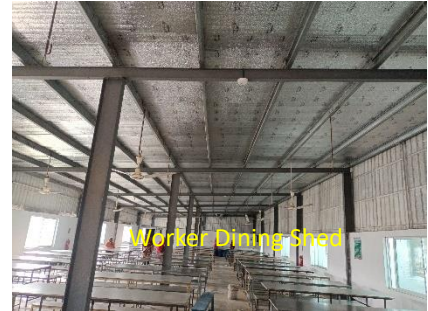
**Observation-08:** Lack of lateral stability. (Fabric Godown Shed, Knitting Shed, Worker Dining Shed)

**Description:** Load transfer media (bracing & strut) along the long direction was found missing. The building engineer is required to carry out an Engineering Assessment (EA) to check the lateral stability, connection and member adequacy of these structures.

| Item No | Observation | Action Plan | Timeline |
|---|---|---|---|
| 11. | Lack of lateral stability and inadequate member size. (Fabric Godown Shed, Knitting Shed, Worker Dining Shed) | The building engineer is required to check the lateral stability, connection and member adequacy of these structures. | within 6 weeks |

| 12. | Lack of lateral stability and inadequate member size.<br>(Fabric Godown Shed, Knitting Shed, Worker Dining Shed) | Carry out the suggested remedial work if required. | within 6 months |

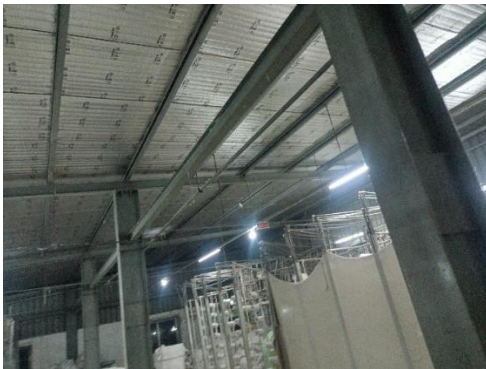
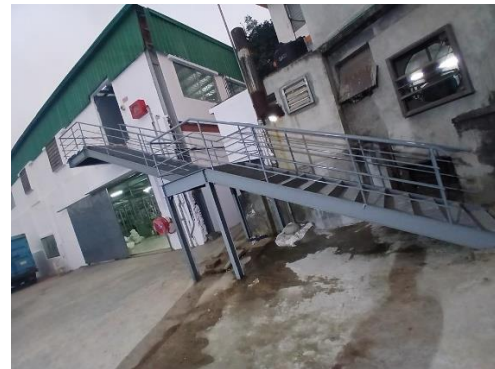
**Observation 09:** Absence of floor load plan (Knitting Shed & adjacent steel stair).

**Description:** There is no floor load plan for the suspended floor and steel stairs. The building engineer is required to prepare a floor live load plan based on floor, column and foundation capacity. Implement the floor load management program.

| 13. | Absence of floor load plan (Knitting Shed & adjacent steel stair). | The building engineer is required to prepare a floor live load plan based on floor, column and foundation capacity. | within 6 weeks |
| 14. | Absence of floor load plan (Knitting Shed & adjacent steel stair). | Implement the floor load management program. | within 6 months |

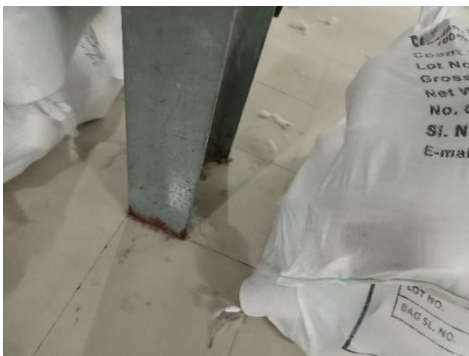
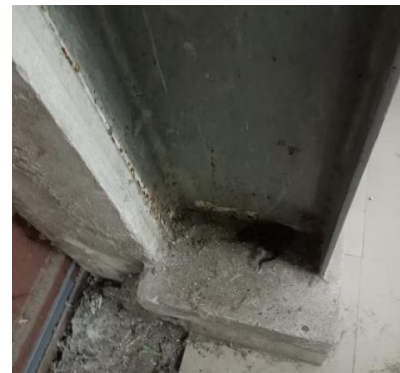
**Observation-10:** Corrosion on steel member. (Knitting Shed)

**Description:** Corrosion was found in the steel member. The building engineer is required to remove the corrosion and provide anti corrosive coating to the steel members.

| 15. | Corrosion on steel member. (Knitting Shed) | The building engineer is required to apply anti-rust proof coating on exposed rebar. | within 6 weeks |

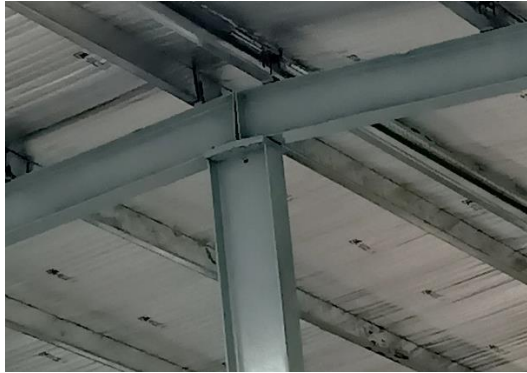
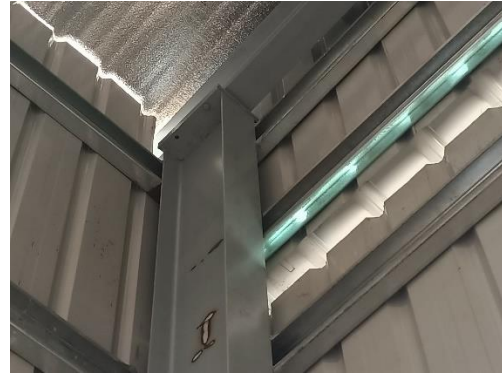
**Observation-11: Bolt missing and connection gap. (All Sheds)**

**Description:** Bolt missing and connection gap were found in the Knitting Shed. The building engineer is required to repair the gap with a suitable method. Also, install missing bolts where necessary.

| 16. | Bolt missing and connection gap. (All Sheds) | The building engineer is required to repair the gap with a suitable method. | within 6 weeks |
| 17. | Bolt missing and connection gap. (All Sheds) | Install missing bolts where necessary. | within 6 weeks |

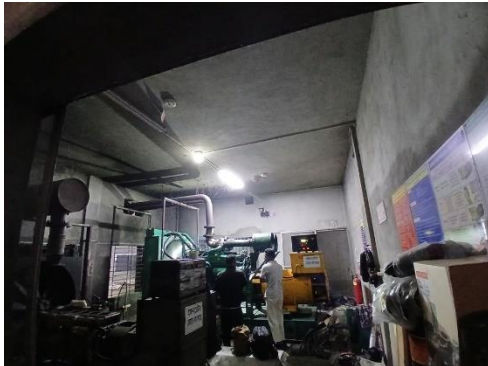
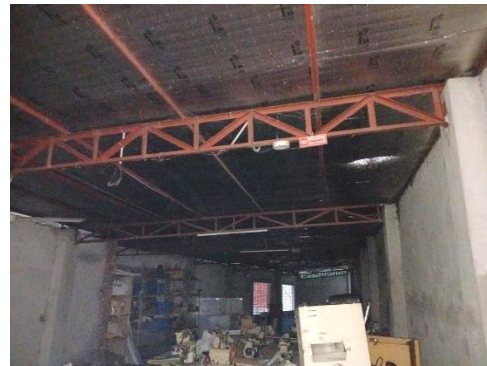
**Observation-12: Vibration on floor due to operation of heavy machine. (Utility Building)**

**Description:** Significant vibration was felt on the first floor due to the operation of heavy machinery. The building engineer is required to investigate the long-term effect of the vibration and suggest proper remediation accordingly.

| 18. | Vibration on floor due to operation of heavy machine. (Utility Building) | The building engineer is required to investigate the long-term effect of the vibration and suggest remediation. | within 6 weeks |
| 19. | Vibration on floor due to operation of heavy machine. (Utility Building) | Carry out the suggested remedial work if required. | within 6 months |

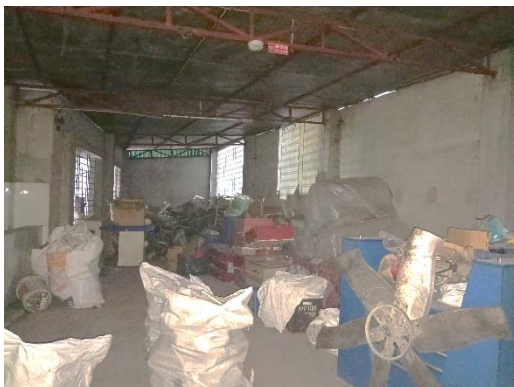
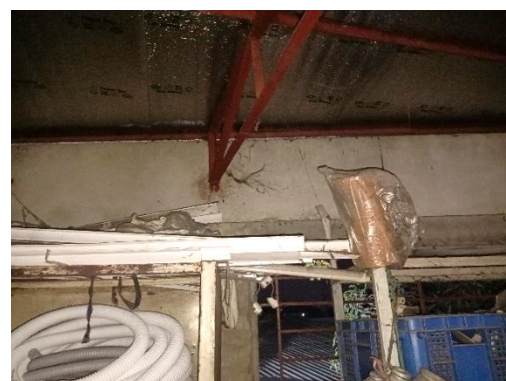
**Observation-13: Inadequate connection of roof truss. (Roof Shed-Utility Building)**

**Description:** Few truss frames were poorly connected with 5 inches brick walls at the roof of the Utility Building. The building engineer is required to check the connection adequacy of the roof truss and suggest proper remedial measures.

| 20. | Inadequate connection of roof truss. (Roof Shed-Utility Building) | The building engineer is required to check the connection adequacy of the roof truss and suggest proper remedial measures. | within 6 weeks |
| 21. | Inadequate connection of roof truss. (Roof Shed-Utility Building) | Carry out the suggested remedial work if required. | within 6 months |

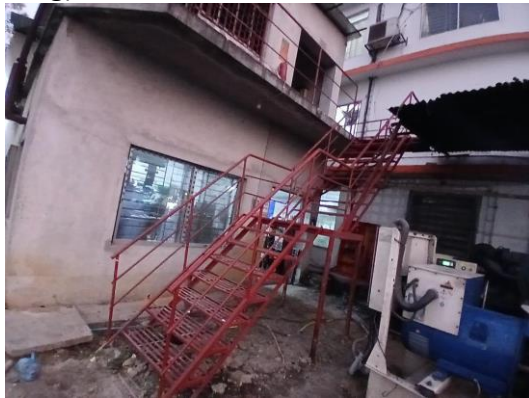
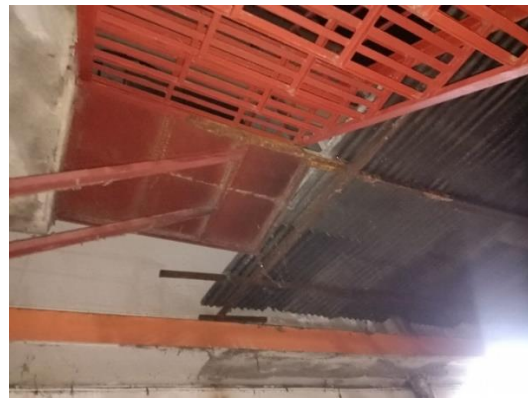
**Observation-14:** Lack of lateral stability and inadequate member size. (External steel stair-Utility Building)

**Description:** Lack of lateral stability system and inadequate member sizes were observed in the external steel stair of the building. The building engineer is required to check the stability, connection & member adequacy of the steel stair and suggest proper remedial measures.

| 22. | Lack of lateral stability and inadequate member size. (External steel stair-Utility Building) | The building engineer is required to check the stability, connection & member adequacy of the steel stair and suggest proper remedial measures. | within 6 weeks |
| 23. | Lack of lateral stability and inadequate member size. (External steel stair-Utility Building) | Carry out the suggested remedial work if required. | within 6 months |

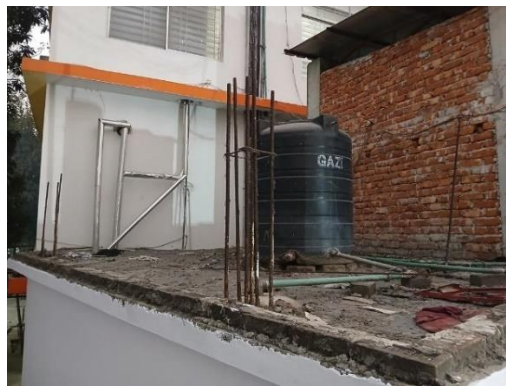
**Observation-15:** Exposed rebar on partial roof. (Utility Building)

**Description:** During inspection, the exposed rebar was found on the roof slab. The building engineer is required to apply anti-rust proof coating on exposed rebar.

| 24. | Exposed rebar on partial roof. (Utility Building) | The building engineer is required to apply anti-rust proof coating on exposed rebar. | within 6 months |

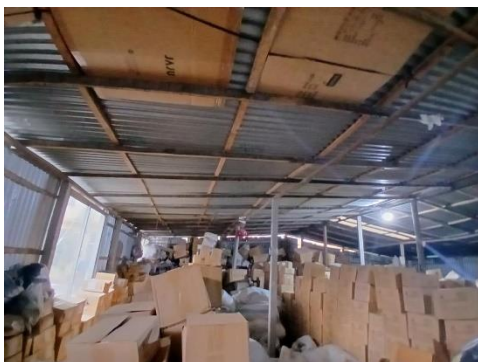
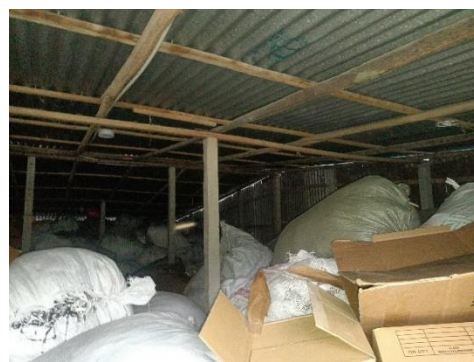
**Observation-16:** Temporary bamboo structure in the factory premises. (Wastage Godown Shed)

**Description:** Temporary Wastage Godown was found on the factory premises. The structure was made of wood and bamboo. The factory is required to demolish the shed or replace with an engineered one.

| 25. | Temporary bamboo structure in the factory premises. (Wastage Godown Shed) | The factory is required to replace the shed with an engineered one. | within 6 months |
