# INITIAL FIRE SAFETY INSPECTION REPORT

**MAS SUMANTRA 2 PRIVATE LIMITED**

**RSC ID: 25921**

**SFB 08, Factory Bay Area, CEPZ, CHATTOGRAM 4223**

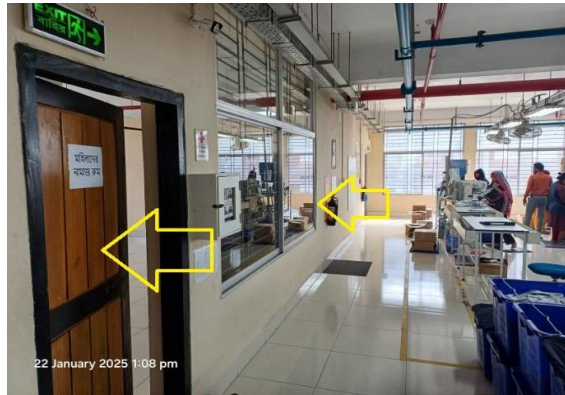
| Sl No. | Category | Findings | Required Action | Remediation Time Frame |
|---|---|---|---|---|
| F-01 | Fire Rated Construction | Female prayer room was not separated from the CMD and packing area during the inspection. | Separate the female prayer room from the CMD,Packing area as per BNBC 2006, Table 3.2.1. Seal and/or protected all openings to maintain fire separations. | Within 3 months |

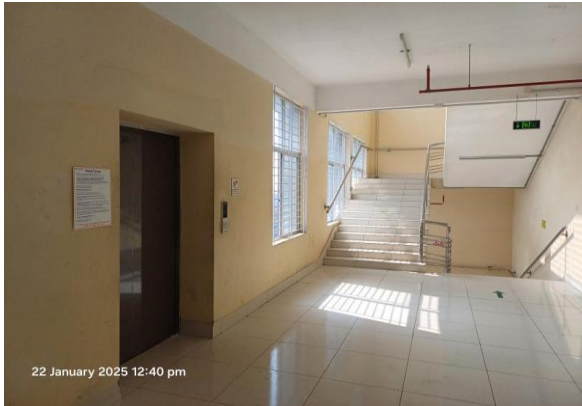
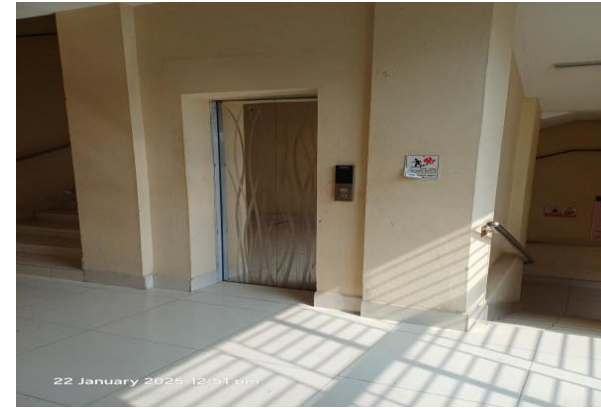
| F-02 | Fire Rated Construction | Elevator shafts are directly open into exit enclosure which is a violation of RSC technical guideline-6.14.3. | <p>Ensure minimum 1.5-hr fire rating for the doors of elevator shafts otherwise close the shafts area with 2-hr fire rated construction barrier and 1.5-hr fire rated doors. (In new construction, elevators shall not open into an exit enclosure RSC technical guideline-6.14.3.</p> <p>So, rearrange the facility to provide separate enclosure for lifts. If not possible anyway provide a minimum 2-hr fire- rated elevator shaft with listed fire rated lift landing door to separate from each floor level.)</p> <p>Elevators shall not open into an exit enclosure as per RSC technical guideline-6.14.3. So, separate the stair enclosure from elevator shaft although the building.</p> | Within 3 months |

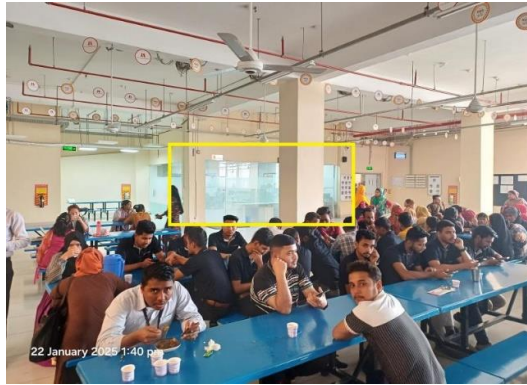
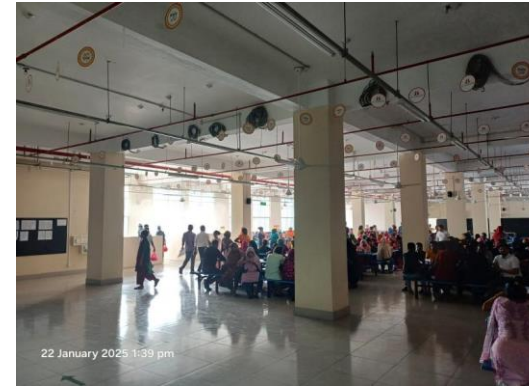
| F-03 | Fire Rated Construction | Dining capacity (less than 300) was not separated from the Medical room and HR office during the inspection | To classify the occupancy as E4, it's necessary to limit the occupant load to 300 or below. Afterward, ensure the fire separation from other occupancies as per BNBC 2006 table 3.2.1. Additionally, ensure that there are required direct exits available for the dining facilities, or consider relocating them to a dedicated building. . | Within 3 months |

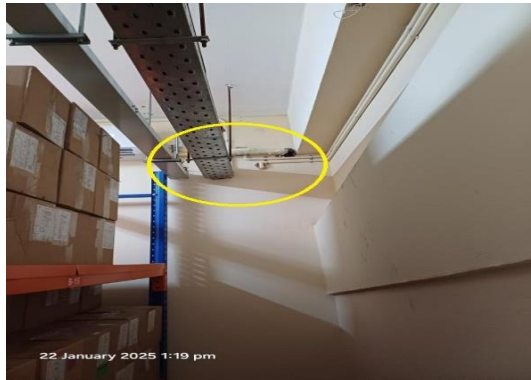
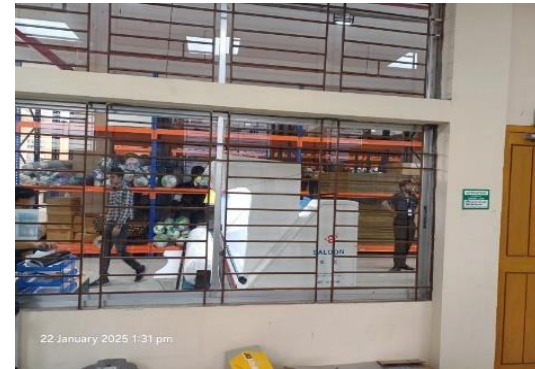
| F-04 | Fire Rated Construction | Trim Store at 1st floor was not separated from DB room due to cable penetration and Fabric store at ground floor was not separated from the maintenance room due to non rated glass wall and opening. | Separate the store by a minimum 1-hr fire-rated construction. Seal and/or protect all openings to maintain the required fire separations. | Within 3 months |

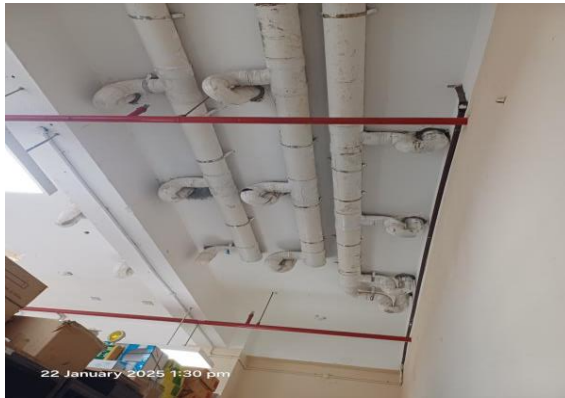
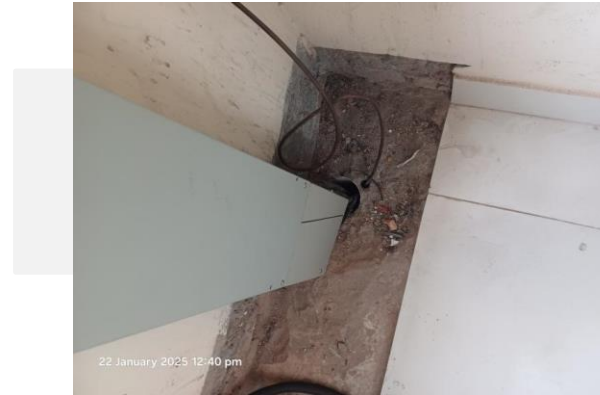
| F-05 | Fire Rated Construction | <p>Penetrations through floor/ceiling assemblies due to PVC pipe of toilet and Electric cable riser was found unsealed and every floor toilet block area, maintenance room and the DB room at main building.</p> | <p>Seal all penetrations and openings in floor/ceiling assemblies by a listed through-penetration fire stop system tested in accordance with ASTM E814 or approved alternative standard to maintain minimum 3-hr. fire resistance rating. Installation shall be as per manufacturer published installation guideline and the certification authority guideline to ensure the fire-rating in accordance with section 4.7 of RSC Technical Guideline (Standard)</p> <p>Or,</p> <p>Provide a minimum 2-hr fire rated shaft to separate the penetration from each floor if required.</p> | Within 3 months |

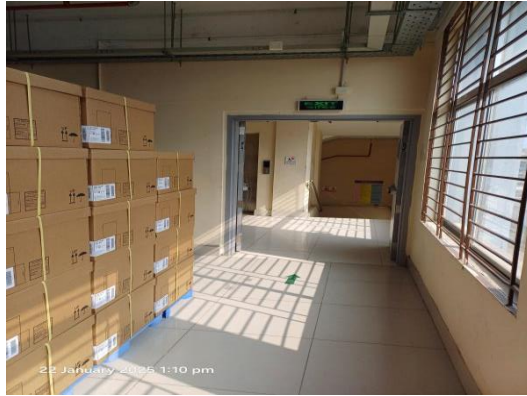
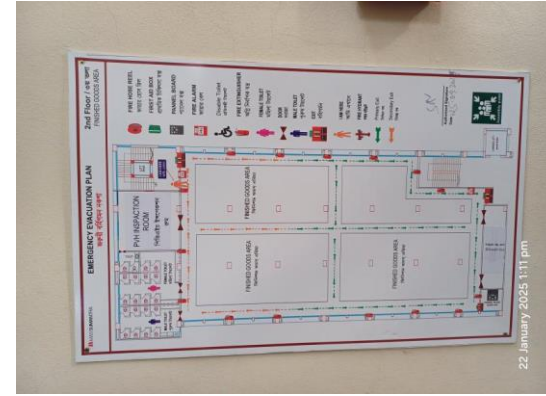
| F-06 | Means of Egress | The store was found to discharge directly into the exit enclosure without a vestibule at the finished goods store on the 2nd floor, the RM store on the 1st floor, and the raw material store on the ground floor | Openings from exit enclosure to storage and machine room spaces shall be provided with a vestibule with fire rated construction and openings. Provide a 1.5-hr. fire rated door on the exit stair side and a 1-hr. fire rated door on the storage and machine room side as per 6.14.3-RSC Technical Guidelines Standard V1.0. Ensure that the fire rating of the vestibule construction matches that of the exit stair enclosure. The minimum width for vestibules shall not be less than 1.1m and length 1.8m. | Within 3 months |

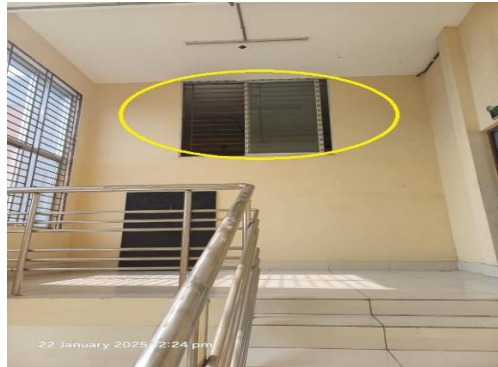
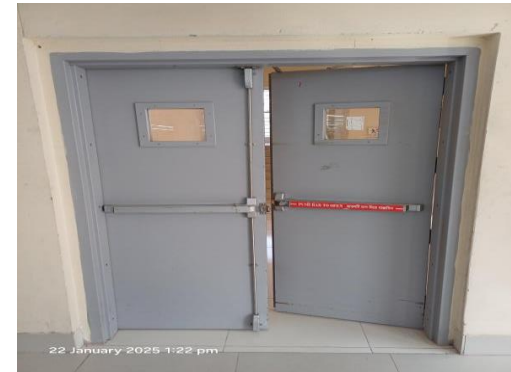
| F-07 | Means of Egress | <p>The exit stairs are not separated from other spaces due to unprotected opening (Lift machine room window) and Non-functional fire door.</p> <p>Location: East stair, west stair, and both middle stair at the main building.</p> | <p>Stair shall be enclosed with a minimum 2-hr fire-rated construction. Seal all unprotected openings and provide minimum 1.5-hr fire rated doors to separate the exit stairs from work areas and other building spaces on all floor levels. The clearance under the bottom of a door shall be a maximum of 3/4 in. (19 mm).</p> <p>Penetrations into and through an exit enclosure shall be prohibited with the exception of required exit doors, sprinkler piping, standpipes, electrical raceway for fire alarm equipment, and electrical conduit serving the exit enclosure.</p> <p>Ensure that the fire doors are self-closing, positive latching and that they are provided with fire exit (panic) hardware where serving production floors. If fire doors are required to be held open for functional reasons, provide automatic-closing devices tied to the fire alarm system. Once fire doors are installed, every door in a stair enclosure serving more than 5 stories shall be provided with re-entry.</p> | Within 3 months |

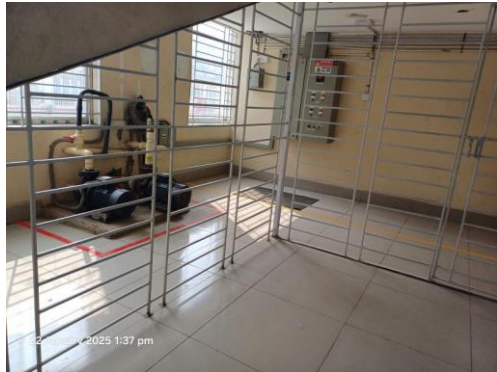
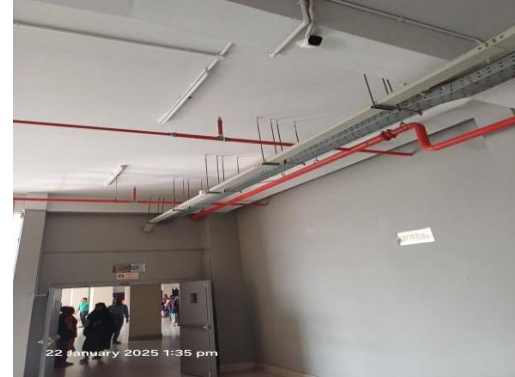
| F-08 | Means of Egress | Electric cable riser and Domestic pump and 3-pin socket/switch box was found in exit enclosure at both middle stair. | Remove all electric cable riser and domestic pump & switch box from the exit stair enclosures. Seal all penetrations and openings in the wall of exit enclosure walls (full thickness of the wall) by fire rated materials to maintain the fire resistance rating. Penetrations into and through an exit enclosure shall be prohibited with the exception of required exit doors, sprinkler piping, standpipes, electrical raceway for fire alarm equipment, and electrical conduit serving the exit enclosure. | Within 3 months |

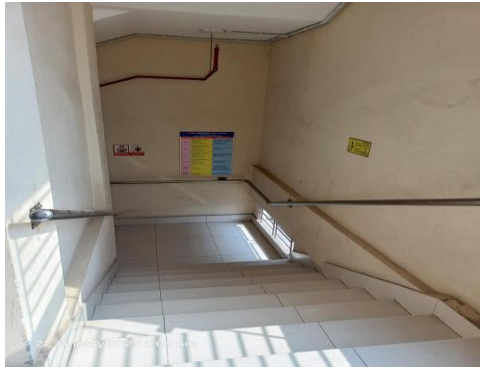
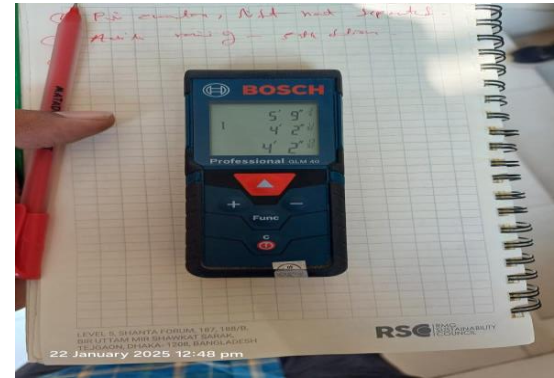
| F-09 | Means of Egress | The building is Interim construction and East Stair and west stair width was found less than 60 inch. East Stair ( 4 feet 2 inch) and west Stair ( 4 feet 1 inch). | Provide minimum clear and unobstructed exit stair widths of 1.5 m(60 in.) in accordance with the RSC standard 6.5.6.2.1 | Within 3 months |

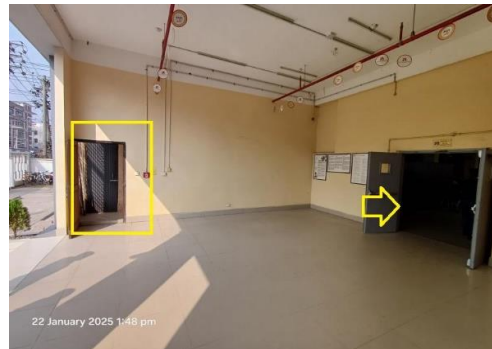
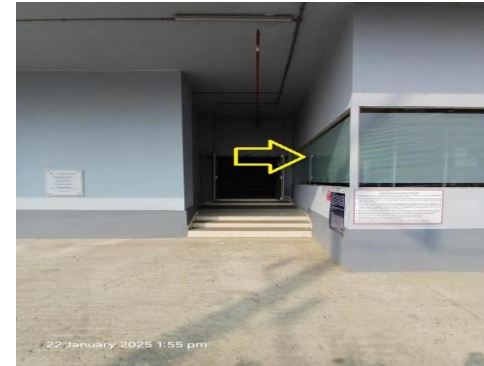
| F-10 | Means of Egress | Exit discharge from the middle stair was not separated from the IT/FACP room due to non rated glass wall and also Canteen area exit discharge was not separated from the toilet area and pvc pipe penetration from above floor). | Seal all penetrations and openings to the interior of the building along the discharge path, up to a height of 10 ft., to provide a minimum 1-hr fire separation.<br>Alternatively, provide a second remote discharge path to the public way (only include this if feasible) | Within 3 months |

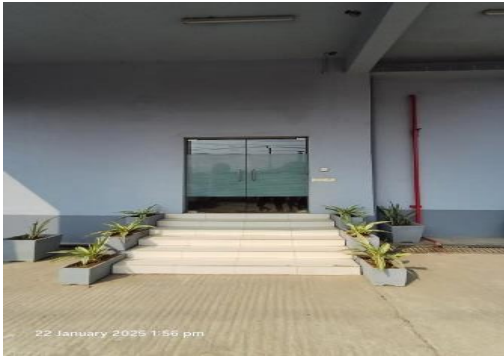
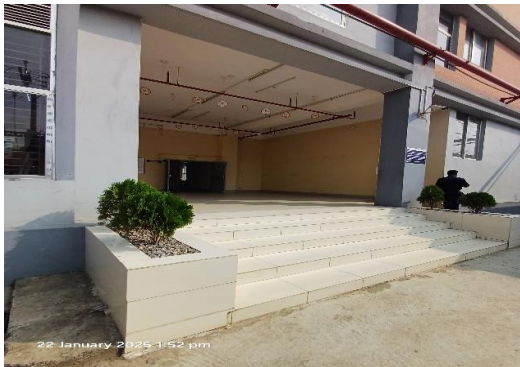
| F-11 | Means of Egress | Handrails was not provided in the exit serving discharge path stair at the ground floor. | Provide handrails on both side of exit stair having a minimum height 34 in. Intermediate handrails shall be provided when the stair width exceeds 2.2 m (87 in.). | Within 1 month |

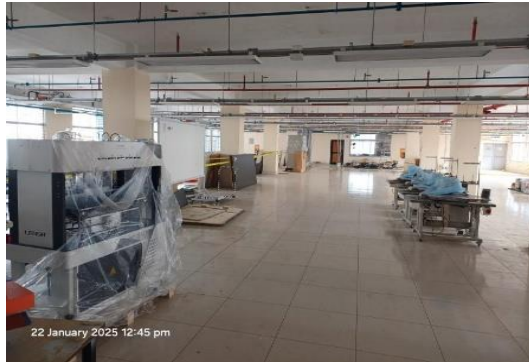
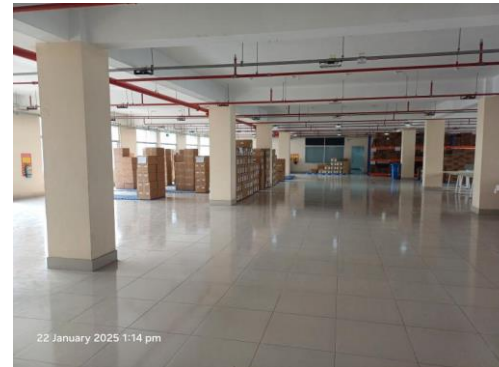
| F-13 | Means of Egress | Aisle was missing at several floor location including 5th floor and 2nd floor finished goods store and other areas during the inspection. | Provide minimum aisle widths of 36-in. Aisles mark shall be clearly visible. | Within 1 month |

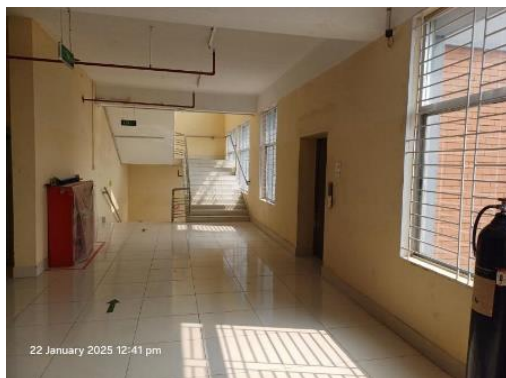
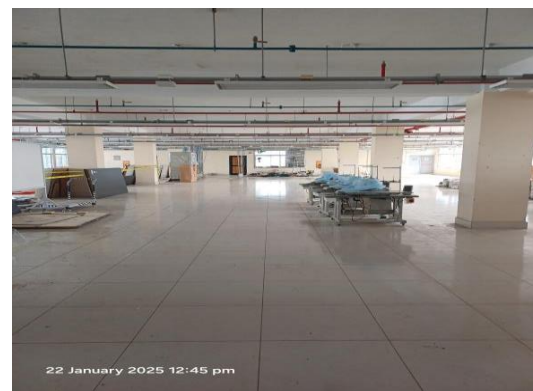
| F-15 | Egress Lighting | <p>Based on the number and location of emergency lights observed, adequate illumination levels are not anticipated along egress routes.</p> <p>Location: Ground floor , 1st floor and 3rd floor and all the Exit stair enclosure.</p> | <p>Test the emergency lighting system on each floor and provide additional emergency fixtures to provide adequate illumination along the means of egress. Provide a minimum illumination of 10 lux at the floor level within exit stairs and exit discharge paths and minimum 2.5 lux along exit access aisles.</p> | <p>Within 2 months</p> |

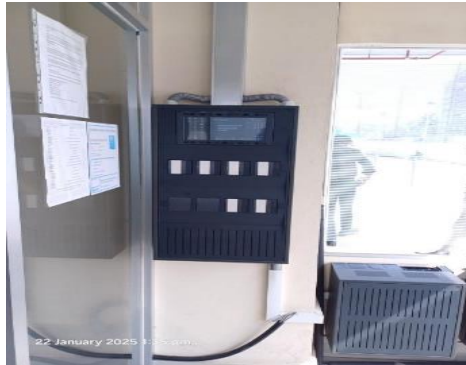
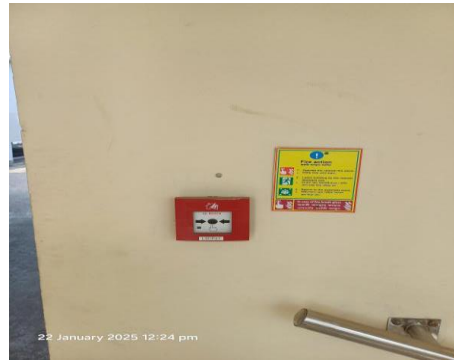
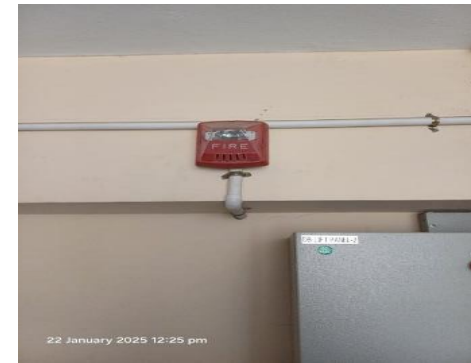
| F-16 | Fire Alarm & Detection System (FADS) | <p>The fire alarm detection system was found installed during the inspection. The proposed design was available on-site. Fire alarm detection system requires a detailed review to confirm compliance with NFPA 72 and RSC Technical Guidelines (Standard).</p> | <p>Addressable fire alarm and detection systems shall be installed throughout all buildings and structures (When complete sprinkler protection is provided throughout a floor with water flow devices designed to initiate the alarm notification, smoke and fire detection devices can be eliminated throughout that floor).</p> <p>Submit the proposed fire alarm system design to RSC for review. Once the design is reviewed, install the fire detection and alarm system throughout the building in accordance with review comment, RSC Technical Guidelines (Standard) and NFPA 72.</p> <p>After installation the owner shall conduct internal testing and commissioning and then contact the RSC for witness of final acceptance testing.</p> | <p>Design within 2 months and modification/ installation with 4 months</p> |

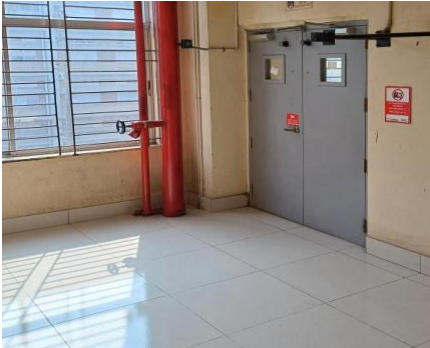
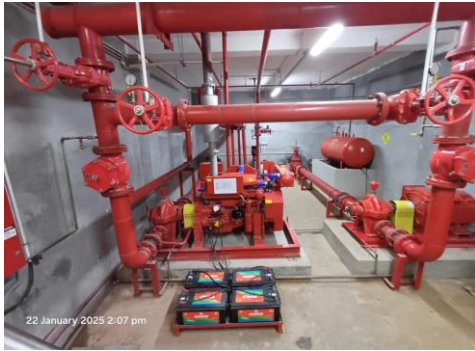
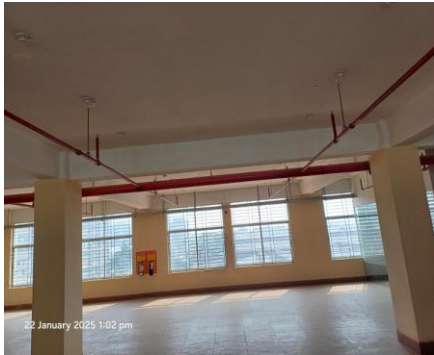
| F-18 | Fire Suppression System (SUPS) | <p>The building's highest occupied floor is 66 feet, where the sprinkler system is mandatory as the factory has installed sprinklers throughout the building as the primary detection system. The factory has installed a sprinkler system with a class-1 standpipe, requiring a detailed review to ensure compliance with NFPA 13, 14, 20, 22, and 24 and RSC Technical Guidelines (Standard).</p> | <p>Submit the fire Suppression System (fire pump, standpipe and sprinkler) design to RSC for review. Once the design is reviewed, install and modify the fire Suppression System throughout the building in accordance with review comment, RSC Technical Guidelines (Standard) and NFPA 13, 14, 20, 22 and 24. After installation the owner shall conduct internal testing and commissioning and then contact the RSC for witness of final acceptance testing.</p> | <p>Design within 2 month and modification/ installation with 4 months</p> |
