# MAS SUMANTRA 2 PRIVATE LIMITED

SFB 08, Factory Bay Area, CEPZ, CHATTOGRAM 4223

22 January 2025

## **1. Building Information**

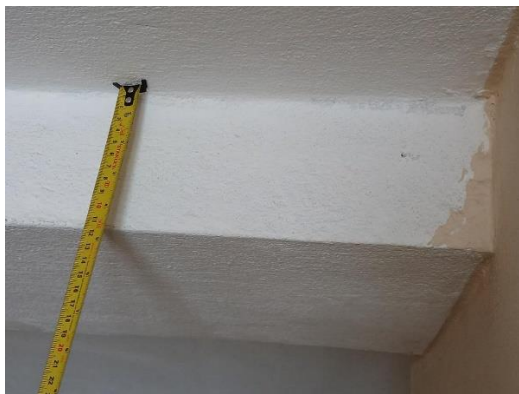
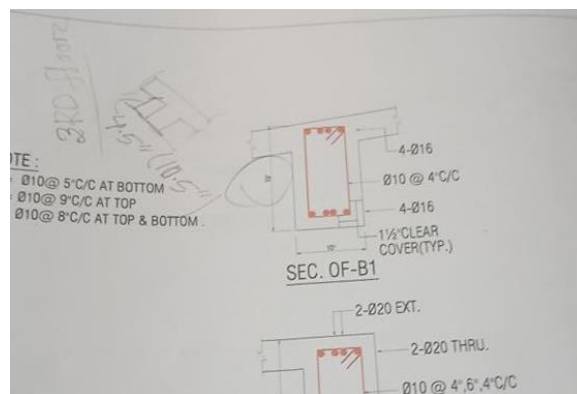
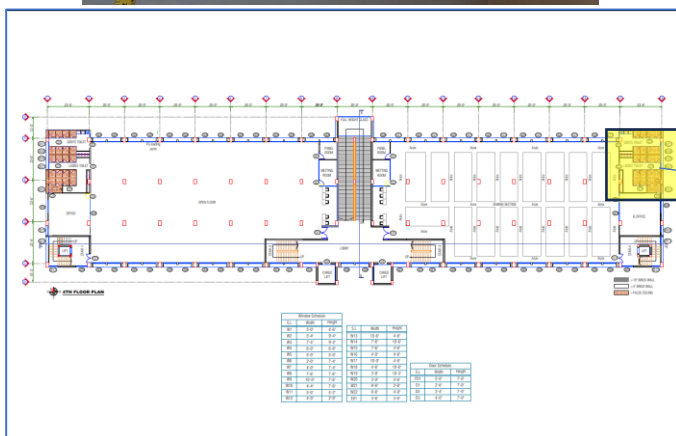
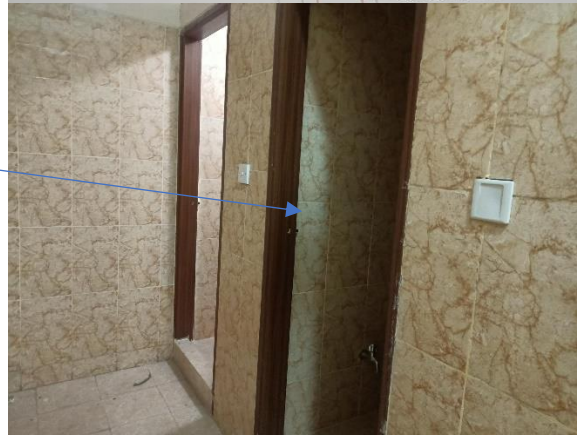
### Observation-01: Discrepancies in as built drawings (Main Building).

**Description:** Beam size of the ramp didn't match with drawings. Down stand of beam at ramp area was found 115mm instead of 240mm. Also, the architectural floor layout of the toilet zone did not fully match with the provided drawings. The building engineer is required to update the as-built drawing as per onsite condition.

| Item No | Observation | Action Plan | Timeline |
|---|---|---|---|
| 1. | Discrepancies in as built drawings (Main Building). | The building engineer is required to update the as-built drawing as per onsite condition. | within 6 weeks |

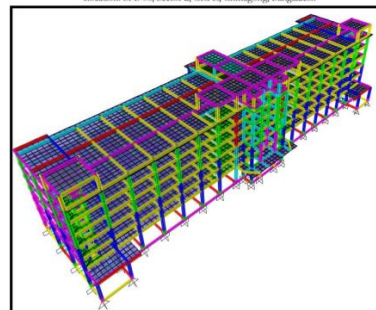
### Observation-02: Inconsistencies in design report (Main Building).

**Description:** Response modification co-efficient factor,  $R=8$  has been considered but required justification/calculation has not been provided in the design report. The building engineer is required to revise the design report as per existing condition and incorporate all kinds of serviceability checks in the design report.

| Item No | Observation | Action Plan | Timeline |
|---|---|---|---|
| 2. | Inconsistencies in design report (Main Building). | The building engineer is required to revise the design report as per existing condition and incorporate all kinds of serviceability check in the design report. | within 6 weeks |

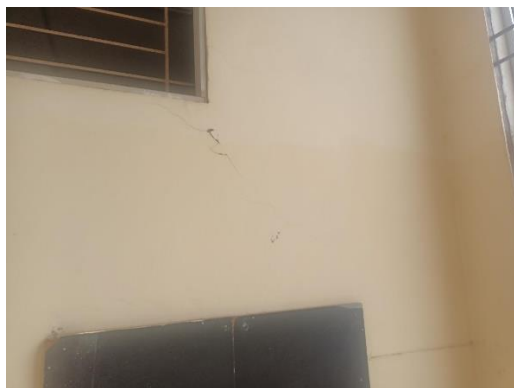
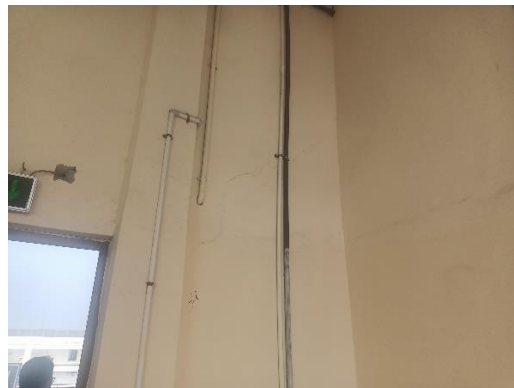
**Observation-03:** Diagonal cracks on stair walls (Main Building).

**Description:** Diagonal cracks were found on the stair wall near the roof. The building engineer is required to investigate the cause of cracking and repair the cracks with suitable methods.

| Item No | Observation | Action Plan | Timeline |
|---|---|---|---|
| 5. | Diagonal cracks on stair walls (Main Building). | The building engineer is required to investigate the cause of cracking and repair the cracks with suitable methods. | within 6 weeks |

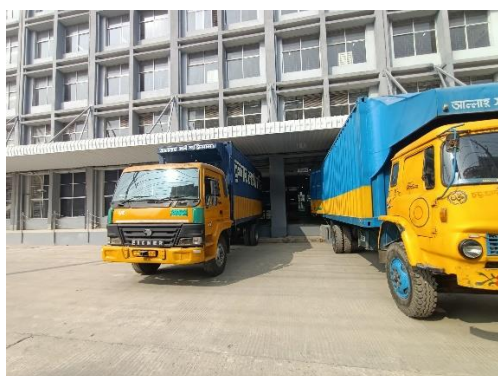
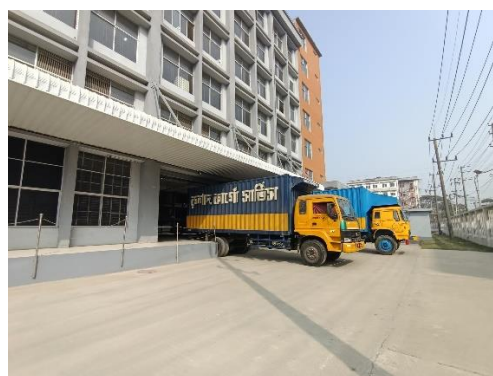
**Observation-04:** Column susceptible to vehicle impact (Main Building).

**Description:** Columns at loading/unloading areas are susceptible to vehicle impact. The factory has provided steel angles to column surface which is not appropriate. The building engineer is required to provide separate barriers outside the columns to avoid possible vehicle impact on columns.

| Item No | Observation | Action Plan | Timeline |
|---|---|---|---|
| 6. | Column susceptible to vehicle impact (Main Building). | The building engineer is required to provide separate barriers outside the columns to avoid possible vehicle impact on columns. | within 6 weeks |

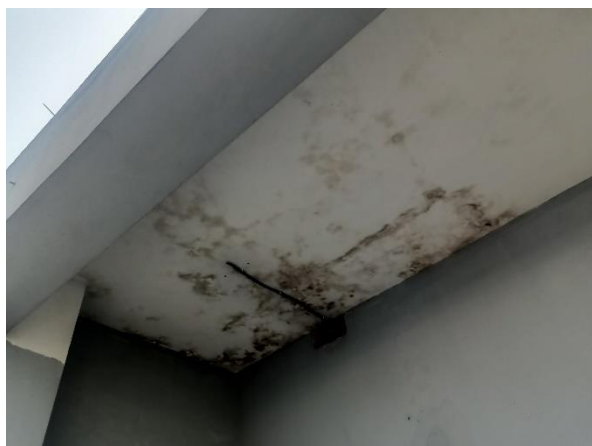
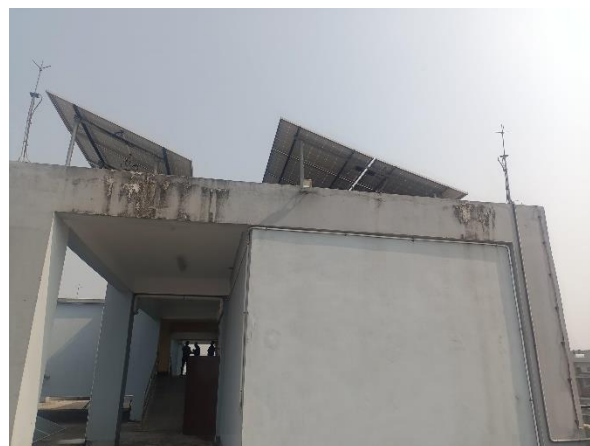
**Observation-05:** Dampness in the stair slab and walls (Main Building).

**Description:** Dampness was found in the stair slab and walls. The building Engineer is required to investigate the damped portion and repair accordingly

| Item No | Observation | Action Plan | Timeline |
|---|---|---|---|
| 7. | Dampness in the stairs and walls (Main Building). | The building Engineer is required to investigate the damped portion and repair with suitable method. | within 6 weeks |

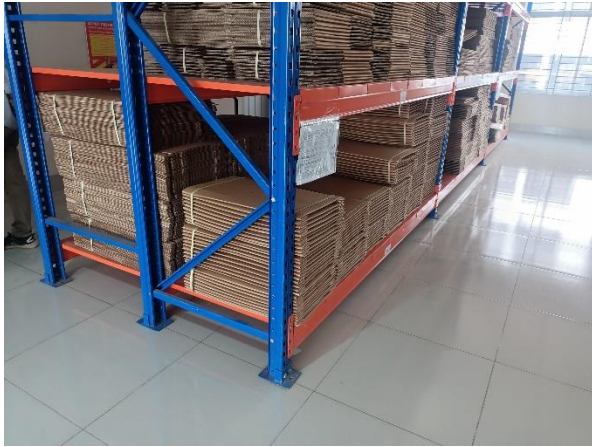
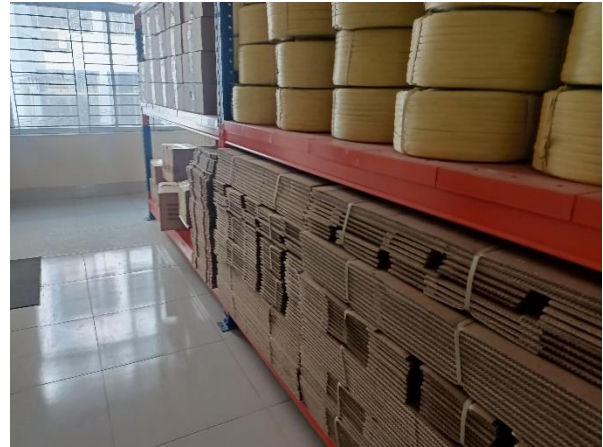
**Observation-07:** Non-structural elements not fully anchored or braced (Main Building).

**Description:** Non-structural elements were found on different floors of the building which were not fully anchored or braced. The building engineer is required to anchor or brace all non-structural elements to avoid falling hazard during earthquake.

| Item No | Observation | Action Plan | Timeline |
|---|---|---|---|
| 8. | Non-structural elements not fully anchored or braced (Main Building). | The building engineer is required to anchor or brace all non-structural elements to avoid falling hazard during earthquake. | within 6 months |

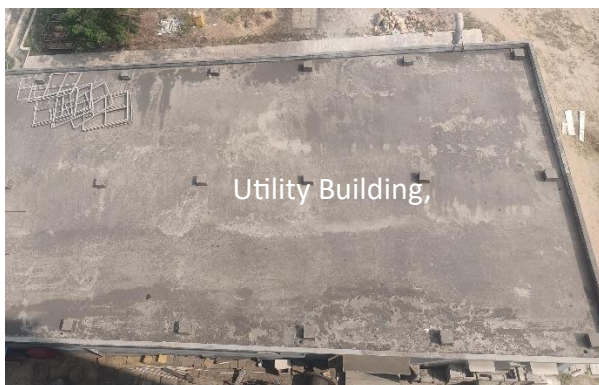
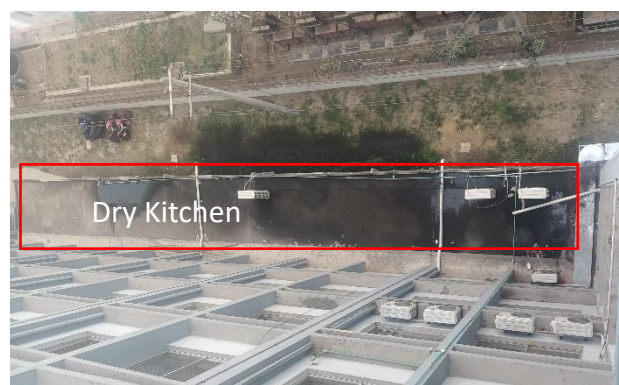
**Observation-08:** Improper drainage on roof (Utility Building, Dry Kitchen).

**Description:** Sign of water clogging was observed on the roof of Utility Building, Dry Kitchen. Building engineer is required to improve the roof drainage with proper slope and adequate number of water outlets.

| Item No | Observation | Action Plan | Timeline |
|---|---|---|---|
| 9. | Improper drainage on roof (Utility Building, Dry Kitchen). | The building engineer is required to improve the roof drainage with proper slope and an adequate number of water outlets. | within 6 months |

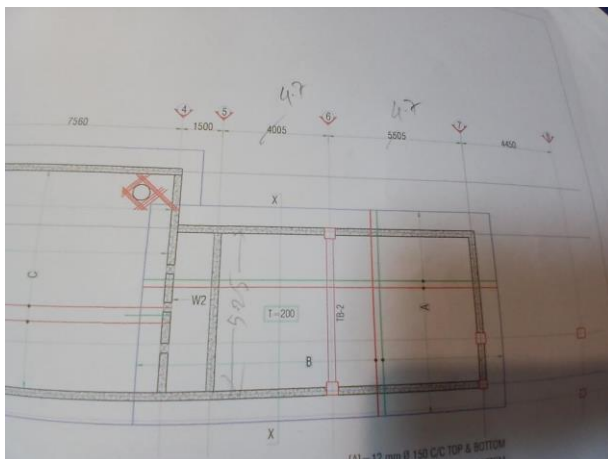
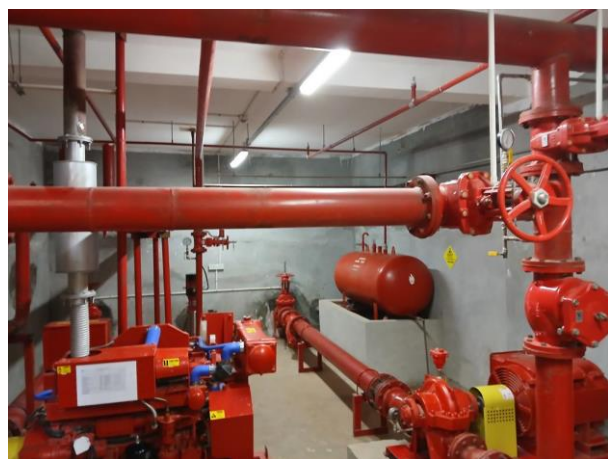
**Observation-09:** Inconsistencies in as-built drawings. (Fire Hydrant Room)

**Description:** Grid dimension and beam layouts were not fully matched with the drawings. The building engineer is required to prepare complete as-built drawing as per onsite condition.

| Item No | Observation | Action Plan | Timeline |
|---|---|---|---|
| 10. | Inconsistencies in as-built drawings. (Fire Hydrant Room) | The building engineer is required to revise the as-built drawing as per onsite condition. | within 6 weeks |

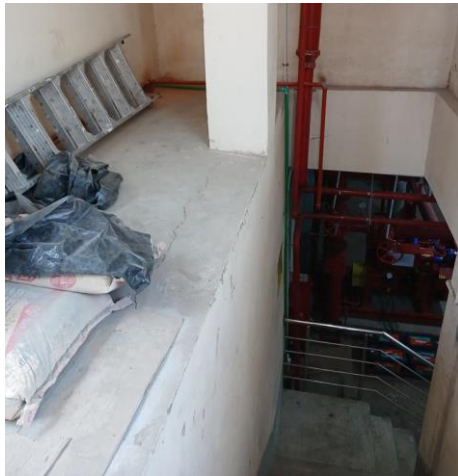
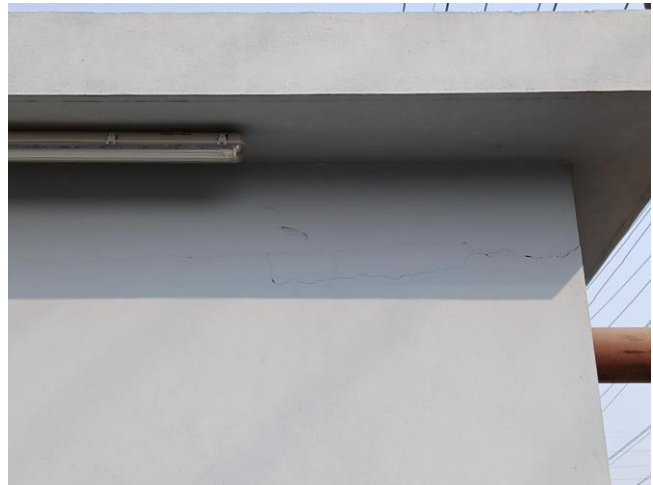
**Observation-10:** Crack on floor and wall (Fire Hydrant Room).

**Description:** Cracks were found on the floor and walls of Fire Hydrant Room. The building engineer is required to investigate the cause of the crack, prepare an investigation report and submit it to the RSC. Repair the cracks as per the recommendation of investigation report.

| Item No | Observation | Action Plan | Timeline |
|---|---|---|---|
| 11. | Crack on floor and wall (Fire Hydrant Room). | The building engineer is required to investigate the cause of the cracking, prepare an investigation report and submit it to the RSC. Repair the cracks as per the recommendation of investigation report. | within 6 weeks |
