# REEDISHA TEXSTRIPE LTD. (EXTENSION)

TEKNOGPARA, CHANDONA, SALNA, GAZIPUR

26 January 2025

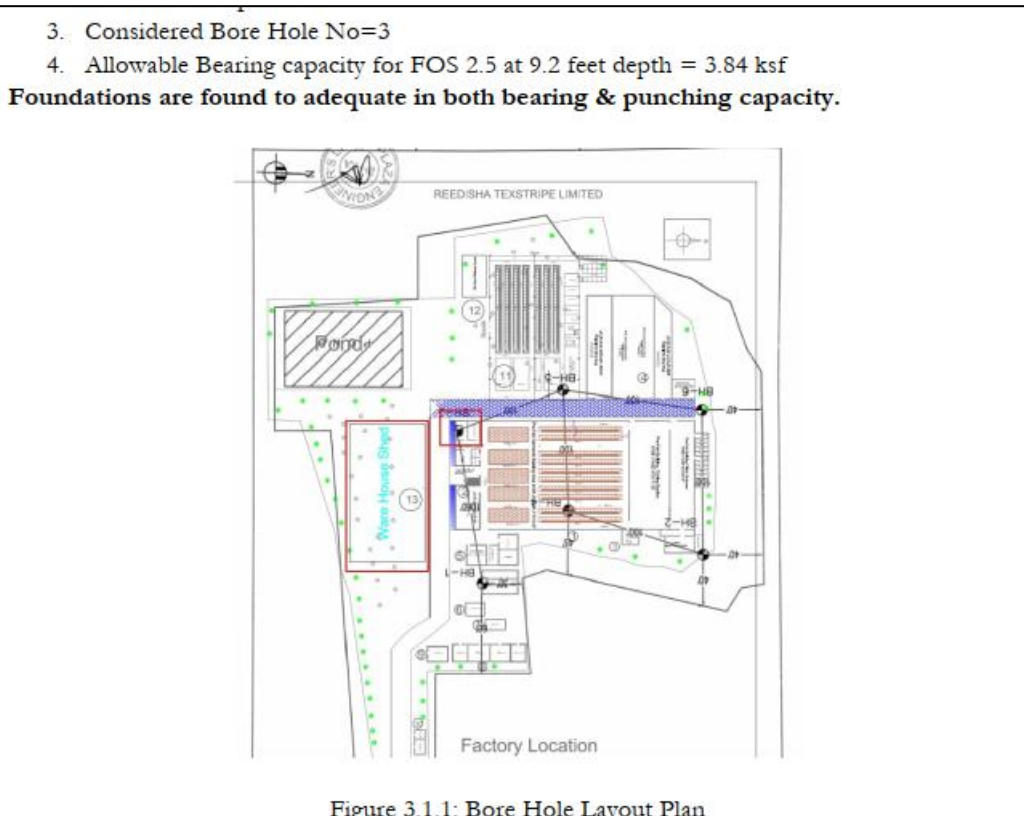
**Observation-2:** Lack of geotechnical investigation report (Building 11, Building 13).

**Description:** Foundation adequacy checks were incorporated in the EA report considering one borehole of data from the nearest existing building location. But no geotechnical investigation report was conducted in the mentioned building locations.

As per the BNBC, on uniform soils, at least three borings should be made for small buildings and at least five borings one at each corner and one at the middle should be made for large buildings.

The building engineer is required to conduct necessary geotechnical testing/investigation to confirm the foundation adequacy checks.

2.		Carry out remedial work if required.	within 6 months
3.	Lack of geotechnical investigation report. (Building 11)	The building engineer is required to conduct necessary geotechnical testing/investigation to confirm the foundation adequacy checks.	within 6 weeks

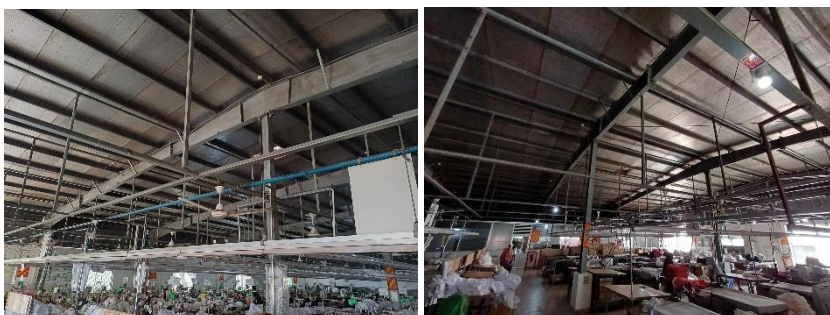
**Observation-3:** Lack of lateral load transfer media (strut) and load resisting system. (Building 11)

Building 11: lack of compression strut in E-W direction.

**Description:** Lack of bracing system along the long direction of the shed was observed. The building engineer is required to check the lateral stability and suggest adequate size of strut member. Submit the EA report to RSC for review.

4.	Lack of lateral load transfer media (strut) and load-resisting system. (Building 11)	The building engineer is required to check the lateral stability and suggest adequate size of strut member. Submit the EA report to RSC for review.	within 6 weeks

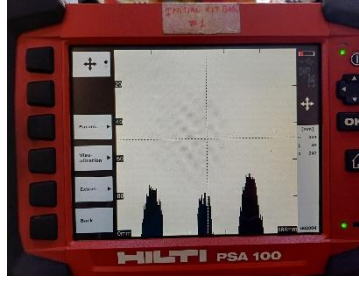
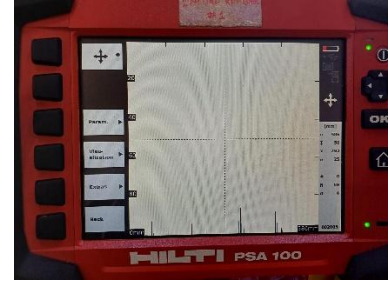
**Observation-4:** Discrepancy between the provided drawing and site condition (Building 11).

As per drawing, all RC column is C1 with 12 no's re-bar profile

On-site ferro scanning, the RC column C1 re-bar profile found 10 no's instead of 12 no's

**Description:** During inspection, the discrepancy was found between the provided as-built drawing and the actual site condition. The building engineer is required to survey the structure and update the as-built drawing as per the actual site condition.

5.		Carry out remedial work.	within 6 months
6.	Discrepancy between the provided drawing and site condition (Building 11).	The building engineer is required to survey the structure and update the accurate as-built drawing as per actual site condition.	within 6 weeks

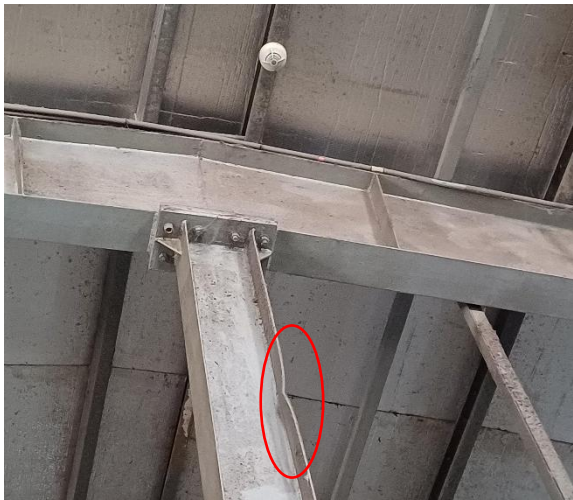
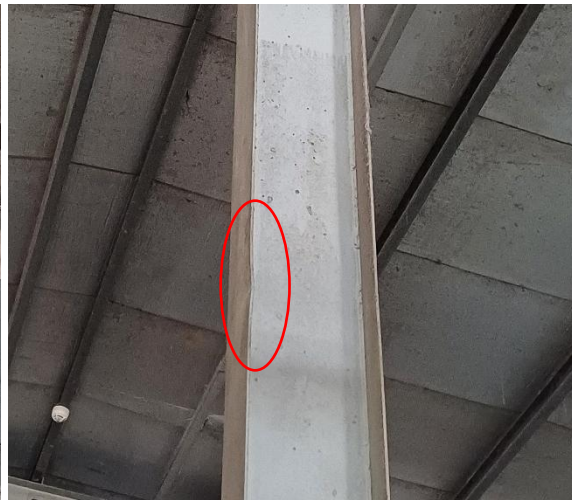
**Observation-5:** Distorted steel column (Building 11).

**Description:** During the inspection, distorted steel column flange was observed in several locations. The factory is required to identify the location and repair the damaged steel column flange with suitable method.

7.	Distorted steel column. (Building 11)	The factory is required to identify the location and repair the damaged steel column flange with suitable method.	within 6 months

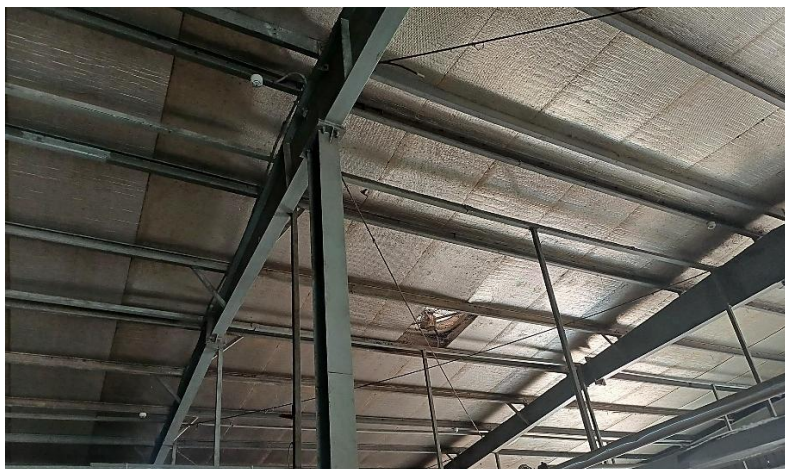
**Observation-6:** Loose cable bracing (Building 11).

**Description:** During the inspection, loose bracings were observed. The factory is required to tighten up the loose bracings.

8.	Loose cable bracing. (Building 11)	The factory is required to tighten up the loose bracings.	within 6 weeks
9.	Lack of lateral load transfer media (bracing & strut) and load resisting system. (Building 12)	The building engineer is required to check the lateral stability and suggest adequate size of bracing and strut member. Prepare a safety check report as per the Accord Building Standard and submit to RSC for review.	within 6 weeks

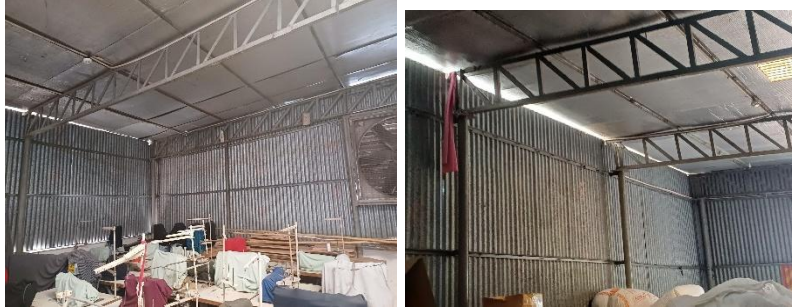
**Observation-7:** Lack of lateral load transfer media (bracing & strut) and load resisting system. (Building 12).

Building 12: lack of bracing & strut in E-W direction.

**Description:** Lack of bracing system along the long direction of the shed was observed. The building engineer is required to check the lateral stability and suggest adequate size of bracing and strut member. Prepare a safety check report as per the Accord Building Standard and submit to RSC for review.

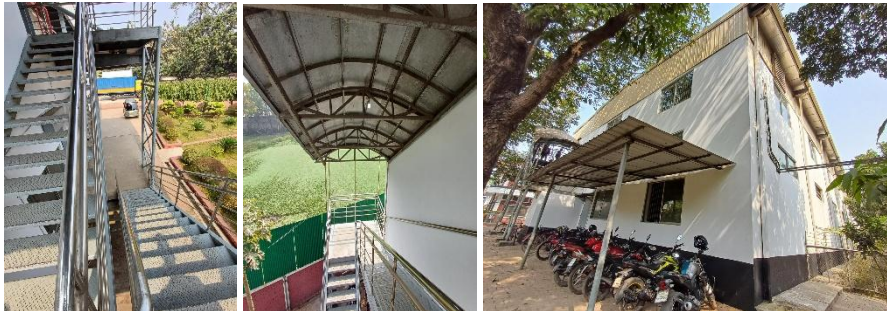
**Observation-8:** Lack of lateral load transfer media (bracing & strut) and load resisting system. (External Steel Stair & Parking (Building 13))

Building 13: lack of lateral stability in Steel stair & parking

**Description:** Lack of bracing system along the long direction of the shed was observed. The building engineer is required to check the lateral stability and suggest adequate size of bracing and strut member. Prepare a safety check report as per the Accord Building Standard and submit to RSC for review.

Item No	Observation	Action Plan	Timeline
14.	Lack of lateral load transfer media (bracing & strut) and load resisting system.	The building engineer is required to check the lateral stability and suggest adequate size of bracing and strut member. Prepare a safety check report as per the Accord Building Standard and submit to RSC for review.	within 6 weeks

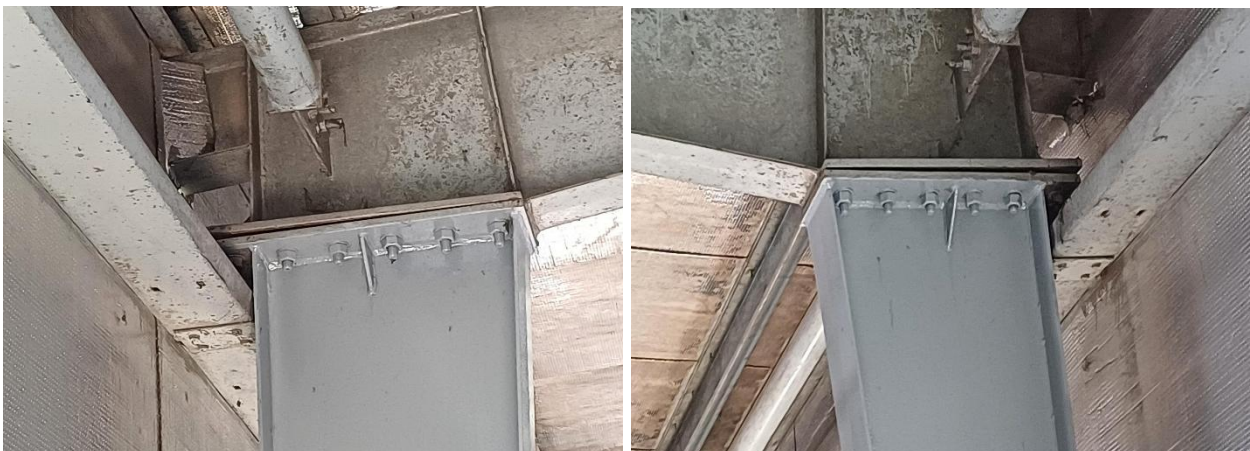
**Observation-9:** Connection gap on steel plates (Building 13).

**Description:** During the inspection, connection gaps were observed in several rafter-column joints. The factory is required to identify the location and tighten up the connection joints or fill the connection gap with shim plate if required.

15.	(External Steel Stair & Parking (Building 13))	Carry out remedial work.	within 6 months
16.	Connection gap on steel plates (Building 13).	The factory is required to identify and tighten up the connection joints or fill the connection gap with shim plate if required.	within 6 weeks

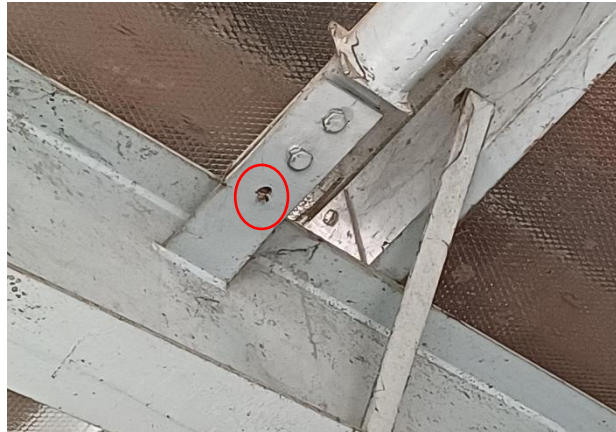
**Observation-10:** Nut-bolt missing (Building 13).

**Description:** During the inspection, the missing nut-bolt was found in several locations. The factory is required to identify the location and install all missing nut bolts.

17.	Nut-bolt missing (Building 13).	The factory is required to identify and install all missing nut-bolts.	within 6 weeks
18.	Possible falling hazard in the load-unload zone (Building 13).	The factory is required to install appropriate safety barriers or railings to mitigate the risk of falling and ensure compliance with safety standards.	within 6 weeks

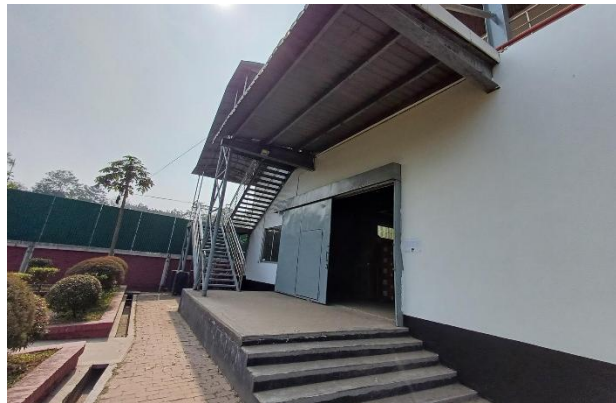
**Observation-11:** Possible falling hazard in the load-unload zone (Building 13).

**Description:** During the inspection, it was noted that the elevated loading-unloading platform lacked railings or barriers at its edges, creating a potential falling hazard.

The factory is required to install appropriate safety barriers or railings to mitigate the risk of falls and ensure compliance with safety standards.
