Shanta Denims Limited (Extension)

Shanta Denims Limited, Plot No: 156 & 177-179, DEPZ (Extension Zone)

17 December 2024

Structural Inspection Report

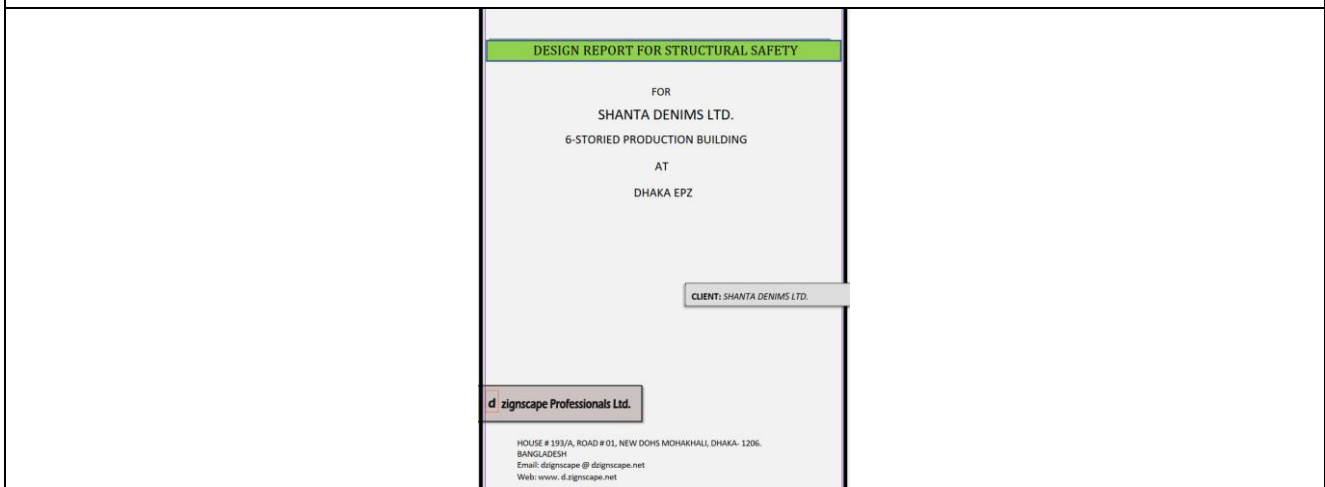
Observation 1: Lack of information in the design report. (New Production Building).

Description: In the design report (as per BNBC-2020), the framing system is not defined. The value of the response modification factor (R) is considered as 5 without any calculation and justification. The building engineer is required to update the design report as per 1.9.1-BNBC and submit it to RSC for review.

Item No.	Observation	Action Plan	Timeline
1.	Lack of information in the design report. (New Production Building).	The building engineer is required to update the design report as per 1.9.1-BNBC and submit it to RSC for review.	within 6 weeks

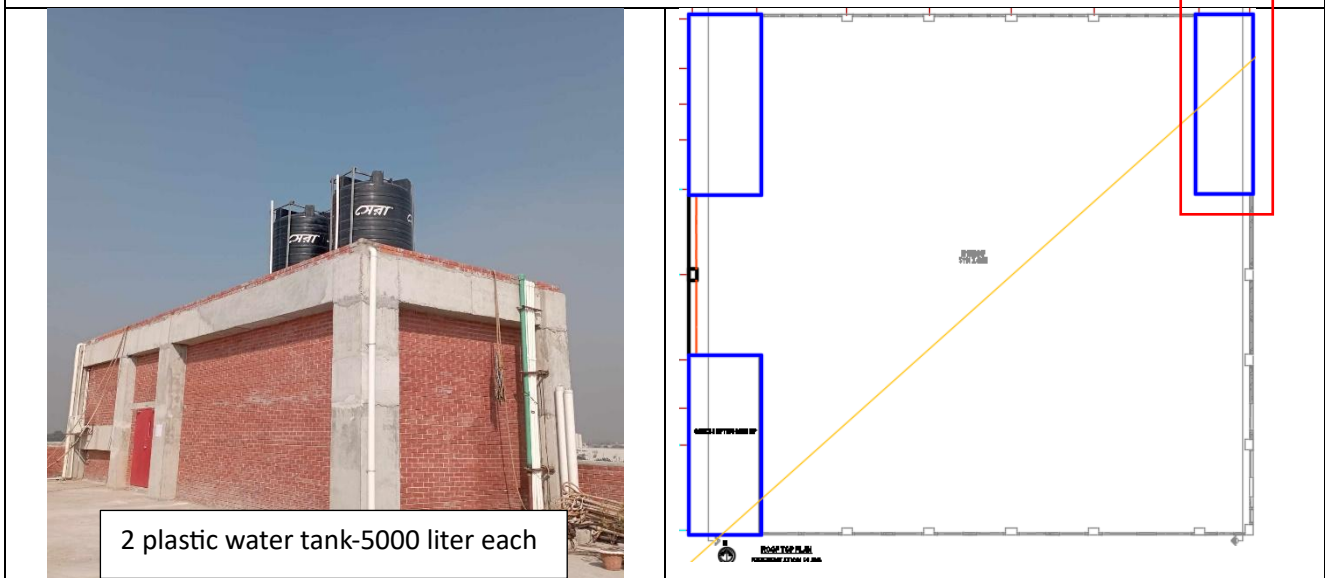
Observation-2: Discrepancy and missing information in as-built drawing (New Production Building).

Description: 2 plastic water tanks-(5000 liters each) were observed on the stair op slab but not shown in the as-built drawing. The building engineer is required to update the as-built drawing.

2.		Implement remediation work if required.	within 6 months
3.	Discrepancy and missing information in as-built drawing (New Production Building).	The building engineer is required to update the as-built drawing.	within 6 weeks

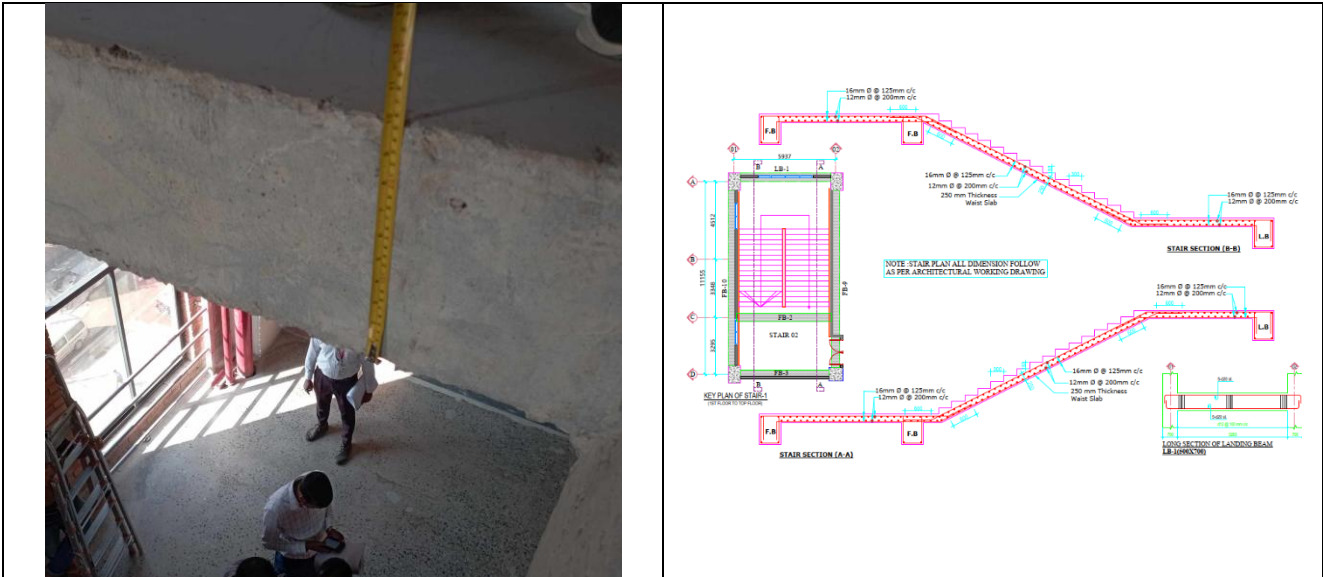
Description: Slab thickness of landing slab is not shown in the as-built drawing. The building engineer is required to update the as-built drawing.

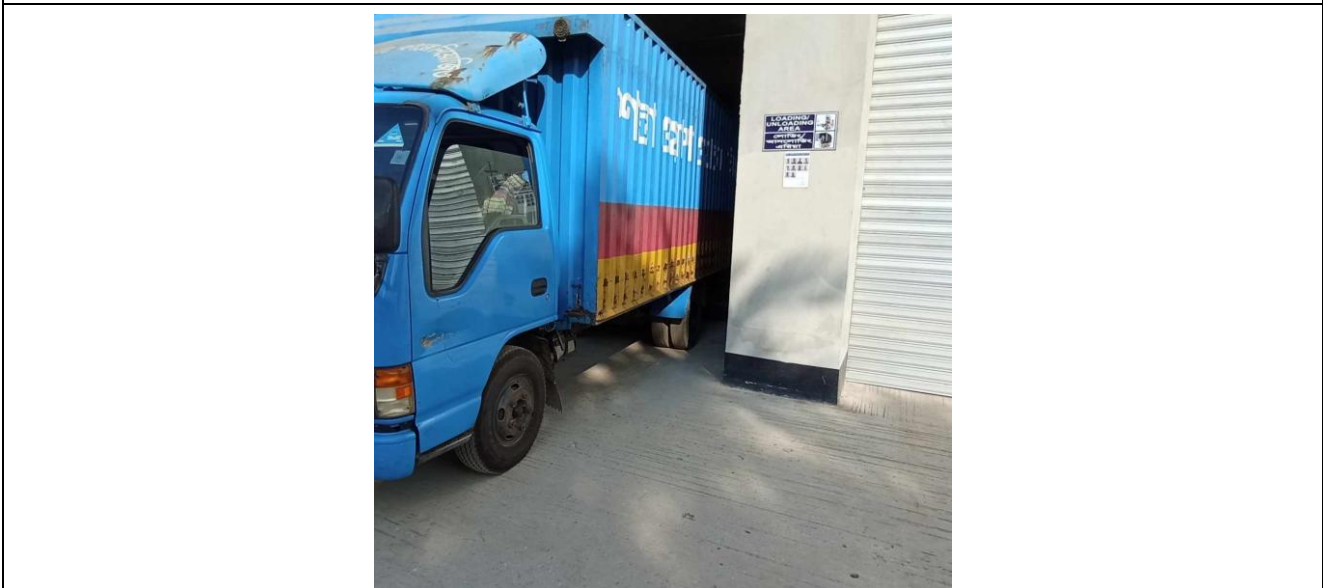
Observation 3: Possibility of vehicle impact (New Production Building).

Description: Exposed columns were found prone to vehicle impact. The building engineer is required to provide a barrier to the exposed column to avoid vehicle impact.

4.	Possibility of vehicle/trolley impact (New Production Building).	The building engineer is required to provide a barrier to the exposed column to avoid vehicle impact.	within 6 weeks

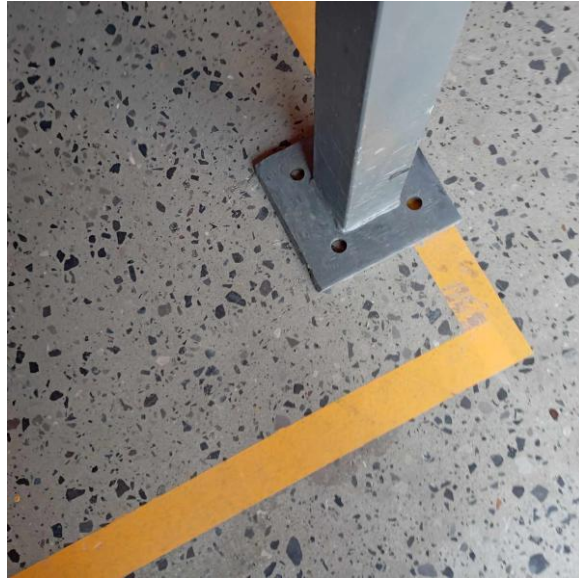
Observation-4: Nonstructural elements found not anchored/braced (New Production Building).

Description: Nonstructural elements (storage racks) were found not anchored/braced. The building engineer is required to anchor/brace all nonstructural elements within the factory.

5.	Nonstructural elements (storage racks) were found not anchored/braced (Main Production Building).	The building engineer is required to anchor/brace all nonstructural elements within the factory.	within 6 weeks

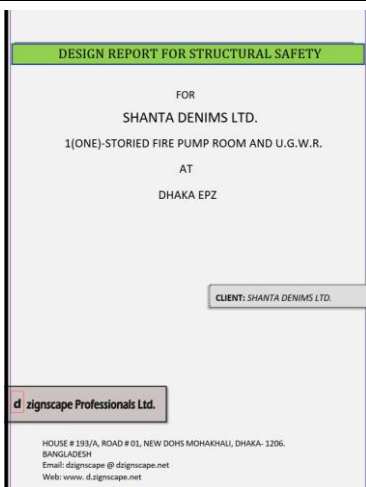
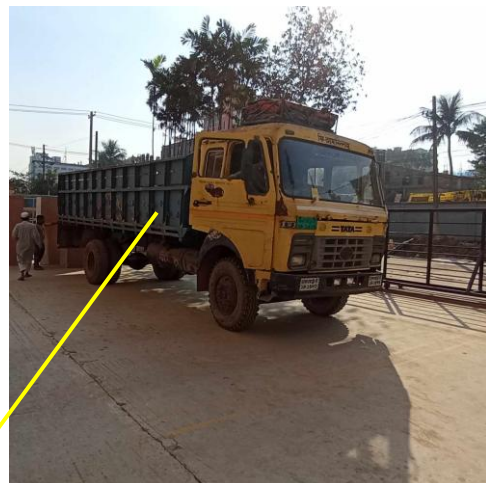
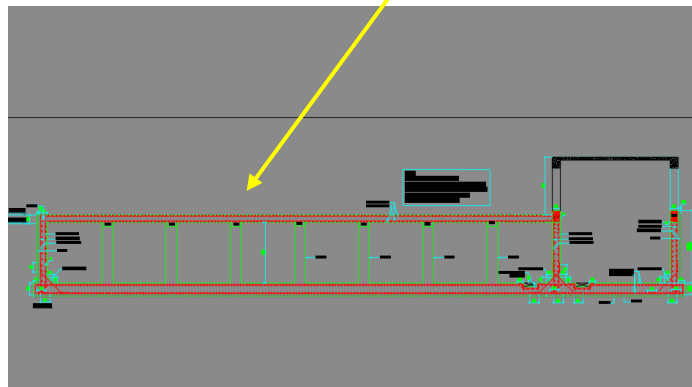
Observation-5: Lack of load plan and information in the design report (Fire pump room-2).

Description: No load plan was available for the structure (parking area over water tank). The value of response modification factor (R) is considered as 5 without any calculation and justification. The building engineer is required to update the design report as per 1.9.1-BNBC and submit it to RSC for review.

6.	Lack of load plan and information in the design report (Fire pump room-2).	The building engineer is required to update the design report as per 1.9.1-BNBC and submit it to RSC for review.	within 6 weeks

7.		The building engineer is required to produce a load plan for the parking area over the water tank.	within 6 weeks
8.		Implement remediation work if required.	within 6 months

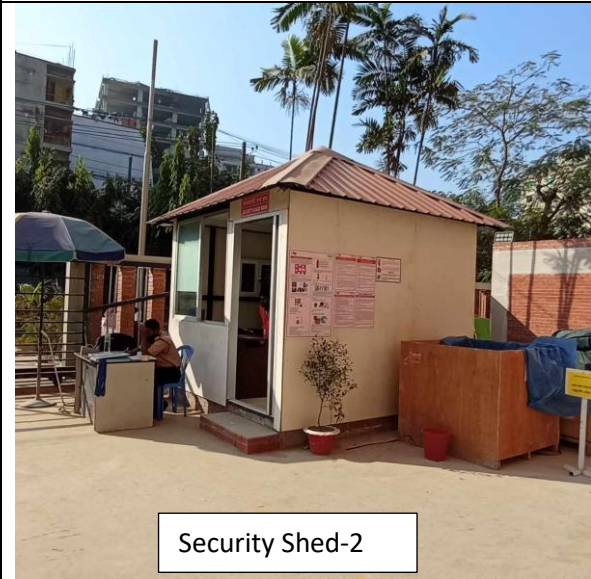
Description: As-built drawing of Security Shed-2 and RMS Room-2 was not found on site. The building engineer is required to prepare the as-built drawing of Security Shed-2 and RMS Room-2.

9.	Lack of as-built drawing (Security Shed-2, RMS Room-2).	The building engineer is required to produce the as-built drawing.	within 6 weeks
