Denitex Ltd (Extension)

9/1 & 10/2 Hazi Younus Ali Sarak, Karnapara, Savar, Dhaka.

27 January 2025

1. Building Information

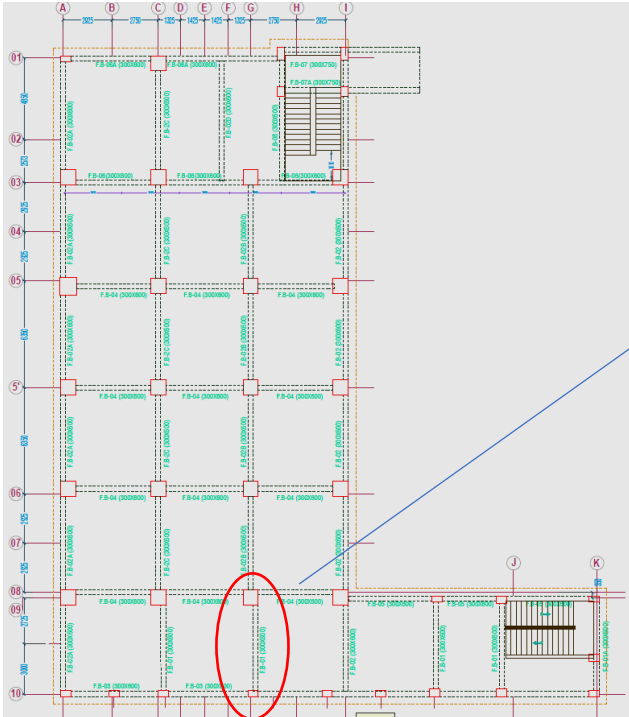
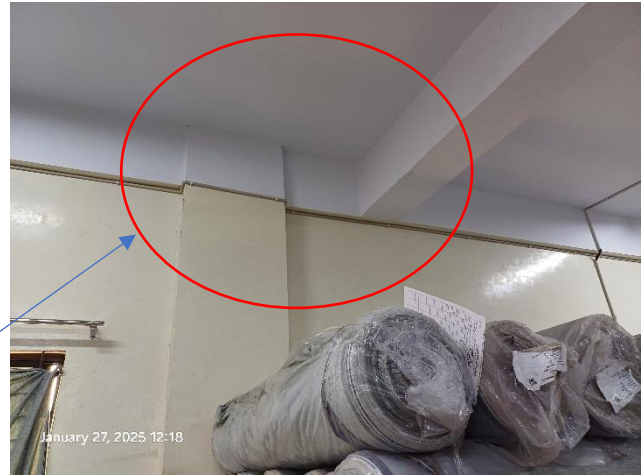
Beam layout

Beam is not aligned with the column line

Description: At the first-floor level beam was found not aligned with the column grid.

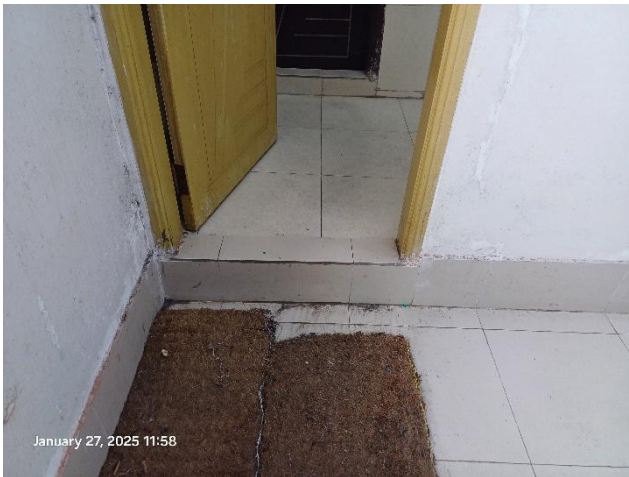
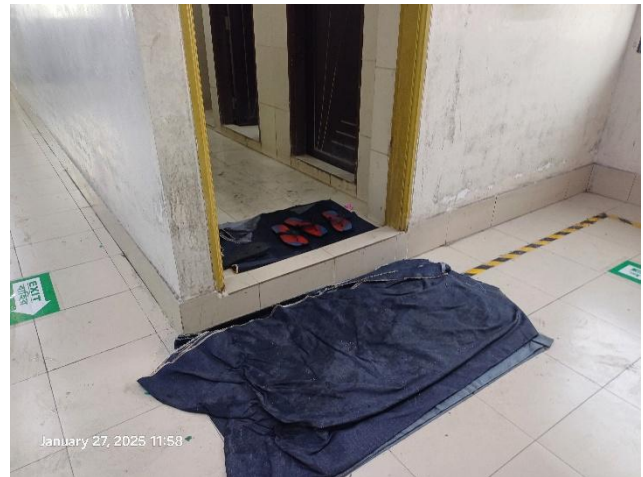
Description: Toilet block details and built-up were not provided in architectural drawings. Building engineer is required to survey the structure and prepare the as-built drawing.

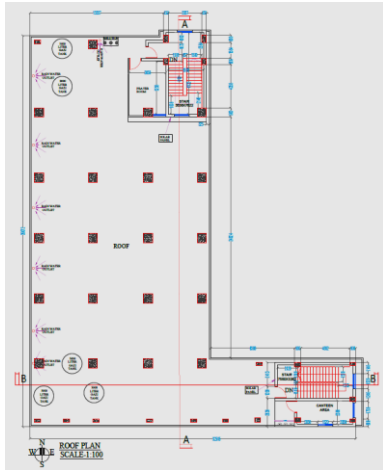
Description: The building is irregular in plan. Re-entrant corners are present in both directions as per BNBC (section 2.5.5.3). The building engineer is required to consider the plan irregularity and revise the design documents.

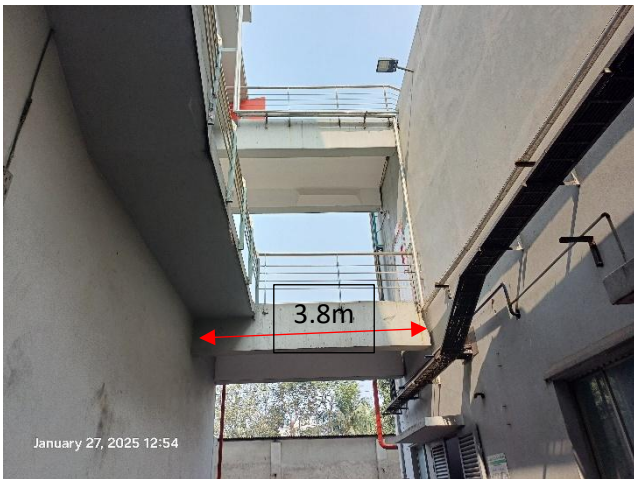
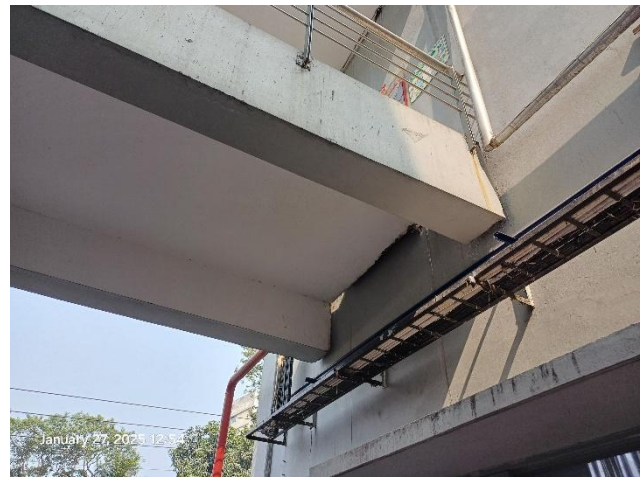
Description: A large cantilever corridor (3.8 m) from ETP to Boiler building. No deflection check is provided for the cantilever in the design report. The building engineer is required to check the deflection and incorporate it in the design report.

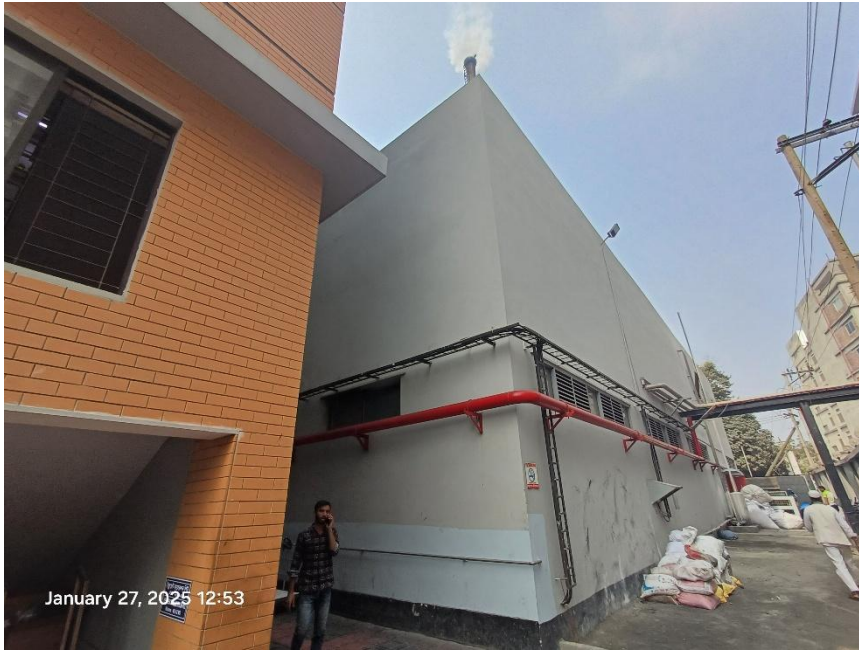
Description: As per BNBC, every building or structure designed shall have its design documents prepared following the provision of Section 1.9.1. The design document shall include a design report, and a set of structural drawings, which shall be prepared in compliance with section 1.9.1.1 and section 1.9.1.2 as per BNBC.

At the time of inspection, design documents (design report, load plan) were not available which are required to be prepared in compliance with section 1.9.1 (part-6, BNBC).

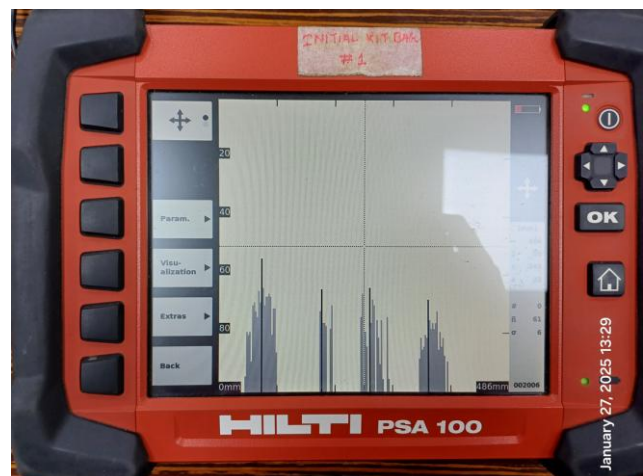
Unbraced racks on the floor

Description: Rebar at C-2 type column not matched with drawings. The number of rebars found was 12 instead of 16. The building engineer is required to confirm the amount of rebar in the column and update the drawing.

7	Mismatches in as-built drawings. (Boiler Building)	Building engineer is required to confirm the amount of rebar in the column and update the drawing.	within 6 weeks
8	Standing water and dampness on the roof. (Boiler Building)	Building engineer is required to improve the drainage system on the roof and repair the dampness with a suitable method.	within 6 weeks

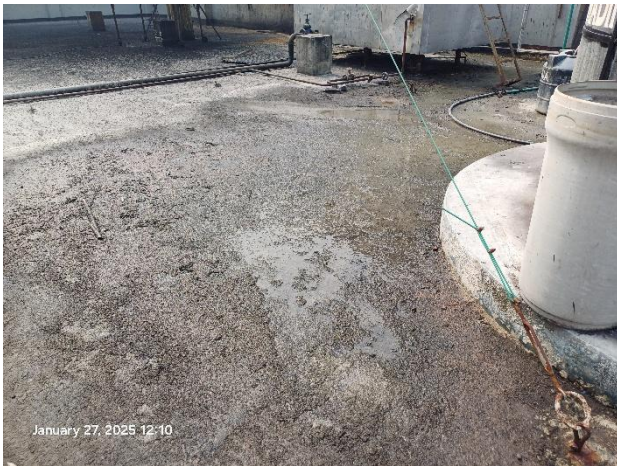
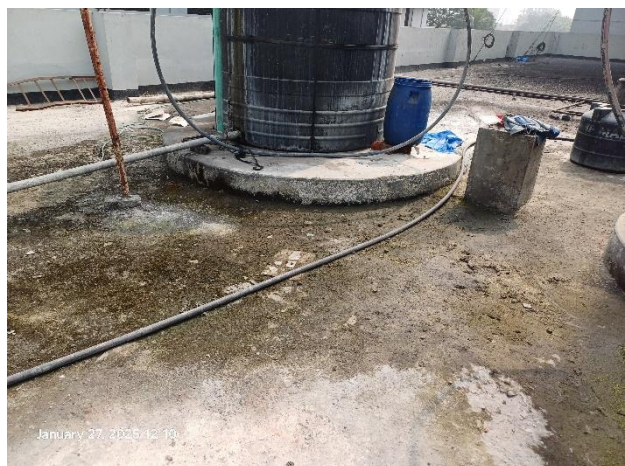
Description: Standing water and dampness were observed on the roof. Building engineer is required to improve the drainage system on the roof and repair the dampness with a suitable method.
