# Southend Sweater Co Ltd (Extension)

House # 12, Road # 01, Ashulia, Dhour, Turag, Dhaka-1230.

06 February 2025

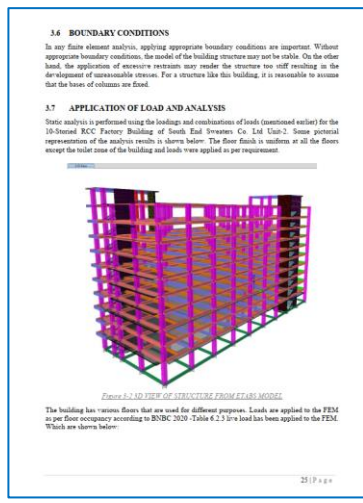
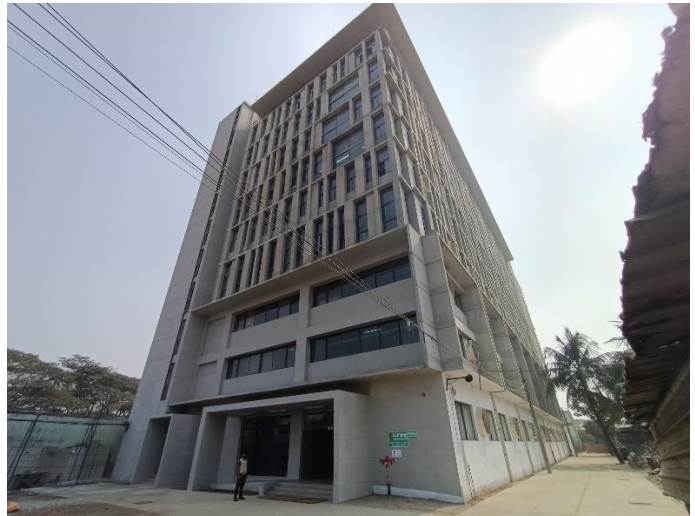
#### Observation-1: Design report needs to be reviewed against lateral forces (Main Factory Building).

**Description:** A design report has been prepared for the ten Main Factory Building. The prepared design report needs to be reviewed against lateral forces. Submit the design report to the RSC for detailed review.

| Item No | Observation | Action Plan | Timeline |
|---|---|---|---|
| 1. | Design report needs to be reviewed against lateral forces (Main Factory Building). | The building engineer is required to revise the design report as per updated drawing and submit it to RSC for review against lateral forces. | within 6 weeks |
| 2. | Design report needs to be reviewed against lateral forces (Main Factory Building). | Carry out remedial work if required. | within 6 months |
| 3. | Design report needs to be reviewed against lateral forces (Main Factory Building). | Continuing to implement loan plan | within 6 months |

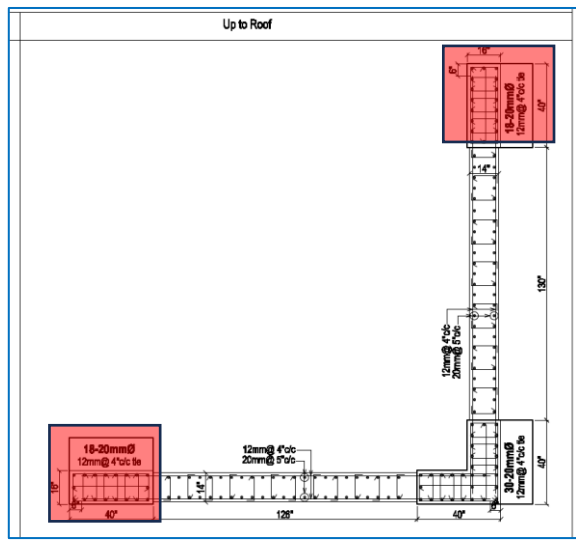
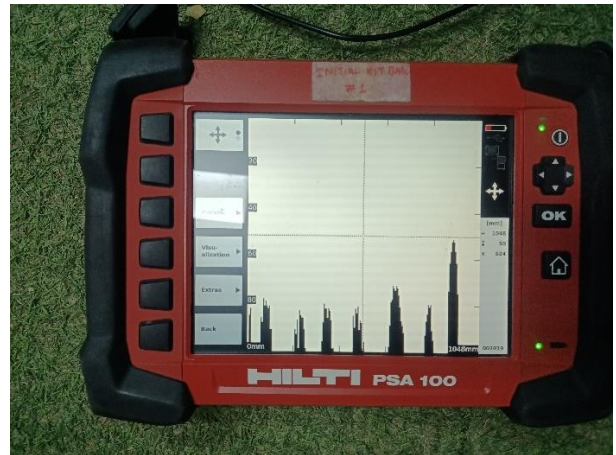
#### Observation-2: Mismatch between drawing & onsite condition (Main Factory Building).

**Description:** Amount of rebar at shear wall head of SW1 (South) did not match with drawings. In long face 7 nos rebar was found instead of 8 nos. The building engineer is required to update the drawing based on the as-constructed structure.

| Item No | Observation | Action Plan | Timeline |
|---|---|---|---|
| 4. | Mismatch between drawing & onsite condition (Main Factory Building). | The building engineer is required to update the drawing to the as-constructed status. | within 6 weeks |

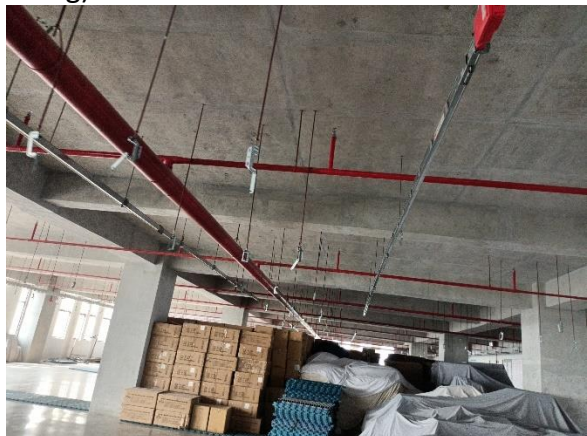
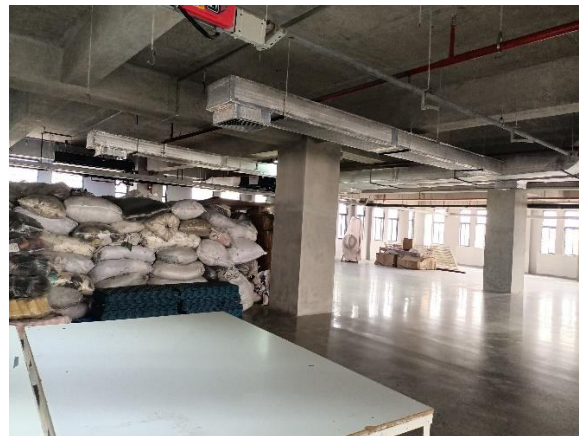
**Observation-3:** Mismatch observed between prepared load plan and onsite floor uses (Main Factory Building).

**Description:** Prepared load plans are not matched with the current floor loading on some floors. A temporary store was found which is not mentioned in the load plan. Building engineer is required to update load plan as per floor uses. Otherwise maintain floor occupancy as per the load plan.

| Item No | Observation | Action Plan | Timeline |
|---|---|---|---|
| 5. | Mismatch observed between prepared load plan and onsite floor uses (Main Factory Building). | Building engineer is required to update load plan as per floor uses. Otherwise maintain floor occupancy as per the load plan. | within 6 weeks |

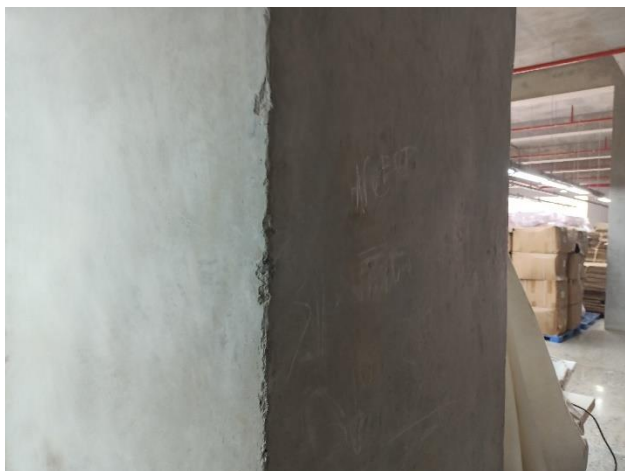
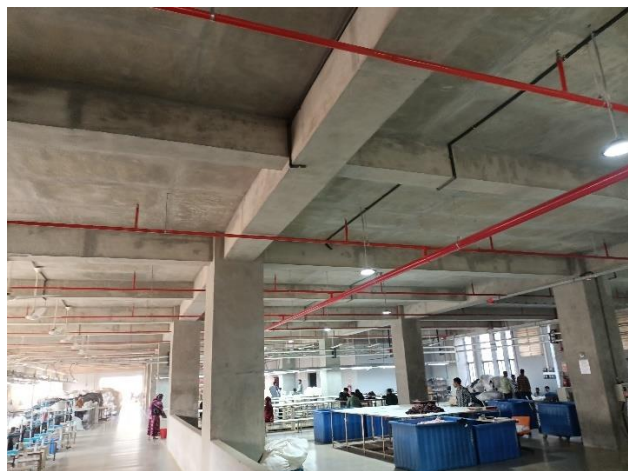
**Observation-4:** Column susceptible to trolley impact on the 1st floor. (Main Factory Building).

**Description:** Columns at the washing areas are susceptible to trolley impact. Building engineer is required to provide column guard to protect the columns from trolley impact.

| Item No | Observation | Action Plan | Timeline |
|---|---|---|---|
| 6. | Column susceptible to trolley impact at 1 <sup>st</sup> floor. (Main Factory Building). | Building engineer is required to provide column guard to protect the columns from trolley impact. | within 6 weeks |

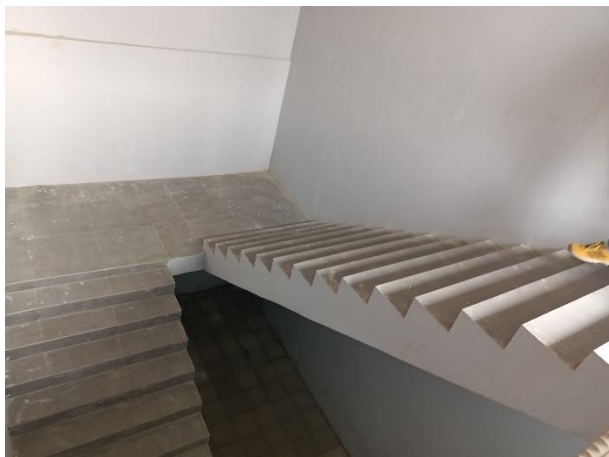
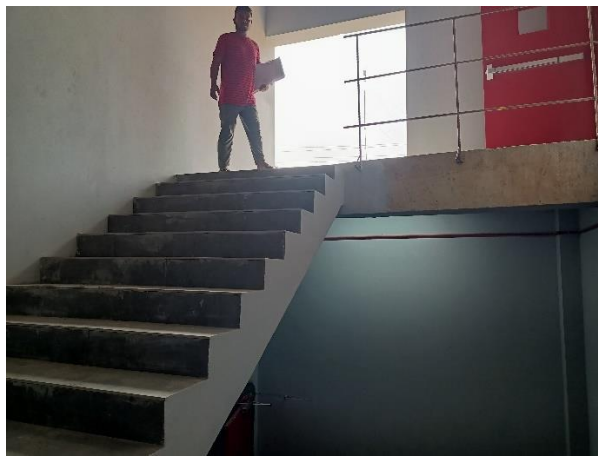
**Observation-5:** Falling hazard risk at stairs (Fire Control Building).

**Description:** Potential falling hazard was observed at stairs due to lack of handrails. Building engineer is required to provide handrails to stairs to prevent probable falling hazard.

| Item No | Observation | Action Plan | Timeline |
|---|---|---|---|
| 7. | Falling hazard risk at stairs (Fire Control Building). | Building engineer is required to provide handrails to stairs to prevent probable falling hazard. | Immediate |
