# Karnaphuli Sportswear Industries Ltd. (Extension)

Plot # 09-20, Sector # 07, Chattogram Export Processing Zone, Chattogram, Bangladesh.

23 January 2025

## 1. Building InformationExecutive Summary

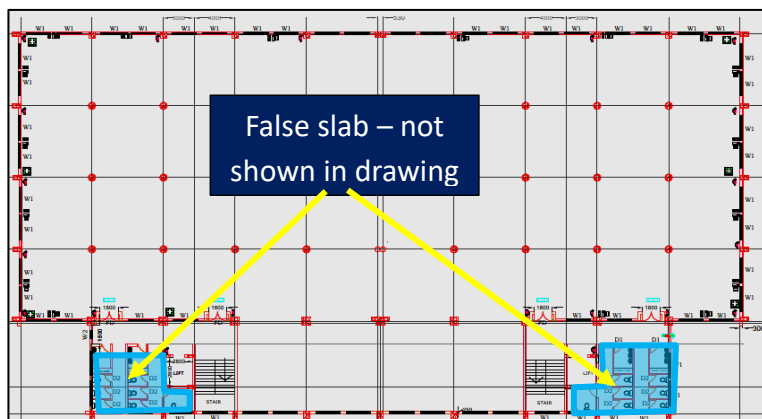
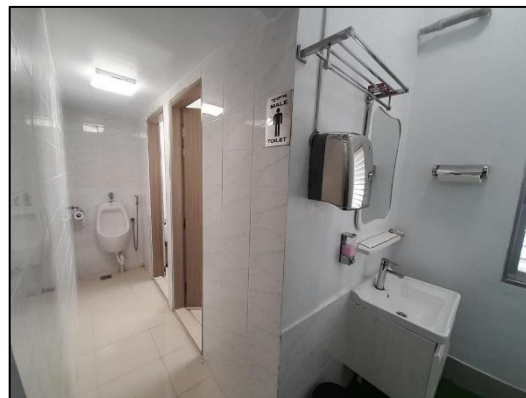
False slab at toilet area

**Description:** Some mismatches (false slab at toilet area, partition wall layout etc.) were found between onsite condition and as-built drawing. The building engineer is required to survey the full structure, update as-built drawings as per site condition and incorporate in the assessment.

| Item No. | Observation | Action Plan | Timeline |
|---|---|---|---|
| 1 | Discrepancies in as built drawings (KSL-3 new part) | The building engineer is required to survey the whole structure and update the as-built drawings. | within 6 weeks |

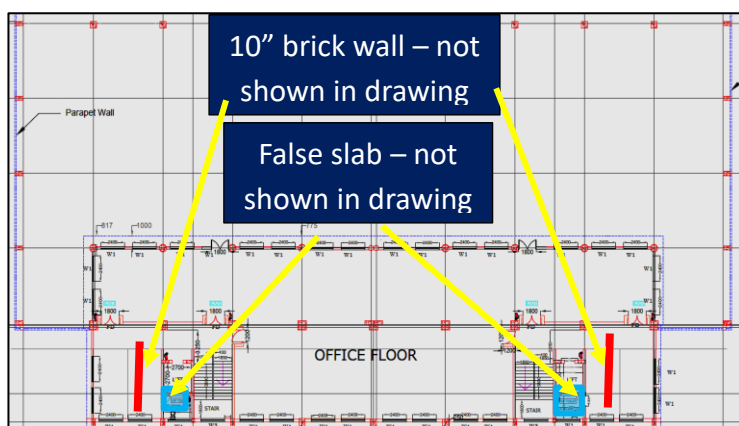
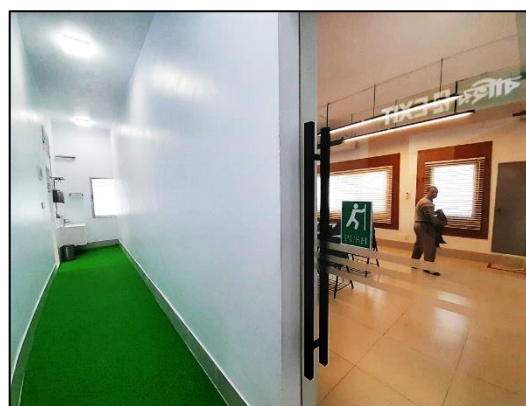
10" brick partition wall

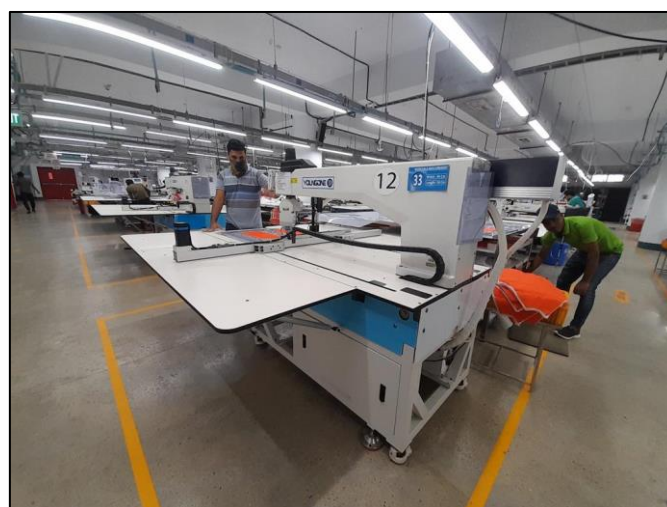
**Observation-3:** Significant vibration at template machine area of 4<sup>th</sup> floor (KSL-3 new part)

**Description:** Significant vibration was felt at template machine area of 4<sup>th</sup> floor. The building engineer is required to provide anti-vibration pads or take any other measures to mitigate the vibration.

| Item No. | Observation | Action Plan | Timeline |
|---|---|---|---|
| 6 | Significant vibration at template machine area of 4th floor (KSL-3 new part) | The building engineer is required to provide anti-vibration pads or take any other measures to mitigate the vibration. | within 6 weeks |

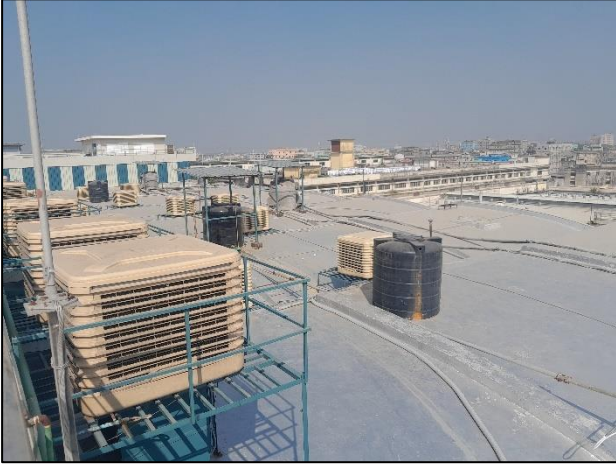
Undocumented plastic water tank at roof.

**Description:** Some mismatches (column C4 size at ground floor, undocumented plastic water tank on roof) were found between onsite condition and as-built drawing. The building engineer is required to survey the full structure, update as-built drawings as per site condition and incorporate in the assessment.

| Item No. | Observation | Action Plan | Timeline |
|---|---|---|---|
| 7 | Discrepancies in as built drawings (KSL-3 old part). | The building engineer is required to survey the full structure, update as-built drawings as per site condition and incorporate in the assessment. | within 6 weeks |

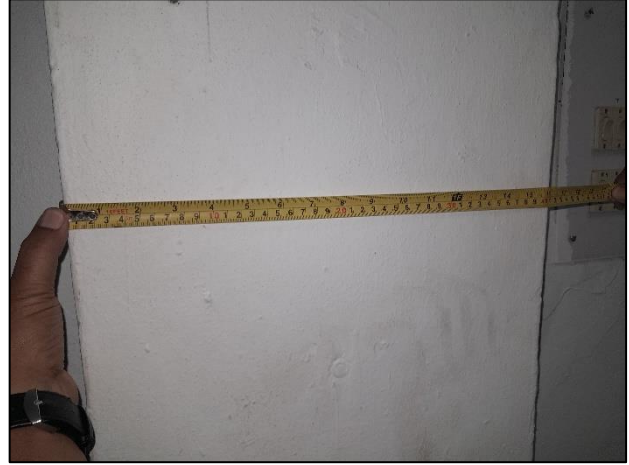
C4 column found 400x400 instead of 500x500 on the ground floor.

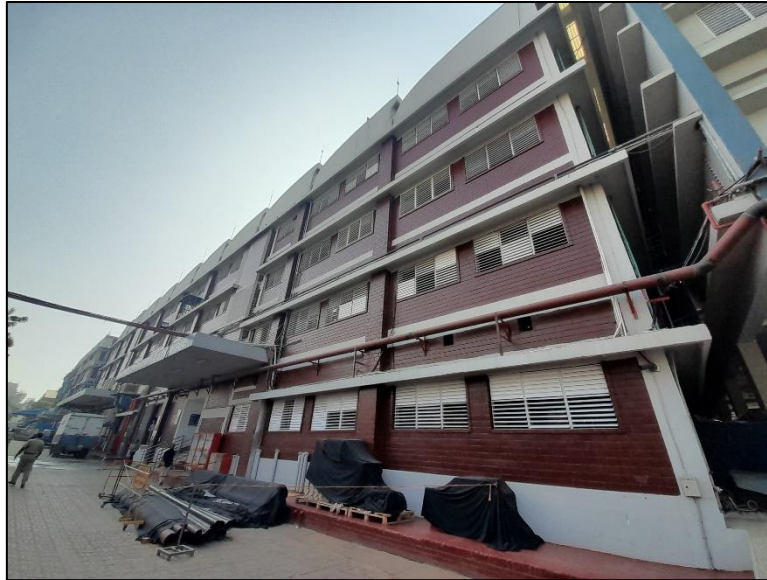
**Observation-5:** Design report needs to be reviewed against lateral forces (KSL-3 Old part).

**Description:** The design report prepared needs to be reviewed against lateral forces. Submit the design report to the RSC for detailed review.

| Item No. | Observation | Action Plan | Timeline |
|---|---|---|---|
| 8 | Design report needs to be reviewed against lateral forces (KSL-3 old part). | The building engineer is required to submit the design report to RSC for review | within 6 weeks |
| 9 | | Implement the remedial works if required. | within 6 months |

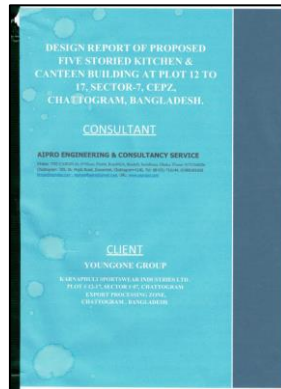
**Observation-6:** Inconsistency and lack of information in the Design Report (Kitchen & Canteen Building).

**Description:** Detailed seismic calculation and framing system consideration not provided in the design report. Concrete strength considering BNBC 5.12.1 not incorporated. Also, serviceability checks not incorporated in the design report.

Building engineer is required to revise the design report as per BNBC 1.9

| Item No. | Observation | Action Plan | Timeline |
|---|---|---|---|
| 11 | Inconsistency and lack of information in the Design Report (Kitchen & Canteen Building). | Building engineer is required to update the design report as per BNBC 1.9.1 | within 6 weeks |

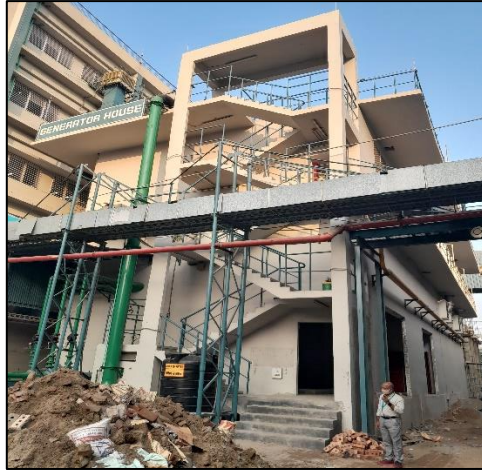
**Observation-7:** Design report needs to be reviewed against lateral forces (Gas Generator).

**Description:** The design report prepared needs to be reviewed against lateral forces. Submit the design report to the RSC for detailed review.

| Item No. | Observation | Action Plan | Timeline |
|---|---|---|---|
| 14 | Design report needs to be reviewed against lateral forces (Gas Generator). | The building engineer is required to submit the design report to RSC for review | within 6 weeks |
| 15 | | Implement the remedial works if required. | within 6 months |

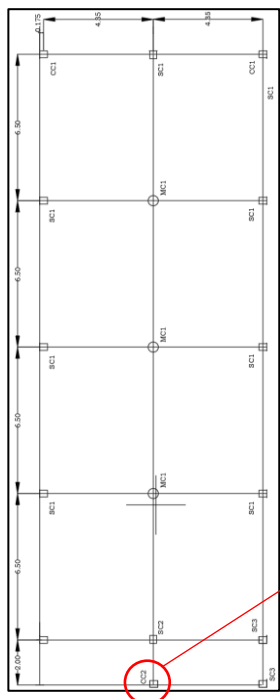
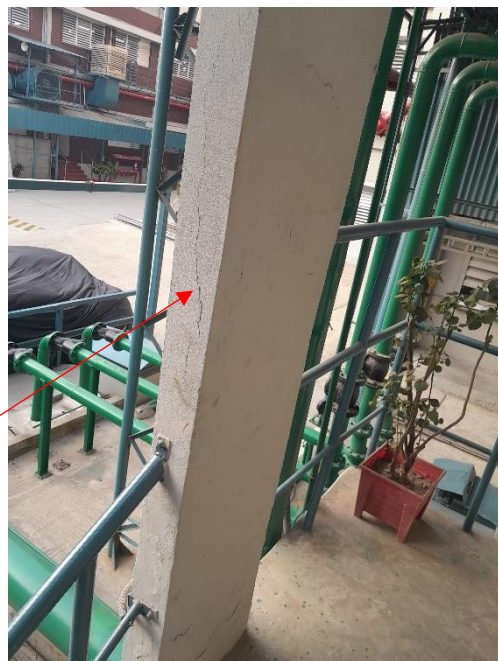
**Observation-8:** Crack on RC column at stair (Gas Generator).

**Description:** Crack was found on the stairs' column. The building engineer is required to investigate the identified cracks and produce an investigation report, along with a detailed repair methodology, must be submitted to RSC.

| Item No. | Observation | Action Plan | Timeline |
|---|---|---|---|
| 17 | Crack on RC column at stairs (Gas Generator). | The building engineer is required to investigate the identified cracks and produce an investigation report, along with a detailed repair methodology, must be submitted to RSC. | Immediate |
| 18 | | Implement the remedial works | within 6 weeks |

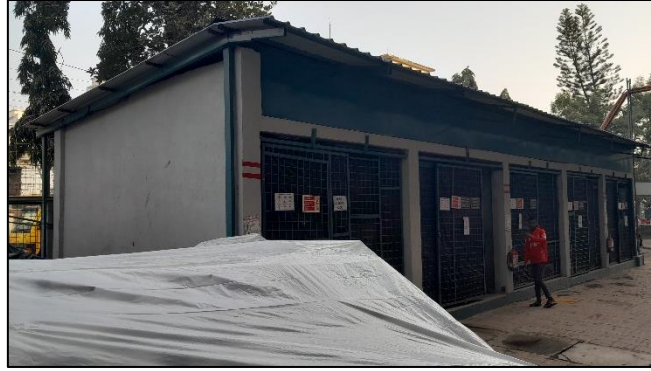
**Observation-9:** Lack of design documents (Garbage shed).

**Description:** As per BNBC, every building or structure designed shall have its design documents prepared in accordance with the provision of Section 1.9.1. The design document shall include a design report, and a set of structural drawings, which shall be prepared in compliance with section 1.9.1.1 and section 1.9.1.2 as per BNBC. At the time of inspection, a design report was not available. Also, no drawing was available for the structure. The building engineer is required to prepare a full set of as-built drawings and a Engineering Assessment (EA) for the structure.

| Item No. | Observation | Action Plan | Timeline |
|---|---|---|---|
| 19 | Lack of design documents (Garbage shed). | The building engineer is required to prepare a full set of as-built drawings and Engineering Assessment (EA) for the structure. | within 6 weeks |

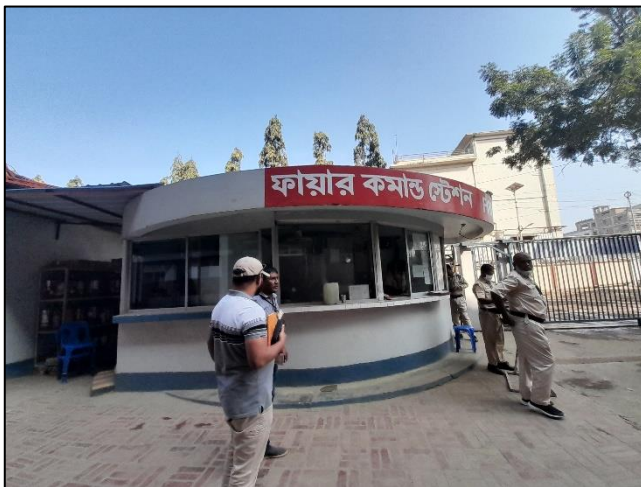
Security Post & Fire Command Station-2

**Description:** No as-built drawing was available of the structures. The building engineer is required to prepare a full set of as-built drawings.

| Item No. | Observation | Action Plan | Timeline |
|---|---|---|---|
| 21 | Lack of as-built drawing (Security Post & Fire Command Station-2 and Kitchen toilet). | The building engineer is required to prepare a full set of as-built drawings. | within 6 weeks |

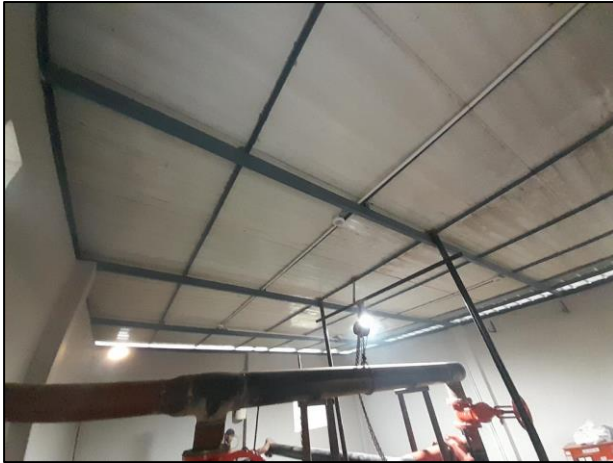
**Observation-11:** Discrepancies in as built drawings [Pump House (positive suction)]

**Description:** Rafter was found box 100X50X5 instead of I-section. The building engineer is required to survey the full structure and update the as-built drawings.

| Item No. | Observation | Action Plan | Timeline |
|---|---|---|---|
| 22 | Discrepancies in as built drawings [Pump House (positive suction)] | The building engineer is required to survey the whole structure and update the as-built drawings. | within 6 weeks |

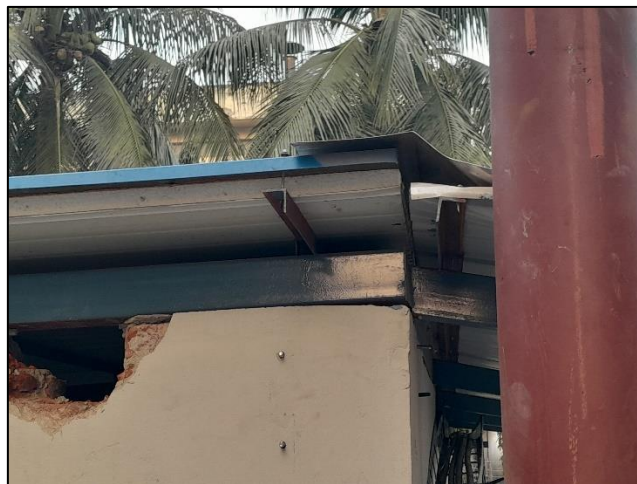
**Observation-12:** Inadequate connection [Pump House (positive suction)]

**Description:** Inadequate connection was observed. The building engineer is required to check the connection adequacy and improve the connection if required.

| Item No. | Observation | Action Plan | Timeline |
|---|---|---|---|
| 23 | Inadequate connection [Pump House (positive suction)] | The building engineer is required to check the connection adequacy. | within 6 weeks |
| 24 | | Carry out suggested remedial works if required. | within 6 months |

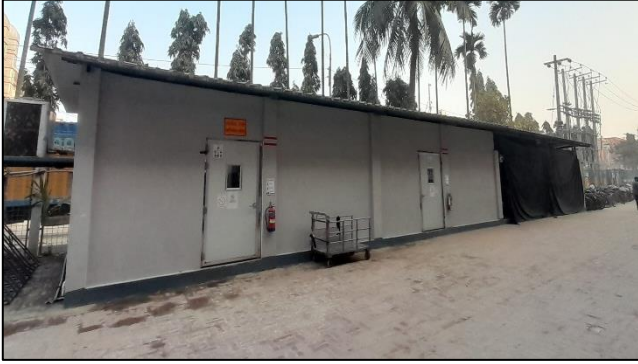
Chemical & Garbage Sorting Area

**Description:** As-built drawing for Chemical & Garbage Sorting Area, Prayer Room were not available. The building engineer is required to survey the whole structures and produce as-built drawings as per onsite condition.

| Item No. | Observation | Action Plan | Timeline |
|---|---|---|---|
| 25 | Lack of as-built drawing (Chemical & Garbage Sorting Area, Prayer Room) | The building engineer is required to survey the whole structure and update the as-built drawings. | within 6 weeks |

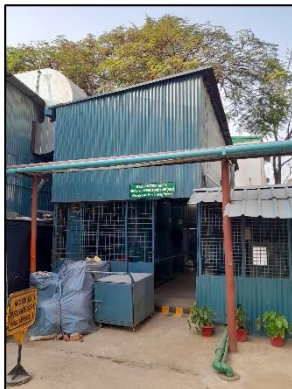
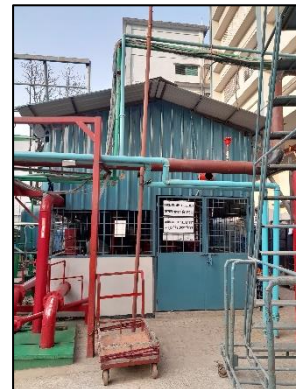
**Observation-14:** Lack of as-built drawing (RO Plant 3, Pump House)

**Description:** As-built drawing for RO Plant 3, Pump House were not available. The building engineer is required to survey the whole structure and produce as-built drawings as per onsite condition.

| Item No. | Observation | Action Plan | Timeline |
|---|---|---|---|
| 26 | Lack of as-built drawing (RO Plant 3, Pump House) | The building engineer is required to survey the whole structure and produce the as-built drawings as per site condition | within 6 weeks |

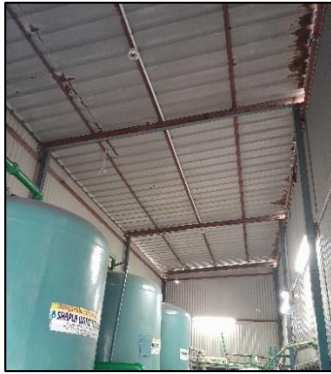
RO Plant

**Observation-15:** Inadequate member size and stability (RO Plant 3, Pump House)

**Description:** Inadequate member size and stability system were observed. The building engineer is required to check the member adequacy and prepare a safety check report.

| Item No. | Observation | Action Plan | Timeline |
|---|---|---|---|
| 27 | Inadequate member size and stability (RO Plant 3, Pump House) | The building engineer is required to check the member adequacy and prepare a safety check report according to Accord Building Standard. | within 6 weeks |
| 28 | | Implement the remedial work if required. | within 6 months |

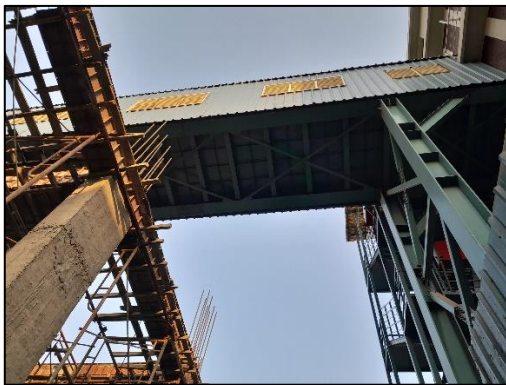
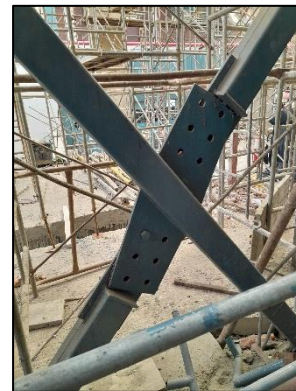
Poor connection details

**Description:** Poor connection details were observed in the connecting bridge. Building engineer is required check the connection adequacy and suggest remedial works.

| Item No. | Observation | Action Plan | Timeline |
|---|---|---|---|
| 29 | Poor connection details of connecting bridge (Connecting Bridge) | The building engineer is required to check the connection adequacy and suggest remedial works. | within 6 weeks |
| 30 | | Implement the remedial works where required. | within 6 months |
