# NKM Fashion Limited

Baliapara Jalsha, Jalsha, Dhamrai, Dhaka.

02 February 2025

## **1. Building Information**

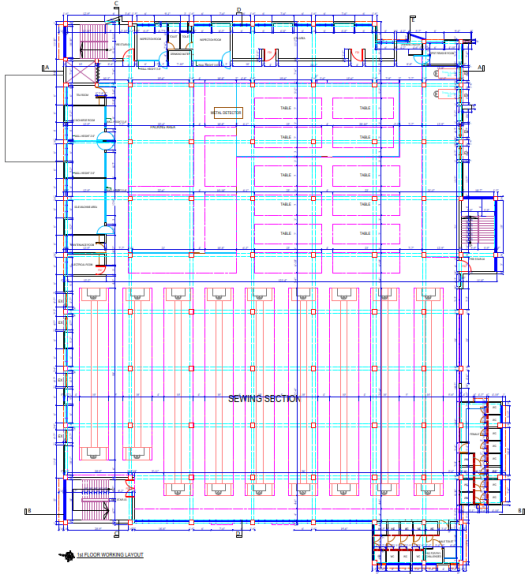
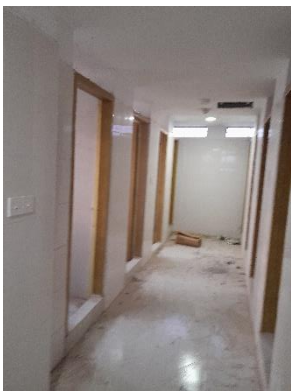
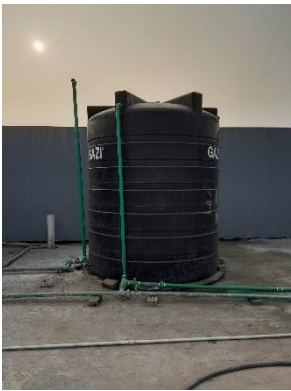
**Observation 2:** Lack of information in as-built drawing. (Production Building)

**Description:** Toiler build-ups and water Tanks are not shown in the as-built drawing. The building engineer is required to survey the structure and prepare accurate and detailed as-built drawings.

| Item No. | Observation | Action Plan | Timeline |
|---|---|---|---|
| 4. | Lack of information in as-built drawing. (Production Building) | The building engineer is required to survey the structure and to prepare accurate, detailed as-built drawings. | within 6 weeks |

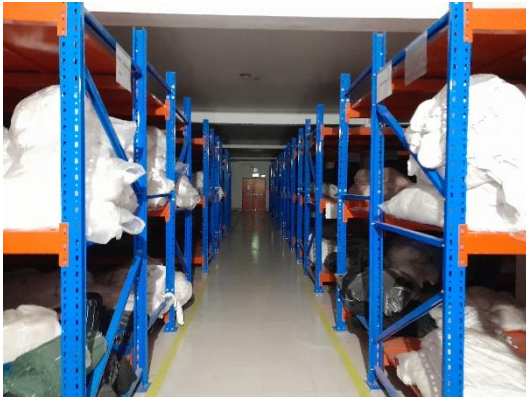
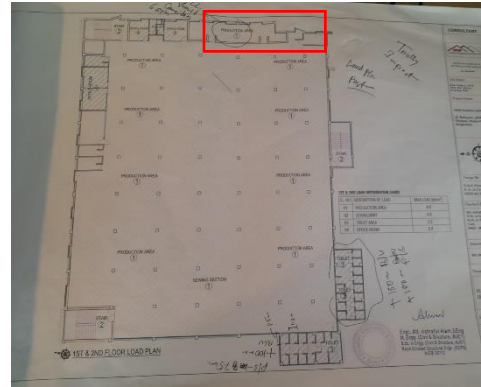
**Observation-3: Live Loading consideration & lack of load management (Production Building)**

**Description:** Storage loading is considered 4 kPa instead of 6 kPa. No load plan was posted on the floors, also no load management program was visible. The building engineer is required to revise the load plan as per BNBC and implement a floor load management program.

| Item No. | Observation | Action Plan | Timeline |
|---|---|---|---|
| 5. | Live Loading consideration & lack of load management (Production Building) | Building engineer is required to revise the load plan as per BNBC requirement | within 6 weeks |
| 6. | | Implementing floor load management program (load plan posting, storage area & height marking and load maintaining). | within 6 weeks |

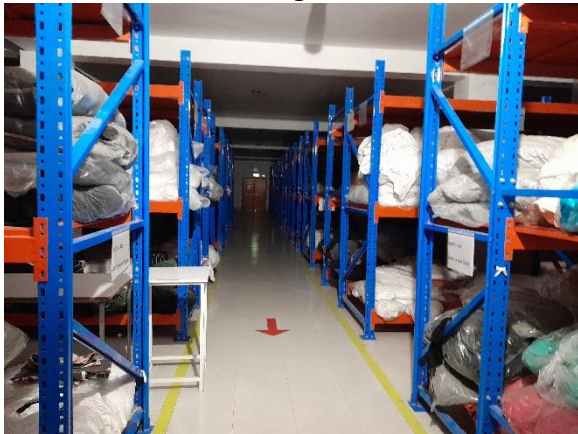
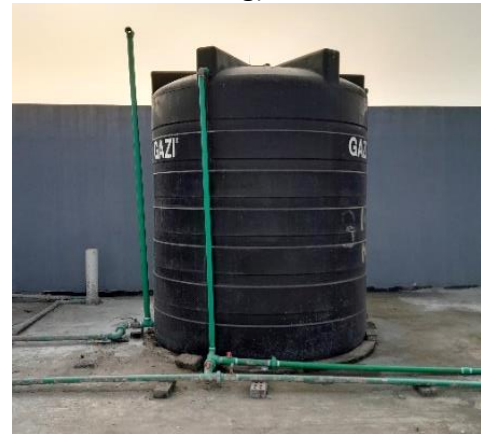
**Observation-4: Anchorage of non-structural elements. (Production Building)**

**Description:** Unbraced storage racks/water tanks were observed. The building engineer is required to provide anchorage/bracing to all nonstructural elements including storage racks/water tanks.

| Item No. | Observation | Action Plan | Timeline |
|---|---|---|---|
| 7. | Anchorage of non-structural elements. (Production Building) | The building engineer is required to provide anchorage/bracing to all non-structural elements including storage racks and water tanks. | within 6 months |

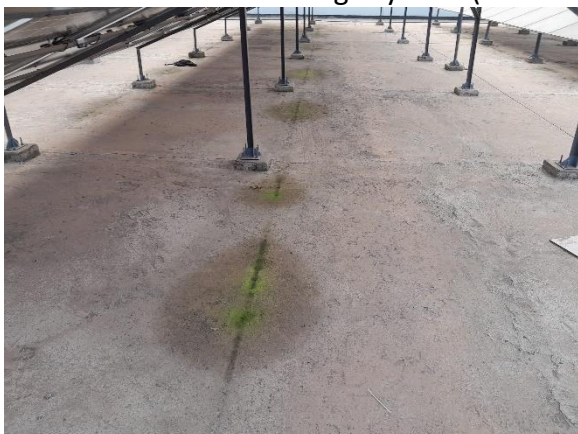
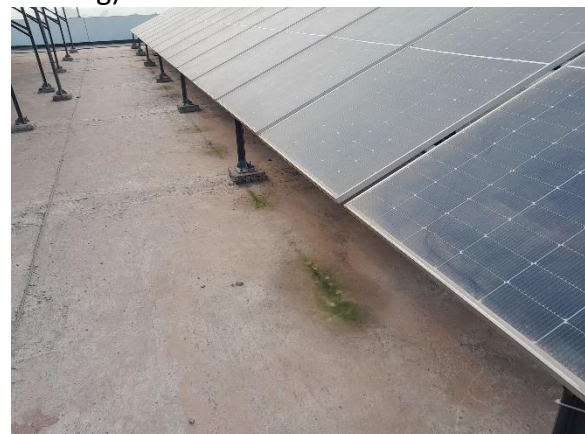
**Observation-5: Roof drainage system (Production Building)**

**Description:** Signage of water ponding observed on the roof. The building engineer is required to improve the roof drainage system.

| Item No. | Observation | Action Plan | Timeline |
|---|---|---|---|
| 8. | Roof drainage system (Production Building) | Building engineer is required to improve the roof drainage system (slope, outlet) | within 6 months |

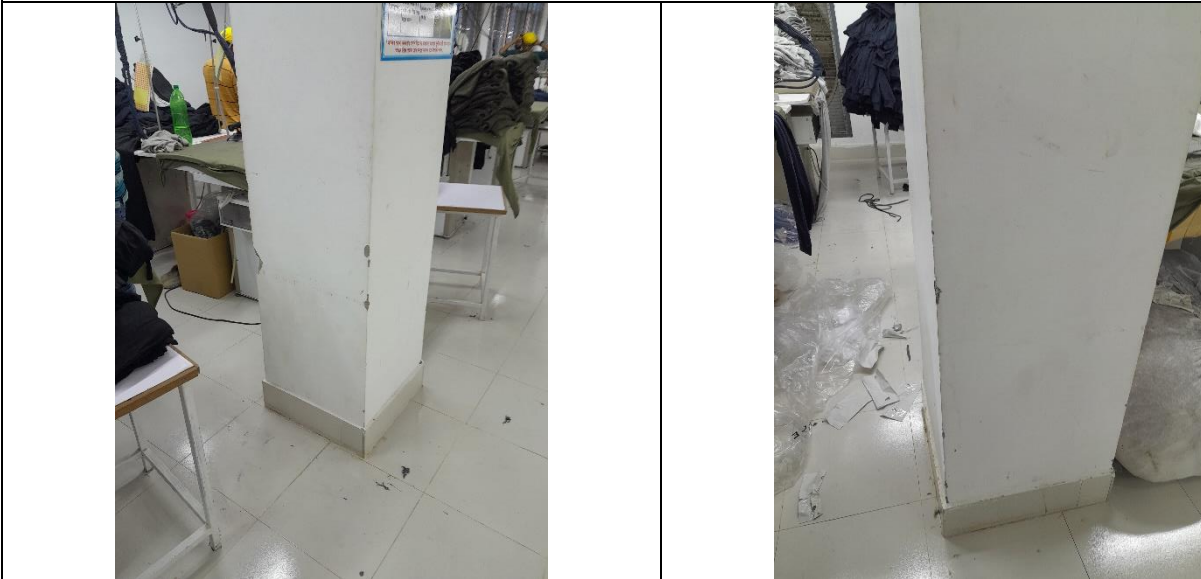
**Observation-6:** Damage of column due to trolley impact. (Production Building)

**Description:** Damage due to trolley impact was observed on the floor. The building engineer is required to repair the damage and provide trolley impact protection.

| Item No. | Observation | Action Plan | Timeline |
|---|---|---|---|
| 9. | Damage of column due to trolley impact | Building engineer is required to repair the damaged surface and provide trolley impact protection guard. | within 6 months |

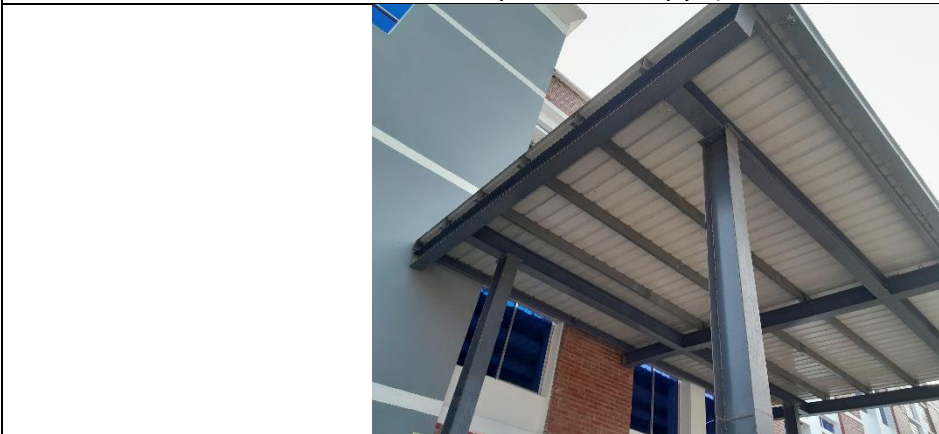
**Observation 7:** Lack of lateral stability of the canopy. (Production Building)

**Description:** The framing connection is not moment resistance and there was no bracing to resist the lateral forces. Therefore, the lateral framing system is incomplete. The building engineer is required to check the stability system of the shed and prepare a safety check report.

| Item No. | Observation | Action Plan | Timeline |
|---|---|---|---|
| 10. | Lack of lateral stability of the canopy. (Production Building) | Building engineer is required to check the lateral stability system of the shed and prepare a safety check report. | within 6 weeks |
| 11. | | Implement remediation work if required. | within 6 months |

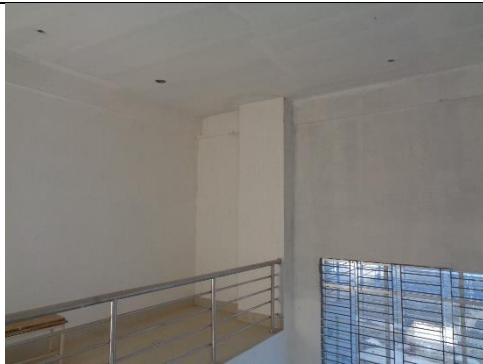
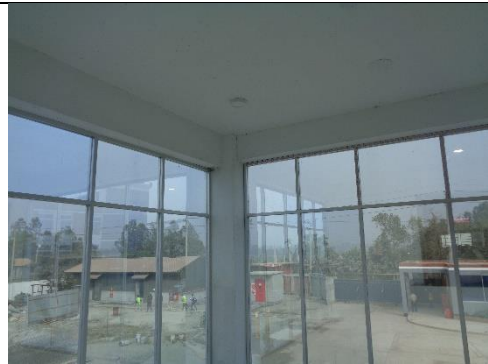
**Observation 9:** Lack of information in as-built drawing. (Admin Building)

**Description:** The height of the FB-1 & FB-5 was found to be 18 inches instead of 20 inches. The building engineer is required to survey the structure & prepare accurate, detailed as-built drawings.

| 15. | Lack of information in as-built drawing. (Admin Building) | The building engineer is required to survey the structure and prepare accurate, detailed as-built drawings. | within 6 weeks |

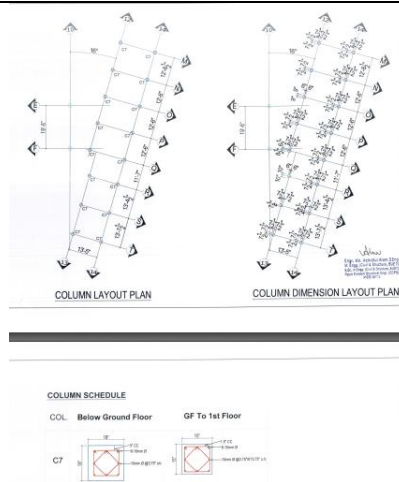
**Observation 10: Slender column. (Utility Building)**

**Description:** The ground floor height is 5.25 m, and the column size is 375 mm X 375 mm. The building engineer is required to check the slenderness of the columns.

| 16. | Slender column. (Utility Building) | The building engineer is required to check the slenderness of the columns. | within 6 weeks |
| 17. | | Implement remediation work if required. | within 6 months |

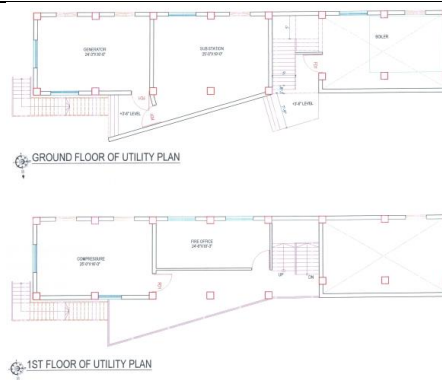
**Observation 11: Lack of information in the as-built drawing (Utility Building)**

**Description:** Dimensions are not provided in the as-built drawings, no sectional drawings are provided in the architectural drawing. The building engineer is required to prepare accurate, detailed as-built drawings.

| 18. | Lack of information in as-built drawing. (Utility Building) | The building engineer is required to survey the structure and to prepare accurate, detailed as-built drawings. | within 6 weeks |

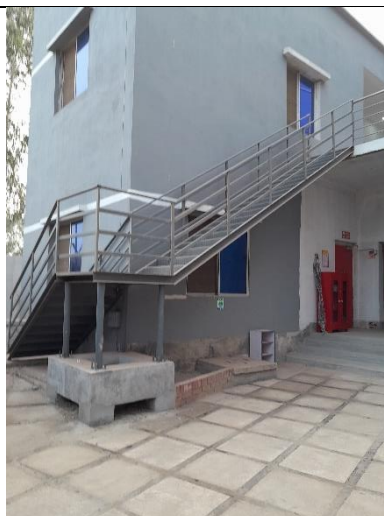
**Observation 12: Inadequate steel stair and lack of as-built drawing (Utility Building)**

**Description:** Inadequate steel stair observed on site having no drawings. The building engineer is required to prepare as-built drawings and prepare a safety check report.

| 19. | Inadequate steel stair and lack of as-built drawing (Utility Building) | Building engineer is required to prepare as-built drawings and prepare a safety check report. | within 6 weeks |
| 20. | | Implement remediation work where required. | within 6 months |

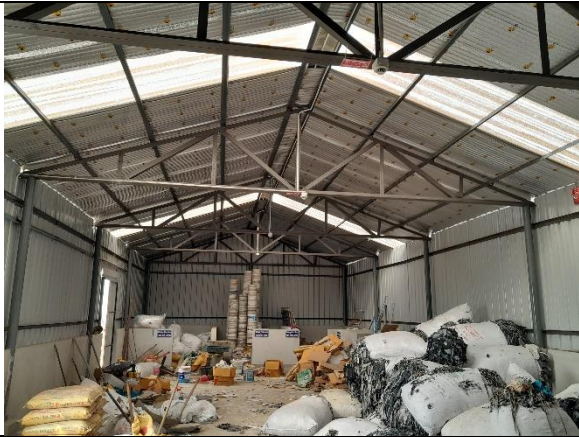
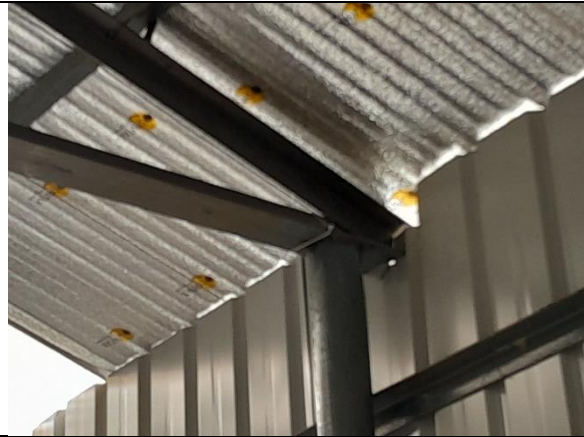
**Observation 13:** Lack of stability system of the shed. (Wastage Shed)

**Description:** Lack of lateral load resistance members (Bracing, Cross truss) and poor connection details were observed. Building engineer is required to check the lateral stability and connection adequacy and prepare a safety check report according to Accord Building Standards.

| 21. | Lack of stability system of the shed. (Wastage Shed) | Building engineer is required to check the lateral stability and prepare a safety check report. | within 6 weeks |
| 22. | | Implement remediation work where required. | within 6 months |

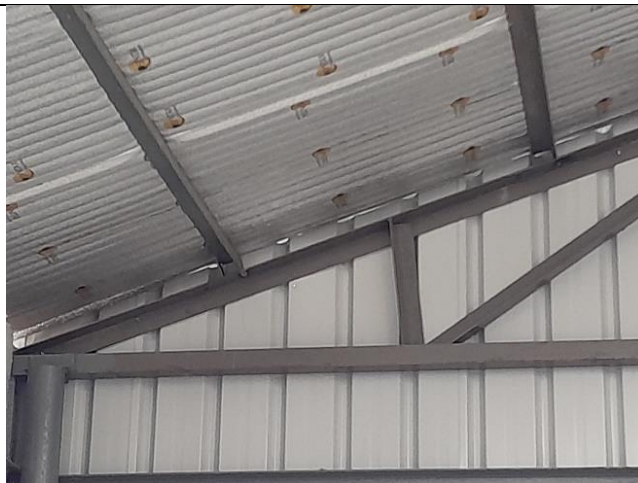
**Observation 14:** Distorted steel truss member (Wastage Storage)

**Description:** Distorted member were observed. Building engineer is required to repair the distorted member with a suitable method.

| 23. | Distorted steel truss member (Wastage Storage) | Building engineer is required to repair the distorted member with a suitable method. | within 6 weeks |
