# Futex (Bangladesh) Garment Manufacturing Co., Ltd.

03 February 2025

## Structural Inspection Report

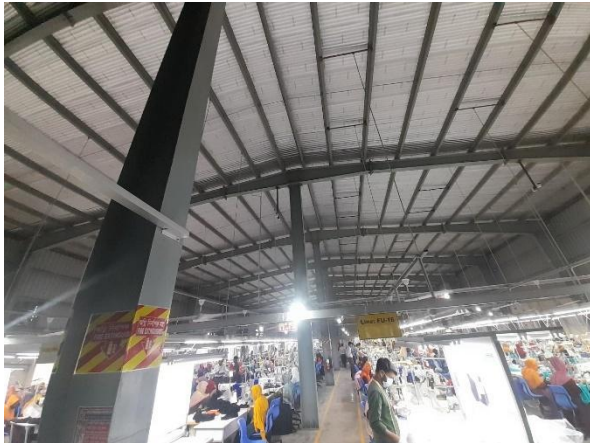
### Observation-1: Lack of lateral load transfer media for the shed 1.

Absence of load transfer media

**Description:** The shed has portal framing action in the east-west direction. However, the roof does not have a lateral load transfer or load-resisting system in the north-south direction.

Additionally, a design report was found on-site during the inspection. As per the report's recommendations, certain remedial works were suggested, but none have been carried out yet.

The building engineer is required to check the lateral stability of the structure and suggest proper remedial actions.

| Item No | Observation | Action Plan | Timeline |
|---|---|---|---|
| 1. | Lack of lateral load transfer media for the shed 1. | The building engineer is required to check the lateral stability of the structure and suggest proper remedial actions. | within 6 weeks |
| 2. | | Carry out remedial work if required. | within 6 months |

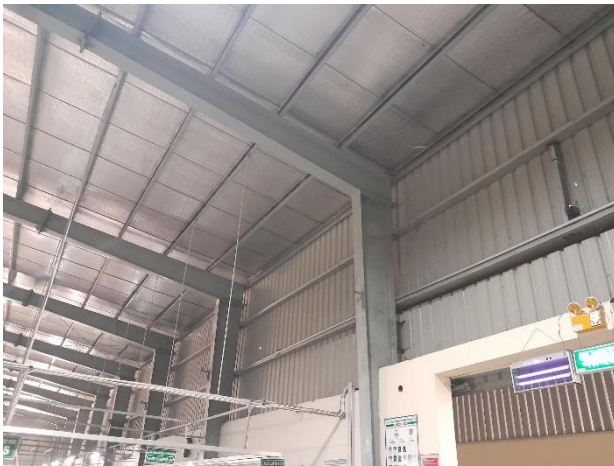
### Observation-2: Lack of lateral load transfer media for the shed 2.

Absence of load transfer media

**Description:** The shed has portal framing action in the east-west direction. However, the roof does not have a lateral load transfer or load-resisting system in the north-south direction.

Additionally, a design report was found on-site during the inspection. As per the report's recommendations, certain remedial works were suggested, but none have been carried out yet.

The building engineer is required to check the lateral stability of the structure and suggest proper remedial actions.

| Item No | Observation | Action Plan | Timeline |
|---|---|---|---|
| 3. | Lack of lateral load transfer media for the shed 2. | The building engineer is required to check the lateral stability of the structure and suggest proper remedial actions. | within 6 weeks |
| 4. | | Carry out remedial work if required. | within 6 months |

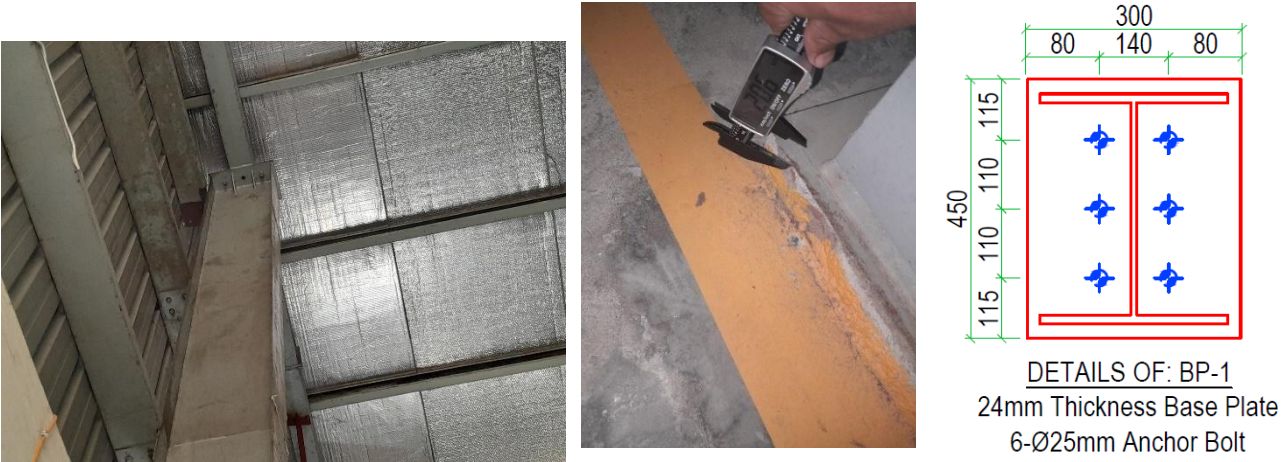
**Observation-3:** Mismatch between drawing & onsite condition (Shed 1 and Shed 2).

**Description:** During the inspection, mismatch was found in connection details and the base plate of the column. The thickness of base plate 1 was found 20 mm instead of 24 mm. The building engineer is required to survey the full structure and update the as-built drawing based on the as-constructed. A credible construction drawing of shed-2 is not available.

| Item No | Observation | Action Plan | Timeline |
|---|---|---|---|
| 5. | Mismatch between the drawing & onsite condition (Shed 1 and Shed 2). | The building engineer is required to update the as-built drawing based on the as-constructed structure. | within 6 weeks |

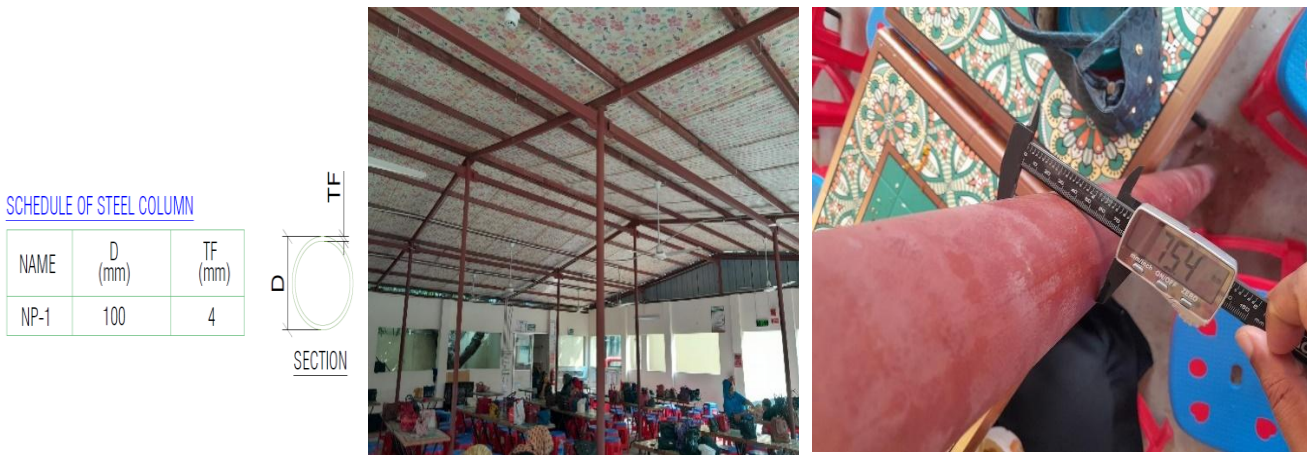
**Observation-4:** Remedial works were not properly carried out as per the retrofitting drawing (Dining Shed).

New Steel Pipe Column  
size

Dining Shed (No details for the  
UGWR)

The retrofitted pipe diameter was  
found 75 mm instead of 100mm

**Description:** A set of retrofitting drawings was found during the inspection, and some remedial works were executed as per the retrofitting drawings. However, no design report was found during the inspection. New steel pipe column was found dia 75 mm instead of dia 100 mm. Also, no information was found in the as-built drawing for the UGWR under the dining shed.

The factory is required to survey the full structure, prepare accurate as-built drawings, reassess the design documents, and submit them to RSC for further review.

| Item No | Observation | Action Plan | Timeline |
|---|---|---|---|
| 6. | Remedial works were not properly carried out as per the retrofitting drawing (Dining Shed). | The factory is required to survey the full structure, prepare accurate as-built drawings, reassess the design documents, and submit them to RSC for further review. | within 6 weeks |
| | | Carry out remedial work if required. | within 6 months |

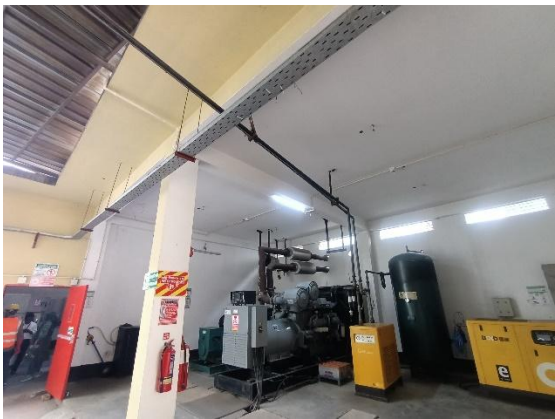
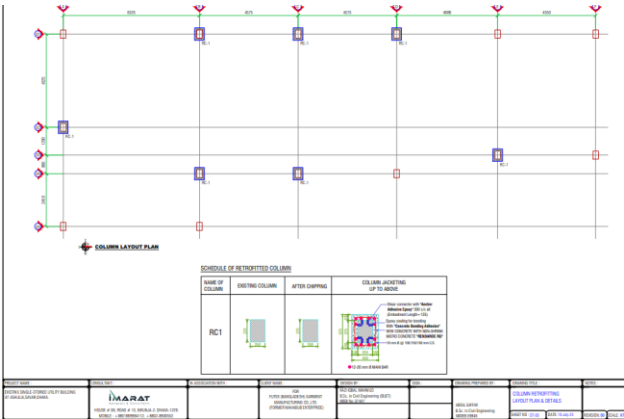
**Observation-5:** Prepared design report and remediation plan are required to be reviewed by RSC (Utility Building).

**Description:** During the inspection, a set of design reports was found along with a remediation plan. A remediation plan for a few columns has been proposed for the Utility Building. However, no remedial work has been executed by the factory for the Utility Building. Therefore, the prepared design report and remediation plan need to be reviewed by RSC. The factory is required to submit the design report and the proposed remediation plan to RSC for review.

| Item No | Observation | Action Plan | Timeline |
|---|---|---|---|
| 7. | Prepared design report and remediation plan are required to be reviewed by RSC (Utility Building). | The factory is required to submit the design report and the proposed remediation plan to RSC for review. | within 6 weeks |
| 8. | | Carry out remedial work if required. | within 6 months |

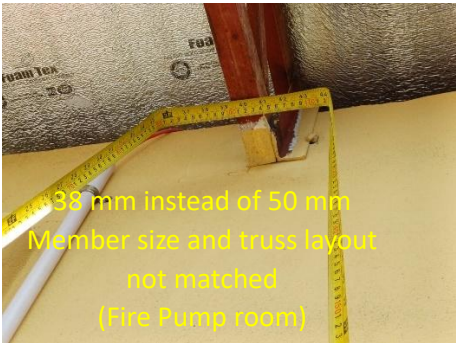
38 mm instead of 50 mm Member size and truss layout not matched (Fire Pump room)

**Description:** Beam size, steel member sizes and rafter layout did not fully match with the provided as-built drawings. A building engineer is required to survey the full structures and prepare accurate drawings.

| Item No | Observation | Action Plan | Timeline |
|---|---|---|---|
| 9. | Mismatches in as-built drawings (Fire pump, Medical & Female Prayer Shed, Office Shed, Chemical & Wastage Shed, Security Shed). | A building engineer is required to survey the full structures and prepare accurate drawings. | within 6 weeks |

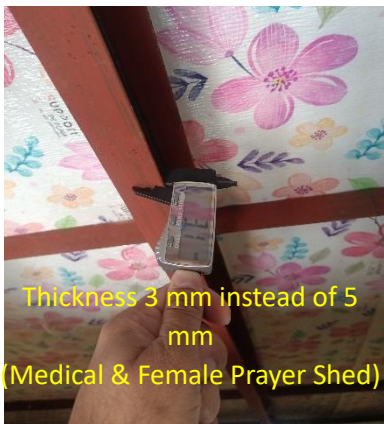
Thickness 3 mm instead of 5 mm (Medical & Female Prayer Shed)

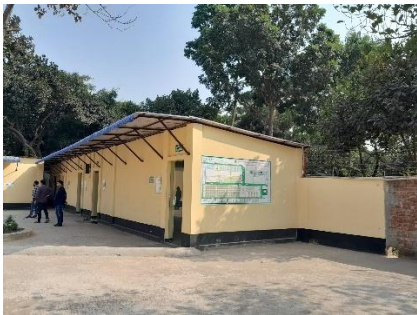
Member size and rafter layout not matched (Office Shed)

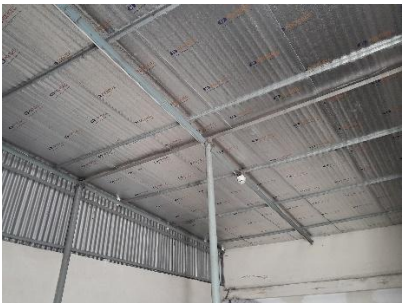
Connection details and rafter layout not matched (Chemical & Wastage Shed)

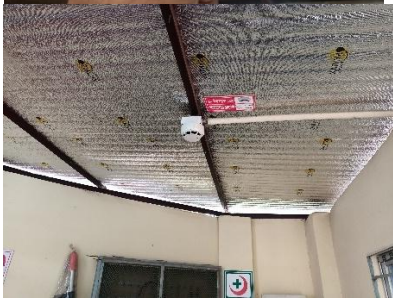
Member size and rafter layout not matched (Security Shed)

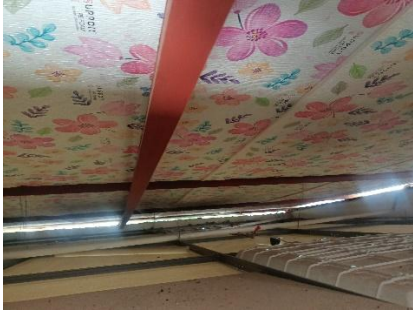
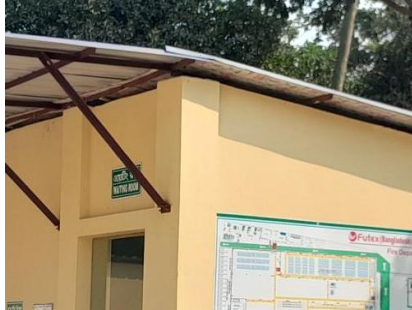
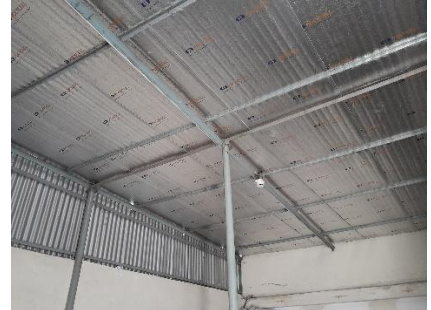
**Observation-7:** Inadequate connection (Medical & Female Prayer Shed, Office Shed, Chemical & Wastage Shed).

**Description:** Inadequate connections were observed against uplift pressure of wind. The building engineer is required to check the connection of roof frames for these structures and prepare safety check report suggesting proper alternatives following Accord Building Standard.

| Item No | Observation | Action Plan | Timeline |
|---|---|---|---|
| 10. | Inadequate connection (Medical & Female Prayer Shed, Office Shed, Chemical & Wastage Shed). | The building engineer is required to check the connection of roof frames for these structures and prepare a safety check report suggesting proper alternatives following Accord Building Standard. | within 6 weeks |
| 11. | | Carry out remedial work if required. | within 6 months |

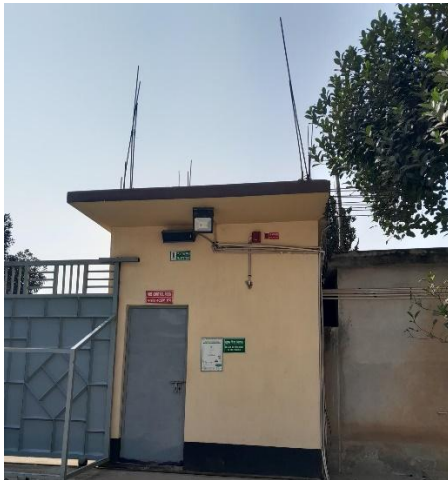
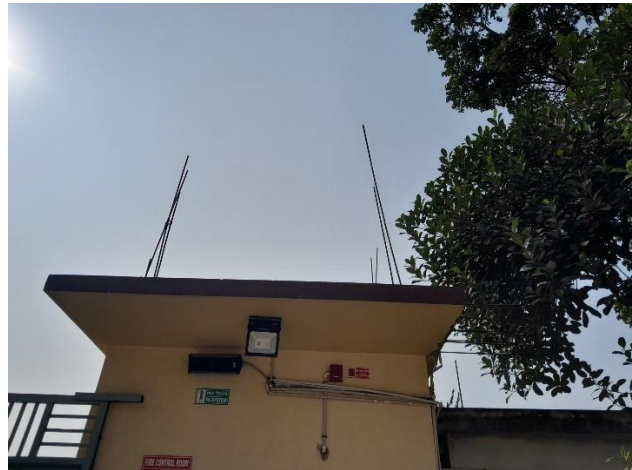
**Observation-8:** Expose rebar (Fire Control Room).

**Description:** Expose rebars were found on the roof of the building. A building engineer is required to provide rust proof paint to protect from corrosion.

| Item No | Observation | Action Plan | Timeline |
|---|---|---|---|
| 12. | Expose rebar (Fire Control Room). | A building engineer is required to provide rust-proof paint to protect from corrosion. | within 6 weeks |
