Fullcharm Fashion Knitters Ltd.

11 February 2025

Structural Inspection Report

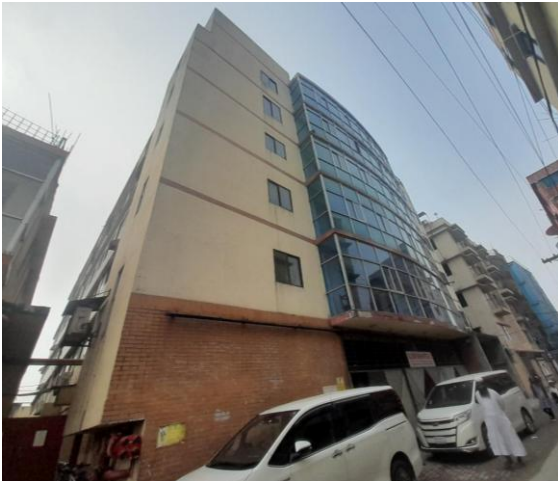
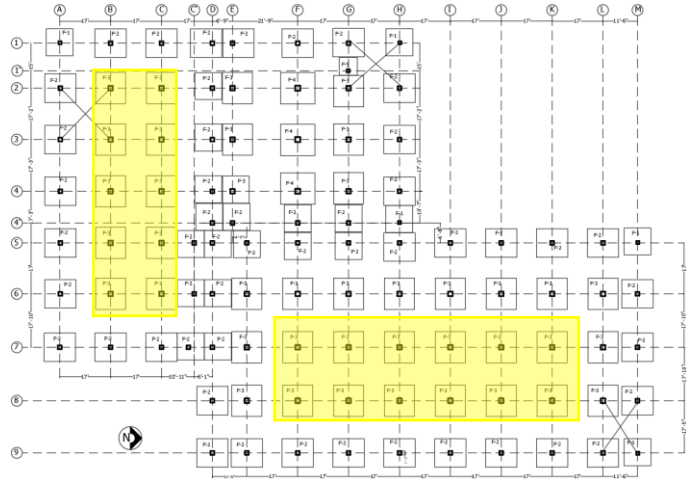
Observation 1: Stress in the foundation exceeds the normal design limit for a partially seven-storied (G+6) structure. [Building-1]

Description: The cursory calculation indicates that foundations are stressed above the normal design limit at the marked locations considering a floor live load of 3 kPa for the typical production floor and 1.5 kPa for the roof.

Action Plan: The building engineer is required to review design loads and foundation stresses. Also, produce and actively manage load management plans.

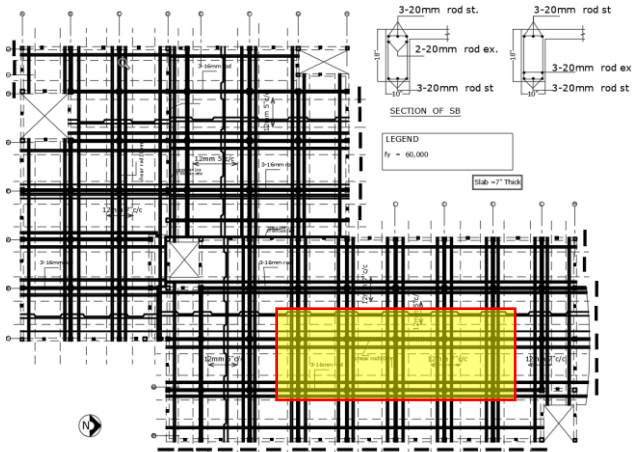
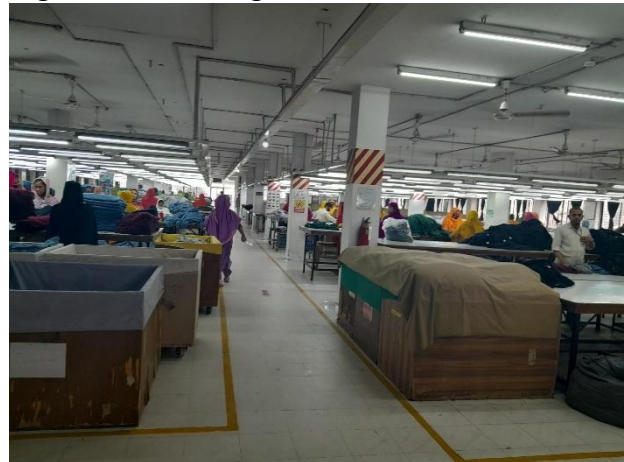
Observation 2: Flat Plate stressed above normal design limit. [Building-1]

Description: Cursory calculation indicates that the stresses in the slab of the Building 1 (Part A) are above the normal design limit, considering 3 kPa floor live load, minimum concrete strength and 375x375 mm column C3 at upper floor above the 1F. Additionally, no material test report for the flat slab was found during the inspection.

Action Plan: The building engineer is required to carry out Engineering Assessment (EA) as well as suggested remedial works. The building engineer is required to confirm material strength of flat slab and incorporate the test result in EA.

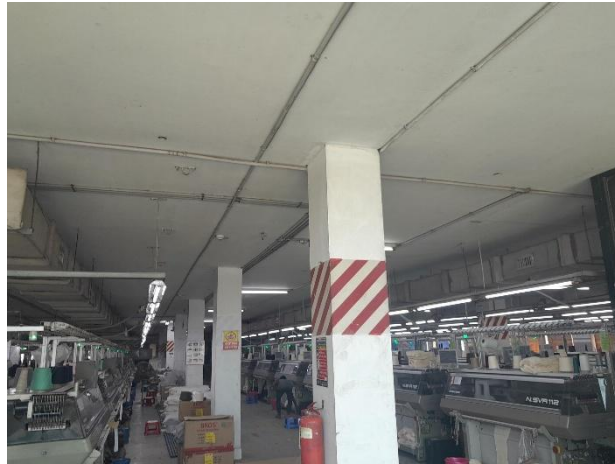
Observation 3: No obvious lateral stability (shear walls, bracing, or a rigid frame system) in the structure. [Building-1]

Description: The structure consists of a reinforced concrete (RC) flat plate system with an edge beam and column frame, incorporating a two-way spanning slab. No apparent lateral stability system (such as shear walls, bracing, or a rigid frame system) was observed during the inspection.

Additionally, a design report for Building 1 (Part A: six story Building) was found on-site. However, no design reports were available for Part B and Part C of the building.

Action Plan: The building engineer is required to check the lateral stability of the structure and suggest proper remedial actions if required.

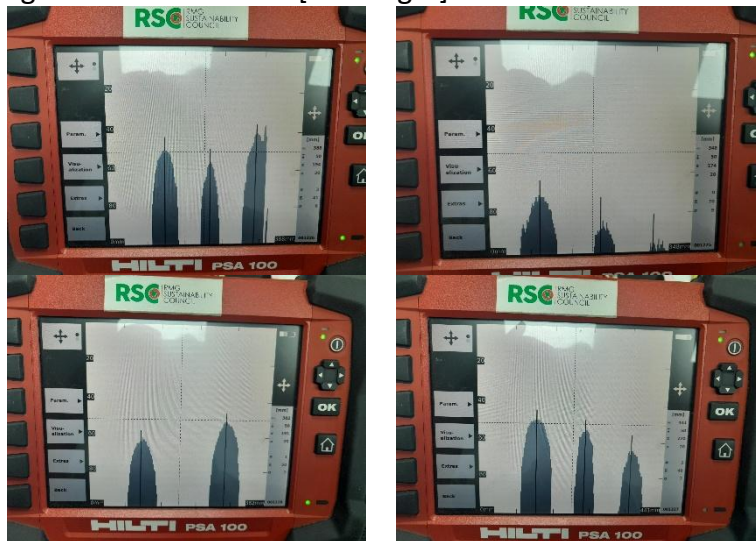
Observation-4: Mismatch between drawing & onsite condition. [Building-1]

Description: The amount of rebar in columns C1, C2, and C2(a) did not match the drawings. Additionally, the C3 column size was found to be 375x375 mm instead of 450x450 mm from the 1st floor to the roof floor. In columns C2 and C2(a), 8 nos rebars were found instead of the specified 12 nos, and in column C1, 8 nos rebars were found instead of 10 nos.

Action Plan: The building engineer is required to update the drawings based on the as-constructed structure.

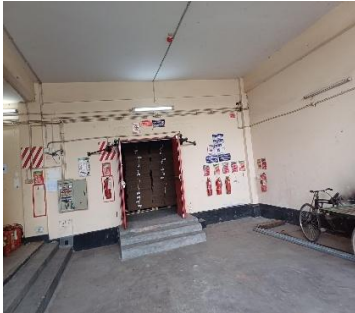
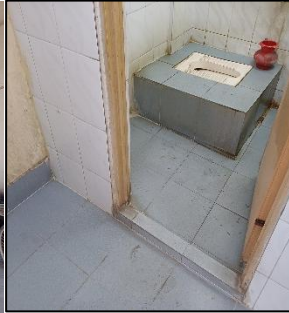
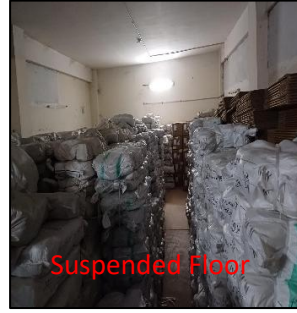
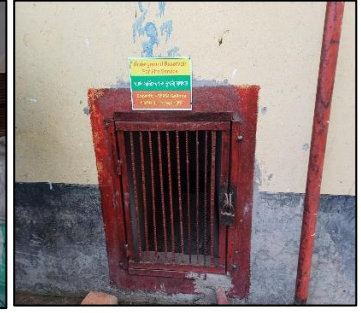
Observation-5: Lack of information and discrepancy between the provided drawing and site condition. [Building-2]

Suspended Floor

Floor and toilet built-ups were not mentioned in the drawing

Undocumented UGWR (55954 gallons)

Description: During the inspection, lack of information and discrepancy was found between the provided as-built drawing and the actual site condition.

Action Plan: The building engineer is required to survey the structure and update the as-built drawing along with the design report as per the actual site condition.

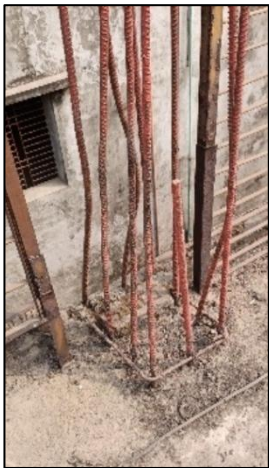
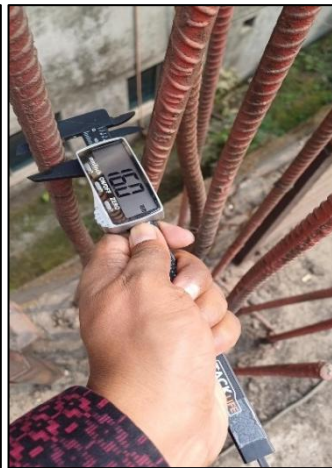
Column C1 (grid H-5) 10Ø16 re-bar found instead of 4Ø16+6Ø20

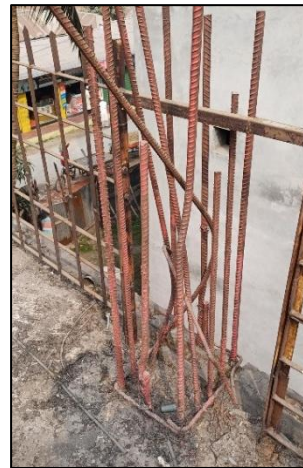
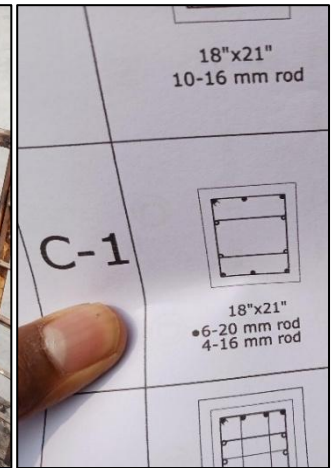
Column C1 (grid I-7) 12 no's re-bar found instead of 10 no's

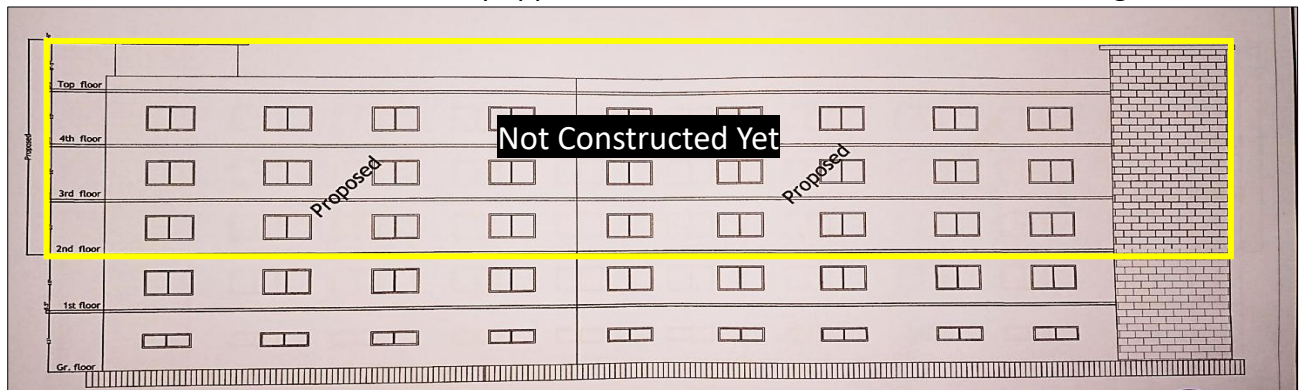
Observation-6: Lack of local authority approval and future vertical extension. [Building-2]

Description: The building is an existing two-storied (G+1) and proposed five-storied (G+4) reinforced concrete (RC) structure. But no local authority was available. However, the factory has a plan for future vertical extension. Projected rebar left on the roof.

Action Plan: The factory is required to collect the local authority approval. The building engineer is required to follow the construction safety measures during the commencement of further extension work.

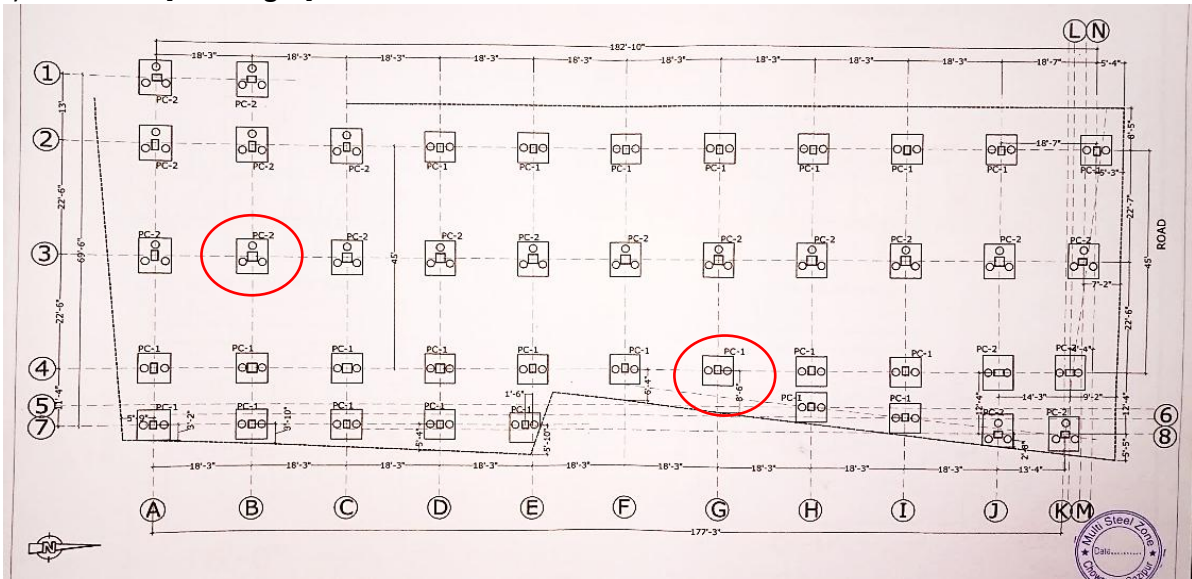
Observation-7: Stress in the foundation exceeds the normal design limit for the proposed five-storied (G+4) structure. [Building-2]

Description: The cursory calculation indicates that foundations are stressed above the normal design limit at the marked locations considering floor live load of 3 kPa for the typical production floor, 1.5 kPa for the roof, and 6 kPa for ground suspended floor storage.

Action Plan: The building engineer is required to review design loads and foundation stresses. Also, produce and actively manage load management plans.

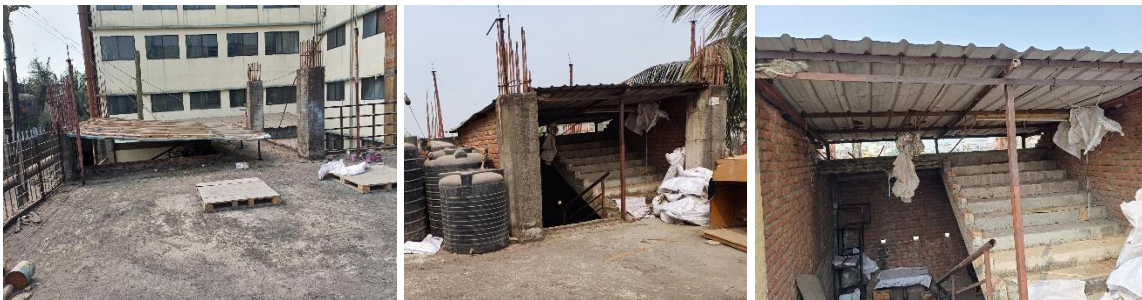
Observation-8: Lack of lateral stability. [Building-2 (Staircase Roof)]

Description: lack of lateral stability in the steel roof of both staircases was observed.

Action Plan: The building engineer is required to check the lateral stability and suggest adequate size of steel members.

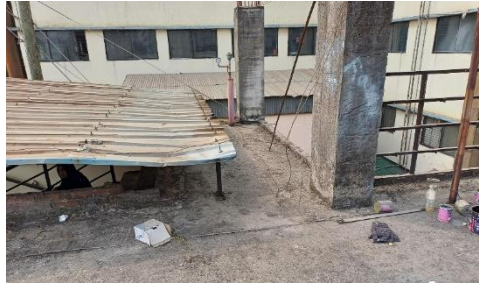
Observation-9: Potential falling hazard at the Roof. [Building-2]

Description: During the inspection, it was noted that toilet zone peripheral lacked barriers at its edges, creating a potential falling hazard.

Action Plan: The factory is required to install appropriate safety barriers to mitigate the risk of falls and ensure compliance with safety standards.

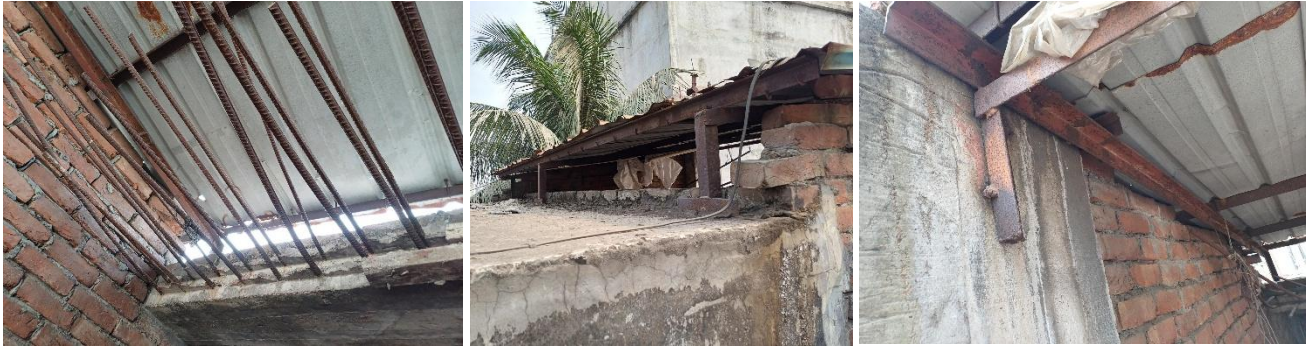
Observation-10: Exposed re-bar and corrosion on steel member. [Building-2]

Description: During the inspection, exposed re-bar corrosion was observed on the roof.

Action Plan: The factory is required to repair/replace the corroded member and apply anti-corrosive coating on the steel member & re-bar.

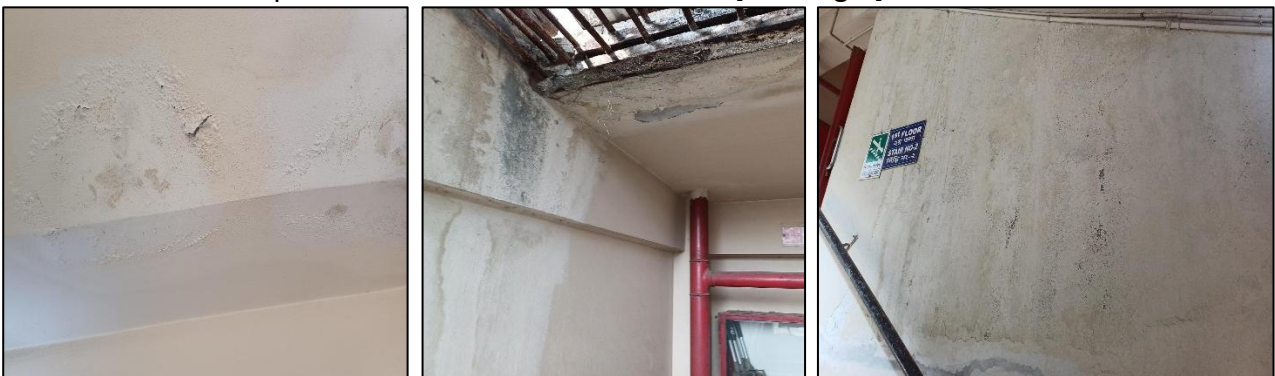
Observation-11: Dampness on beam-slab and brick wall. [Building-2]

Description: During the inspection, dampness was observed on beam-slab and brick wall.

Action Plan: The building engineer is required to investigate the extent of the dampness & repair accordingly.

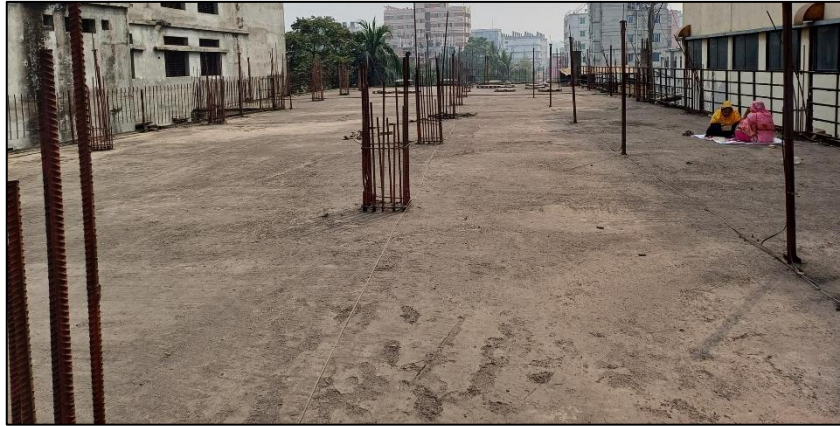
Observation-12: Lack of water proofing layer on roof. [Building-2]

Description: During the inspection, the waterproofing and drainage system was not observed on the roof.

Action Plan: The factory is required to develop the roof drainage system and apply water proofing membrane on the roof.

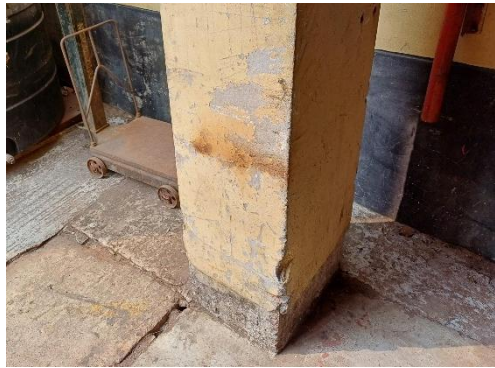
Observation-13: Trolley impact on columns surface. [Building-2]

Description: The cover of the floor columns was damaged due to the trolley impact.

Action Plan: The factory is required to provide column guards to protect the trolley impact.

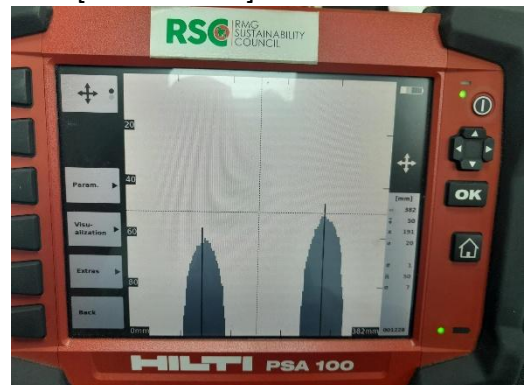
C1 Column schedule

Observation 14: Mismatch between drawing & onsite condition. [Boiler Room]

Description: The amount of rebar in columns C1 did not match the drawings. In columns C1 4 nos rebars were found instead of the specified 8. Also the beam layout doesn't match onsite conditions.

Action Plan: The building engineer is required to update the drawings based on the as-constructed structure.

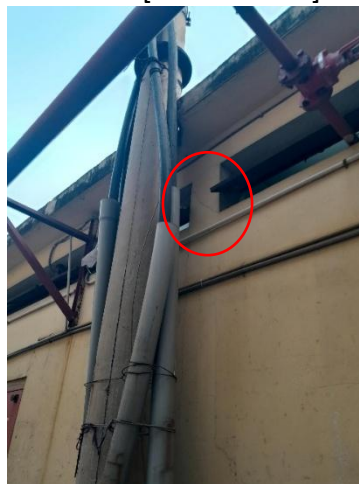
Observation-15: Hairline crack on RC column. [Boiler Room]

Description: During the inspection, a hairline crack was observed in the RC column of the Boiler Room.

Action Plan: The building engineer is required to produce a crack investigation report, identifying the cause of the crack and providing the repair methodology.

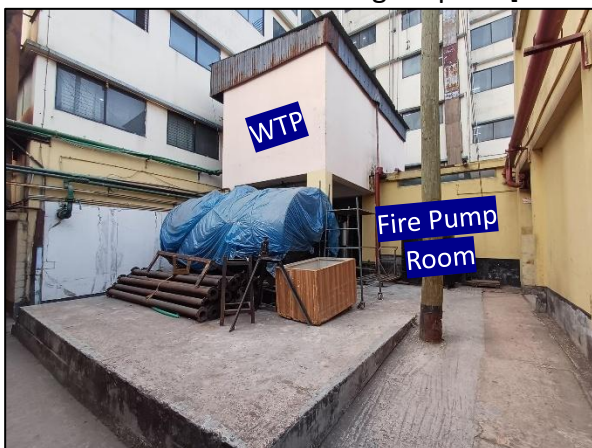
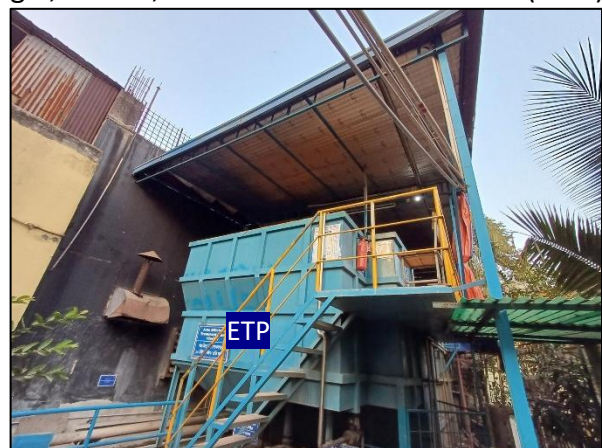
Observation-16: Absence of design report. [Building 4, Shed 2, and Water Treatment Plant (WTP)]

Description: The design report was not prepared for Building 4 (Fire Pump Room), Shed 2: Effluent Treatment Plant (ETP), and Water Treatment Plant (WTP).

Action Plan: The building engineer is required to prepare a design report following BNBC (Part-6, section 1.9.1).

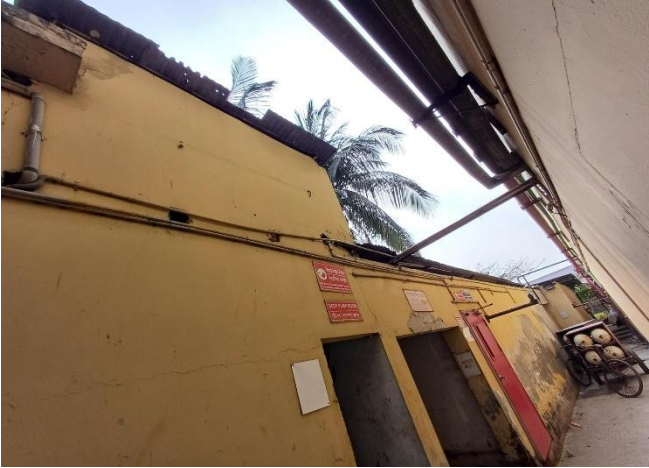
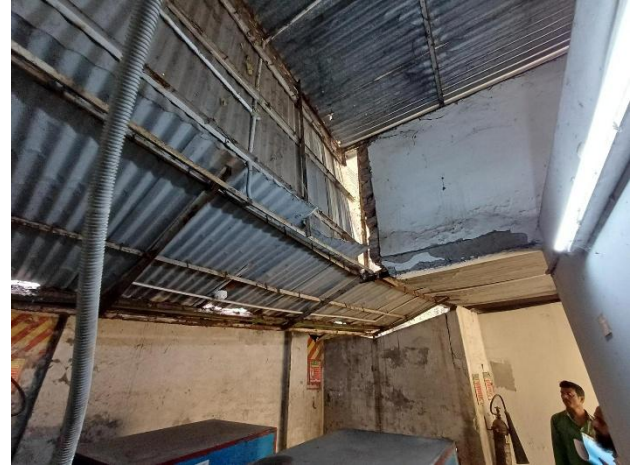
Observation-17: Lack of lateral load transfer media and load resisting system. [Shed 1]

Description: Lack of lateral load transfer media and load resisting system of the shed was observed in Shed 1: Water Pump-Chemical-Wastage.

Action Plan: The building engineer is required to check the lateral stability and suggest adequate size of steel members. Prepare a safety check report as per the Accord Building Standard and submit to RSC for review.

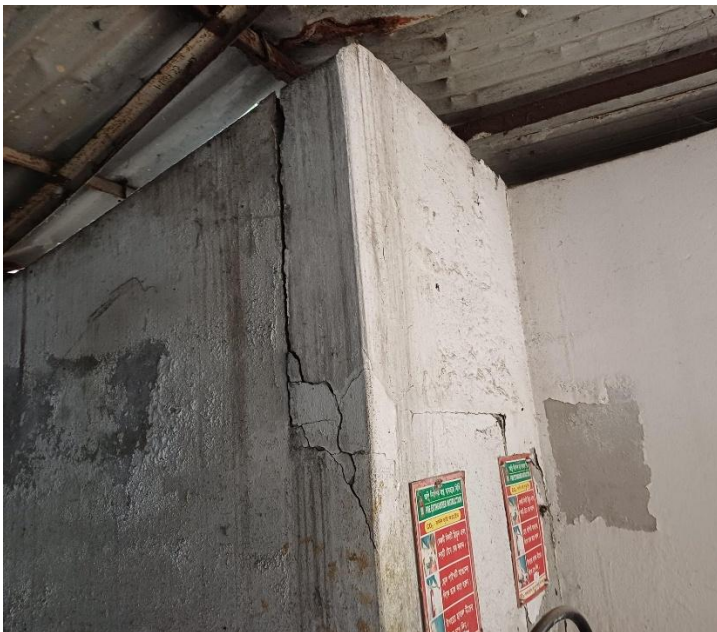
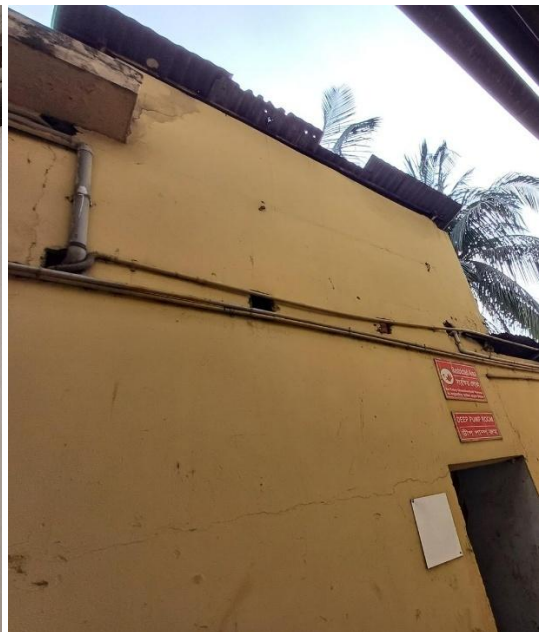
Observation-18: Crack in brick wall. [Shed 1]

Description: Several cracks in brick walls were observed in the cantilever stair portion of the building.

Action Plan: The building engineer is required to investigate the reason for the crack and repair the cracks following suitable repair methodology.

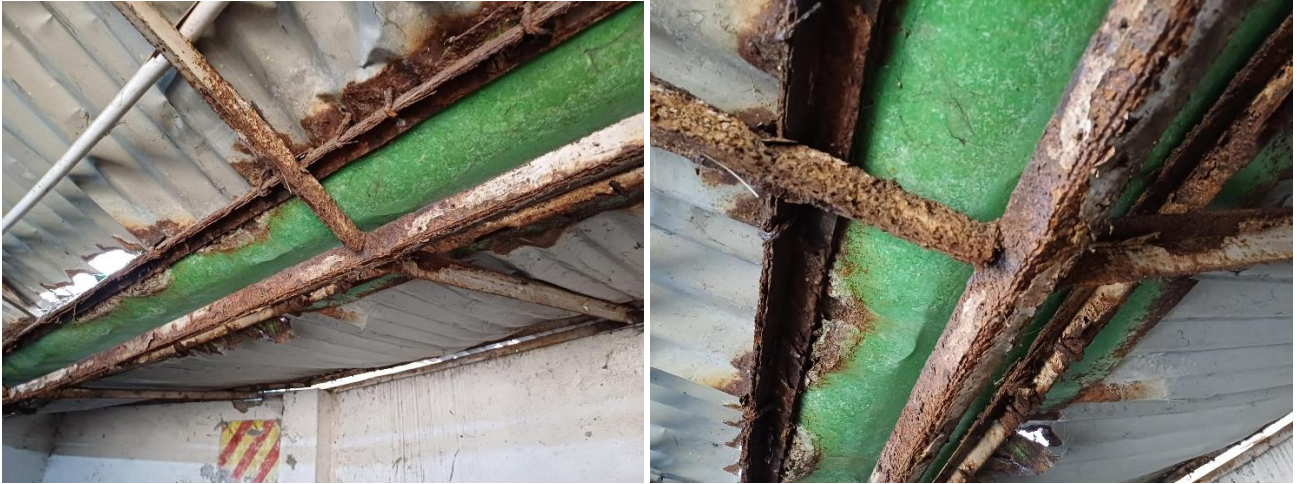
Observation-19: Severe corrosion on steel member. [Shed 1]

Description: During the inspection, severe corrosion was observed on the steel member.

Action Plan: The factory is required to repair/replace the corroded member and apply anti-corrosive coating.

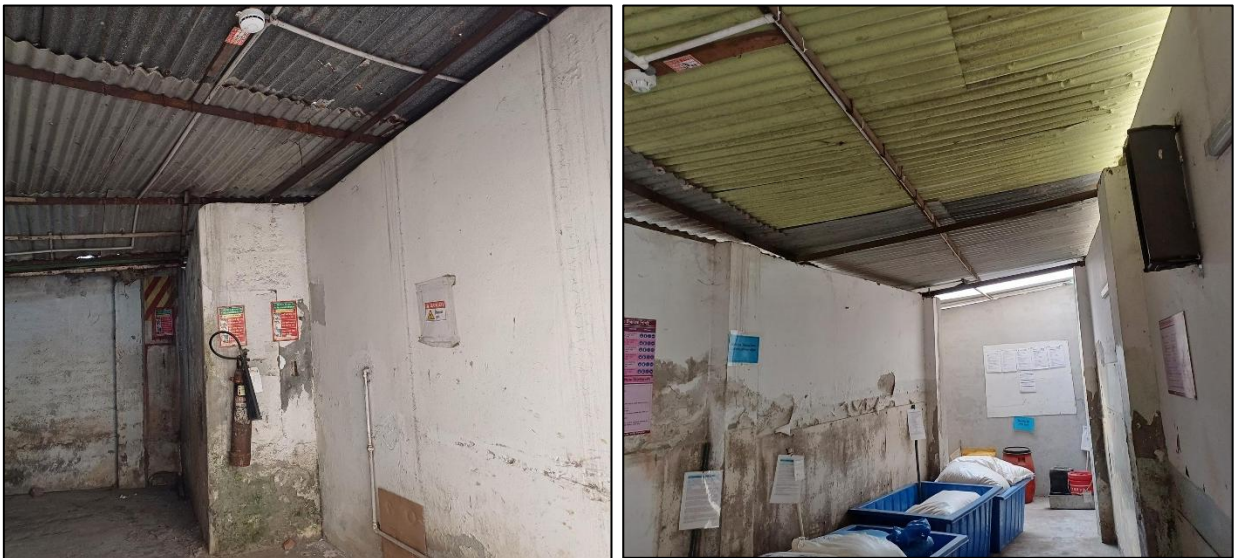
Observation-20: Dampness on brick wall. [Shed 1]

Description: During the inspection, dampness was observed on the brick wall.

Action Plan: The building engineer is required to investigate the extent of the dampness & repair accordingly.
