# INITIAL FIRE SAFETY INSPECTION REPORT

**SOUTHERN CLOTHINGS LIMITED (EXTENSION-2)**

**RSC ID: 25992**

**Date: 09 February 2025**

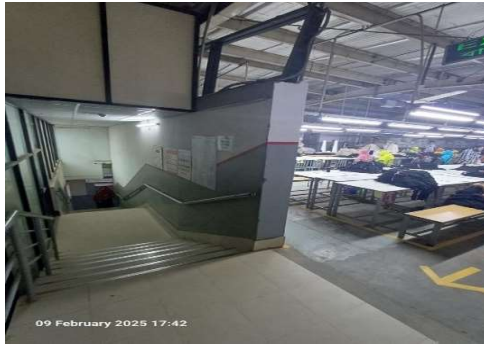
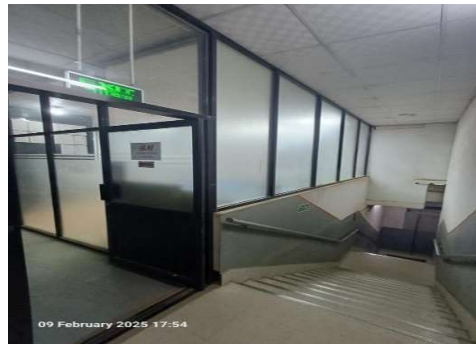
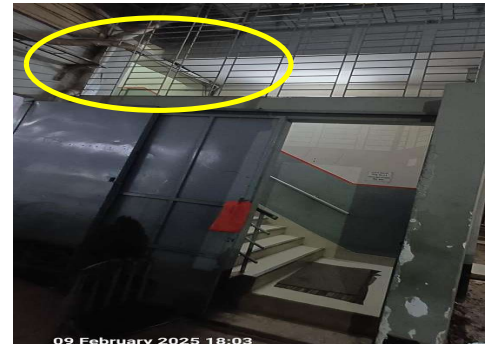
| 1 | Means of Egress | <p>Exit stairs are not separated from work areas &amp; other spaces on each floor by fire-rated construction due to unprotected openings, penetrations.</p> <p>Electrical cable raceway is located on stair enclosure.</p> <p><b>Location: Building 2 (Wash Building).</b></p> | <p>Separate the exit stairs from work areas and other building spaces on all floor levels by minimum 2- hr. fire-rated construction. Provide a minimum 1.5- hr. fire-rated doors and seal all unprotected openings and penetrations to maintain the fire separation.</p> <p>Ensure that all fire doors are self-closing and positive latching, and are provided with fire exit (panic) hardware where serving production floors or assembly occupancies.</p> <p>If fire doors are required to be held open for functional reasons, provide automatic closing devices tied to the fire alarm system.</p> <p>Penetrations into and through an exit enclosure shall be prohibited with the exception of required exit doors, sprinkler piping, standpipes, electrical raceway for fire alarm equipment, and electrical conduit serving the exit enclosure.</p> | Within 3 months |

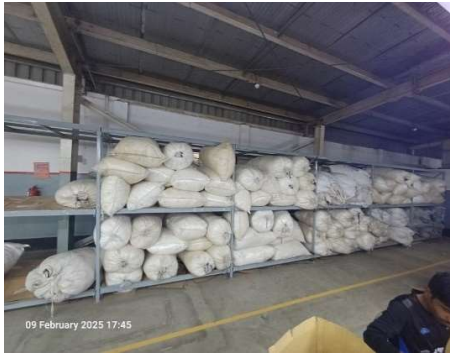
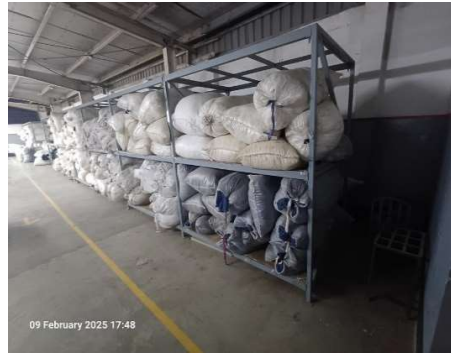
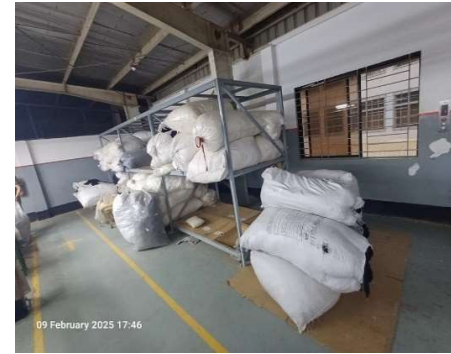
| 2 | Fire Rated Construction | <p>Areas used for in-process storage of combustible materials are open to the surrounding occupancy.</p> <p><b>Locations: 1st floor of Building 2.</b></p> | <p>Separate the dedicated storage rooms by minimum 1-hr fire-rated construction. Provide 1-hr. fire rated door and seal all penetrations and openings by 1 hr. fire rated fire rated barrier construction.</p> <p>Where separate storage rooms are not feasible, provide defined storage areas and limit the storage arrangement as follows: - Maximum height of 2.45m (8ft.) , maximum area of 23m2 (250 ft2) and 3m (10ft.) clear distance from adjacent another unenclosed combustible storage.</p> <p>- In-process storage shall not exceeds 10 percent of floor or compartment area.</p> | Within 3 months |

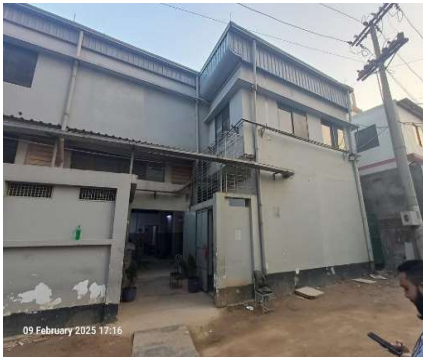
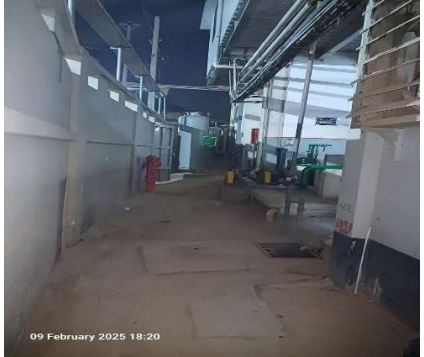
| 3 | Fire Rated Construction | The required fire separation distance for Building-02 (Wash Building) does not comply with the requirements of BNBC 2006. | The exterior walls shall have a fire resistance and opening protection as specified in BNBC 2006, Tables 3.2.2 and Part 3 Section 2.4.1.3. | Within 6 months |

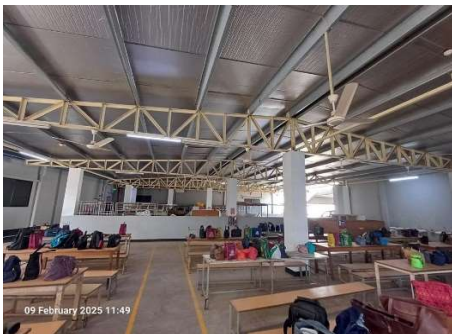
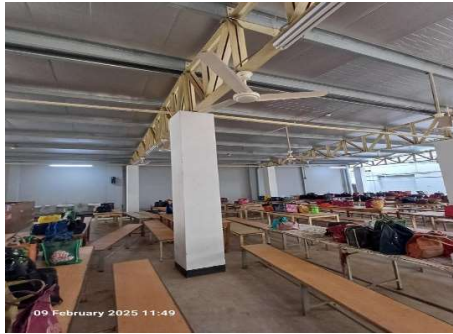
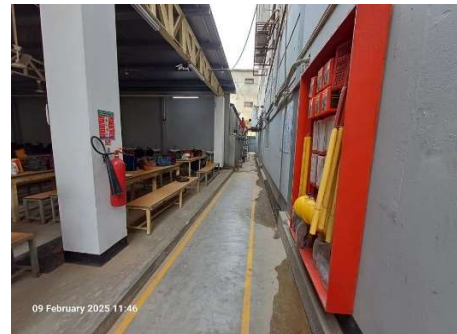
| 4 | Fire Rated Construction | The required fire separation distance for Building-07 (Dining Shed) does not comply with the requirements of BNBC 2020. | The exterior walls shall have a fire resistance and opening protection as specified in BNBC 2020 Part 3 Table 3.2.2 & 3.2.3 and BNBC 2020 Part 3 Section 2.4.1.3. | Within 6 months |

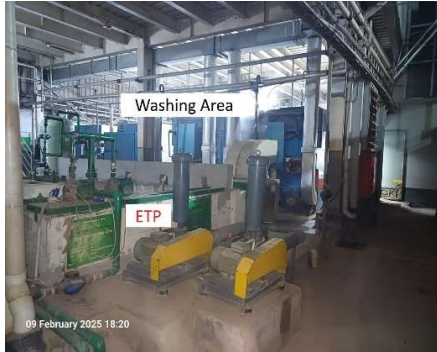
| 5 | Fire Rated Construction | <p>The ETP area is not separated by fire rated construction (openings, non-rated doors, penetrations) from surrounding occupancies.</p> <p><b>Location: Ground floor of Building 2.</b></p> | Separate the ETP area by a minimum 2-hr fire rated construction. Seal and/or protected all openings to maintain fire separations. | Within 3 months |

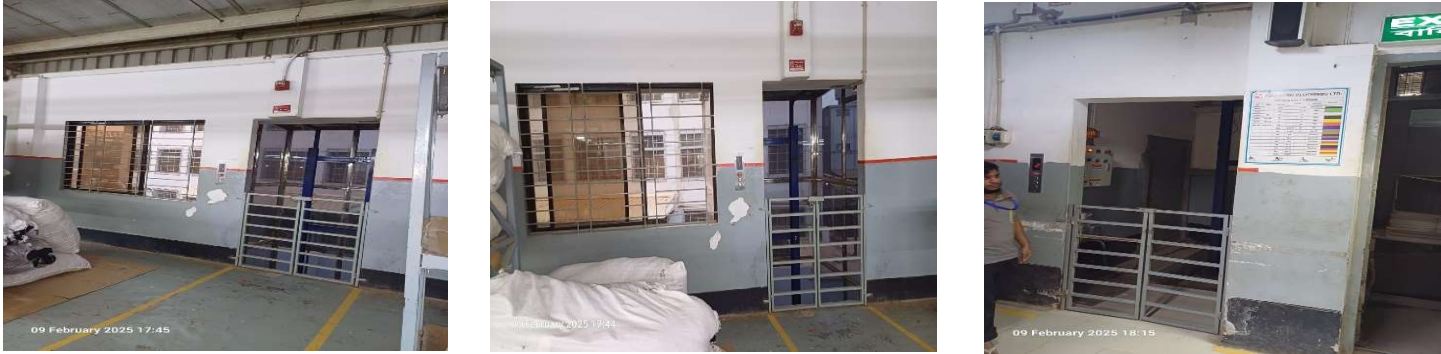
| 6 | Fire Rated Construction | <p>Elevator shafts are directly open into the inside of production floor.</p> <p><b>Location: Building 2 (Wash Building).</b></p> | Elevator shaft shall be separated from production area by 2 hours fire rated construction. 2-hr fire barriers shall be protected with minimum 1.5-hr fire protective opening assemblies. | Within 3 months |

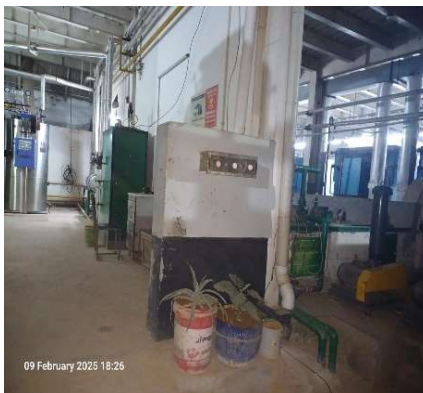
| 7 | Fire Rated Construction | <p>The boiler room is not separated by fire rated construction (openings, non-rated doors, penetrations).</p> <p><b>Location: Ground floor of Building 2.</b></p> | Separate the boiler room by a minimum 1-hr fire rated construction (for low rise building). Seal and/or protected all openings to maintain fire separations. | Within 3 months |

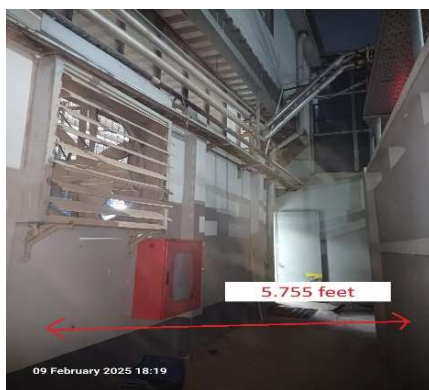
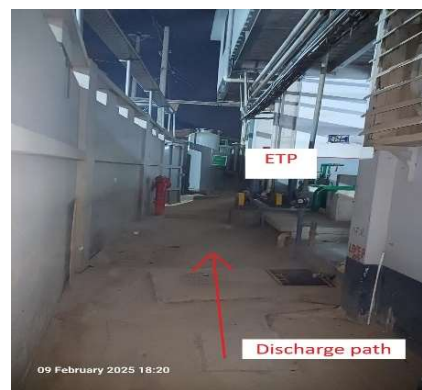
| 8 | Means of Egress | <p>The exit discharge path [serving exit] is less than 10 ft wide and is not separated from the building interior.</p> <p><b>Location: Building 2, Ground floor.</b></p> | <p>Seal all penetrations and openings to the interior of the building along the discharge path, up to a height of 10 ft., to provide a minimum 1-hr fire separation.</p> | Within 3 months |

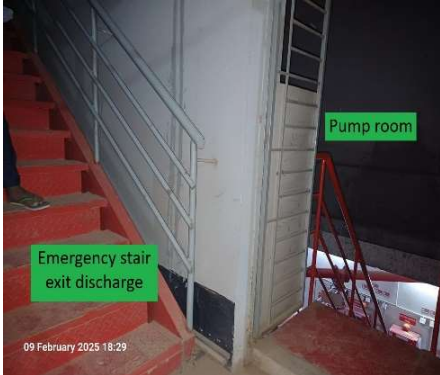
| 9 | Fire Rated Construction | <p>Fire pump room is not provided with required fire separation located besides exterior exit stair.</p> <p><b>Location: Building 2.</b></p> | <p>Provide fire pump room with 2 hr rated fire separation when not sprinklered and 1 hr rated fire separation when provided with automatic sprinklers in accordance with NFPA 20.</p> <p>Or,</p> <p>Physically separate the pump room from the protected building by a minimum of 50 ft (15.3 m) in accordance with NFPA 20.</p> | Within 3 months |

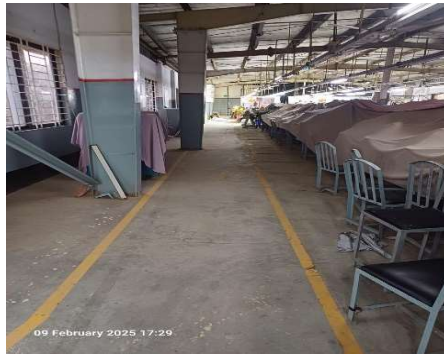
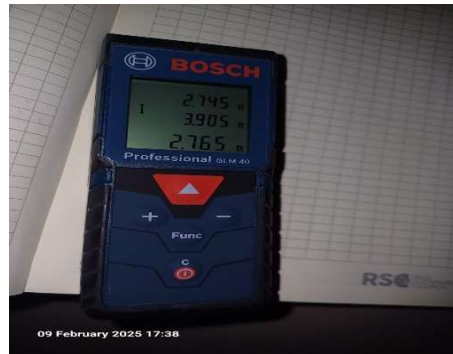
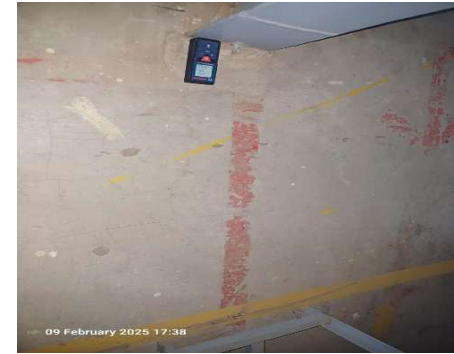
| 10 | Means of Egress | <p>The width of egress aisles is less than 36-inch.</p> <p><b>Location: Ground floor &amp; 1st floor of Building 2.</b></p> | <p>Provide minimum aisle widths of 36-inch. All the aisles shall be free from any kind of obstruction.</p> | Within 3 months |

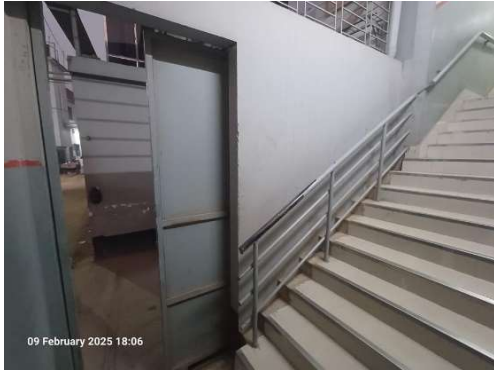
| 11 | Means of Egress | <p>Sliding doors are provided at exit discharge.</p> <p><b>Location: Discharge exit of 1st floor of Building 2.</b></p> | <p>Replace all collapsible gates/ sliding doors/ rolling shutter doors along the means of egress with side-hinged, swinging egress doors.</p> <p>If locks are required for security reasons, utilize specialized door locking features complying with NFPA101.</p> | Within 1 month |

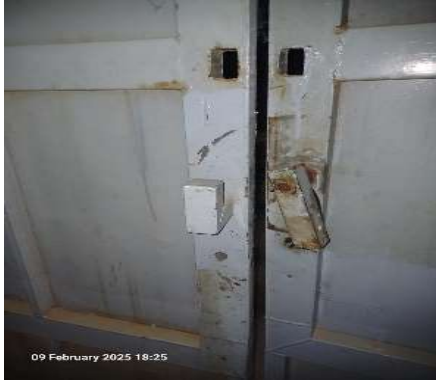
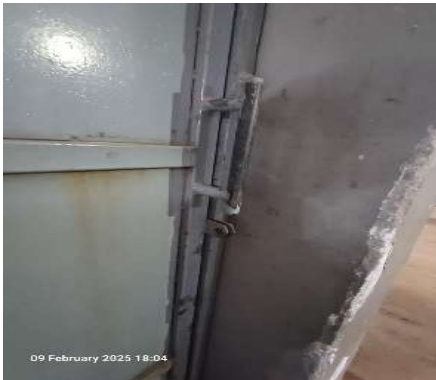
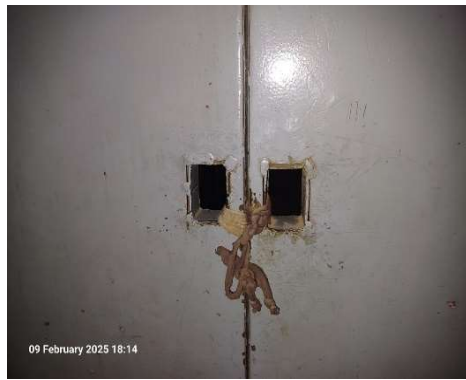
| 12 | Means of Egress | <p>Doors along means of egress are provided with non compliant locking system.</p> <p><b>Location: Discharge exit of Stair 1 &amp; 2, Main gate of Ground floor of Building 2.</b></p> | <p>Remove locking features from all egress gates.</p> <p>If locks are required for security reasons, utilize special door locking features complying with RSC standard 6.8.2 and NFPA 101.</p> | Immediate |

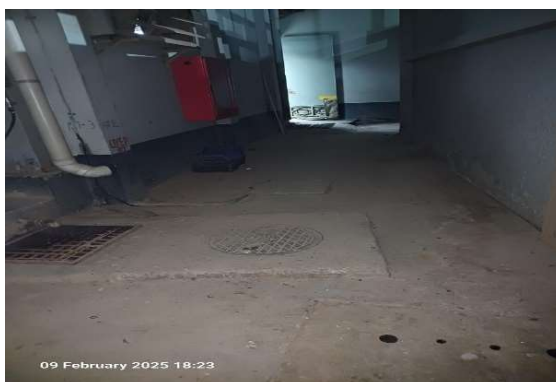
| 13 | Means of egress | <p>Uneven path of travel in exit access.</p> <p><b>Location: Building-2 (North side exit discharge at ground level).</b></p> | <p>Level exit path to the public way.</p> | Within 1 month |

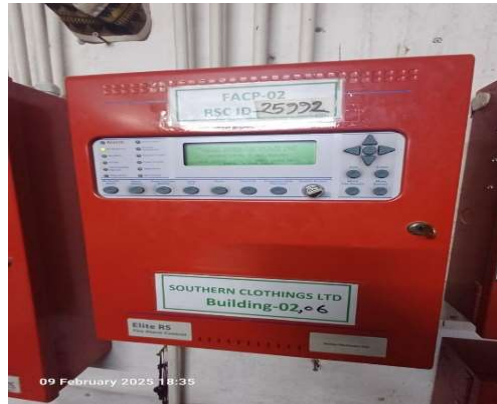
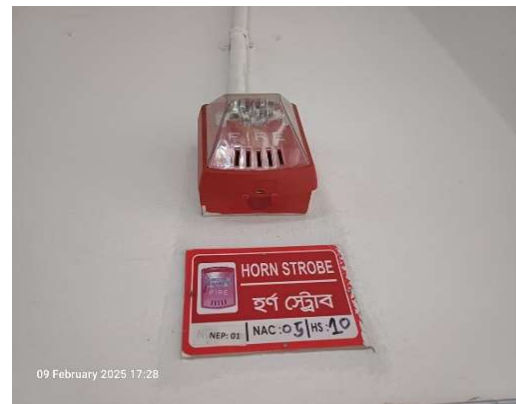
| 15 | Fire Alarm & Detection System (FADS) | <p>The fire alarm and detection system installation requires detailed review to confirm compliance with NFPA 72 and RSC standard.</p> <p><b>Location(s): All building/shed covered in this ID.</b></p> | Submit as-built drawings, testing records, equipment certification and other relevant documentation to the RSC for review and approval/acceptance test. | Within 2 months |
