# Tasniah Fabrics Ltd.

Nayapara, Kashimpur, Gazipur  
(23.989718 N 90.318837 E)

28<sup>th</sup> November 2015

# Observations

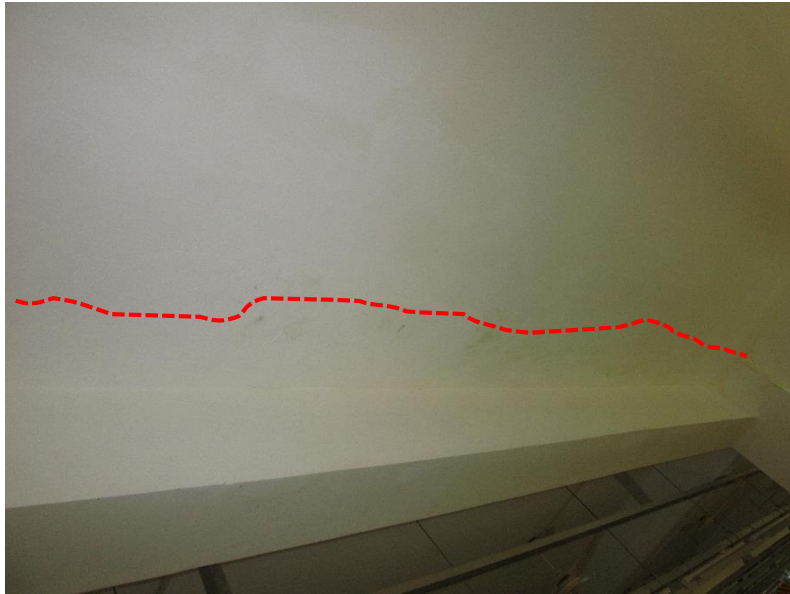
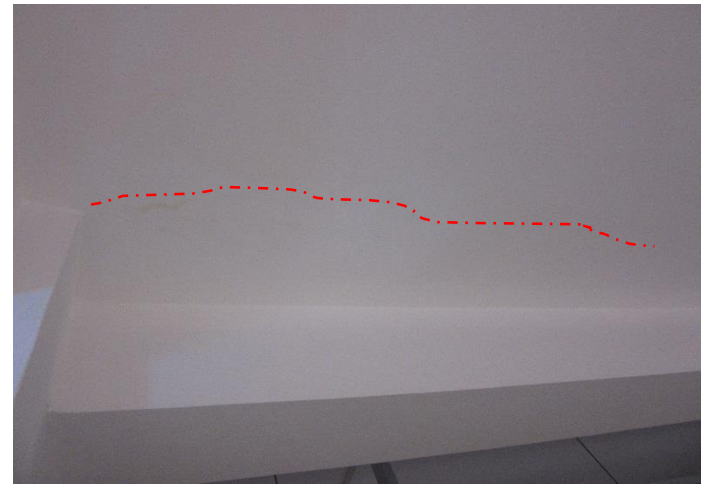
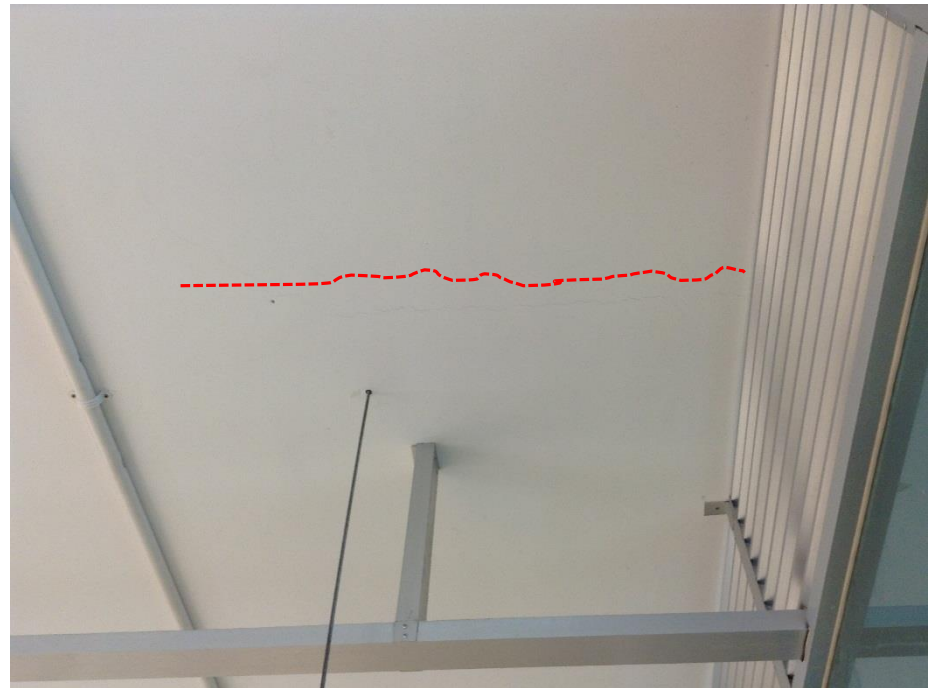
# Cracking and deterioration observed at roof level slab

Cracking observed at 6th floor (roof level slab).

**ITEM 1: Cracking and deterioration observed at roof level slab**

| Item No. | Observation | Recommended Action Plan | Recommended Timeline |
|---|---|---|---|
| 1 | Cracking and deterioration observed at roof level slab due to water ingress. | Engineer to inspect water damaged structure including the exterior and propose a suitable repair. | 6-months |

| Item No. | Observation | Recommended Action Plan | Recommended Timeline |
|---|---|---|---|
| 2 | Cracking and deterioration observed at roof level slab due to water ingress. | Roof drainage system to be installed. | 6-months |

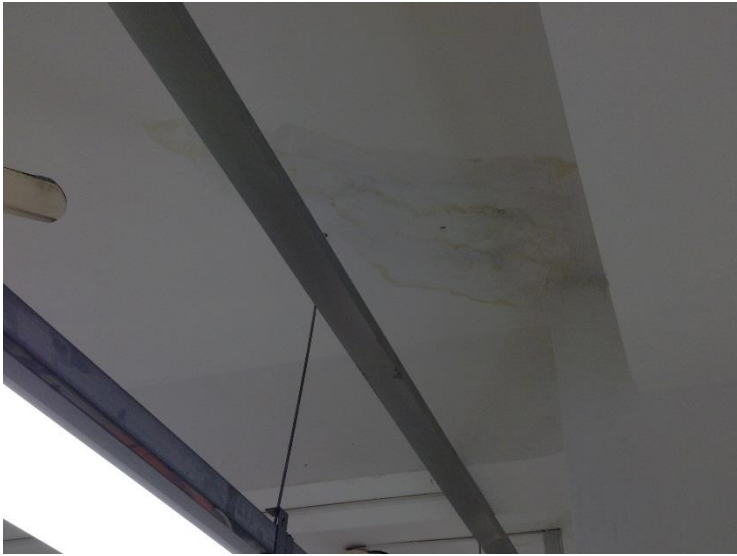
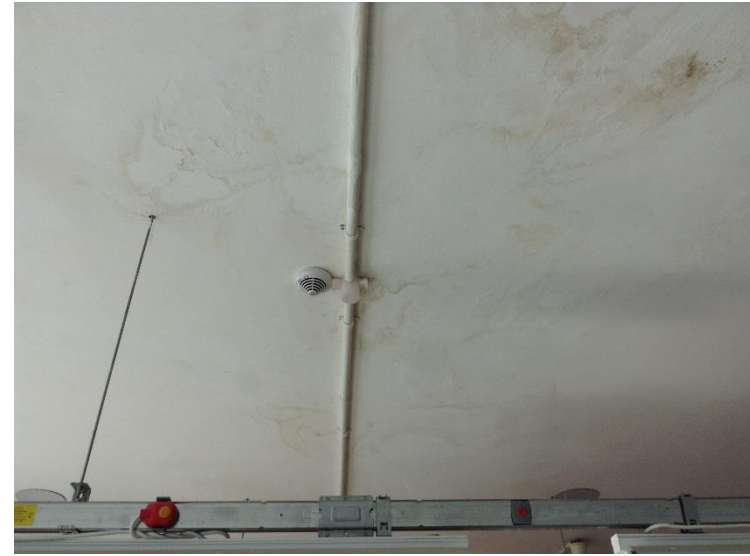
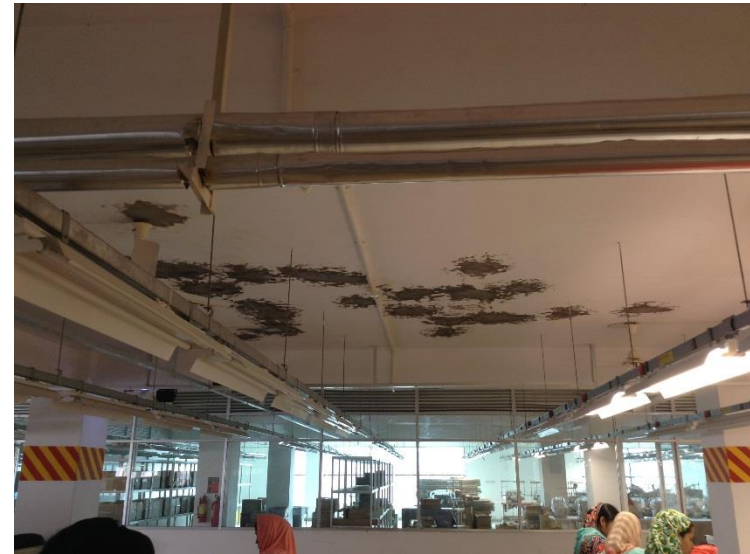
Extensive water ingress at roof level is evident causing deterioration of structure.

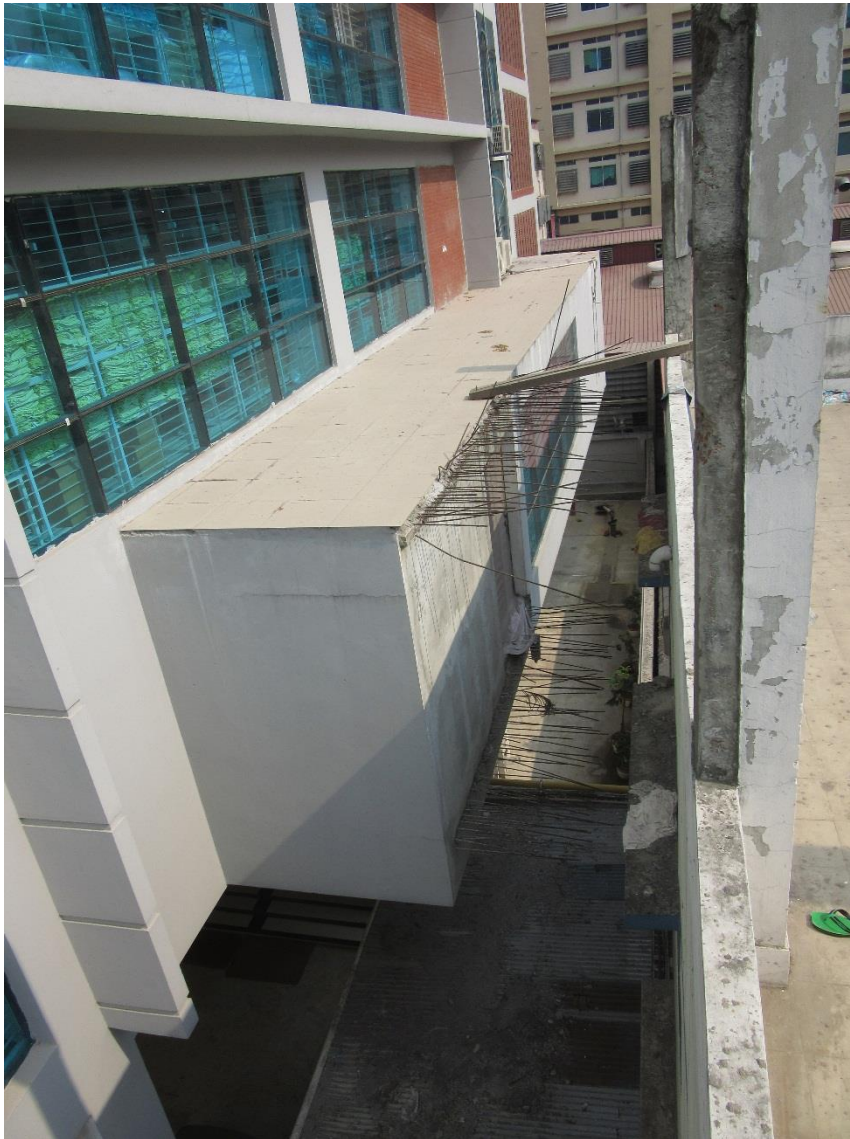
# Exposed rebar of cantilever slab passage

Exposed rebar is prone to corrosion. Provide corrosion protection before commencing further construction.

Structural system and joint detailing is not evident and was not provided with drawings. Building engineer to provide accurate joint detailing providing required seismic joint between two buildings.

**ITEM 2: Exposed rebar of cantilever slab passage**

| Item No. | Observation | Recommended Action Plan | Recommended Timeline |
|---|---|---|---|
| 3 | Exposed rebar of cantilever slab passage | Provide proper corrosion protection before commencing further construction. | 6-months |
| 4 | Exposed rebar of cantilever slab passage | Building engineer to provide accurate joint detailing providing required seismic joint between two buildings | 6-months |
