Topaz Dresses Ltd.

Singerdighi, Mawna, Sreepur, Gazipur
(24.2292789 N, 90.3679179 E)

29th November 2015

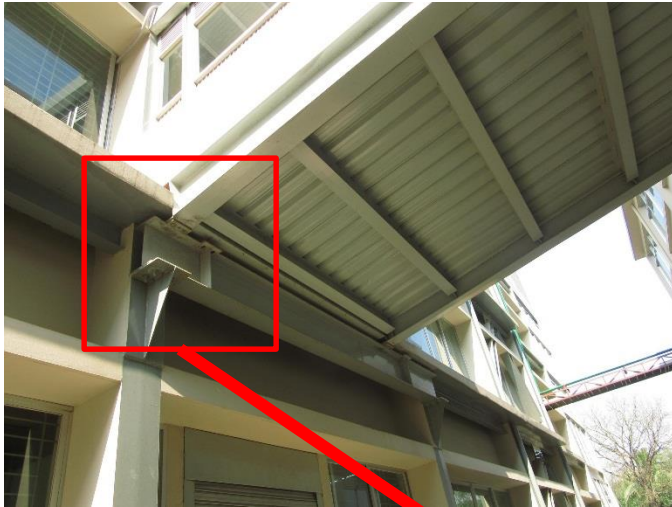
Connection detailing at Building 1 to Building 2 passageway

Connection detailing at Building 1 to Building 2 passageway appears to be weak.

ITEM 1: Connection detailing at Building 1 to Building 2 passageway

Item No.	Observation	Recommended Action Plan	Recommended Timeline
1	Connection detailing at Building 1 to Building 2 passageway appears to be weak	Building engineer to inspect connection detailing at either side of the the passageway. Provide adequate joint detailing where required.	6-months
2	Water accumulation and leaking with potential to cause corrosion and lasting damage to structure.	Repair leaks in water tanks.	6-months

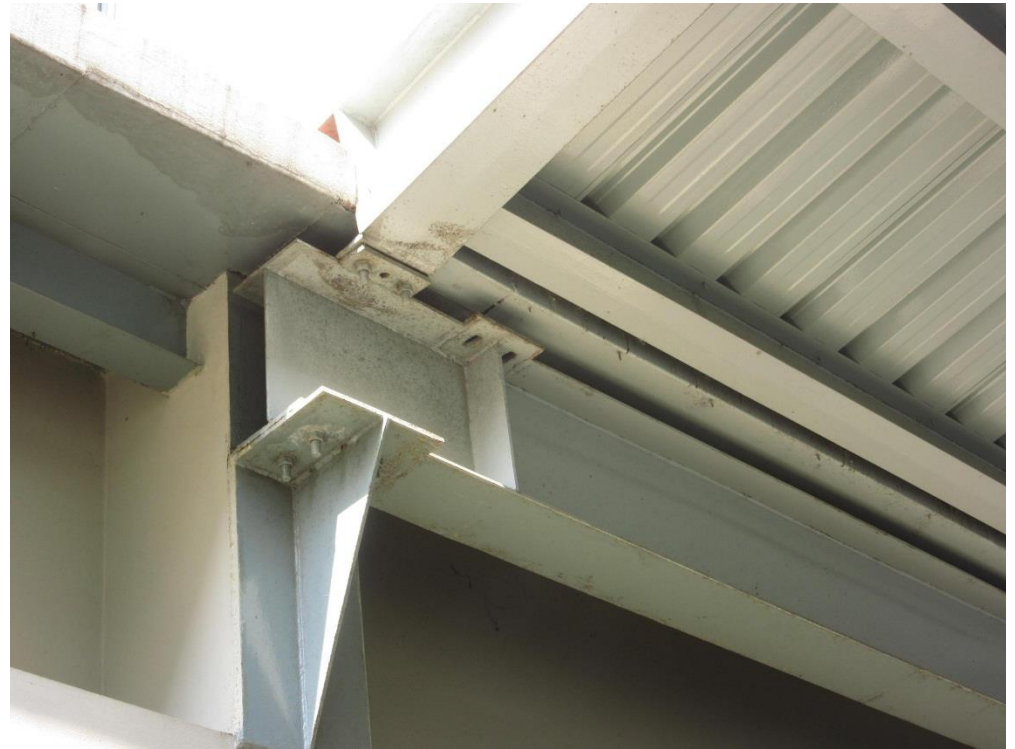
Water accumulation and leaking with potential to cause corrosion and lasting damage to structure.

ITEM 2: Water leakage at roof level may cause deterioration of structure

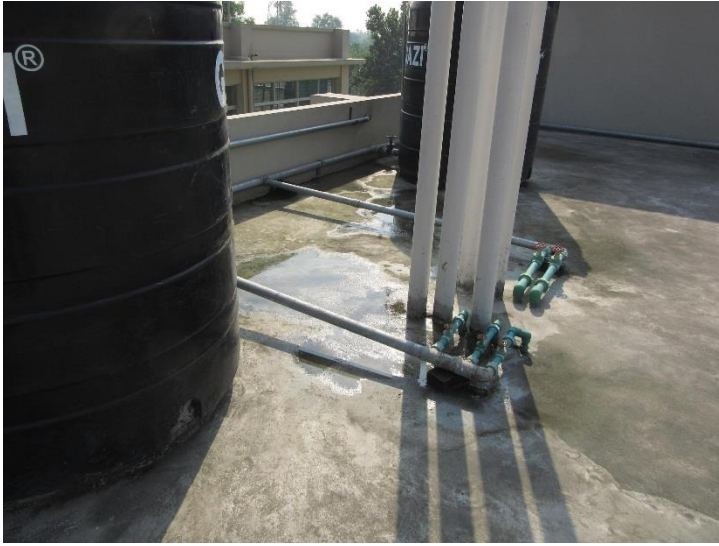
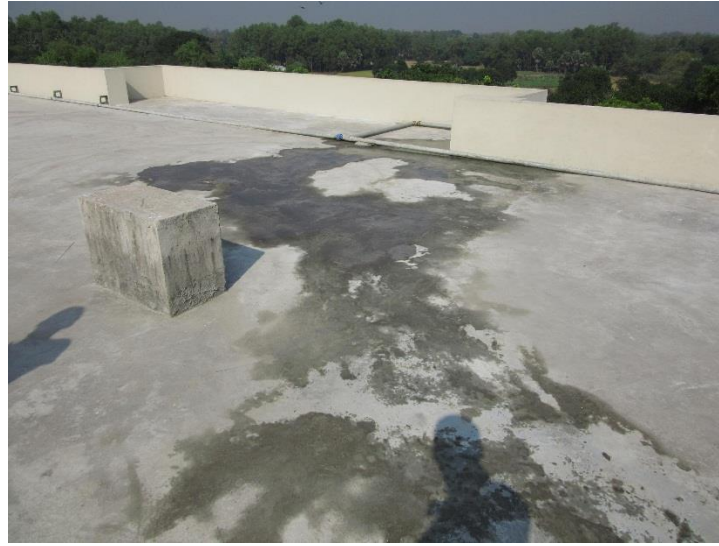
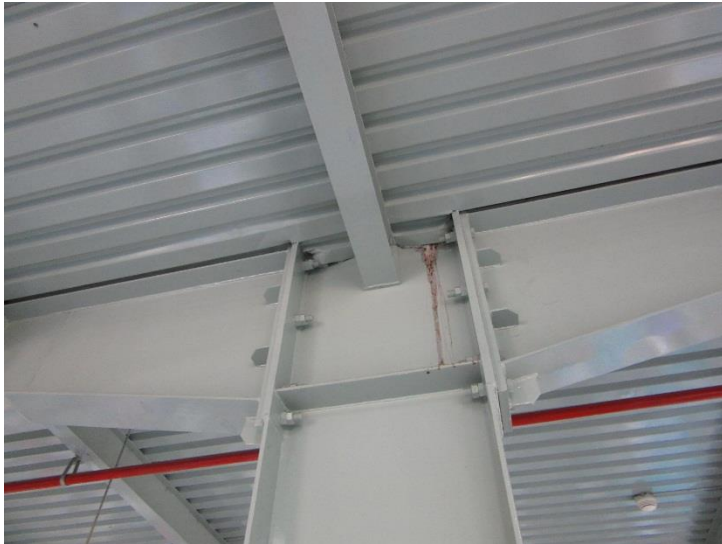
Water accumulation on roof slab

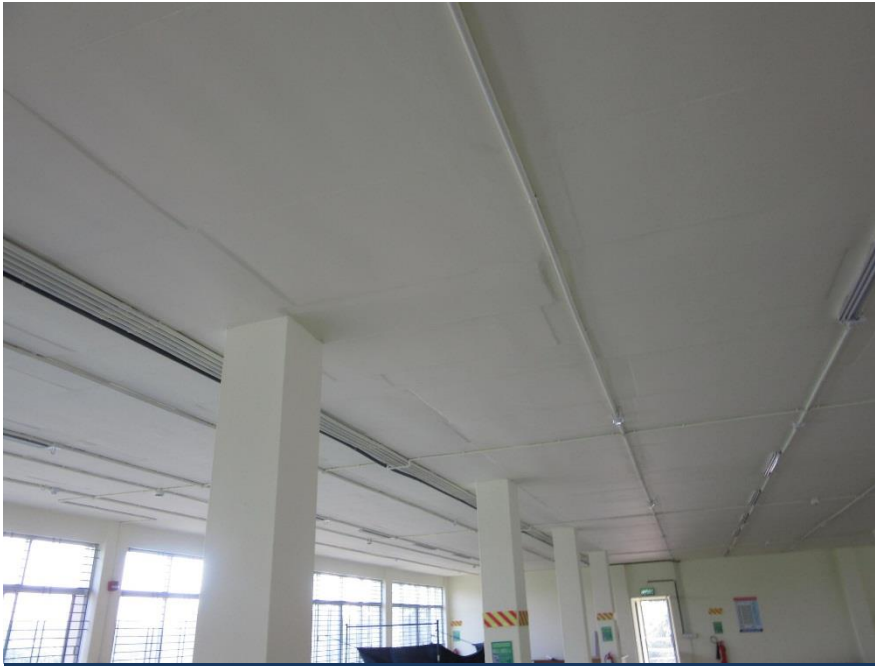
Flat slab without drop panels

Cursory calculations indicate that flat slab stresses may become critical if heavily loaded.

ITEM 1: Punching stress level of flat slabs without drop panels

Verify insitu concrete strength and aggregate type to ensure flat slab punching shear strength is adequate.

Item No.	Observation	Recommended Action Plan	Recommended Timeline
3	Punching stress level of flat slabs without drop panels	Building engineer to review design, loads and slab punching shear stresses at flat slabs.	6-months
4	Punching stress level of flat slabs without drop panels	Verify insitu concrete stresses either by 100mm dia. cores or existing cylinder strength data.	6-months
5	Punching stress level of flat slabs without drop panels	Building Engineer to create controlled loading plans for all floors.	6-months
