# Eco Couture Ltd.

Mogorkhal, Dhaka Bypass Road, Joydebpur, Gazipur  
(23.972172 N, 90.390718 E)

25<sup>th</sup> November 2015

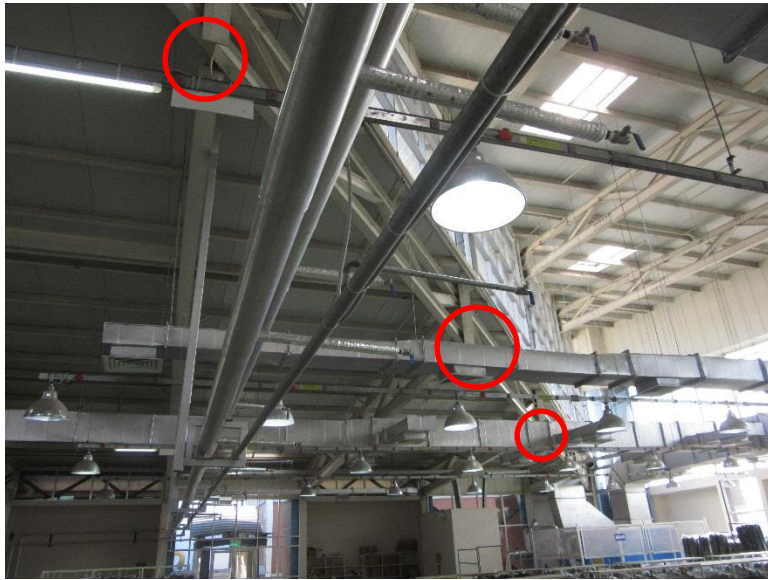
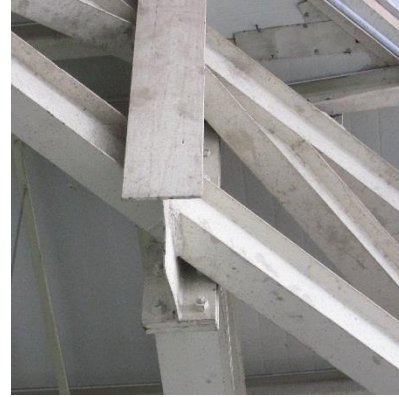
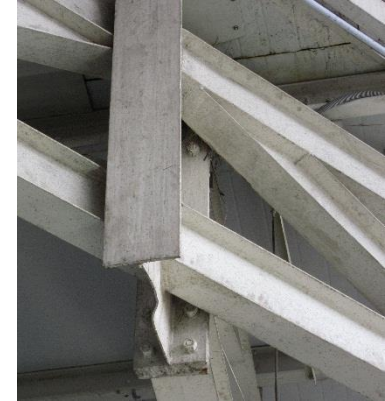
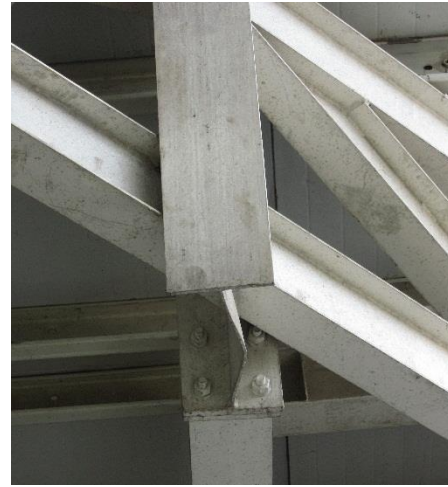
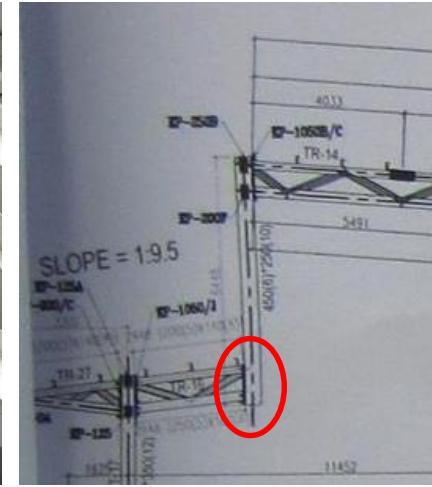
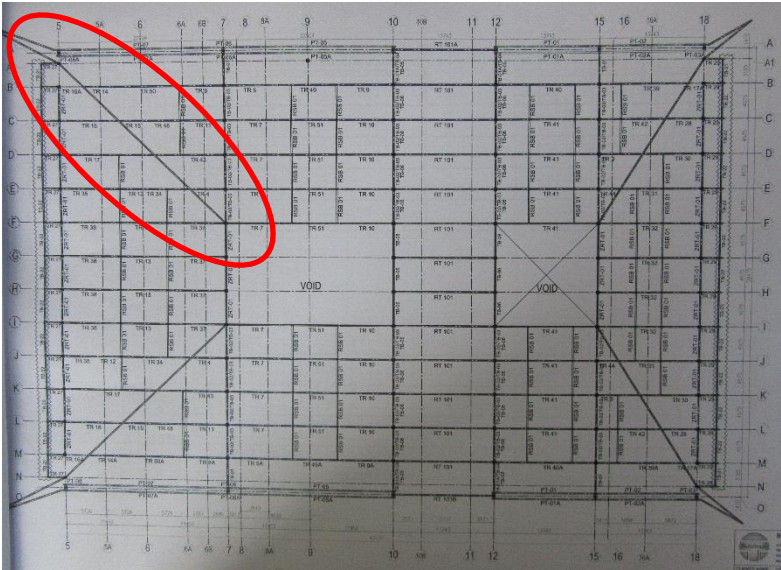
# **Nonconformities and deformations observed at several steel connections**

Nonconformities and deformations observed at several steel connections  
 Diagonal truss elements welded directly on web of I-section without proper detailing (no stiffeners)  
 This caused buckling & crippling at the web of profile.

| Item No. | Observation | Recommended Action Plan | Recommended Timeline |
|---|---|---|---|
| 1 | Building 1- Factory Building<br>Nonconformities and deformations observed at several steel connections | Building engineer to locate and inspect the deformations at vertical transfer elements between trusses (indicated at observation slides) | 6-weeks |
| 2 | Building 1- Factory Building<br>Nonconformities and deformations observed at several steel connections | Building engineer to ensure structural steel connections (especially to the web of sections) has been designed and fabricated as per code for vertical & wind loads. | 6-weeks |
| 3 | Building 1- Factory Building<br>Nonconformities and deformations observed at several steel connections | Building engineer to verify main frame connections has proper capacity by carrying out calculations | 6-weeks |
| 4 | Building 1- Factory Building<br>Nonconformities and deformations observed at several steel connections | Monitor any further deformation at connections | 6-months |
| 5 | Building 1- Factory Building<br>Nonconformities and deformations observed at several steel connections | Carry out remedial works where required. | 6-months |

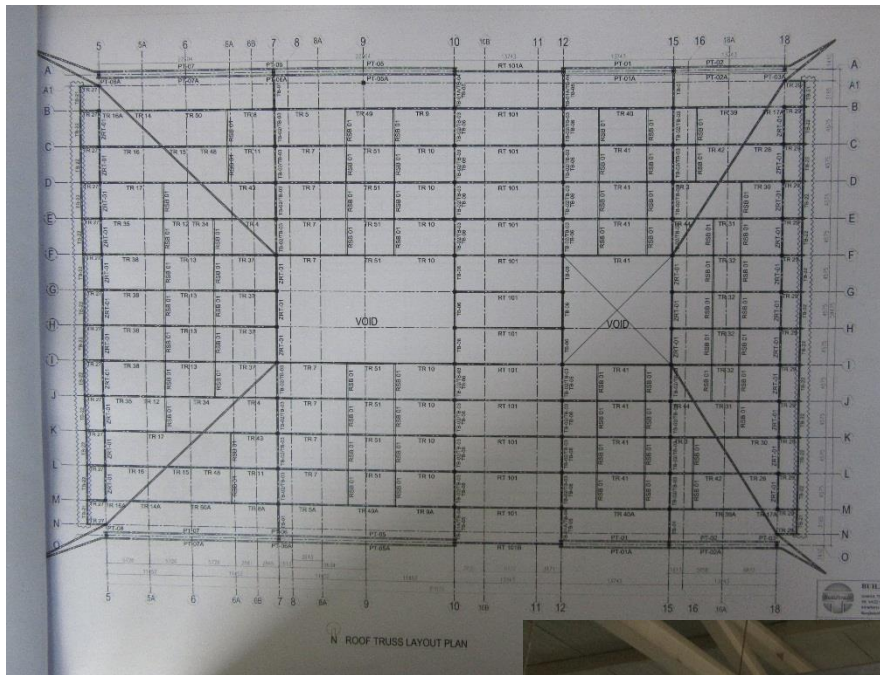
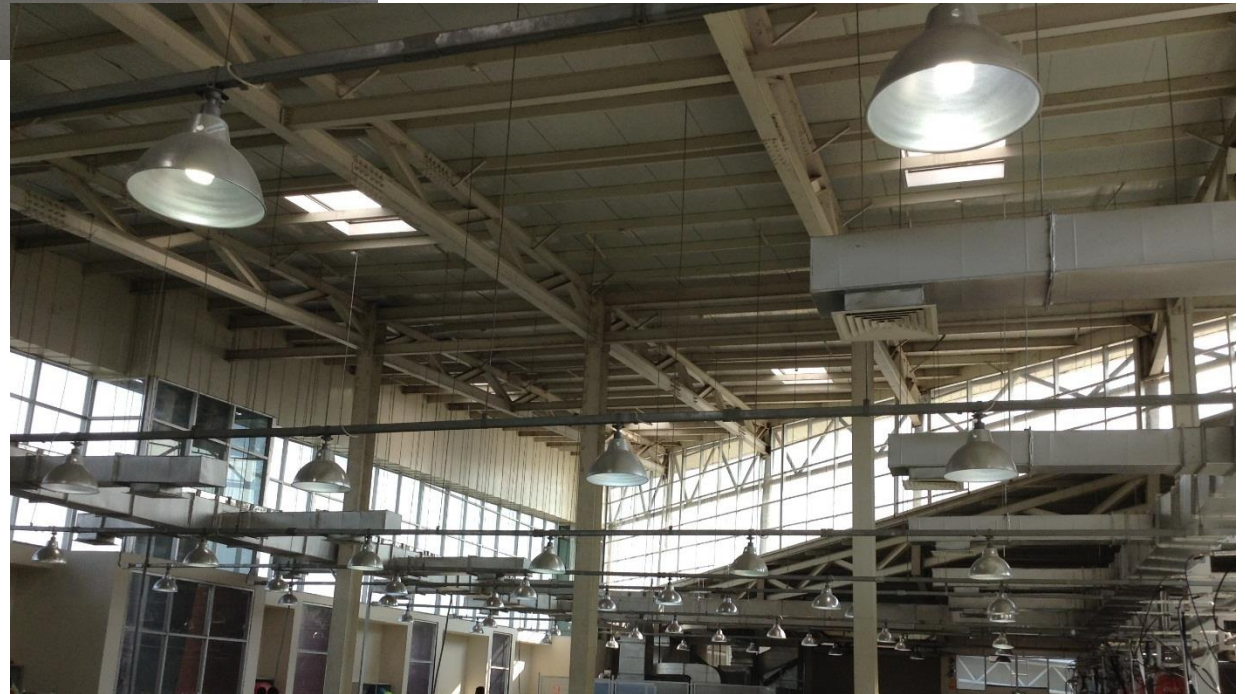
# **Lack of diagonal stability elements at roof level**

Stability at roof level is provided by orthogonal frame elements at bottom flange of truss and purlins at top.

No diagonal bracing has been provided.

Building engineer to verify roof stability without diagonal bracing is adequate to resist wind loads.

| Item No. | Observation | Recommended Action Plan | Recommended Timeline |
|---|---|---|---|
| 6 | Building 1- Factory Building<br>Lack of diagonal stability elements at roof level | Building engineer to carry out checks that stability of truss system at roof level is adequate and provide stability elements where required. | 6-months |

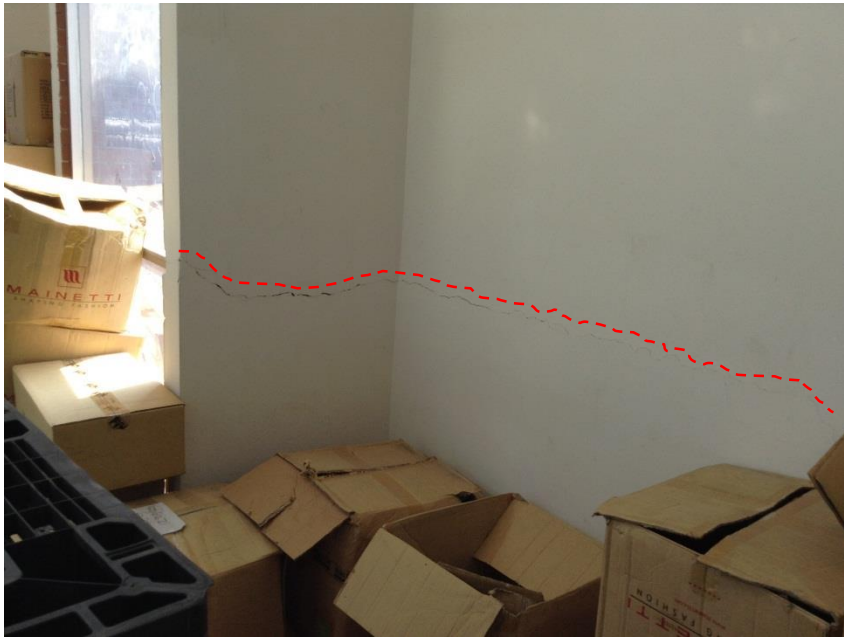
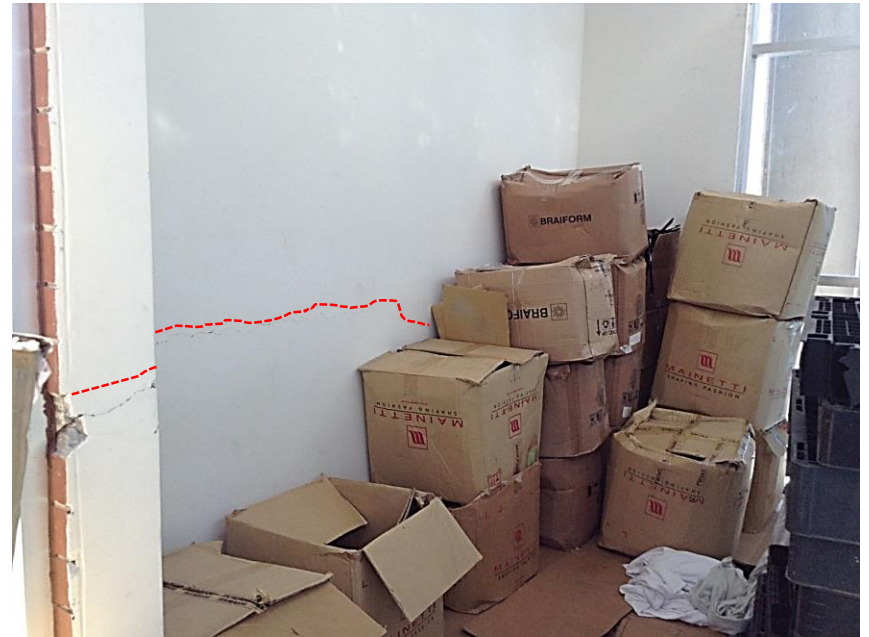
# **Cracking at brick walls on cantilever portion of 1st floor**

Cracking observed at exterior brick Wall. This appears to be due to uncontrolled loading at cantilever.

| Item No. | Observation | Recommended Action Plan | Recommended Timeline |
|---|---|---|---|
| 7 | Building 1- Factory Building<br>Cracking at brick walls on cantilever portion of 1st floor | Verify the capacity of cantilever and check if excessive deflection exists. Remove excess loading where needed. | 6-months |
