ESQUIRE SWEATERS LTD. (EXTENSION)

HOSSAIN AHMED ROAD, OPSITE POLICE LINE, FATULLAH, NARAYANGONG -1400

16 February 2025

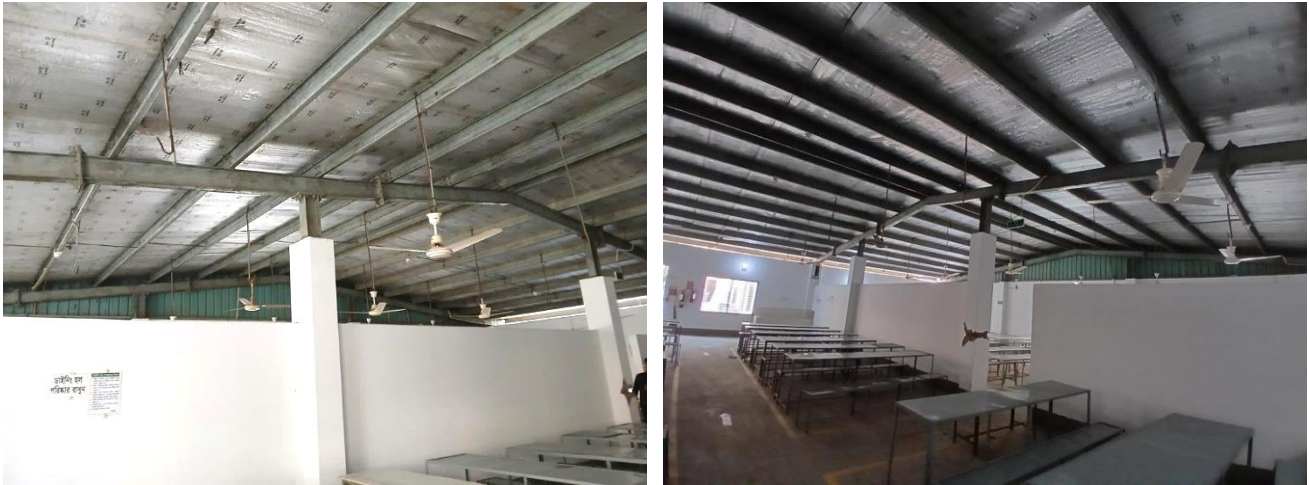
Observation-01: Lack of lateral stability system (load transfer media, vertical bracing) (Dining and Yarn Store Shed)

Lack of stability system

Description: Portal frames were observed along the short direction of the sheds, Along the long direction of the sheds, lateral stability systems (load transfer media/ compression strut, vertical & horizontal bracing) were not observed.

Building engineer is required to carry out an Engineering Assessment (EA) of the shed to check the lateral stability of the shed and suggest necessary remedial action.

Item No.	Observation	Action Plan	Timeline
1.	Lack of lateral stability system (load transfer media, bracings) (Dining and Yarn Store Shed)	The building engineer is required to carry out an Engineering Assessment (EA) of the shed to check the lateral stability of the shed.	within 6 weeks

2.		Carry out suggested remedial works if required.	within 6 months
3.	Incomplete as-built drawings. (Dining and Yarn Store Shed)	The building engineer is required to survey the structures and prepare comprehensive as-built drawings, including steel specifications, sections, foundation details, and necessary connection information.	within 6 weeks

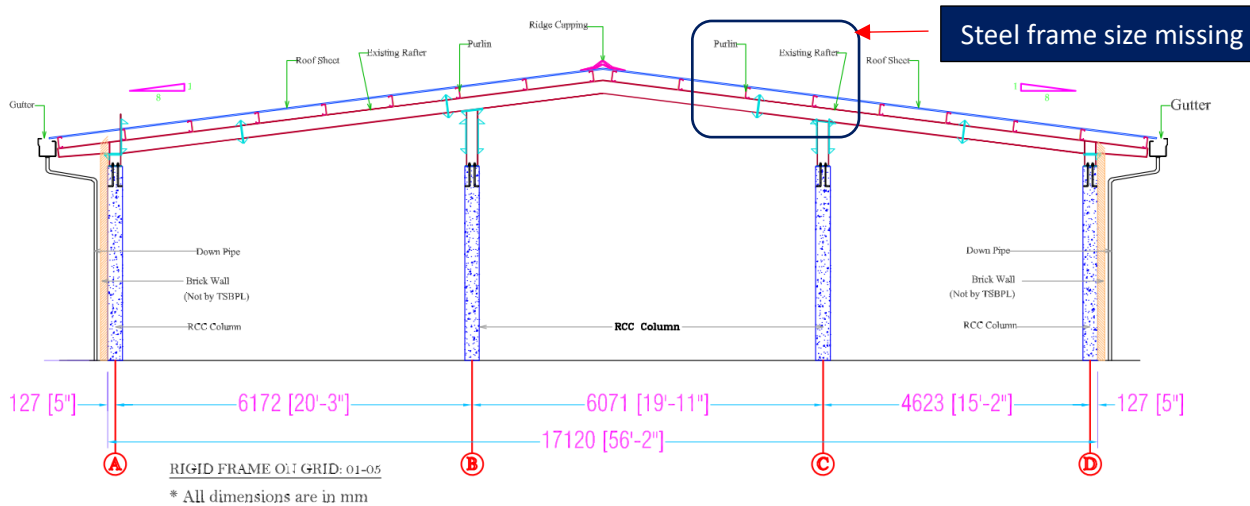
Observation-02: Incomplete as-built drawings. (Dining and Yarn Store Shed)

Description: During the inspection, as-built drawings were available on-site; However, the drawings were incomplete, lacking information on the steel drawings, steel frame sizes, and connection details. The building engineer is required to survey the structures and prepare comprehensive as-built drawings, including steel specifications, sections, foundation details, and necessary connection information.

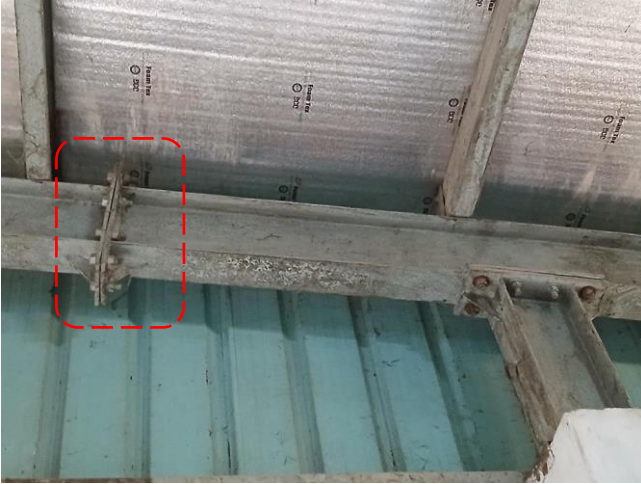
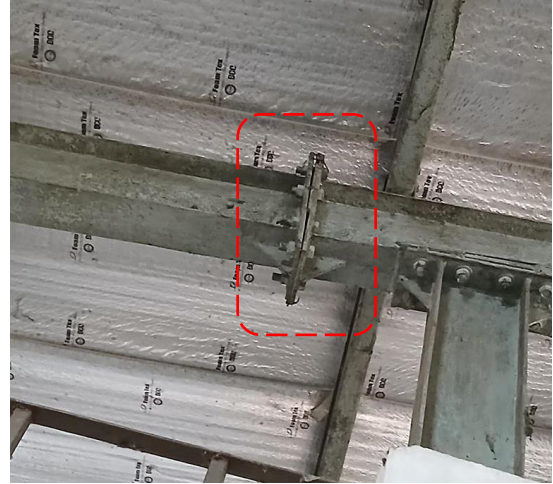
Observation-03: Improper connection and connection gap (Dining and Yarn Store Shed)

Improper connection and connection gap

Description: Improper connections and connection gaps were found in the dining and yarn store areas. The building engineer is required to repair the gaps with a suitable method and ensure adequate strengthening where necessary.

4.	Improper connection and connection gap (Dining and Yarn Store Shed)	The building engineer is required to repair the gaps with a suitable method.	within 6 weeks

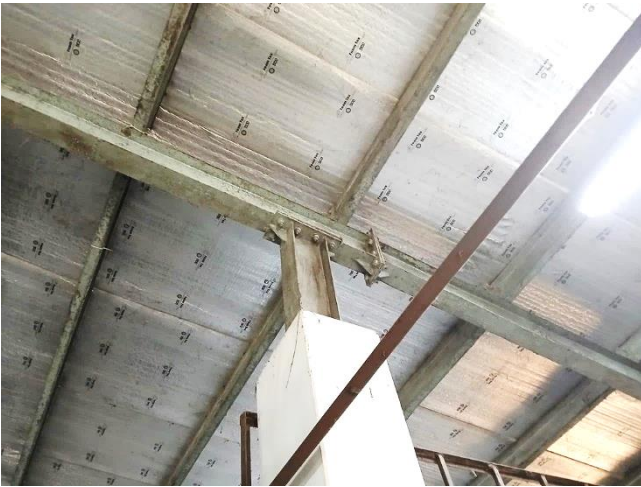
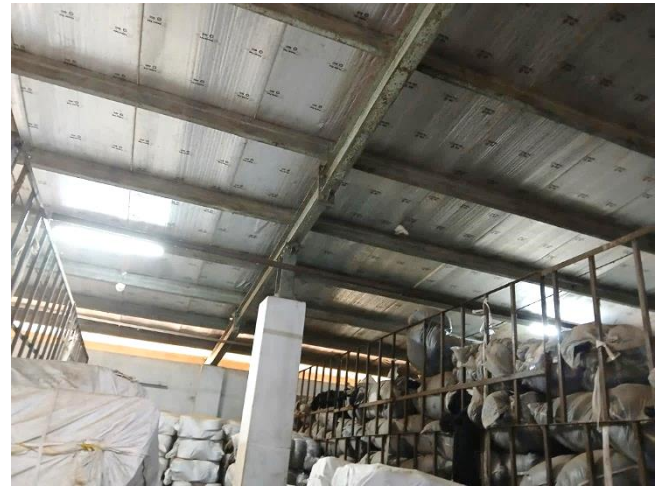
Observation-04: Corrosion on steel member (Dining and Yarn Store Shed)

Description: Corrosion was found in the steel member. The building engineer is required to remove the corrosion and provide anti-corrosive coating to the steel members.

5.	Corrosion on steel member (Dining and Yarn Store Shed)	The building engineer is required to remove the corrosion and provide anti-corrosive coating to the steel members.	within 6 weeks

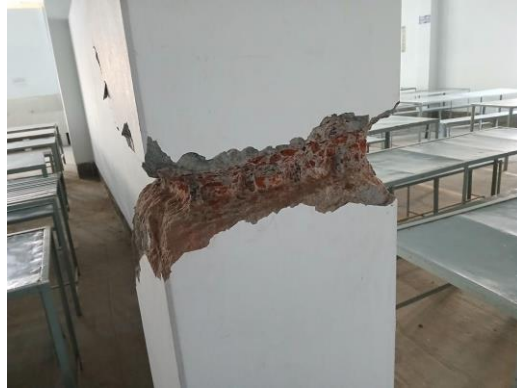
Observation-05: Damage on column due to in-situ testing (Dining and Yarn Store Shed)

Description: Damaged columns were found due to the testing. The building engineer is required to apply micro-concrete or suitable concrete mortar to restore the damaged section.

6.	Testing Damage of column (Dining and Yarn Store Shed)	The building engineer is required to apply suitable repair mortar or micro-concrete to restore the damaged section.	within 6 weeks

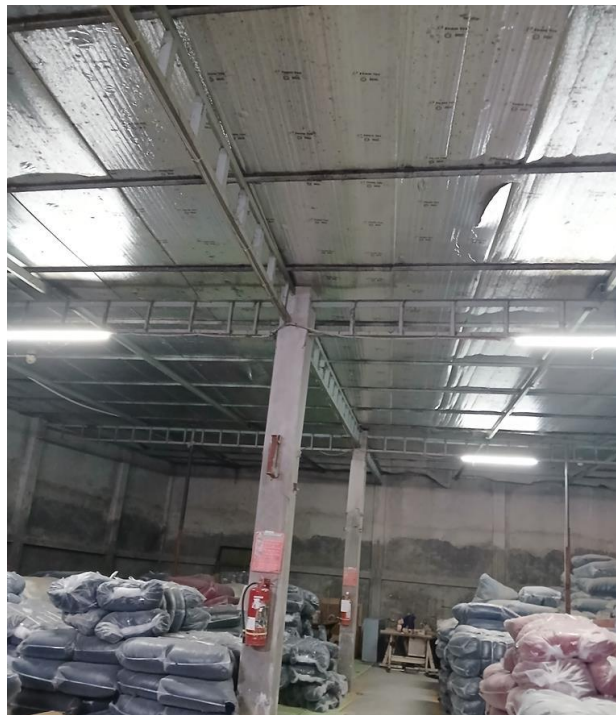
Observation-06: Lack of truss/member adequacy and poor connection. (Wastage store)

Stability System

Description: The span/depth ratio of the truss is smaller, which indicates the truss appeared to be inadequate. Also, the connections were appeared to be improper. The building engineer is required to check the adequacy for the truss & connections as part of EA report and suggested proper remedial actions accordingly.

7.	Lack of truss/member adequacy and poor connection. (Wastage store)	The building engineer is required to check the adequacy for the truss & connections as part of EA.	within 6 weeks

8.		Carry out suggested remedial works if required.	within 6 months
9.	Discrepancy in as-built drawing. (Wastage store)	The building engineer is required to survey the structures and prepare comprehensive as-built drawings, including necessary connection details.	within 6 weeks

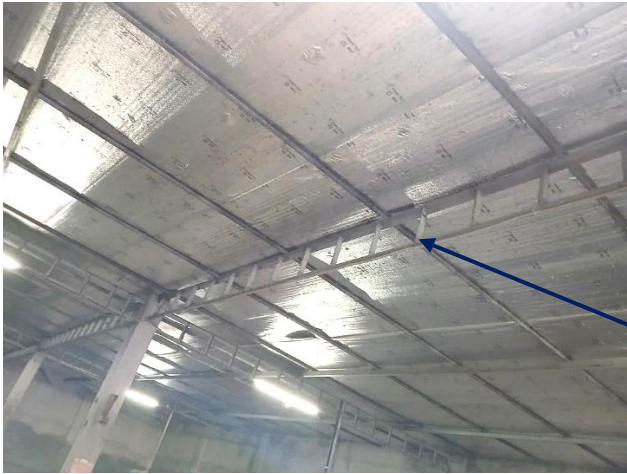
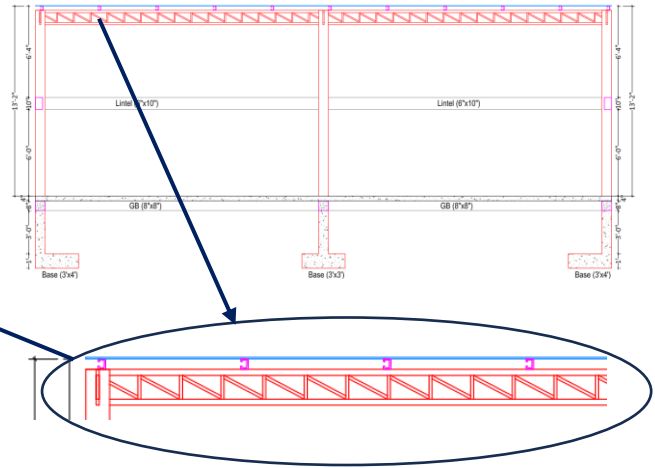
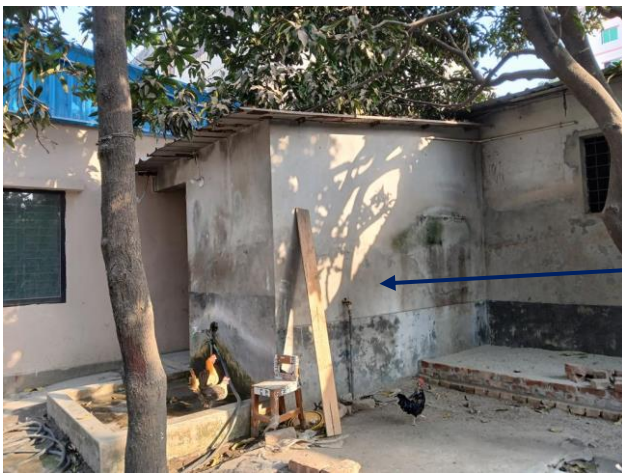
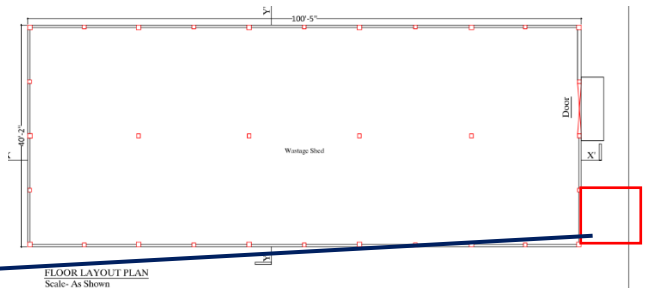
Observation-07: Discrepancy in as-built drawing. (Wastage store)

Description: The as-built drawing indicates a flat truss, while a Vierendeel truss was found on-site. Also, an undocumented kitchen room located in the north-east corner. The building engineer is required to survey the structures and prepare comprehensive as-built drawings, including necessary connection details.

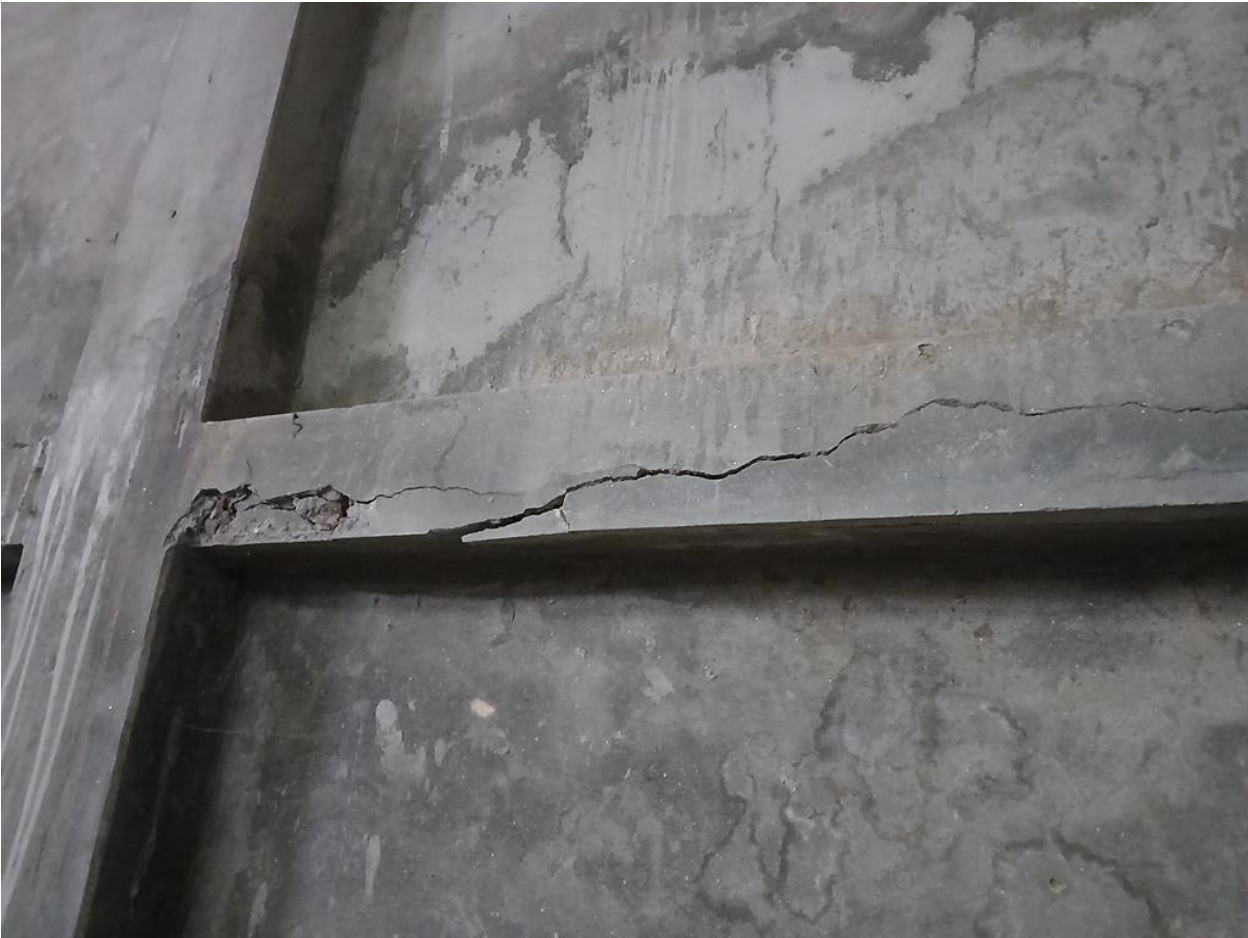
Observation-08: Crack on Tie beam (Wastage store)

Description: Cracks were observed on the tie beam of the Wastage Store. The building engineer is required to investigate the reason for the crack and repair it with a suitable method.

10.	Crack on Tie beam (Wastage store)	The building engineer is required to investigate the reason for the crack and repair with suitable method.	within 6 weeks

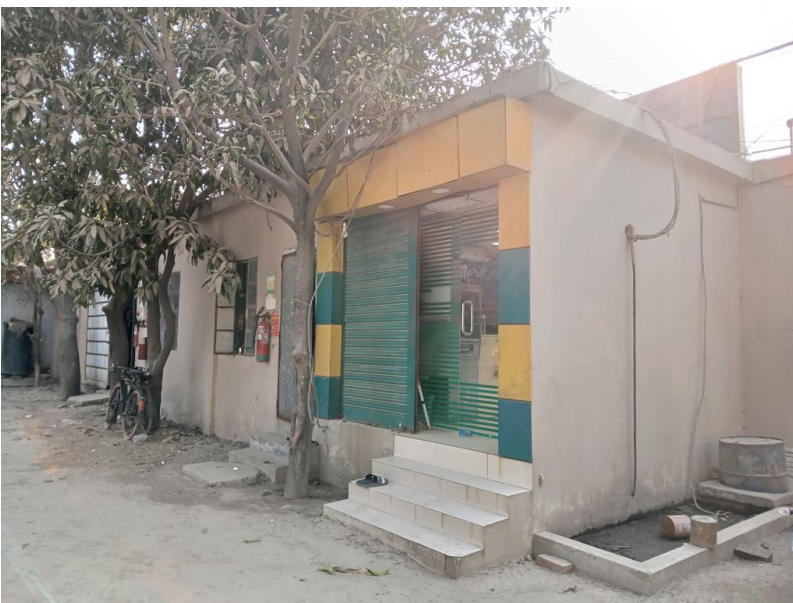
Observation-09: Lack of as-built drawings (Security Dormitory Building)

Description: As-built drawings were not available on site.

The building engineer is required to survey the structures and prepare as-built drawings for the structures with foundation details.

11.	Lack of as-build drawings (Security Dormitory Building)	The building engineer is required to survey the structures and prepare as-built drawings for the structures with foundation details.	within 6 weeks

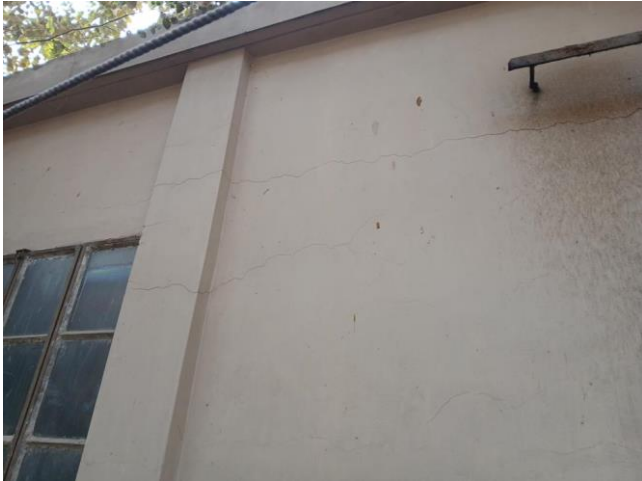
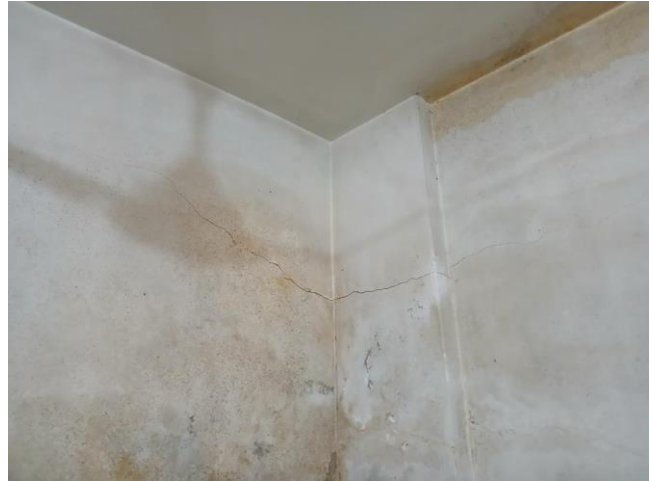
Observation-10: Crack on the brick wall (Security Dormitory Building)

Description: Cracks were observed on the façade wall of the Security Dormitory Building. The building engineer is required to investigate the reason for the crack and repair it with suitable method.

12.	Crack on the brick wall (Security Dormitory Building)	The building engineer is required to investigate the reason for the crack and repair with a suitable method.	within 6 weeks

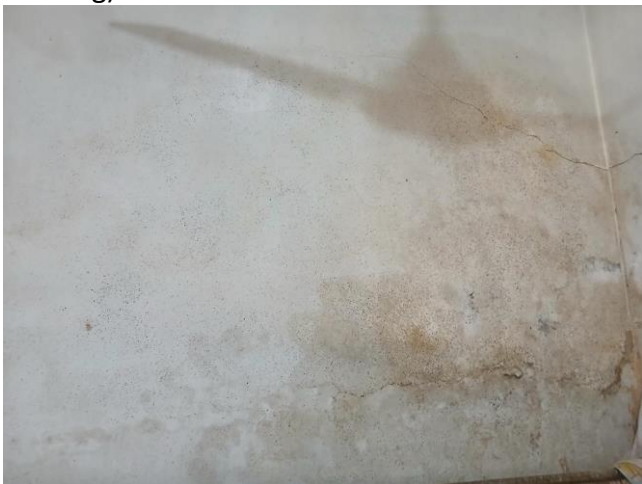
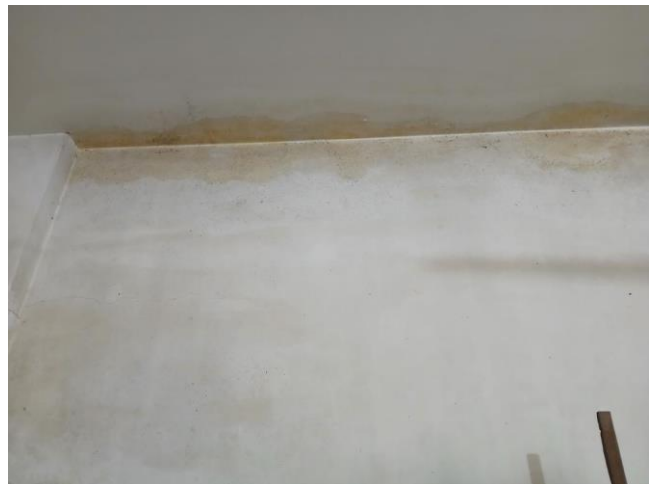
Observation-11: Dampness due to water intrusion on roof slab and brick wall. (Security Dormitory Building)

Description: Dampness was observed on the roof slab and internal brick partition walls due to water intrusion. The building engineer is required to identify all the damp locations throughout the building, seal the source of water, and repair the damp areas with suitable methods.

13.	Dampness due to water intrusion on the roof slab and brick wall. (Security Dormitory Building)	The factory is required to identify all the damp locations throughout the building, seal the source of water, and repair the damp areas with suitable methods.	within 6 weeks

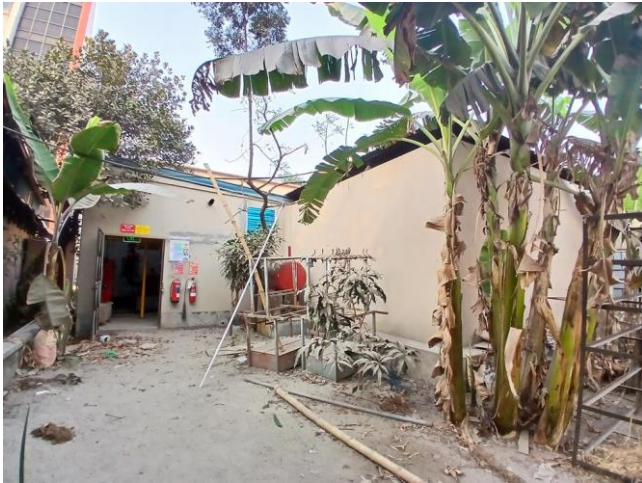
Observation-12: Lack of as-built drawings (Fire Pump & Water Reservoir)

Description: As-built drawings were not available on site.

The building engineer is required to survey the structures and prepare as-built drawings for the structures with foundation and necessary connection details.

14.	Lack of as-built drawings (Fire Pump & Water Reservoir)	The building engineer is required to survey the structures and prepare as-built drawings with foundation & connection details.	within 6 weeks

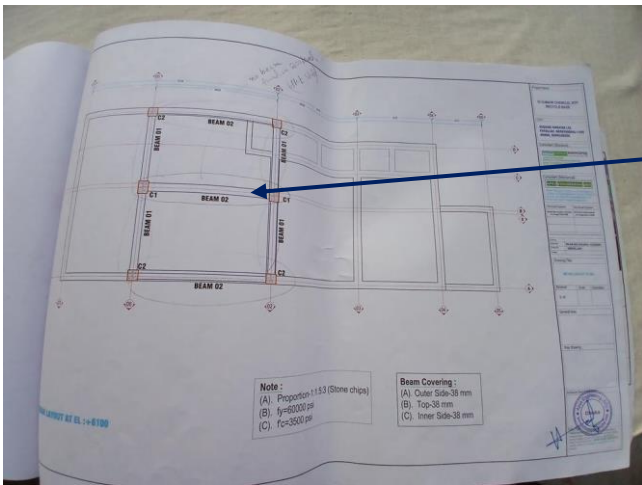
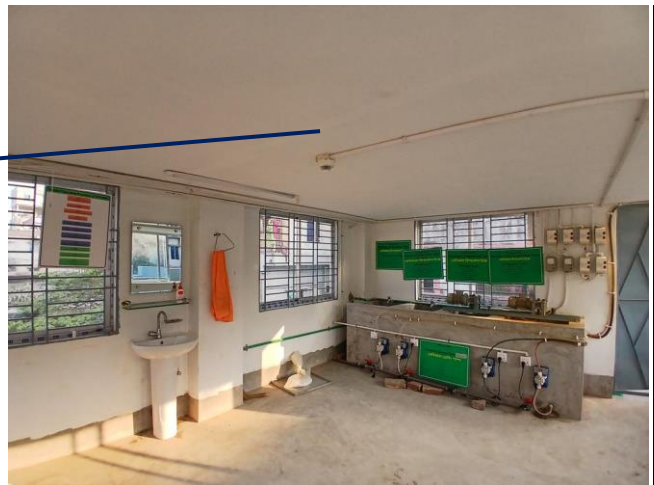
Observation-13: Discrepancy in as-built drawing. (ETP Building)

Description: During the inspection, a flat slab was observed on the roof slab, whereas the drawings indicate a beam-column frame system.

The building engineer is required to survey the structures and prepare comprehensive as-built drawings.

15.	Discrepancy in as-built drawing. (ETP Building)	The building engineer is required to survey the structures and prepare comprehensive as-built drawings.	within 6 weeks

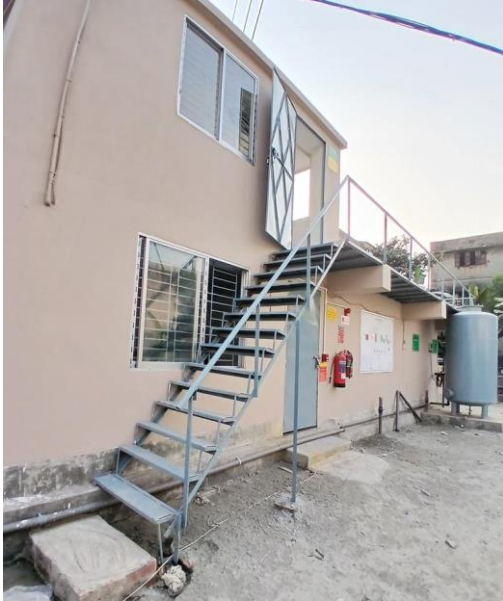
Observation-14: Inadequate stair with poor connection and lack of drawings (ETP Building)

Description: An inadequate steel staircase with poor connections & member size was observed at the ETP building. Also, drawing was not available.

The building engineer is required to check the adequacy of the member and connections, prepare the necessary drawings and Safety check report and suggest necessary remedial actions accordingly. Submit the Safety check report to the RSC for review.

16.	Inadequate stairs with poor connection and lack of drawings (ETP Building)	The building engineer is required to prepare the necessary drawings, check the adequacy of members & connections as part of Safety check report. Submit the Safety check report to the RSC for review.	within 6 weeks

17.		Carry out suggested remedial works if required.	within 6 months
18.	Lack of as-built drawings (RMS & Security Office)	The building engineer is required to survey the structures and prepare as-built drawings for the structures.	within 6 weeks

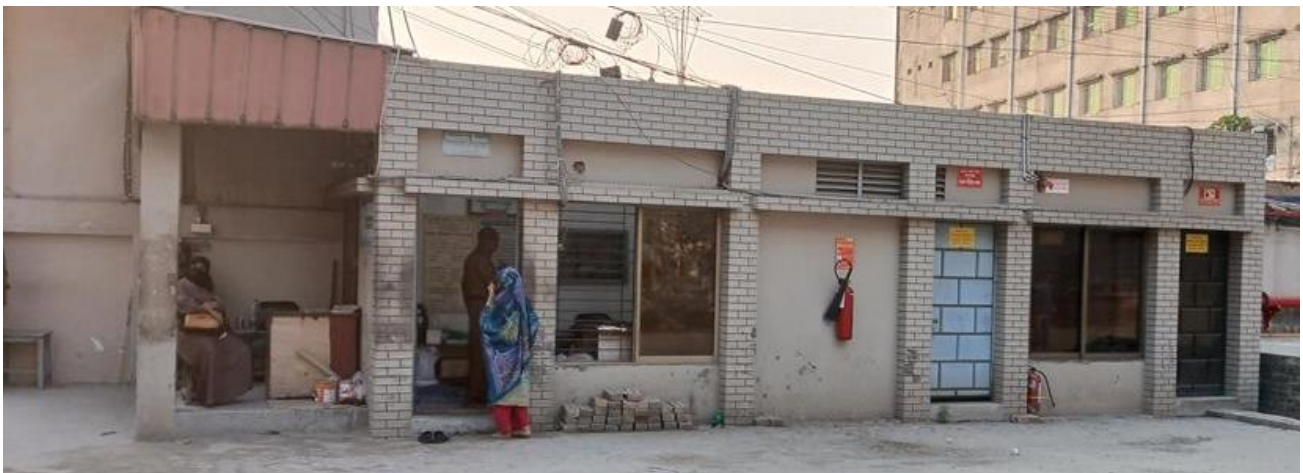
Observation-15: Lack of as-built drawings (RMS & Security Office)

Description: As-built drawings were not available on site.

The building engineer is required to survey the structures and prepare as-built drawings for the structures.
