# Padma Satell Arab Fashions Ltd.(Extension)

Luna Complex Joy Bangla Road, Khaikur, Borobari, Gazipur.

17 February 2025

## 1. Building Information

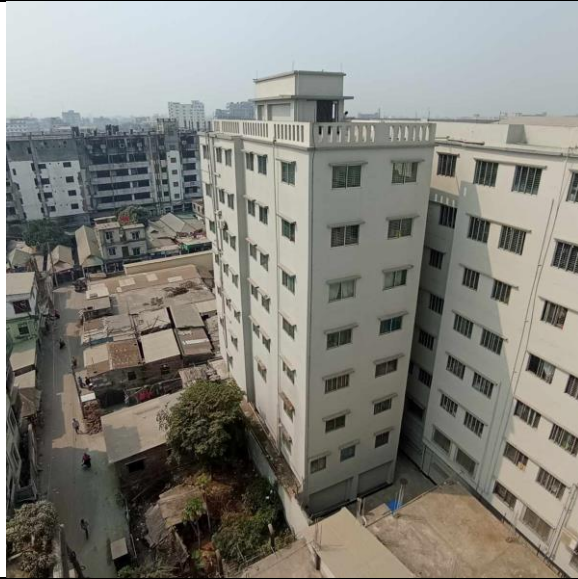
### Observation 1: Lack of design documents and test report. (Extension Building).

**Description:** As per BNBC, every building or structure designed shall have its design documents prepared in accordance with the provision of Section 1.9.1. The design document shall include a design report, and a set of structural drawings, which shall be prepared in compliance with section 1.9.1.1 and section 1.9.1.2 as per BNBC. At the time of the inspection, design report was not available. Also, no test report was available. The building engineer is required to prepare a set of design reports based on in situ concrete strength in compliance with section 1.9.1 (part-6, BNBC).

| Item No. | Observation | Action Plan | Timeline |
|---|---|---|---|
| 1. | Lack of design documents and test report. (Extension Building). | The building engineer is required to prepare a design report as per 1.9.1-BNBC and submit it to RSC for review. | within 6 weeks |
| 2. | | Take minimum 4 concrete core from column (lower level). | within 6 weeks |
| 3. | | Implement remediation work if required. | within 6 months |

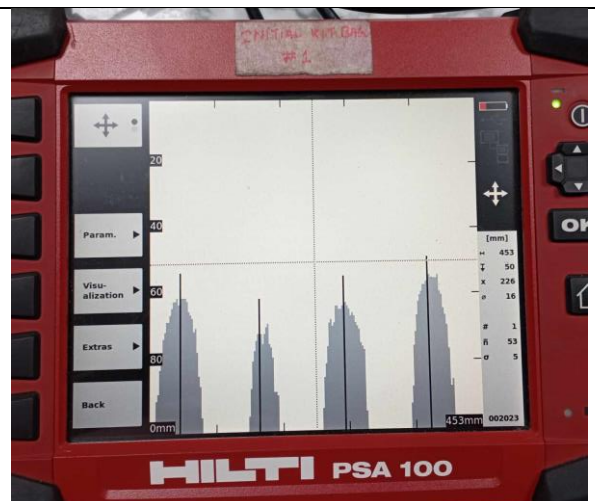
C2: Rebar found 4X4 instead of 5X4 at 7<sup>th</sup> floor

**Description:** Details of floor beam not provided in available drawing. Besides, mismatch was found in number of rebar in column as follows: C-2: 4X4 instead of 5X4 at 7<sup>th</sup> floor, C-4: 5X5 instead of 6X5 at 7<sup>th</sup> floor, C-5: was found 5X5 instead of 6X5 at 4<sup>th</sup> floor. The building engineer is required to update the as-built drawing.

| Item No. | Observation | Action Plan | Timeline |
|---|---|---|---|
| 4. | Discrepancy and missing information in provided drawing (Extension Building). | The building engineer is required to update the as-built drawing. | within 6 weeks |

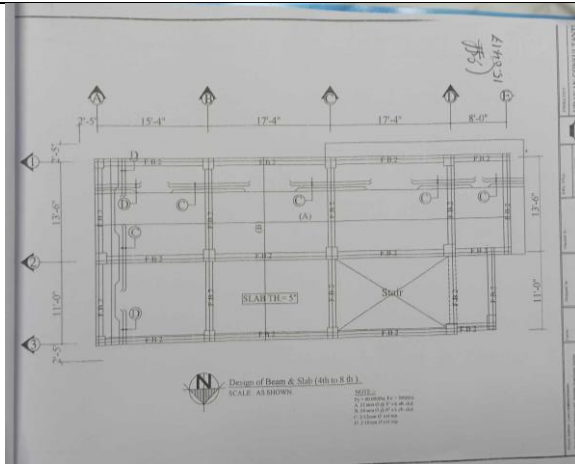
Details of floor beam not provided

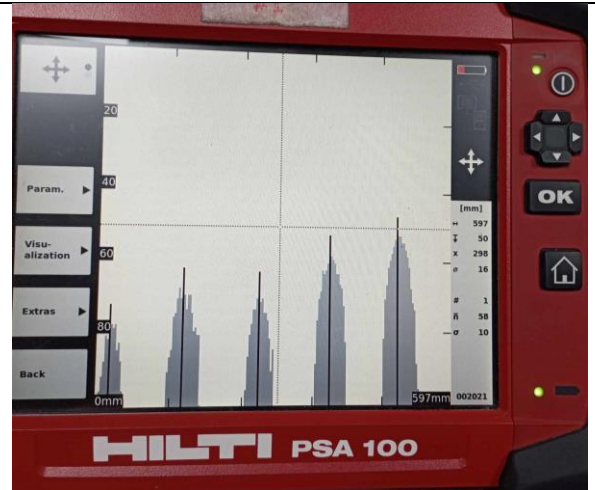
C5: Rebar found 5X5 instead of 6X5 at 4<sup>th</sup> floor

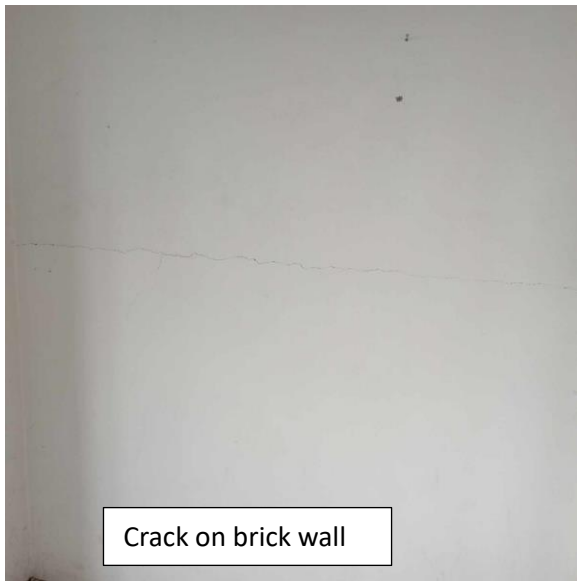
Crack on brick wall

**Description:** Plaster crack was observed on beam surface and brick wall. The building engineer is required to repair the crack with a suitable method.

| Item No. | Observation | Action Plan | Timeline |
|---|---|---|---|
| 5. | Crack on beam surface and brick wall (Extension Building). | The building engineer is required to repair the crack with a suitable method. | within 6 weeks |

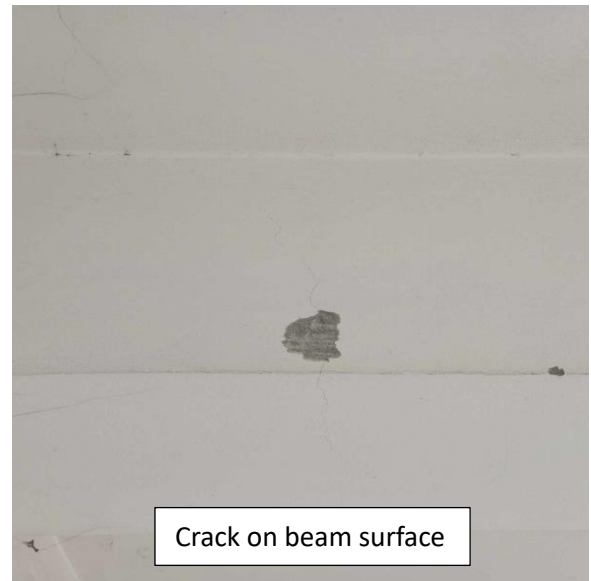
Crack on beam surface

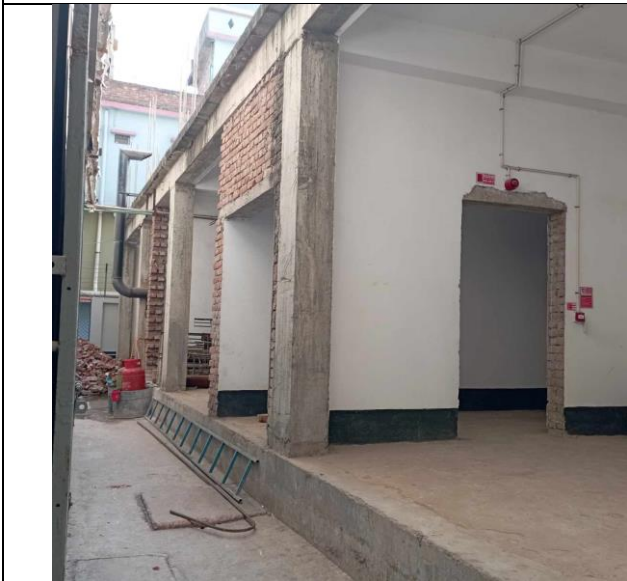
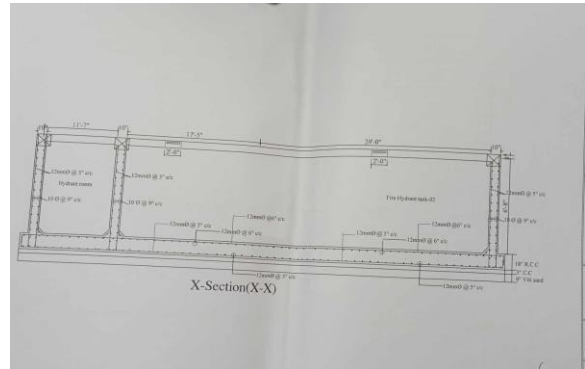
**Observation 4: Lack of load plan (Utility Building).**

**Description:** Ground floor is a suspended slab as it is over an underground water tank, but no live load plan was available. The building engineer is required to prepare a floor load plan for ground floor slab.

| Item No. | Observation | Action Plan | Timeline |
|---|---|---|---|
| 6. | Lack of load plan (Utility Building). | The building engineer is required to prepare a set of live load plan and submit it to RSC for review. | within 6 weeks |

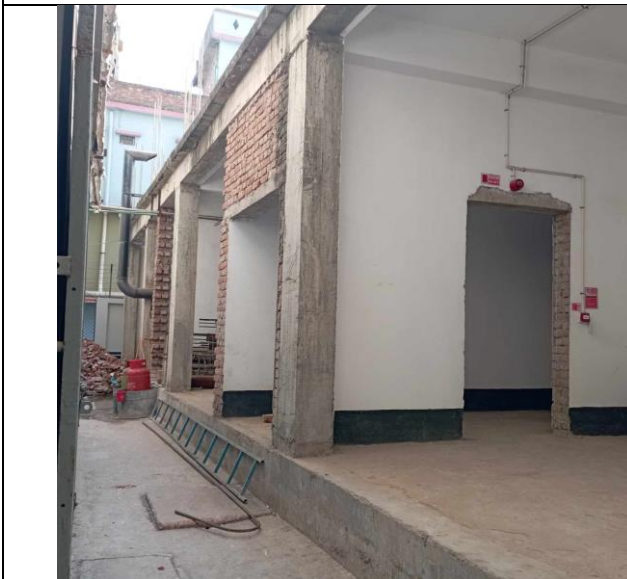
**Observation-5: Discrepancy/incomplete drawing (Utility Building).**

**Description:** The structure was found as single stoired column schedule provided up to 3<sup>rd</sup> floor. The factory has not any plan for future extnsion. Also, no information of grade beam and no plan of retaining/tank wall shown in provided drawing. The building engineer is required to prepare a full set of accurate the as-built drawing as per existing condition.

| Item No. | Observation | Action Plan | Timeline |
|---|---|---|---|
| 7. | Discrepancy in provided drawing (Utility Building). | The building engineer is required to update the as-built drawing. | within 6 weeks |

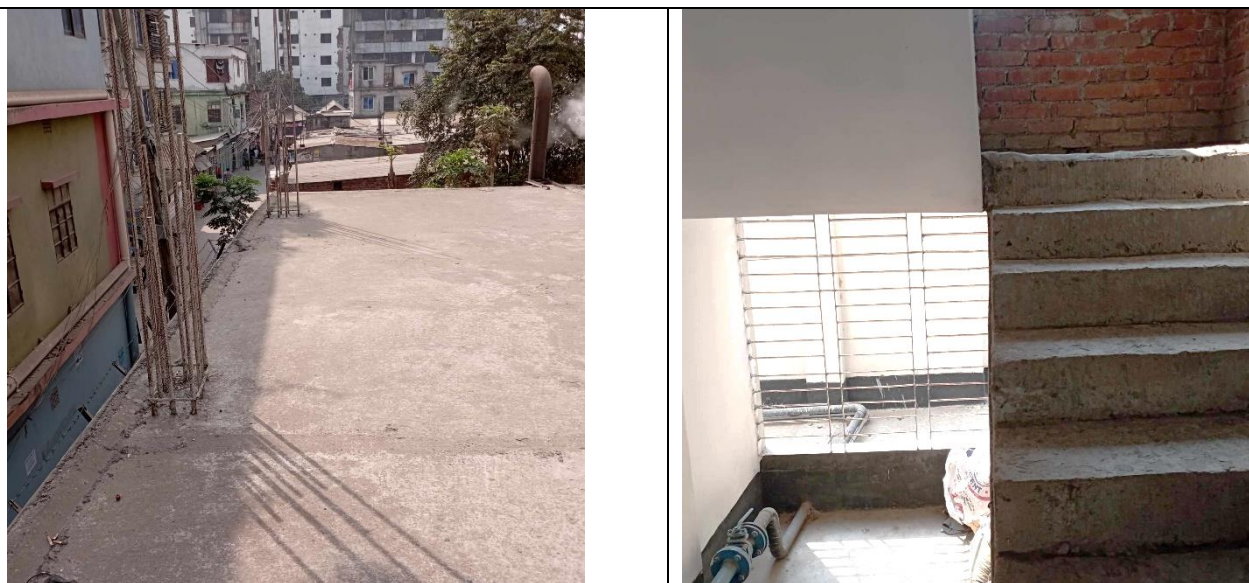
**Observation-6:** Falling hazard at roof and staircase (Utility Building).

**Description:** No parapet/railing was found at roof and staircase. The building engineer is required to provide edge protection to avoid falling hazard.

| Item No. | Observation | Action Plan | Timeline |
|---|---|---|---|
| 8. | Falling hazard at roof and staircase (Utility Building). | The building engineer is required to provide edge protection to avoid falling hazard. | within 6 weeks |

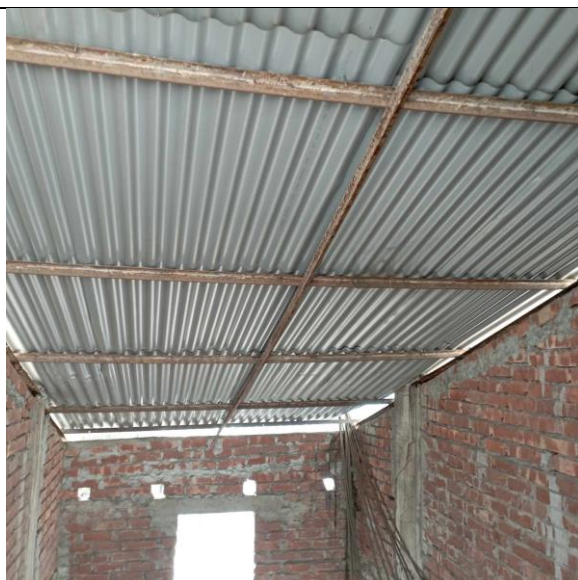
**Observation-7:** Corroded sagged rafter at stair roof shed (Utility Building).

**Description:** Sagged rafter was found at stair roof shed. Besides, all steel members were found corroded. The building engineer is required to check the capacity of steel members of stair roof shed. Also, remove rust from steel members and provide rust proof paint.

| 9. | Corroded sagged rafter at stair roof shed (Utility Building). | The building engineer is required to check the capacity of steel members of stair roof shed. | within 6 weeks |
| 10. | | Implement remediation work where required. | within 6 months |
| 11. | | Remove rust from steel members and provide rust proof paint. | within 6 weeks |
