# N R Knitting Mills Limited. (Extension)

Enayetnagar, Fatullah, Narayanganj-1400, Bangladesh

16 February 2025

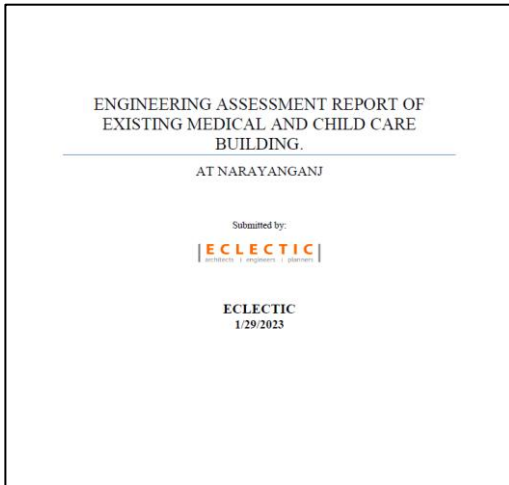
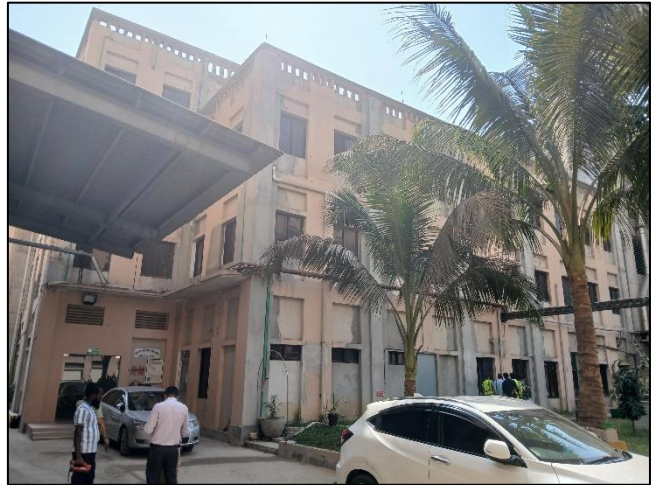
**Observation-1:** Design report needs to be reviewed against lateral forces (Childcare & Medical building).

**Description:** An Engineering Assessment Report has been prepared for the four storied Childcare & Medical building. The prepared design report needs to be reviewed against lateral forces. Submit the design report to the RSC for detailed review.

| Item No | Observation | Action Plan | Timeline |
|---|---|---|---|
| 1. | Design report needs to be reviewed against lateral forces (Childcare & Medical building). | The building engineer is required to revise the design report as per updated drawing and submit to RSC for review against lateral forces. | within 6 weeks |

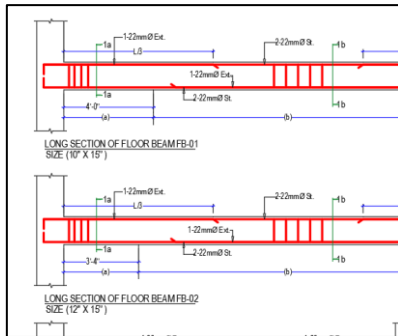
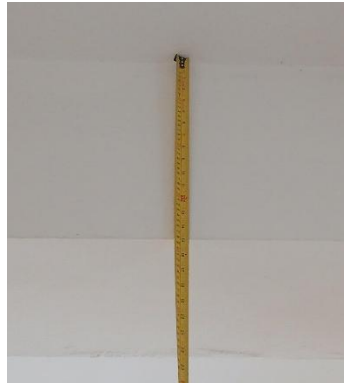
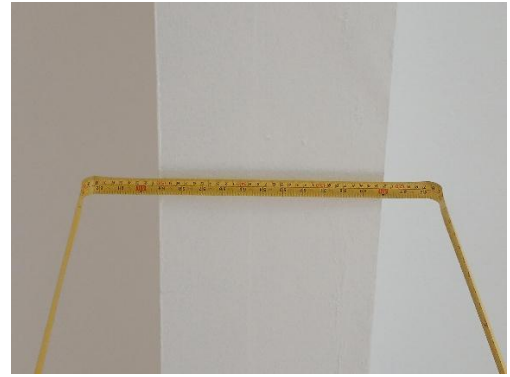
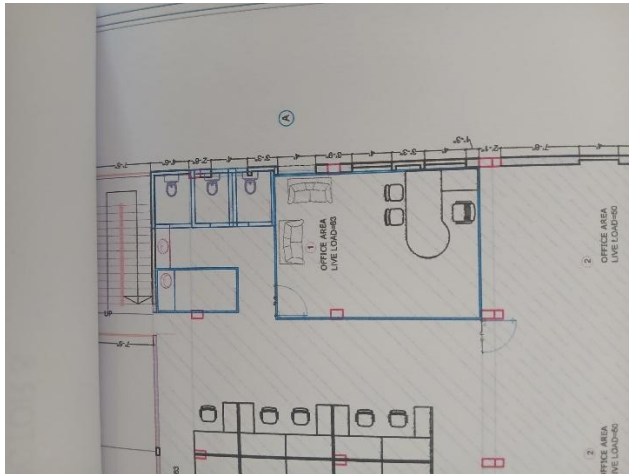
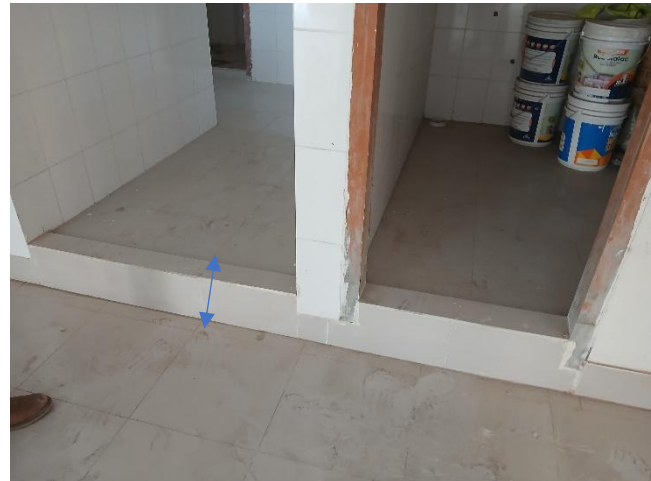
**Observation-2:** Mismatch between drawing & onsite condition (Childcare & Medical building).

**Description:** During inspection, FB1 and FB2 were measured 10"X18" and 10"X20" which were shown 10"X15" and 12"X15" respectively in available structural drawing. In addition, 12" (300 mm) buildup was observed in the toilet block area which was not shown in available architectural drawing. The building engineer is required to update the drawing based on the as-constructed structure.

| Item No | Observation | Action Plan | Timeline |
|---|---|---|---|
| 4. | Mismatch between drawing & onsite condition (Childcare & Medical building). | The building engineer is required to update the drawings to the as-constructed status. | within 6 weeks |

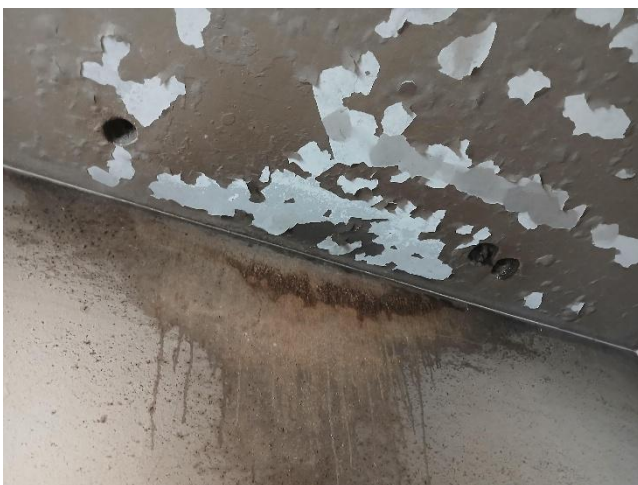
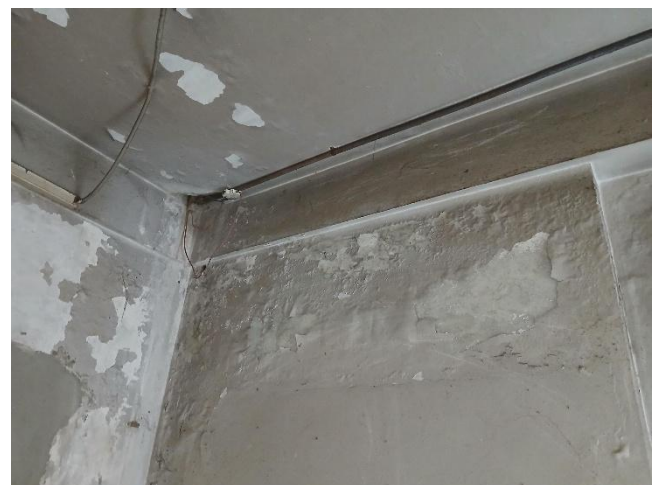
**Observation 3:** Dampness on roof slab and cracks on masonry walls (Childcare & Medical building).

**Description:** Dampness on roof slabs and cracks on masonry walls were observed. The building engineer is required to investigate the reason for dampness & cracks; and repair following suitable method.

| Item No | Observation | Action Plan | Timeline |
|---|---|---|---|
| 5. | Dampness on roof slab and cracks on masonry walls (Childcare & Medical building). | The building engineer is required to investigate the reason for dampness & cracks; and repair following suitable method. | within 6 weeks |

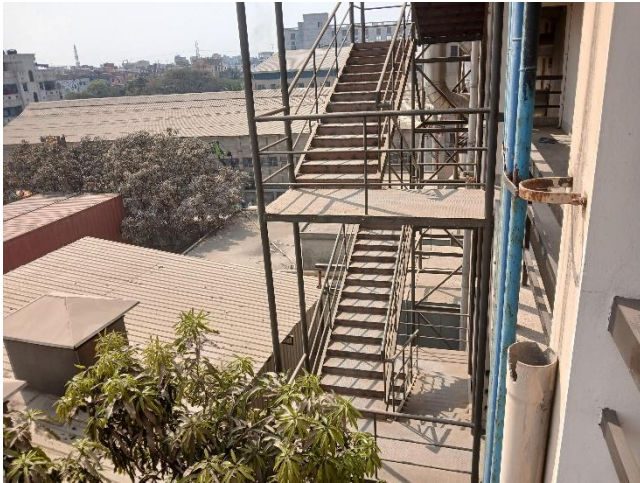
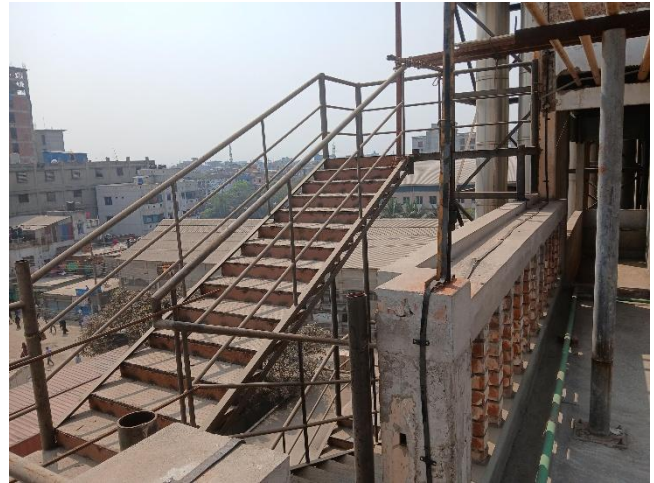
**Observation-4:** Undocumented steel stair with lack of lateral stability system adjacent to Childcare & Medical building.

**Description:** During inspection, an undocumented steel stair was observed with improper lateral load transfer media. So lateral stability in the long direction is incomplete. Also, improper connection between structural members was observed. The building engineer is required to prepare a full set of as-built drawings, collect necessary approvals from the concerned local authority, and check the stability system and connection adequacy for the existing structure.

| Item No | Observation | Action Plan | Timeline |
|---|---|---|---|
| 6. | Undocumented steel stair with lack of lateral stability system adjacent to Childcare & Medical building. | The building engineer is required to prepare a full set of as-built drawings to the as-constructed status. | within 6 weeks |
| 7. | | The building engineer is required to check the stability system and connection adequacy for the existing structure as part of EA and submit to RSC for review. | within 6 weeks |

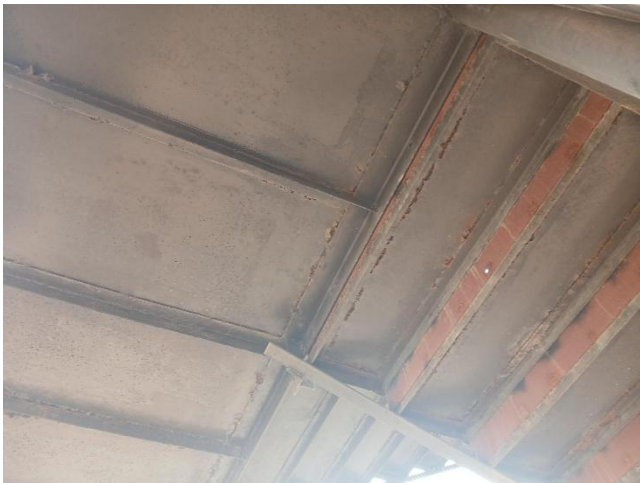
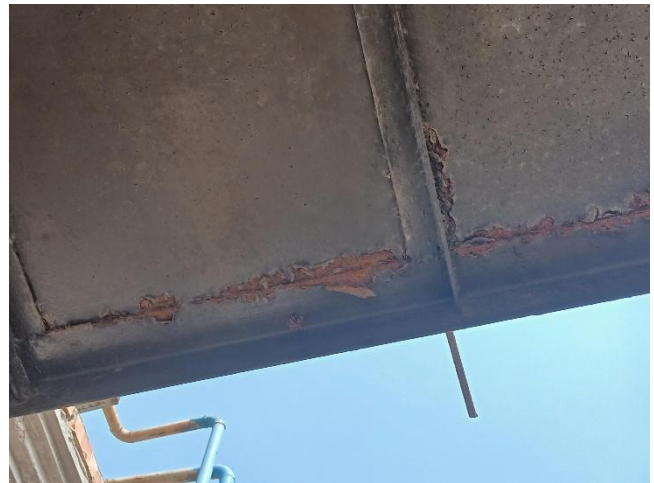
**Observation 5:** Corrosion on steel members of the steel stair (Childcare & Medical building).

**Description:** Corrosion was observed on steel members of steel stairs. The building engineer is required to provide rust-proof paint on steel members.

| Item No | Observation | Action Plan | Timeline |
|---|---|---|---|
| 9. | Corrosion on steel members of the steel stair (Childcare & Medical building). | The building engineer is required to provide rust-proof paint on steel members. | within 6 weeks |

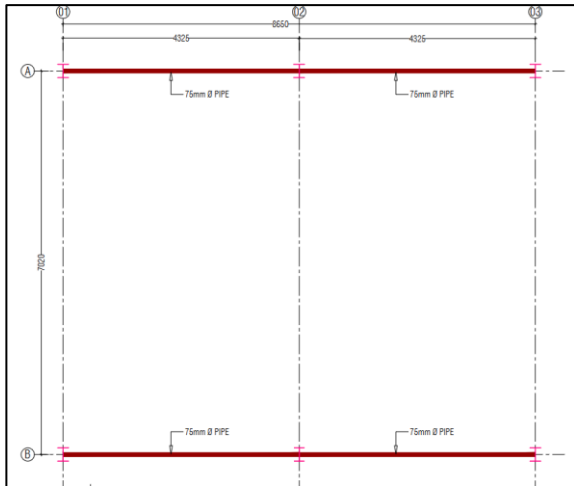
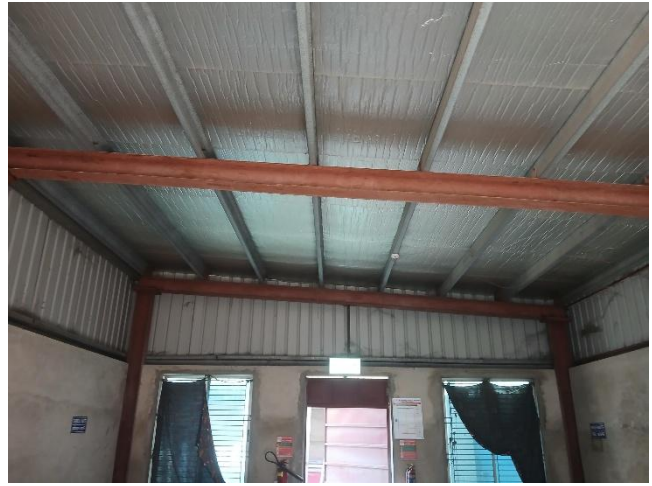
**Observation-6:** Mismatch between drawing & onsite condition (Wastage Store).

**Description:** During inspection, 76 mm dia pipe as compression member was shown in structural drawing which was not installed onsite. The building engineer is required to update the drawing based on the as-constructed structure.

| Item No | Observation | Action Plan | Timeline |
|---|---|---|---|
| 10. | Mismatch between drawing & onsite condition (Wastage Store). | The building engineer is required to update the drawings to the as-constructed status. | within 6 weeks |

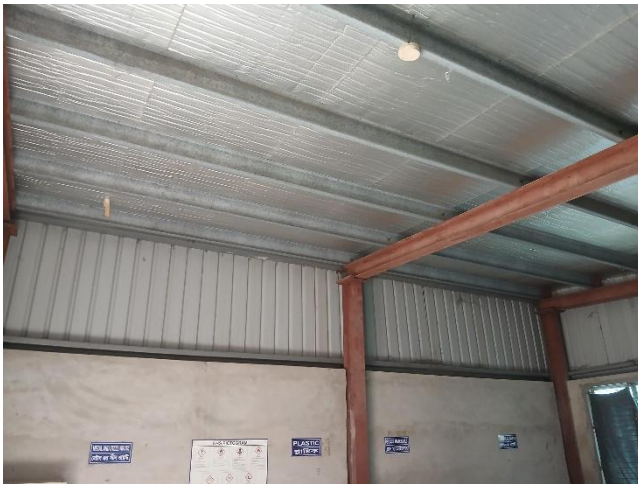
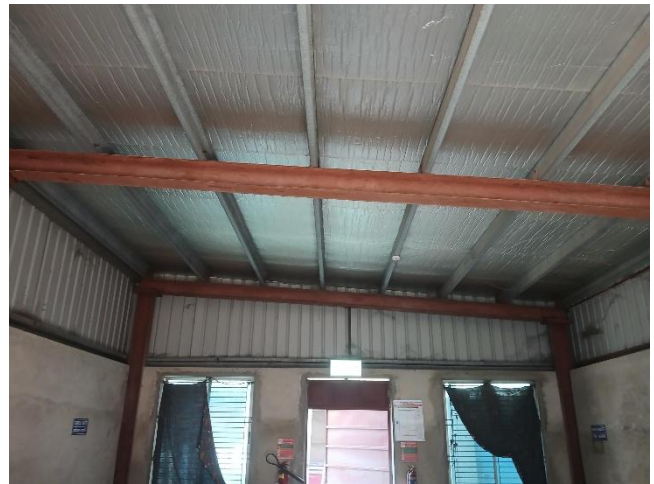
**Observation-7:** Lack of lateral stability system (Wastage Store).

**Description:** During inspection, no load transfer media along the long direction was observed. So lateral stability in the long direction is incomplete. The building engineer is required to check the stability system as part of EA for the existing structure.

| Item No | Observation | Action Plan | Timeline |
|---|---|---|---|
| 11. | Lack of lateral stability system (Wastage Store). | The building engineer is required to check the stability system as part of EA for the existing structure. | within 6 weeks |

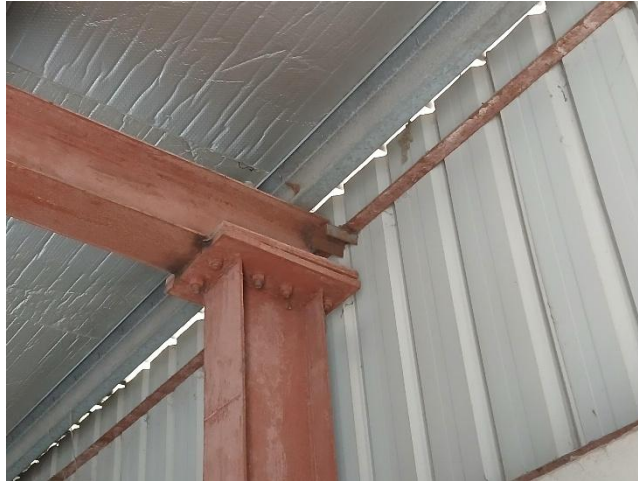
**Observation-8:** Connection gap between steel connections (Wastage Store).

**Description:** During inspection, Connection gap was observed between steel connections. The building engineer is required to fill the connections with proper methodology.

| Item No | Observation | Action Plan | Timeline |
|---|---|---|---|
| 13. | Connection gap between steel connections. | The building engineer is required to fill the connections with proper methodology. | within 6 weeks |
