# INITIAL FIRE SAFETY INSPECTION REPORT

**N R Knitting Mills Limited. (Extension)**

**RSC ID: 25995**

**Date: 16-Feb-2025**

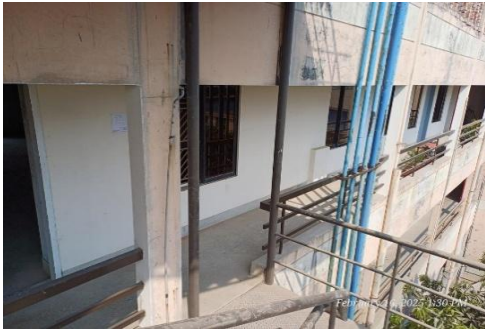
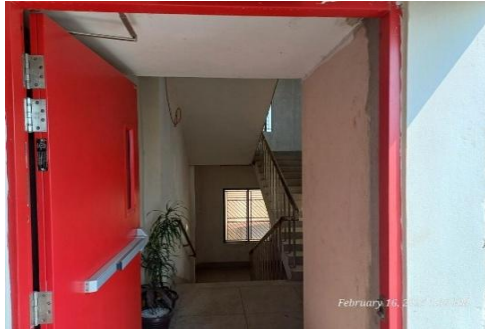
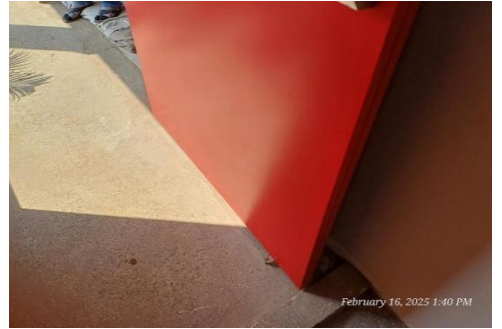
| Sl No. | Category | Findings | Required Action | Remediation Time Frame |
|---|---|---|---|---|
| 1 | Fire Rated Construction | <p>Both the exit stairs (South East and South West Stairs) are not separated from work areas, other spaces on each floor by fire-rated construction due to the following reasons:</p> <ul style="list-style-type: none"> <li>i. Fire doors are not provided at all exits.</li> <li>ii. Fire doors were not functional properly.</li> <li>iii. Unprotected opening was found at floor areas adjacent to the stairs.</li> </ul> <p><b>(Location: 4-storied Existing RCC Childcare and Medical Building)</b></p> | <p>Provide minimum 1.5-hr fire rated doors for buildings that are 4 or more stories. Seal all unprotected openings to separate the exit stairs from work areas and other building spaces on all floor levels. Ensure that the fire doors are self-closing and positive latching and that they are provided with fire exit (panic) hardware where serving production floors. If fire doors are required to be held open for functional reasons, provide automatic closing devices tied to the fire alarm system.</p> | Within 3 months |

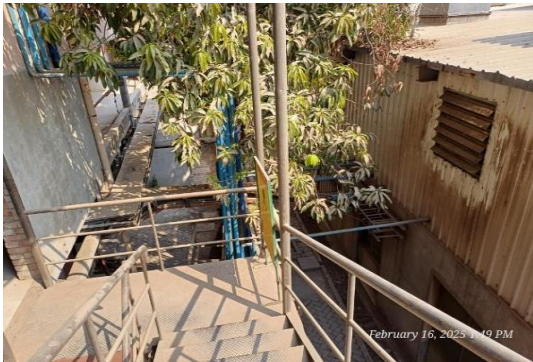
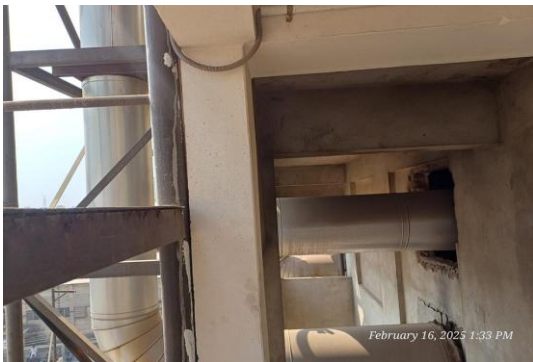
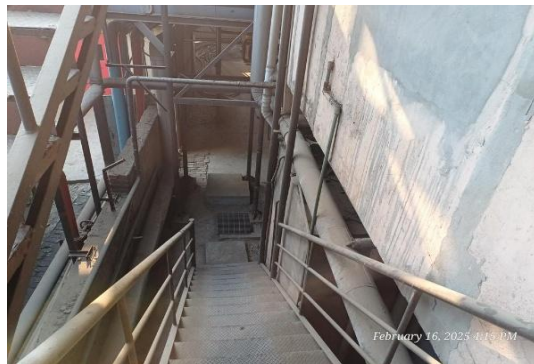
| 2 | Fire Rated Construction | <p>Unprotected opening has been observed building to building within close proximity as follows,</p> <ul style="list-style-type: none"> <li>i. Opening of Single storied compressor shed at 8-ft-6 inches away from the Stair-2 (South West) of the 4 storied RCC Childcare &amp; Medical building.</li> <li>ii. Exhaust of the generator and other openings at 3-storied RCC Utility Building at 7-ft-3-inches away from the Stair-2 (South West) and adjacent to toilet area of the 4 storied RCC Childcare &amp; Medical building.</li> </ul> | <p>All buildings and structures shall be separated from other buildings in accordance with BNBC 2006 Part 3 Table 3.2.2 and BNBC 2006 Part 3 Section 2.4.1.3. Exterior walls of exit enclosures in interim and existing buildings must meet the requirements of BNBC 2006. (See also 6.14.5).</p> <ul style="list-style-type: none"> <li>i. Provide 2-hr fire-rated separation to the stair with surrounding structures.</li> <li>ii. Seal all the penetration and unprotected openings within 10-ft from the stair with 2-hr fire rated construction.</li> </ul> | Within 3 months |

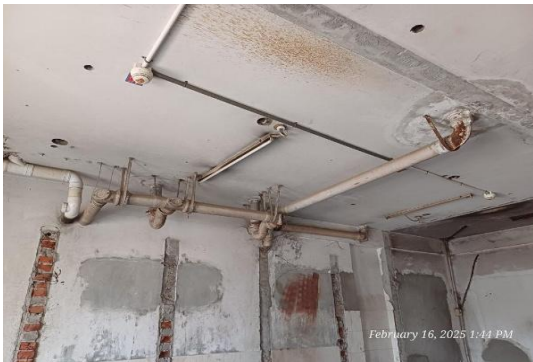
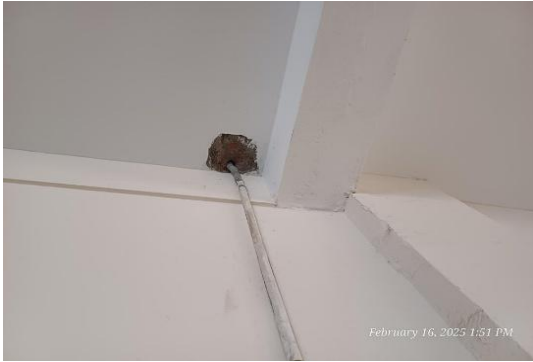
| 3 | Fire Rated Construction | <p>Unsealed penetrations and openings are located in the fire-rated floor/ceiling assemblies due to sanitary piping &amp; cable riser at west corner of the 1st and 2nd floor of the building .</p> <p><b>(Location: 4-storied Existing RCC Childcare and Medical Building)</b></p> | <p>Provide a minimum 2-hr fire rated shaft to separate the utility risers from each floor level or seal all penetrations and openings in floors/ceiling assemblies by 3-hr fire rated listed/certified materials. The installation of such fire rated materials shall be following certified design.</p> | Within 3 months |

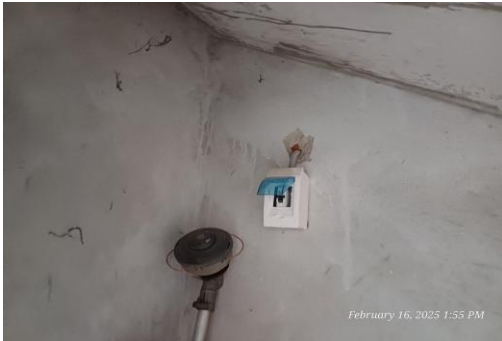
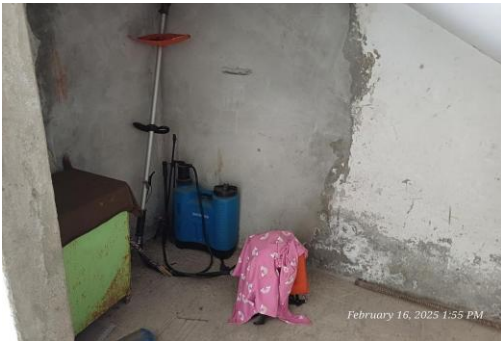
| 4 | Fire Rated Construction | <p>Electrical circuit breaker &amp; electrical connections and other storage materials are located in the exit stair-1 (South East) enclosure.</p> <p><b>(Location: 4-storied Existing RCC Childcare and Medical Building)</b></p> | Remove and re-locate all electrical connections and other storage materials from exit stair enclosures. | Within 3 months |

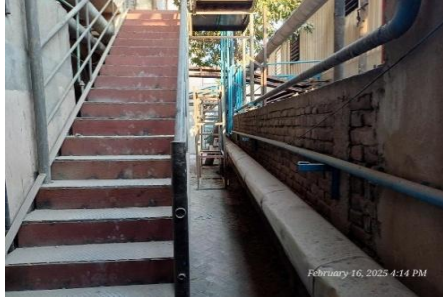
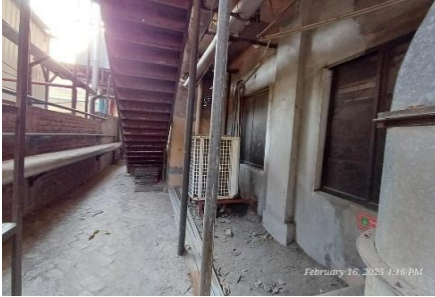
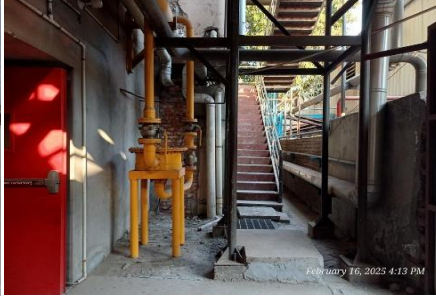
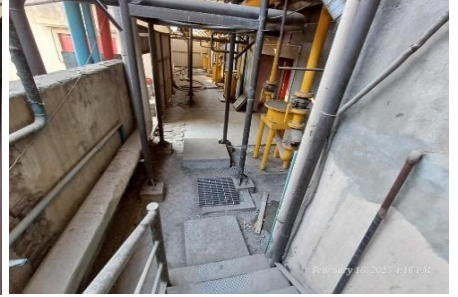
| 5 | Fire Rated Construction | <p>Exit Stair-2 (South West) discharge path is obstructed, uneven and doesn't discharge directly outside the building on the ground floor.</p> <p><b>(Location: 4-storied Existing RCC Childcare and Medical Building)</b></p> | <p>A maximum of 50 percent of the number and capacity of the exit enclosures can discharge through areas on the level of exit discharge where all of the following are met:</p> <p>(1) Automatic sprinkler protection is provided throughout the level of exit discharge or portion of the level of discharge where separated from non sprinklered portions of the floor by fire barriers with the same fire resistance rating as the exit enclosure.</p> <p>(2) The interior discharge is not through a storage or hazardous occupancy.</p> <p>(3) The entire area of the level of exit discharge is separated from areas below by construction having a fire resistance rating not less than that required for the exit enclosure.</p> <p>(4) The way to the exterior shall be free and unobstructed and shall be readily visible, even and identifiable from the point of discharge of the interior exit.</p> | Within 3 months |

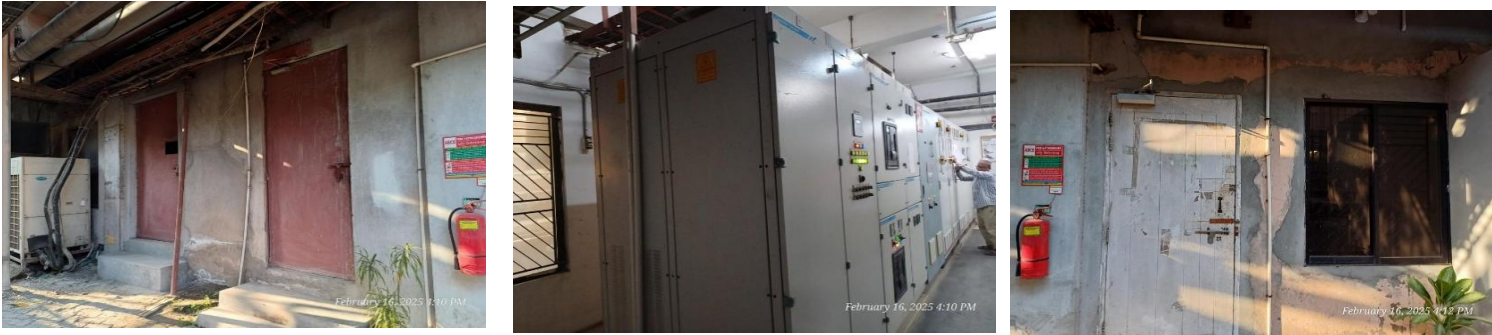
| 6 | Fire Rated Construction | <p>The substation room is not separated by fire rated construction due to openings, non-rated doors, and penetrations.</p> <p><b>(Location: 4-storied Existing RCC Childcare and Medical Building)</b></p> | <p>Separate the substation room by a minimum 2-hr fire-rated construction. Seal and/or protect all openings to maintain the required fire separations. When located to the exterior of a building 3m (10 ft.) spatial distance shall be maintained around the substation.</p> | Within 3 months |

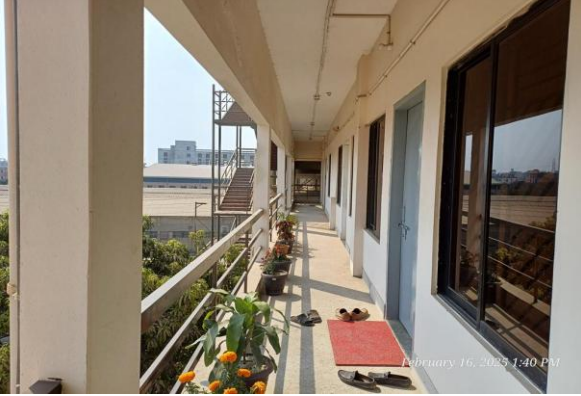
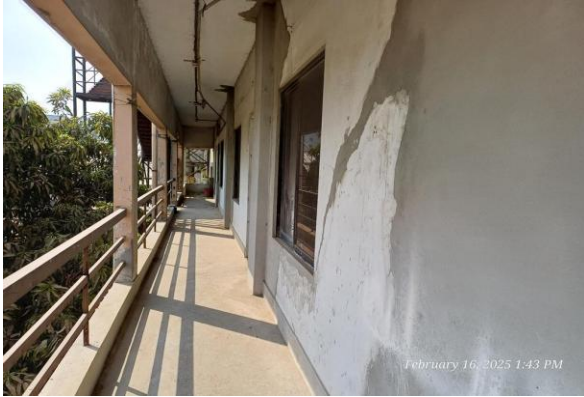
| 7 | Fire Rated Construction | <p>Exit access corridors serving Stair-2 (South West) and Stair-1 (South East) Stairs at 2nd and 3rd floors are not fire separated with unprotected opening from floor areas.</p> <p><b>(Location: 4-storied Existing RCC Childcare and Medical Building)</b></p> | <p>Exit access corridors serving an occupant load exceeding 30 shall be separated by walls having a fire resistance rating of 1 hr unless provided with automatic sprinkler protection throughout the story or building.</p> | Within 3 months |

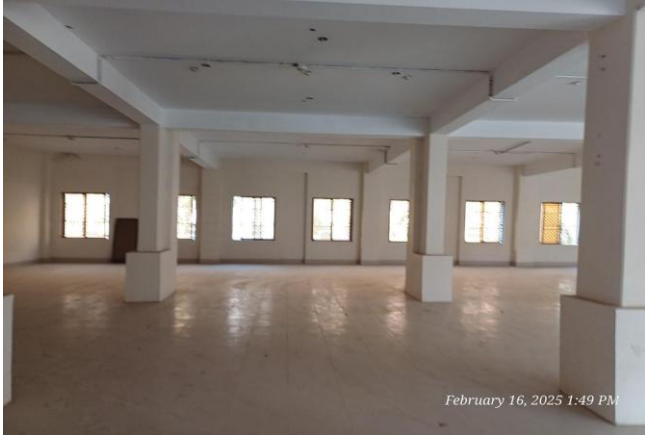
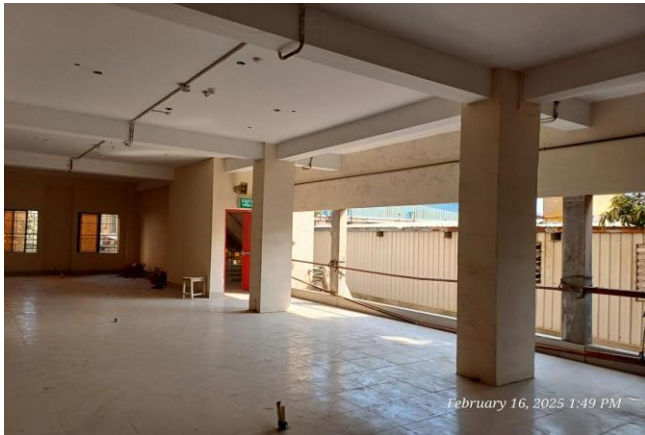
| 8 | Means of egress | <p>Aisles were not provided at all floors.</p> <p><b>(Location: 4-storied Existing RCC Childcare and Medical Building)</b></p> | <p>Provide minimum aisle widths of 36-in.</p> | Within 1 month |

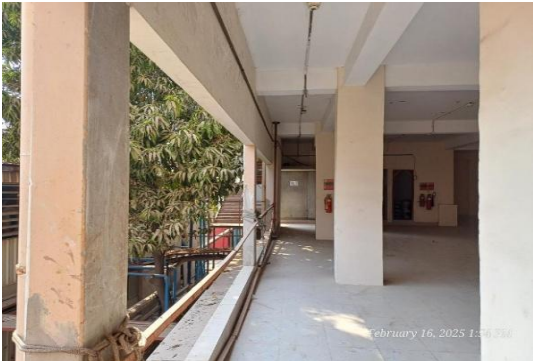
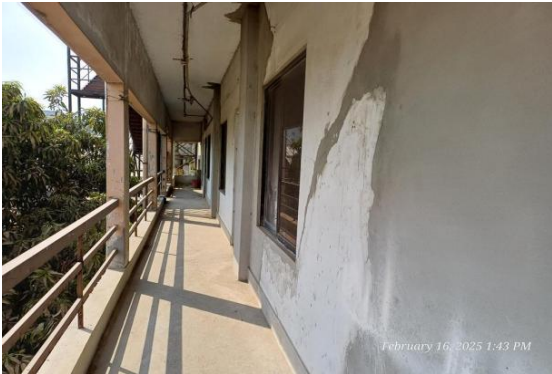
| 9 | Means of egress | <p>Occupiable floor is not provided with guard rails in compliant manner at all floor.<br/><b>(Location: 4-storied Existing RCC Childcare and Medical Building)</b></p> | <p>Guards shall be provided at all open sides of means of egress that exceed 760 mm (30 in.) above the floor or finished ground below. Open guards shall have intermediate rails or pattern such that a sphere 200 mm (8 in.) in diameter cannot pass through any opening up to a height of 865 mm (34 in.)</p> | Within 1 month |

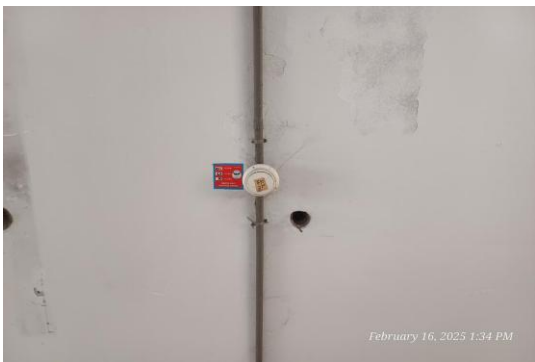
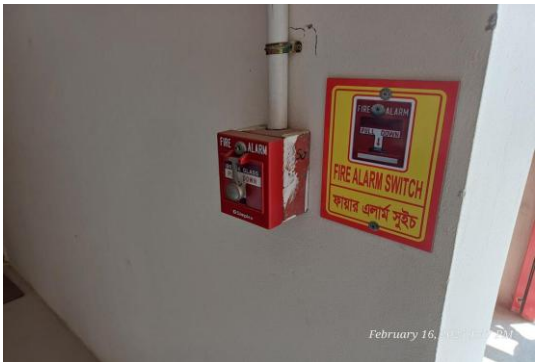
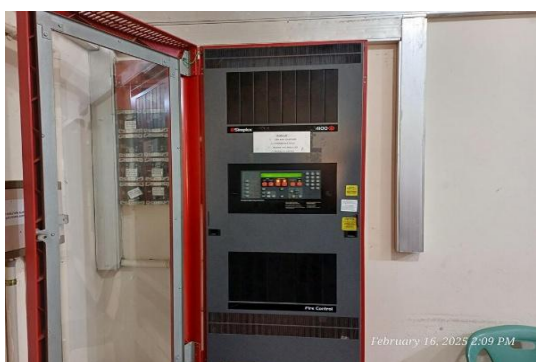
| 15 | Fire Alarm & Detection system | <p>Automatic fire alarm and detection system installation has been found complete which requires detailed review to confirm compliance with NFPA 72 and The RSC Technical Guidelines (Standard).</p> <p><b>(All Building)</b></p> | <p>Submit the fire alarm system design to RSC for review. Once the design is reviewed, install and modify the fire detection and alarm system throughout the buildings in accordance with review comment, RSC Technical Guidelines (Standard) and NFPA 72. After installation the owner shall conduct internal testing and commissioning and then contact the RSC for witness of final acceptance testing. Also inspect, test and maintain the fire alarm system, and keep written records on-site, in accordance with Table-14.3.1 of NFPA 72.</p> | <p>Design Review within 2 months and installation/modification within 4 months</p> |

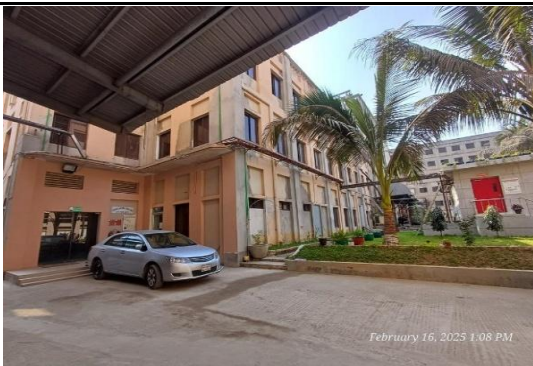
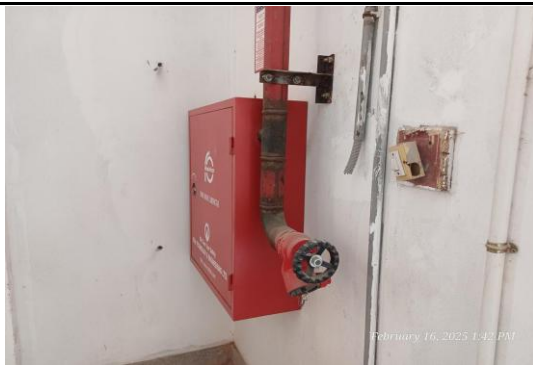
| 16 | Fire Protection System (Standpipe) | <p>The building has highest occupiable floor level more than 10 meter (33 ft.) which requires standpipe system.</p> <p><b>(Location: 4-storied Existing RCC Childcare and Medical Building)</b></p> | <p>Submit the standpipe system drawing to RSC for review. Once the design is reviewed, install and modify the standpipe system throughout the building in accordance with review comment, RSC Standard and NFPA 14, 20, 22 and 24. After installation the owner shall conduct internal testing and commissioning and then contact the RSC for witness of final acceptance testing.</p> | <p>Design Review within 2 month and installation within 4 months (If require).</p> |

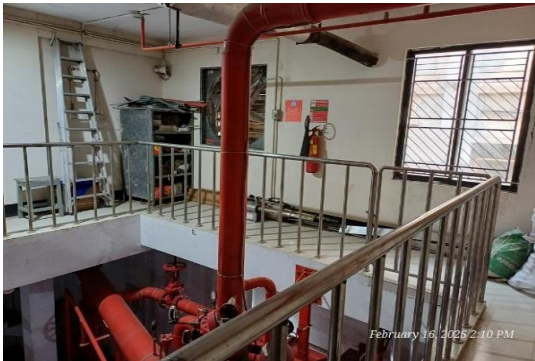
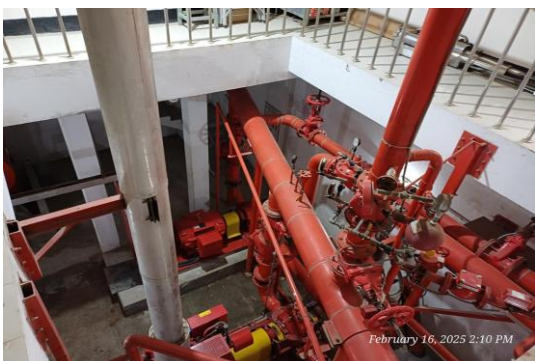
| 21 | Fire Rated Construction | <p>Electrical and Fire equipment accessories storage areas are found not separated from the fire pump room from basement to ground floor.</p> <p><b>(Location: Fire pump and control room)</b></p> | <p>Separate the fire pump rooms by minimum 2-hr fire-rated construction with other occupancies. Remove the storage area from the fire pump room as alternate solution.</p> | Within 2 months |

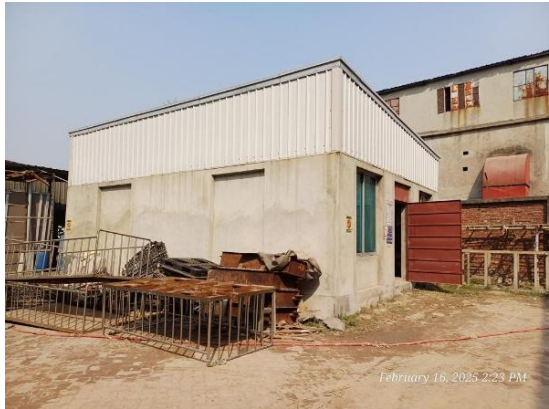
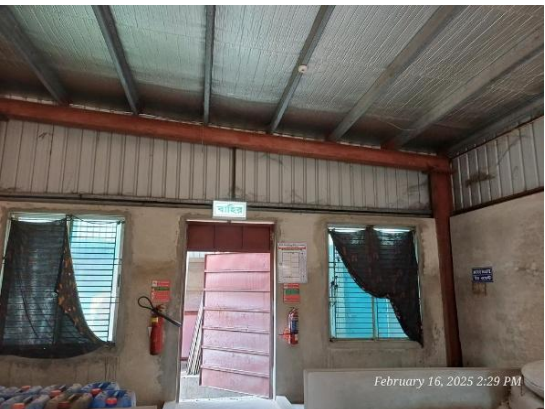
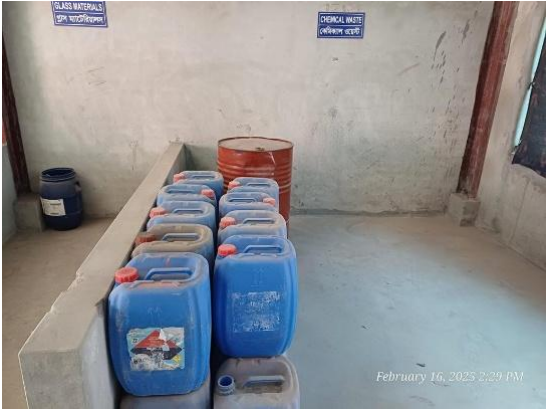
| 22 | Fire Rated Construction | <p>Rooms used for chemical waste storage are not properly separated by fire rated construction in the wastage shed with the surrounding structures (Screen print washing area).</p> <p><b>(Location: Wastage Shed)</b></p> | <p>Where more than one occupancy occurs and is not separated in accordance with 3.4.4, the most restrictive requirements for each occupancy shall apply for fire protection, means of egress, type of construction, and allowable building height and area. Ensure the chemical store fire separated by minimum 4-hr fire rated construction barrier with only occupancies with G and H following table 3.2.1 of BNBC-2020. No opening is permitted in the 4-hr rated wall towards any other occupancy. Follow section 2.13 of BNBC-2020 as a guideline chemical store while rearranging.</p> | Within 3 Months |
