# SOUTHERN CLOTHINGS LIMITED (EXTENSION-2)

Bottola, Zirabo, Ashulia, Dhaka

9 February 2025

## 2. Observations

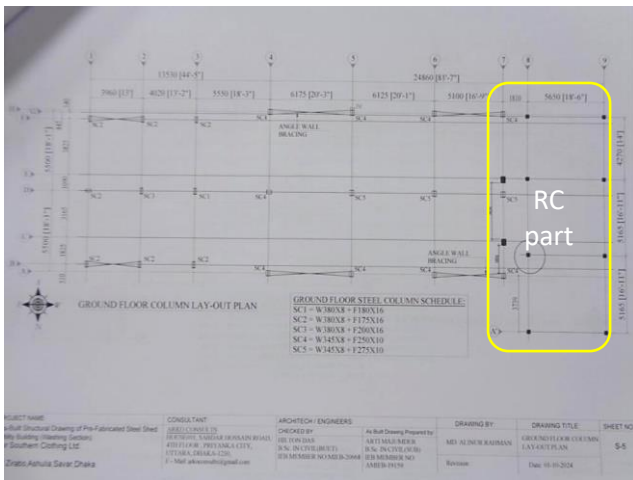
As-built drawing: Column Layout

**Observation 01:** Lack of design report, material test report and foundation details. (Building-2 Wash)

**Description:** The building consists of steel and reinforced concrete parts. It was extended horizontally, adding seven bays instead of the three shown in the permit drawings. No design documents exist for the current structure. The provided structural drawing lacks foundation details for the RC part, and the foundation details for the steel section do not reflect the as-built condition. There is no in-situ material test report for the building. Furthermore, there is no continued lateral load transfer media (compression strut) in the lateral load resisting system in the roof.

The building engineer is required to carry out Detail Engineering Assessment (DEA) for the structure to verify the foundation details, in-situ material strength, check the design against lateral forces, stresses and serviceability's. Prepare a full set of DEA documents with detailed remedial action plan. Submit the DEA documents to the RSC for review.

| SL | Observation | Action Plan | Timeline |
|---|---|---|---|
| 1. | Lack of design report, material test report and foundation details. (Building-2 Wash) | Verify in-situ concrete material strength by taking concrete cores (minimum 4 nos and 100 mm diameter) from lower tier building columns. Also, verify steel plate strength for column and beam/rafter. | within 6 weeks |
| 2. | | Verify foundation details | within 6 weeks |
| 3. | | The building engineer is required to carry out Detail Engineering Assessment (DEA) for the structure to check the design against lateral forces, stresses and serviceability's. Prepare a full set of DEA documents with detailed remedial action plan. Submit the DEA documents to the RSC for review. | within 6 weeks |

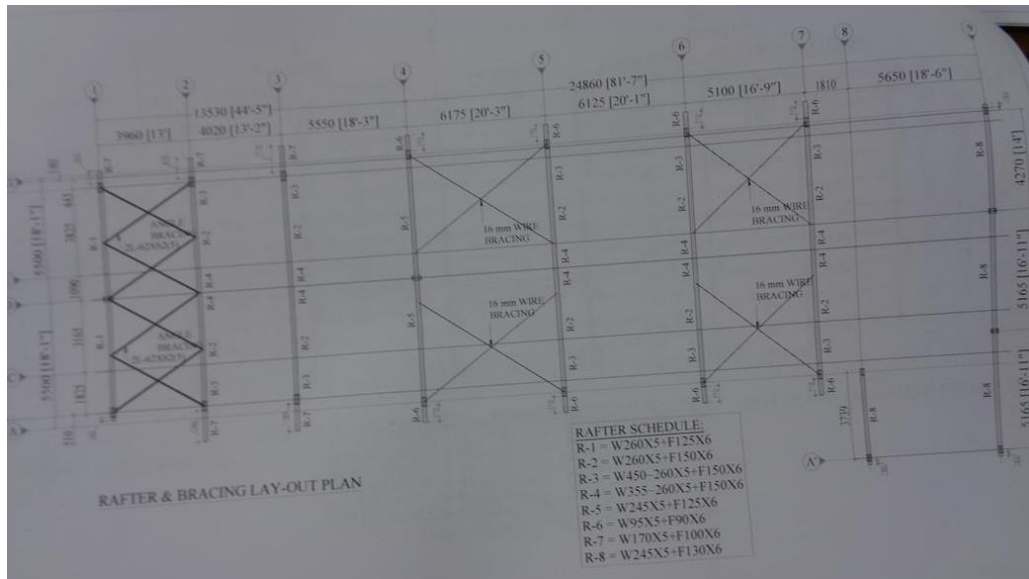
## Observation 02: Mismatch between drawing and as-built condition (Building-2 Wash)

**Description:** Foundation details of RC part were missing. Discrepancies were observed for almost all column grids (around 150 mm variations), rafter sizes (125 mm flange width instead 150), bracing layout & sizes (50 mm angle instead of 75mm), RC column sizes (250 mm instead 375 mm). Also, toilet zone with min. 300 mm floor raise was found on 1<sup>st</sup> floor which was not mentioned in the drawing.

The building engineer is required to survey the structure, prepare accurate as-built drawings with foundation and connection details.

| SL | Observation | Action Plan | Timeline |
|---|---|---|---|
| 6. | Mismatch between drawing and as-built condition (Building-2 Wash) | The building engineer is required to survey the structure and prepare as-built drawings with foundation and connection details. | within 6 weeks |

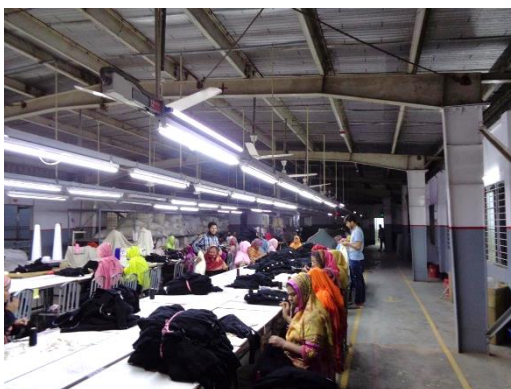
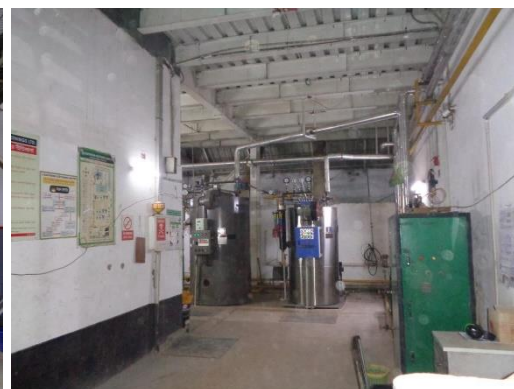
## Observation 03: Lack of floor load management program (Building-2 Wash)

**Description:** The 1<sup>st</sup> floor and ground floor boiler areas have suspended slabs. Neither floor load plan prepared for the suspended slabs nor posted on floor level. The building engineer is required to prepare floor load plan and implement load management program (post allowable floor load plan, mark storage area & height and maintain floor loading).

| SL | Observation | Action Plan | Timeline |
|---|---|---|---|
| 7. | Lack of floor load management program (Building-2 Wash) | The building engineer is required to implement floor load management program (post allowable load plan, mark storage area & height and maintain floor loading). | within 6 weeks |

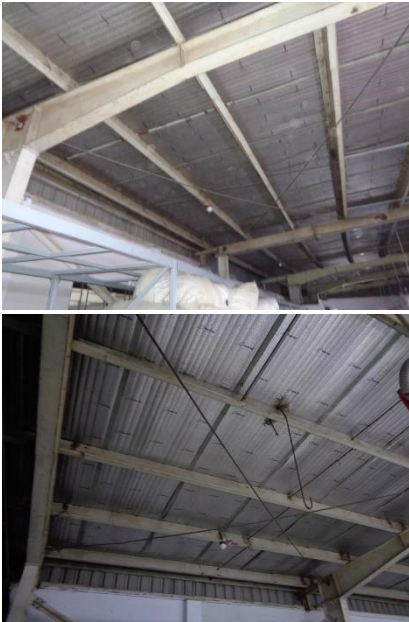
Loose bracing

**Description:** Loose bracing, connection gaps, bolt missing and inadequate edge clearances were observed in the building. The building engineer is required to tighten the loose bracings, repair the connection gap & inadequate clearance with suitable methods.

| SL | Observation | Action Plan | Timeline |
|---|---|---|---|
| 8. | Loose bracing, connection gap, bolt missing and inadequate edge clearance. (Building-2 Wash) | The building engineer is required to tighten the loose bracings, repair the connection gap & inadequate clearance with suitable methods. | within 6 weeks |

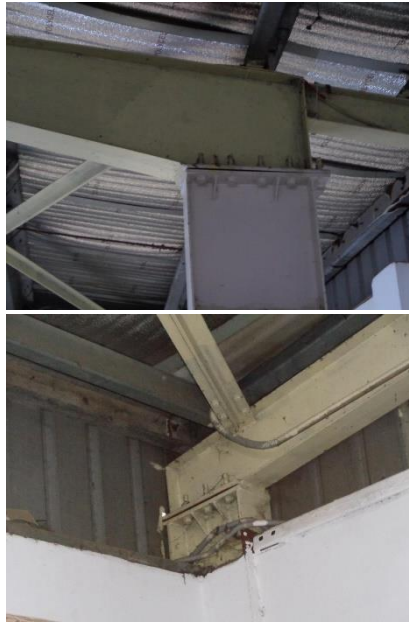
Gap between joint plates

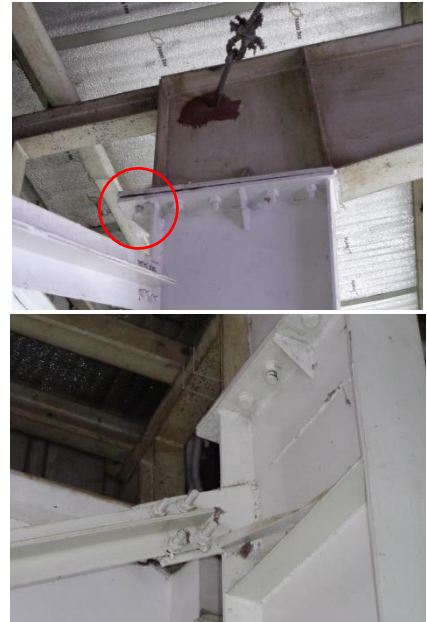
Bolt missing & inadequate edge clearance

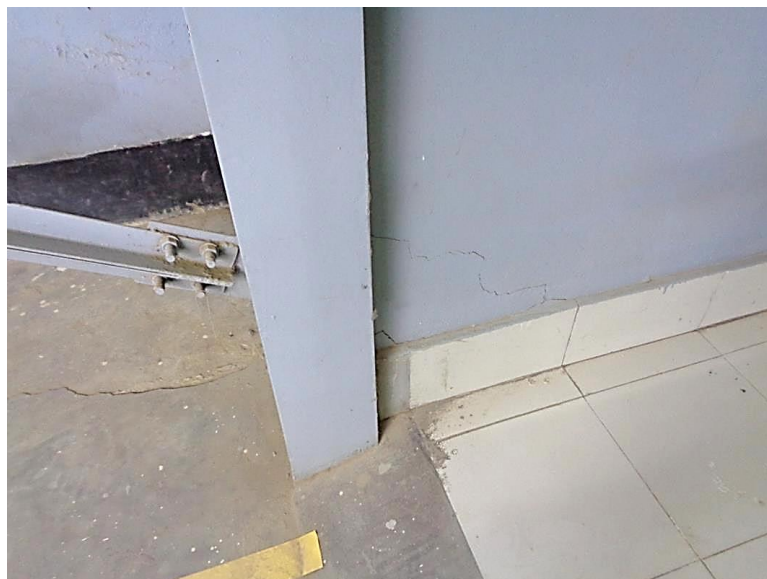
**Observation 05:** Crack on brick wall at stair landing (Building-2 Wash)

**Description:** Crack observed on brick wall at landing zone. The building engineer is required to check the deflection limit of landing slab, check other reasons for crack and repair with suitable method.

| SL | Observation | Action Plan | Timeline |
|---|---|---|---|
| 9. | Crack on brick wall at stair landing (Building-2 Wash) | The building engineer is required to check the deflection limit of landing slab, identify other reasons for the crack and repair with suitable method. | within 6 weeks |

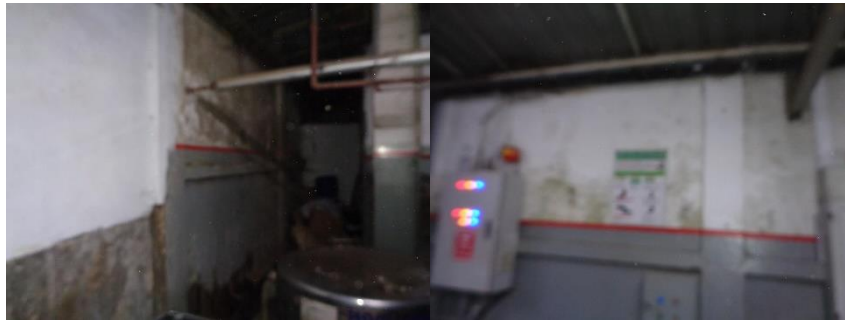
**Observation 06:** Dampness on wall for Building-2 (Wash)

**Description:** Dampness observed on brick facade walls due to water intrusions. The factory is required to identify all the damp locations throughout the building, seal the source of water, and repair the damp areas with suitable methods.

| SL | Observation | Action Plan | Timeline |
|---|---|---|---|
| 10. | Dampness on wall for Building-2 (Wash) | The building engineer is required to identify all the damp locations throughout the building, seal the source of water, and repair the damp areas with suitable method. | within 6 weeks |

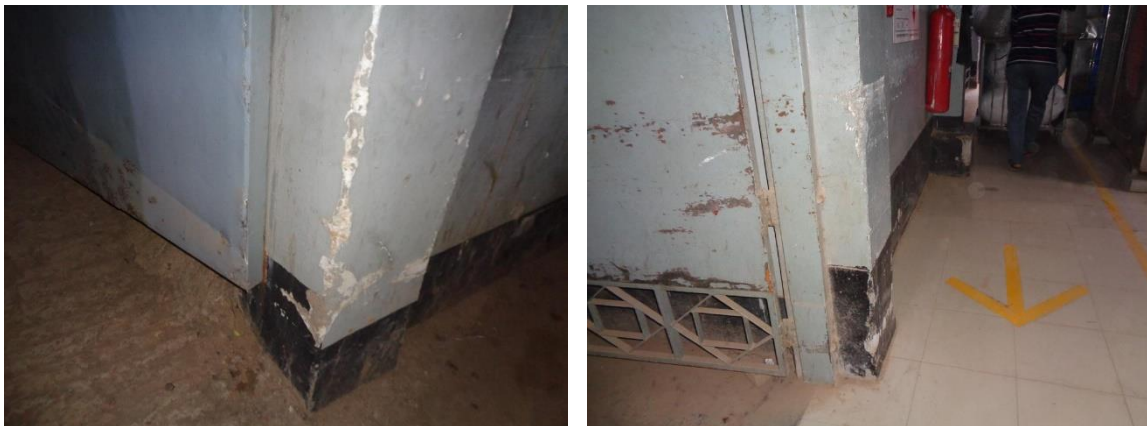
Trolley impact and surface damage on columns

**Description:** Damage due to trolley impact was observed on ground floor columns. The building engineer is required to provide column guard to protect from trolley impact.

| SL | Observation | Action Plan | Timeline |
|---|---|---|---|
| 11. | Trolley impact and surface damage (Building-2 Wash) | The building engineer is required to provide column guard to protect from trolley impact. | within 6 months |

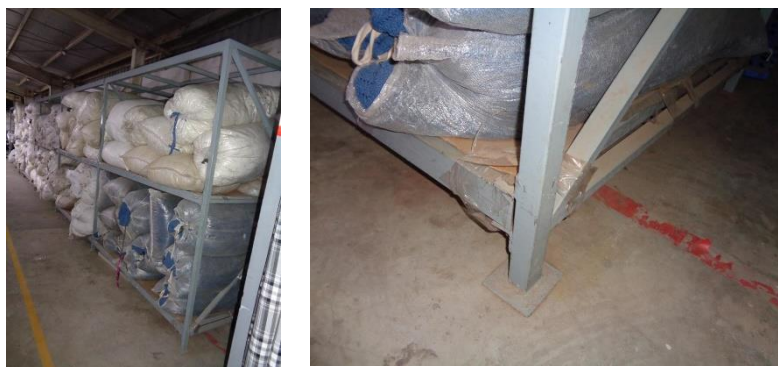
**Observation 08:** Lack of anchorage/braced of non-structural elements. (Building-2 Wash)

**Description:** Non-structural elements (storage racks) were found not anchored & unbraced. The factory is required to brace/anchor all the non-structural elements within the building.

| 12. | Lack of anchorage / bracing of non-structural elements. (Building-2 Wash) | The factory is required to brace/anchor all the non-structural elements within the building. | within 6 months |

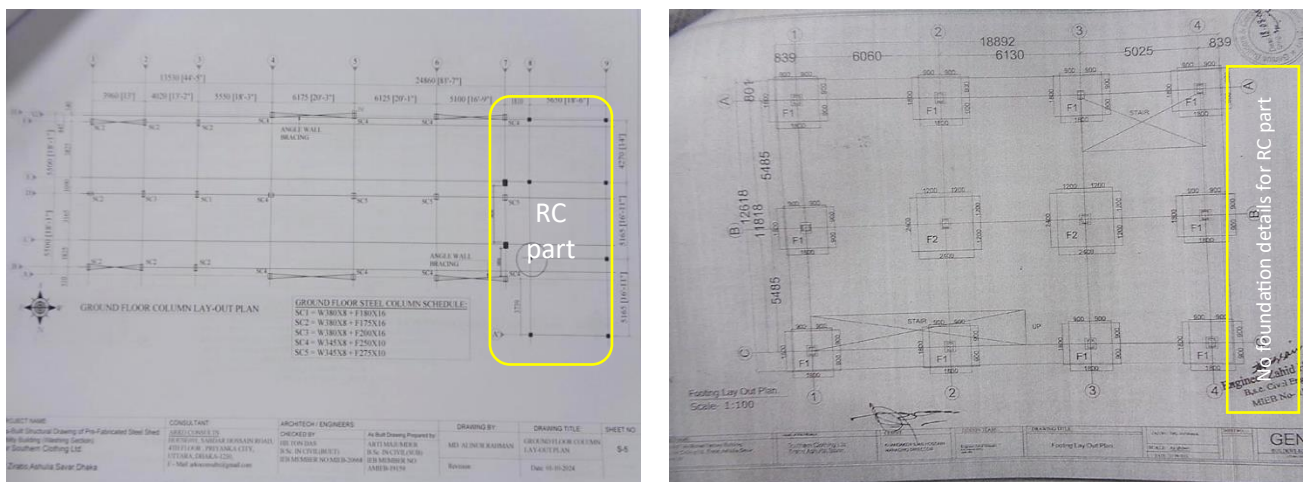
**Building-2 Wash: Permit didn't reflect the as-built construction, a portion of building is missing in permit drawing**

**Description:** The building permit for Building-2 Wash didn't reflect the actual building layout. Also, the date of drawing and date of permit create confusion regarding the authenticity of the permit. The building permit for Building-7 Dining was not taken from BNBC-2020 prescribed local authority. The factory is required to collect building permits from BNBC prescribed local authority.

| 13. | Inconsistency in the Building Permits (Building-2 & Building-7) | The factory is required to collect building permits from BNBC prescribed local authority. | within 6 months |

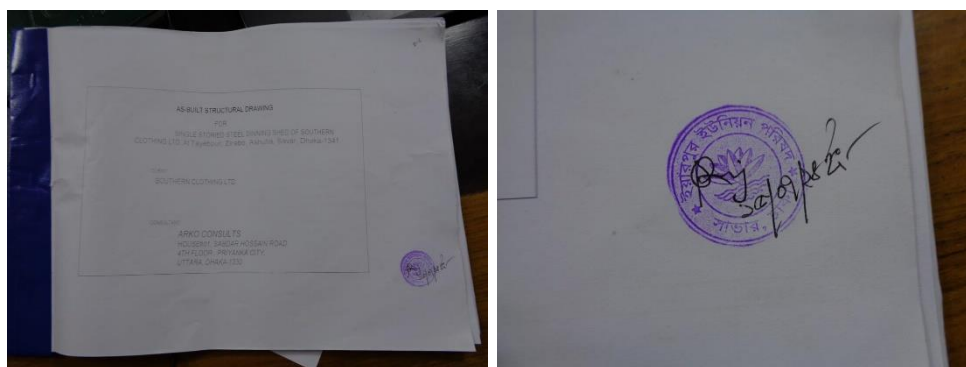
**Building-7 Dining: Permit taken from local Union Parishad dated 15 July 2024**

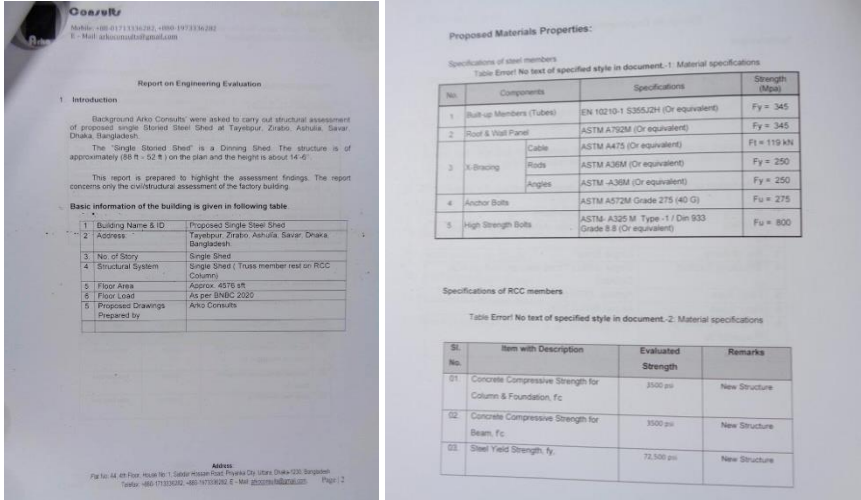
**Observation 10: Revision of design report based on in-situ material strength (Building-7 Dining)**

**Description:** A set of design reports was available for the shed. Steel material strength considered 50 ksi without test report. The building engineer is required to verify in-situ material strength and revise the design documents accordingly.

| 14. | Revision of design report based on in-situ material strength (Building-7 Dining) | The building engineer is required to verify in-situ material strength and revise the design documents accordingly. | within 6 weeks |
| 15. | | Carry out suggested remedial works where required. | within 6 months |

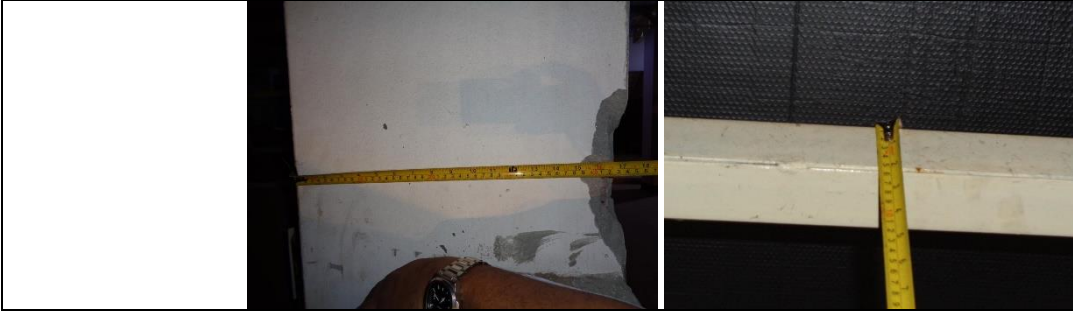
**Observation 11: Mismatch in as-built drawings (Building-7 Dining)**

**Description:** The central edge columns size was found as 400 mm instead 450 mm. Also, the central compression strut was found as 50x50 mm box instead 63x63 mm box. The building engineer is required to survey the structures and prepare as-built drawings.

| 16. | Mismatch in as-built drawings (Building-7 Dining) | The building engineer is required to survey the structure and prepare as-built drawings with details. | within 6 weeks |

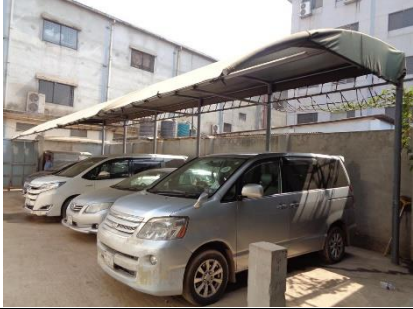
**Observation 12: Lack of as-built drawings (Car Parking Canopy)**

**Description:** There was no drawing for the car parking canopy. The building engineer is required to survey the structures and prepare as-built drawings.

| 17. | Lack of as-built drawings (Car Parking Canopy) | The building engineer is required to survey the structure and prepare as-built drawings. | within 6 weeks |
