# UNITED COSTUME LIMITED (BUILDING-02)

Malancha Nagar, I/A, R#2, West Isdair, Fatullah, Narayanganj,

20 February 2025

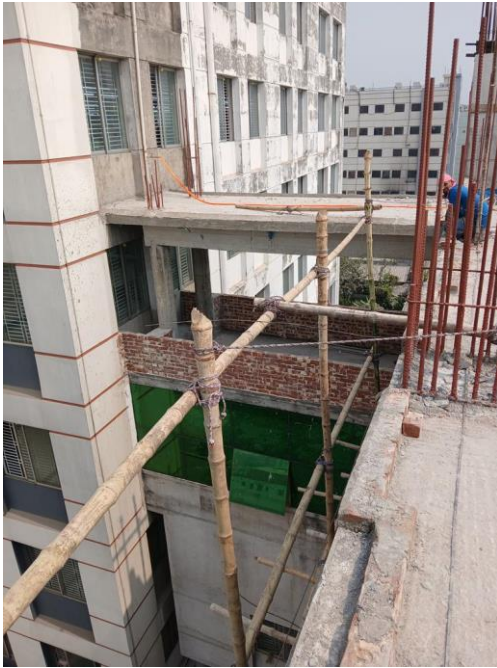
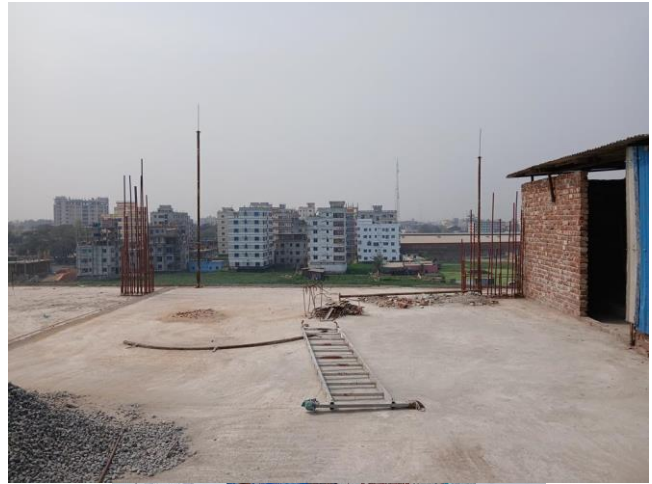
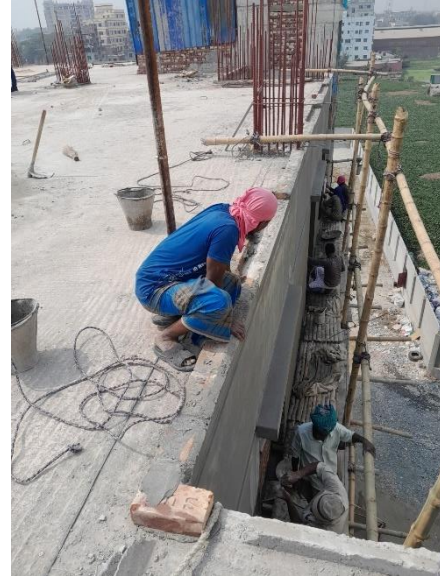
### Observation-01: Construction Safety practice & Falling hazard (Production Building-02).

**Description:** During the inspection, ongoing construction work was observed with a lack of safety measures, including fall protection, unsafe scaffolding, and inadequate edge protection on the roof. The building engineer is required to ensure all the construction safety according to BNBC Part 7, Chapter 3. The ongoing vertical extension and renovation work should be carried out following the required safety measures as per BNBC.

| Item No | Observation | Action Plan | Timeline |
|---|---|---|---|
| 1. | Construction Safety practice & Falling hazard (Production Building-02). | The building engineer is required to ensure all the construction safety according to BNBC Part 7, Chapter 3. The ongoing vertical extension and renovation work should be carried out following the required safety measures as per BNBC. | Immediate |

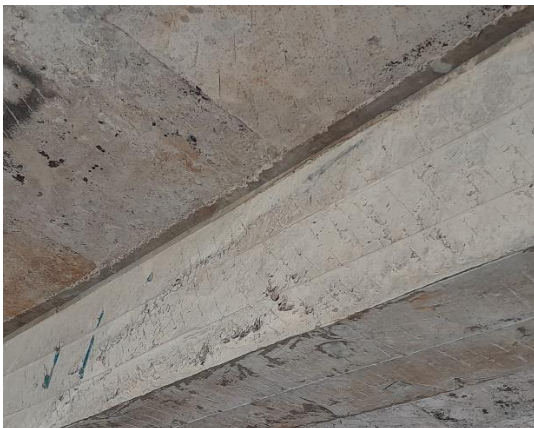
## Observation-02: Inconsistencies in design report and material strength (Production Building-02).

**Description:** During the inspection, the design report was found on-site, and the following observations were noted:

- The Response Modification Coefficient ( $R = 8$ ) has been considered in the design, but the required justification or supporting calculations were not provided in the report.
- The rebar design strength was considered as 72.5 grade, whereas the test report indicates 60 grade rebar.
- The material strength was considered as 24 MPa for beams and slabs and 28 MPa for columns, but no cylinder test report was available on-site.
- Ongoing construction quality and workmanship were observed and monitored less by the building engineer. Segregation in concrete was observed in the beams, columns, and slabs.

The building engineer is required to verify the in-situ concrete strength by extracting 100mm diameter cores from four columns (preferably from the lower tier of the building), as well as from the beam and slab, or by referring to existing cylinder test reports from the specific concrete mix ratio. Also, Check the construction quality by Non-Destructive Test (NDT) & Destructive Test (DT).

| Item No | Observation | Action Plan | Timeline |
|---|---|---|---|
| 2. | Inconsistencies in the design report and material strength (Production Building-02). | The building engineer is required to revise the design report as per the as-built condition and prepare the design report as per BNBC 1.9. | within 6 weeks |
| 3. | | The building engineer is required to verify the in-situ concrete strength by extracting 100mm diameter cores from four columns (preferably from the lower tier of the building), as well as from the beam and slab, or by referring to existing cylinder test reports from the specific concrete mix ratio. | within 6 weeks |
| 4. | | Check the construction quality by Non-Destructive Test (NDT) & Destructive Test (DT). | within 6 weeks |

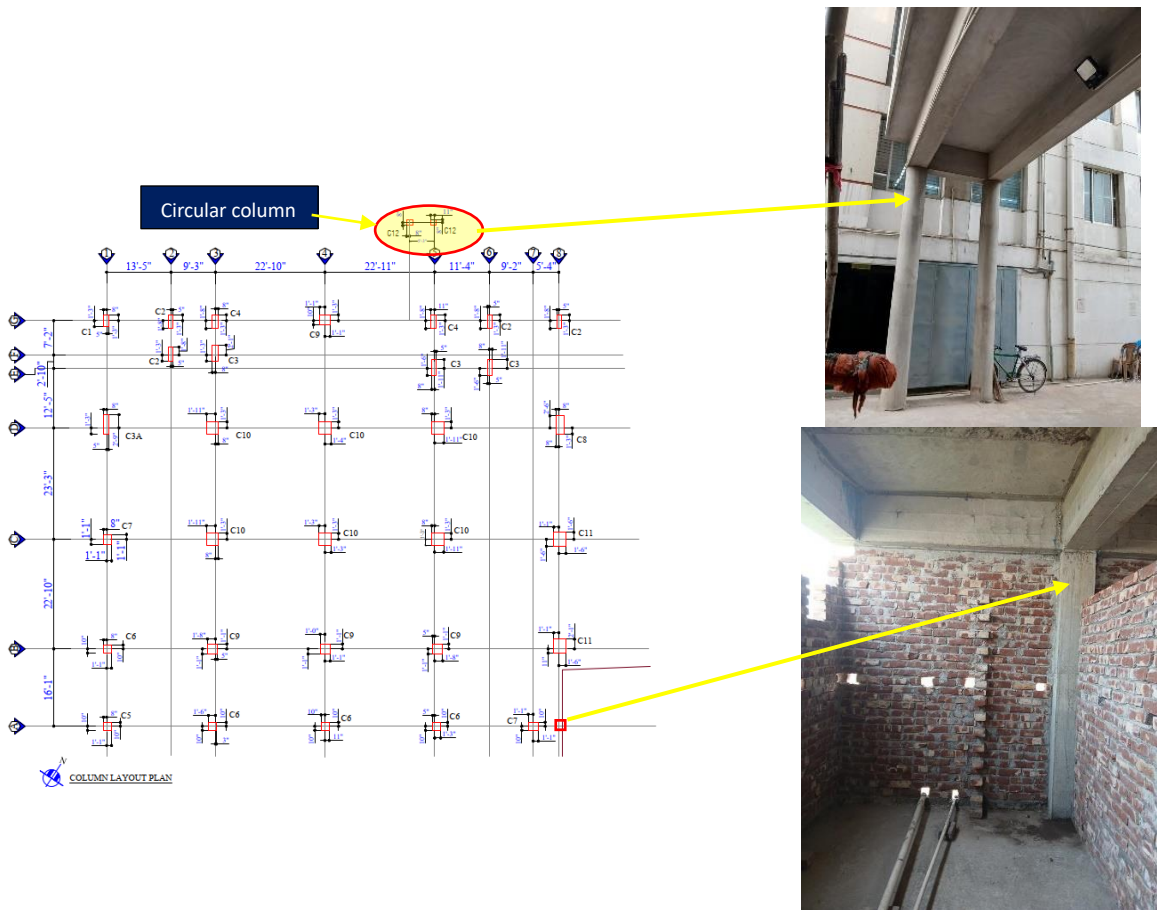
**Observation-03:** Mismatch/Lack of information in as-built drawing (Production Building-02).

**Description:** A 300 x 300 mm column was found at grid A-08, which was not shown in the column layout. Additionally, two 400 mm diameter circular columns were found in the connection bridge instead of a square column.

The building engineer is required to survey the structures and prepare comprehensive as-built drawings, including necessary foundation details.

| Item No | Observation | Action Plan | Timeline |
|---|---|---|---|
| 7. | Mismatch/Lack of information in as-built drawing (Production Building-02). | The building engineer is required to survey the structures and prepare comprehensive as-built drawings, including steel specifications, sections, foundation details, and necessary connection information. | within 6 weeks |

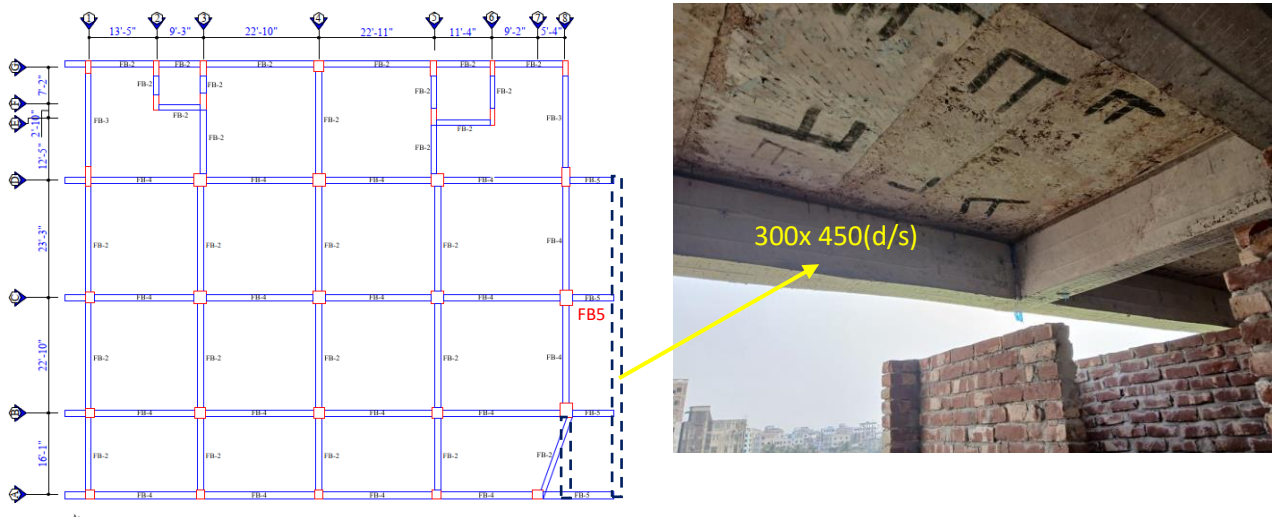
**Description:** A beam was found from 8-B to 8A instead of 8B to 7A, and a sub-beam was observed in the cantilever portion [size 300x450 (d/s)], which was not shown in the beam layout. Additionally, FB5 was found to be 300x450 (d/s) instead of 300x600 (d/s).

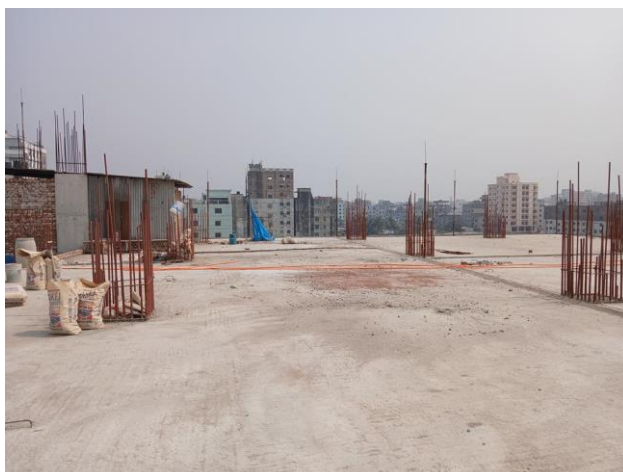
**Observation-04:** Waterproofing is required for the Masonry Chips Aggregate Concrete (MCAC) construction on the roof (Production Building-02).

**Description:** The slab of the building is constructed with MCAC. The building engineer is required to provide a waterproofing layer with proper installation of the adequate number of drainage outlets.

| Item No | Observation | Action Plan | Timeline |
|---|---|---|---|
| 8. | Waterproofing is required for the Masonry Coarse Aggregate Concrete (MCAC) construction on the roof (Production Building-02). | The building engineer is required to provide a waterproofing layer with proper installation of the adequate number of drainage outlets. | within 6 months |

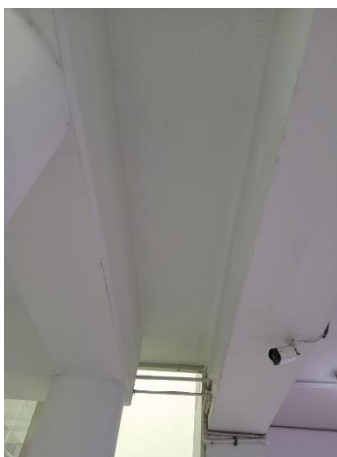
**Observation-05:** Connection bridge is rigidly attached to the adjacent building (Production Building-02).

**Description:** The structure shows no visible signs of expansion joints or flexible connections to the adjacent building.

A clear gap is required to be provided with an expansion joint, and the gap is to be filled with appropriate compressible materials as per the engineer's recommendation. Otherwise, consider the design of the main building.

| Item No | Observation | Action Plan | Timeline |
|---|---|---|---|
| 9. | The connection bridge is rigidly attached to the adjacent building (Production Building-02). | A clear gap is required to be provided with an expansion joint, and the gap is to be filled with appropriate compressible materials as per the engineer's recommendation. | within 6 weeks |

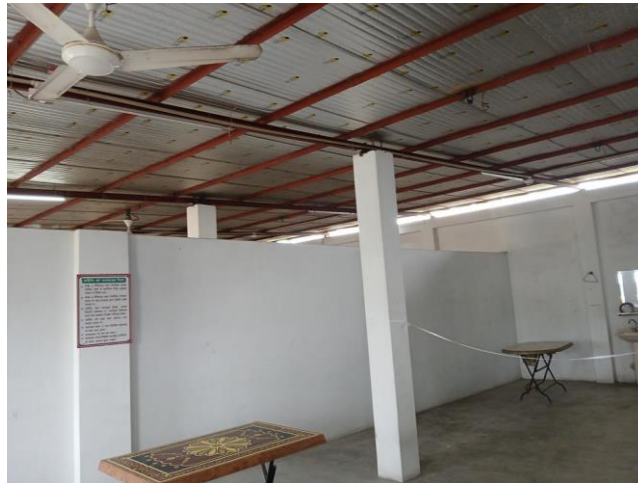
**Observation-06:** Lack of lateral stability system (load transfer media, bracing & proper connection)  
(Dining and Prayer Shed)

**Description:** Load transfer media and bracing along both directions was found missing. The building engineer is required to carry out an Engineering Assessment (EA) to check the lateral stability, connection and member adequacy of these structures.

| 9. | Lack of lateral stability system (load transfer media, bracing & proper connection) (Dining and Prayer Shed) (Dining and Prayer Shed) | The building engineer is required to carry out an Engineering Assessment (EA) to check the lateral stability, connection and member adequacy of these structures. | within 6 weeks |
| 10. | | Carry out the suggested remedial works. | within 6 months |

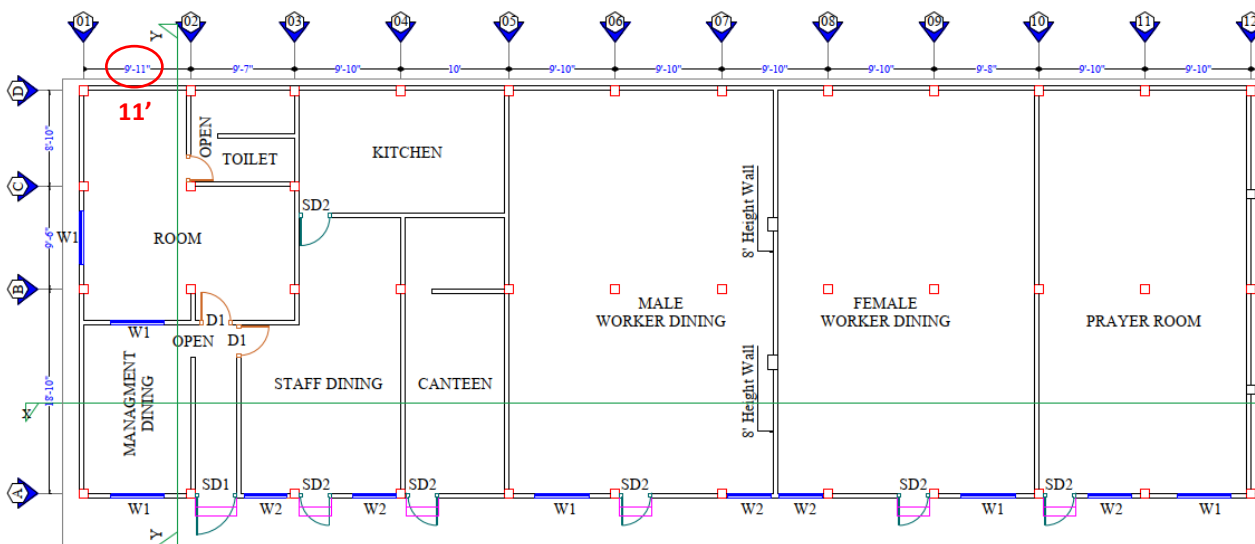
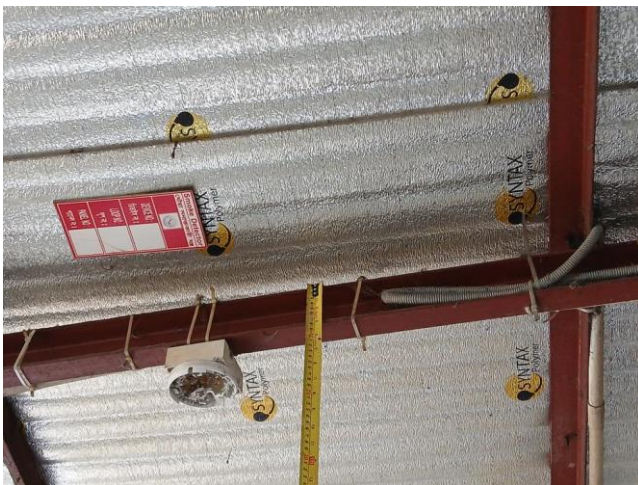
**Observation-07:** Mismatch/lack of information in as-built drawing (Dining and Prayer Shed)

**Description:** The grid dimension between 1-2 was found 11 feet (3.3m) and C-purlin size found 75x38x4 mm which differs from drawings.

The building engineer is required to survey the structures and prepare comprehensive as built drawings, including steel specifications, sections, foundation details, and necessary connection information.

| 11. | Mismatch/Lack of information in as-built drawing (Dining and Prayer Shed) | The building engineer is required to survey the structures and prepare comprehensive as-built drawings, including steel specifications, sections, foundation details, and necessary connection information. | within 6 weeks |

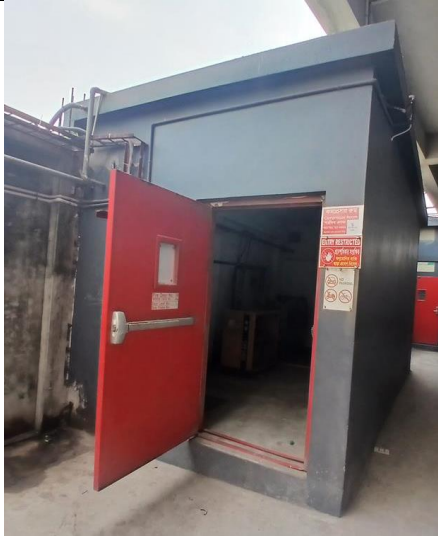
Compressor Room-02

**Description:** As-built structural & architectural drawings were not available for those structures.

The building engineer is required to survey the structures and prepare as-built drawings.

| 13. | Lack of as-built drawings (Compressor room-02) | The building engineer is required to survey the structures and prepare as-built drawings for the structures. | within 6 weeks |
