# Knit Concern Ltd (Extension)

62, Water Works Road Godnail, Narayangonj.

22 January 2025

## 2. Observation

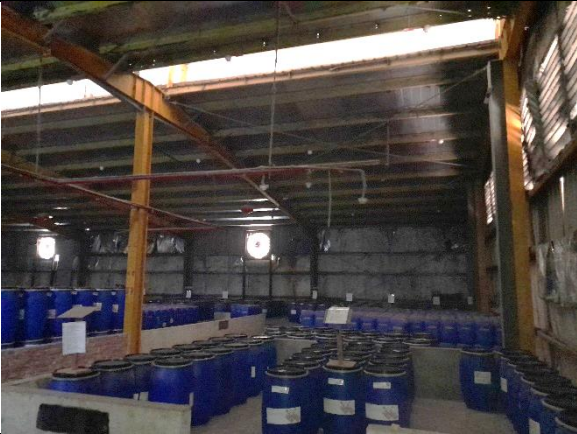
| <b>Observation 1:</b> Stress in foundation above the normal design limit (Shed 1 Chemical Godown). | |
| <p><b>Description:</b> Cursory calculation indicates that stress in foundation exceeds normal design limit considering the live load of 6 kPa on the 1<sup>st</sup> floor, 1 kPa on the roof sheet, allowable soil bearing capacity 1 ksf (FoS:2.5), concrete strength 14.1 MPa minimum for brick chips and considered conservative geometric properties of foundation.</p> <p>The building engineer is required to carry out a Detailed Engineering Assessment (DEA) to check the foundation adequacy and prepare a remedial scheme.</p> | |

| Item No. | Observation | Action Plan | Timeline |
|---|---|---|---|
| 1. | Stress in foundation above the normal design limit (Shed 1 Chemical Godown). | The building engineer is required to carry out a Detailed Engineering Assessment (DEA). | within 6 weeks |
| 2. | | Produce and actively manage load plan | within 6 weeks |
| 3. | | Verify in-situ concrete and steel strength. | within 6 weeks |
| 4. | | Implement remediation work from DEA. | within 6 months |
| 5. | | Implement load plan. | within 6 months |

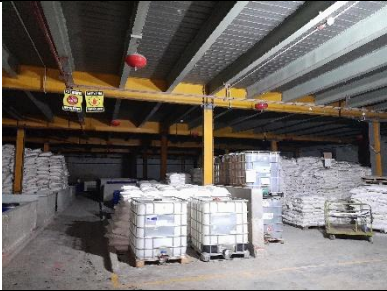
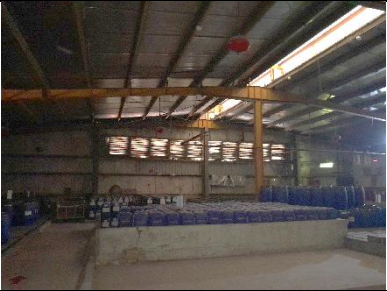
| <b>Observation 2:</b> Lack of lateral Stability of the shed (Shed 1 Chemical Godown). | |
| <p><b>Description:</b> Lack of lateral load resistance system observed in the shed: missing compression strut, moment resisting connection in the long direction.</p> <p>The building engineer is required to check the lateral stability of the structure as part of DEA.</p> | |

| Item No. | Observation | Action Plan | Timeline |
|---|---|---|---|
| 6. | Lateral Stability of the shed (Shed 1 Chemical Godown). | The building engineer is required to check the lateral stability of the shed. | within 6 weeks |

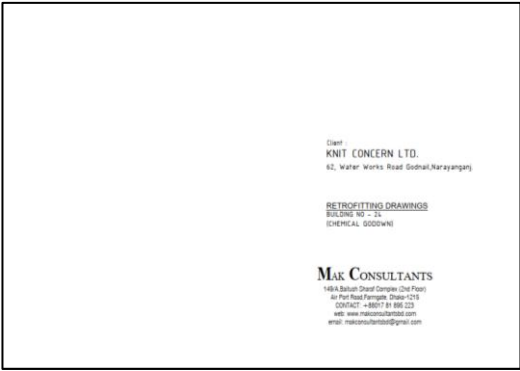
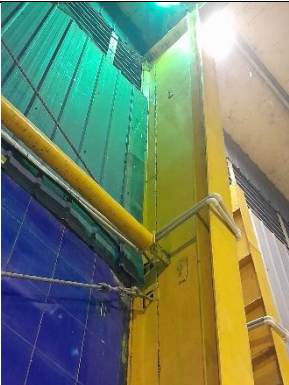
| <b>Observation 3:</b> Incomplete retrofitting works and as-built drawing (Shed 1 Chemical Godown). | |
| <p><b>Description:</b> Incomplete retrofitting works were observed. Lack of information observed in the as-built drawing and there was no substructural detail in the prepared drawings.</p> <p>The building engineer is required to survey the structure and prepare accurate as-built drawings including the retrofitting and substructural details.</p> | |

| Item No. | Observation | Action Plan | Timeline |
|---|---|---|---|
| 7. | Incomplete retrofitting works and as-built drawing (Shed 1 Chemical Godown). | The building engineer is required to survey the structure and prepare an accurate and detailed as-built drawing. | within 6 weeks |

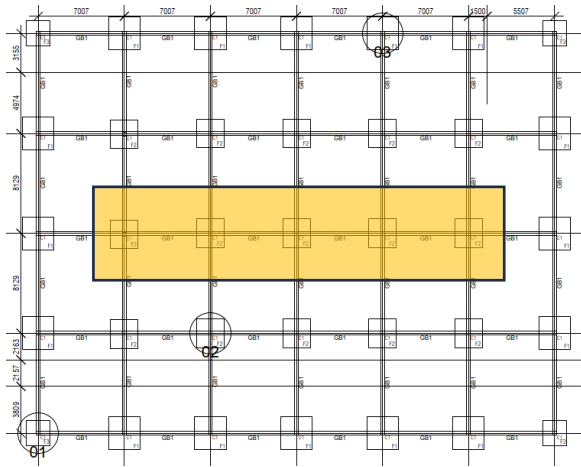
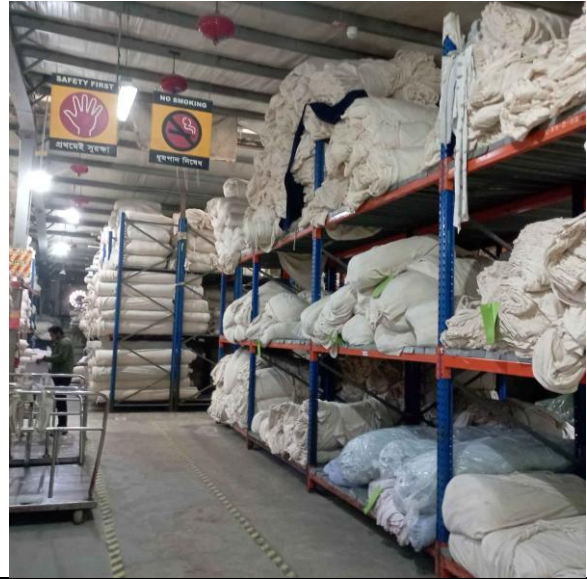
**Observation 4:** High stress in column and foundation that requires immediate design review (Shed 2-Row Fabric Store).

**Description:** Cursory calculation indicates the high stress in the column and foundation (punching) at the marked locations considering the live load of 4 kPa on the 1<sup>st</sup> floor, 1 kPa on the roof sheet, minimum steel strength (248 MPa), and minimum concrete strength (14.1 MPa).

The building engineer is required to check the column, foundation adequacy check and carry out a Detailed Engineering Assessment (DEA).

| Item No. | Observation | Action Plan | Timeline |
|---|---|---|---|
| 8. | High stress in column and foundation that requires immediate design review (Shed 2-Raw Fabric Store). | The building engineer is required to carry out a Detailed Engineering Assessment (DEA). | Immediate |
| 9. | | Produce and actively manage load plan | within 6 weeks |
| 10. | | Verify in-situ concrete and steel strength. | within 6 weeks |
| 11. | | Implement remediation work from DEA. | within 6 months |
| 12. | | Implement load plan. | within 6 months |

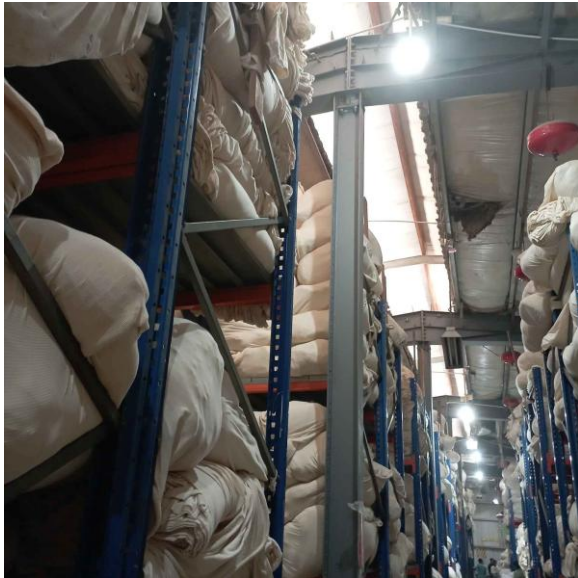
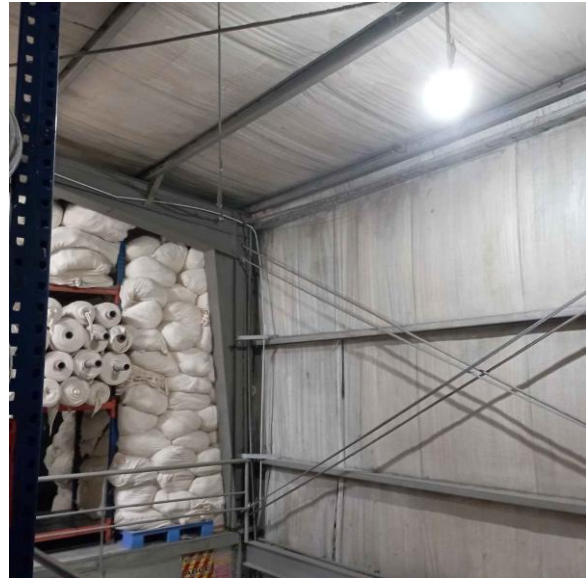
**Observation 5:** Lack of lateral stability (Shed 2-Row Fabric Store).

**Description:** Lateral load transfer media is not provided to transfer the lateral load. As part of DEA, the building engineer is required to check the lateral stability of the structure and prepare remedial scheme.

| Item No. | Observation | Action Plan | Timeline |
|---|---|---|---|
| 13. | Lack of lateral stability (Shed 2-Raw Fabric Store). | The building engineer is required to check the lateral stability of the structure. | within 6 weeks |

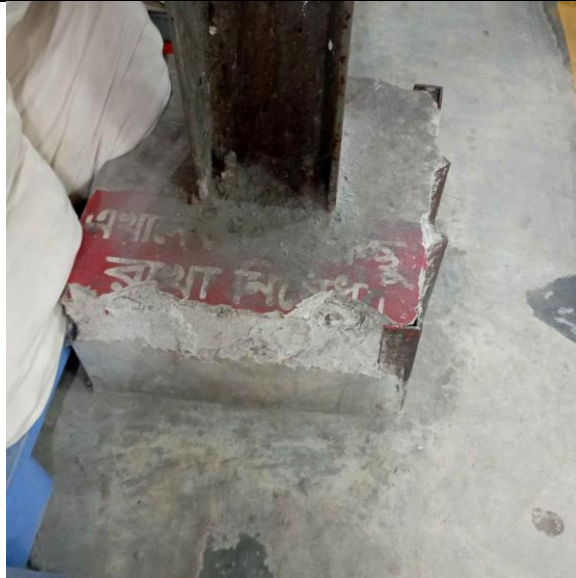
**Observation 6:** Column plaster damage due to trolley impact (Shed 2-Raw Fabric Store).

**Description:** Column plaster was found damaged due to trolley impact. The building engineer is required to repair the damaged plaster and provide the column guard to prevent trolley impact.

| Item No. | Observation | Action Plan | Timeline |
|---|---|---|---|
| 14. | Column plaster damage due to trolley impact (Shed 2-Raw Fabric Store). | The building engineer is required to repair the damaged plaster and provide the column guard to prevent trolley impact. | within 6 weeks |

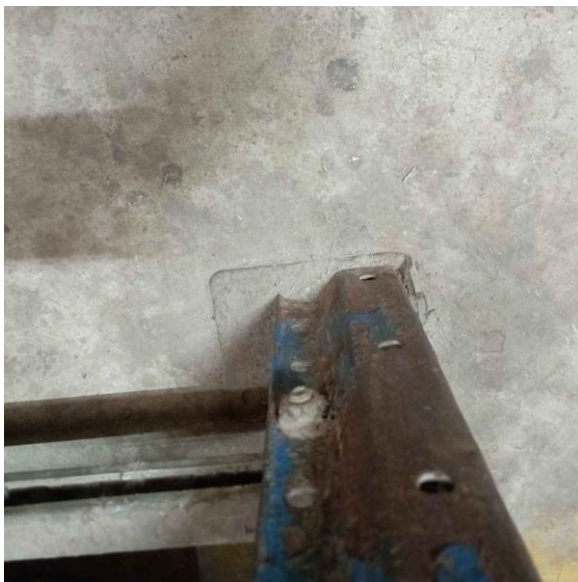
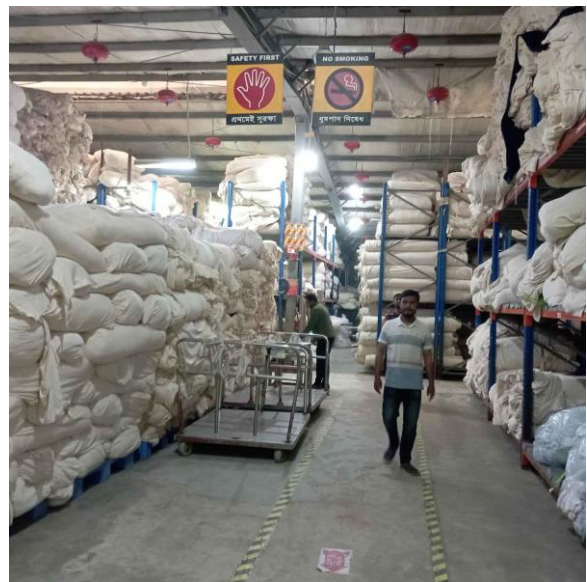
**Observation 7:** Non-structural elements found not anchored/braced (Shed 2-Raw Fabric Store).

**Description:** Nonstructural elements (storage racks) were found not anchored/braced. The building engineer is required to anchor/brace all nonstructural elements within the factory.

| Item No. | Observation | Action Plan | Timeline |
|---|---|---|---|
| 15. | Non-structural elements found not anchored/braced (Shed 2-Raw Fabric Store). | The building engineer is required to anchor/brace all nonstructural elements within the factory. | within 6 months |

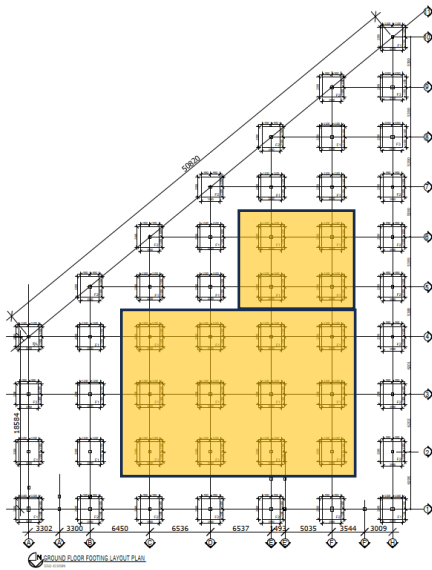
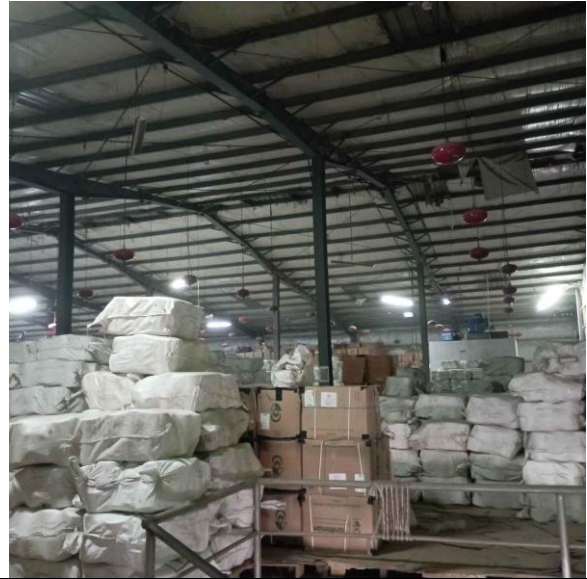
**Observation 8:** High stress in foundation that requires immediate design review (Shed 3 Yarn Godown).

**Description:** cursory calculation indicates the high stress in foundation at the marked locations considering the live load of 4 kPa on the 1<sup>st</sup> floor, 1 kPa on the roof sheet, allowable soil bearing capacity 1 ksf (FoS:2.5) assuming the footing depth 1.5 m considering the onsite condition and found of adjacent structures (footing depth from EGL not shown). The building engineer is required to carry out a Detailed Engineering Assessment (DEA) to check the foundation adequacy and prepare necessary remedial scheme.

| 16. | High stress in foundation that requires immediate design review (Shed 3 Yarn Godown). | The building engineer is required to carry out a Detailed Engineering Assessment (DEA). | Immediate |
| 17. | | Produce and actively manage load plan | within 6 weeks |
| 18. | | Verify in-situ concrete and steel strength. | within 6 weeks |
| 19. | | Implement remediation work from DEA. | within 6 months |
| 20. | | Implement load plan. | within 6 months |

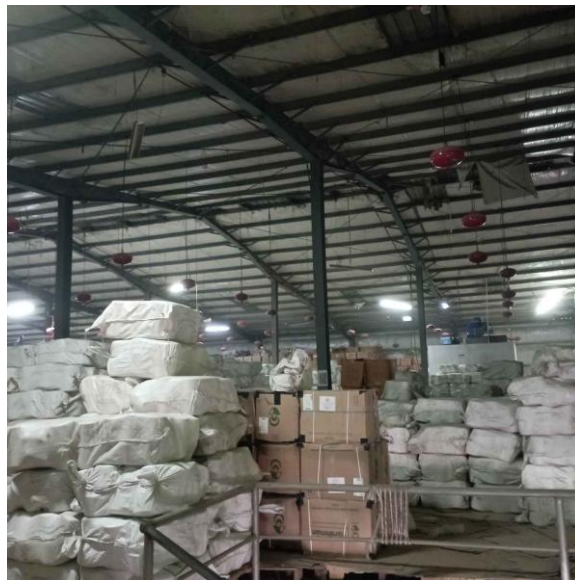
**Observation 9:** Lack of lateral stability (Shed 3 Yarn Godown).

**Description:** Lateral load transfer media is not provided to transfer the lateral load. As part of DEA, the building engineer is required to check the lateral stability of the shed.

| 21. | Lack of lateral stability (Shed 3 Yarn Godown). | The building engineer is required to check the lateral stability of the structure. | within 6 weeks |

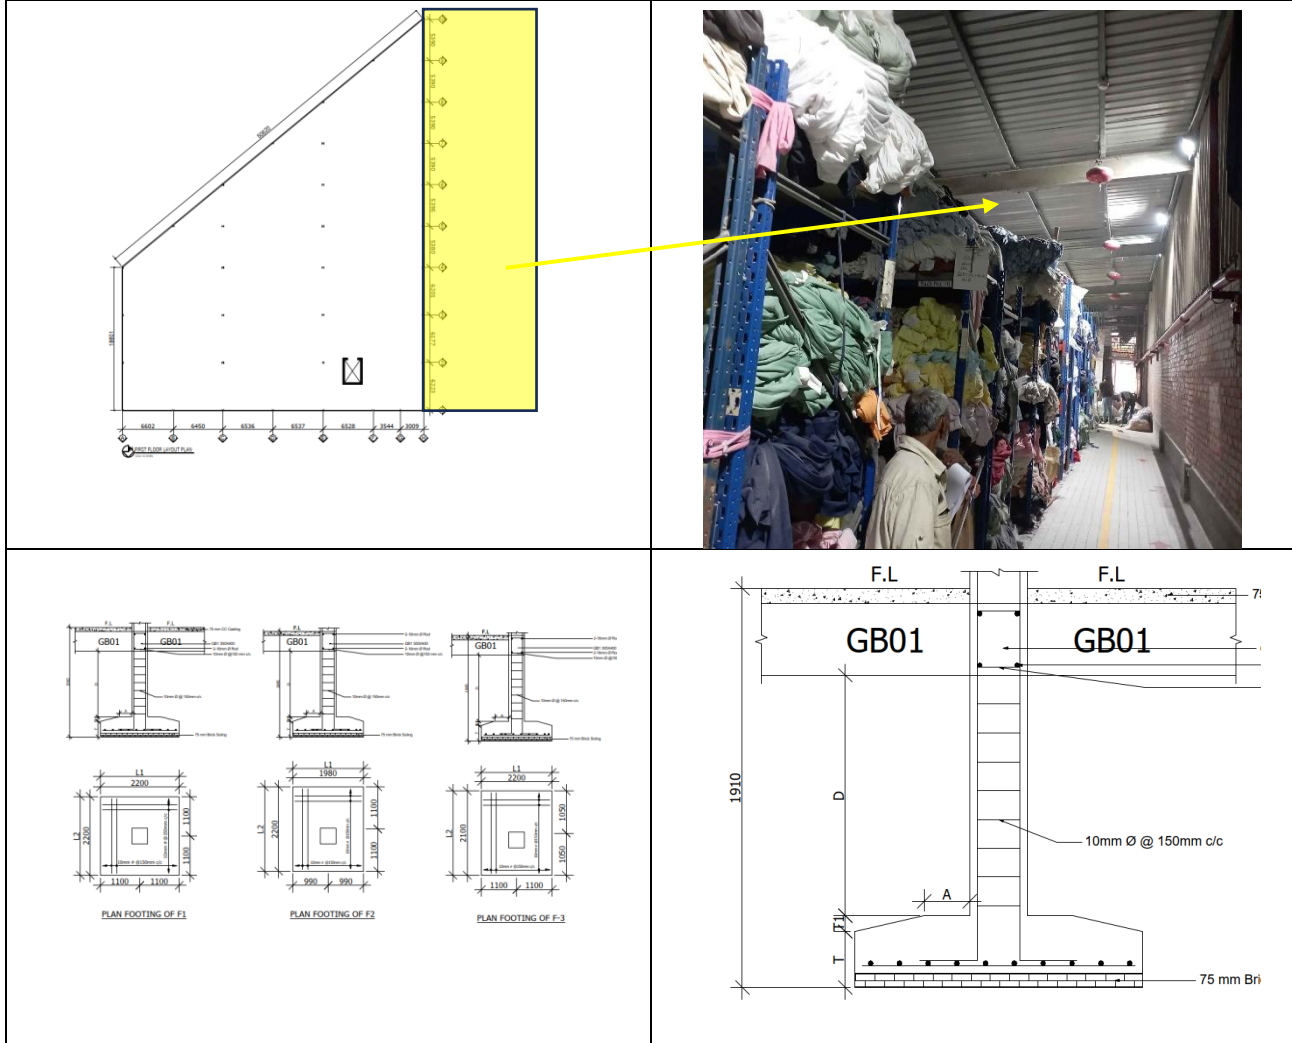
**Observation 10:** Discrepancy/missing information in as built and retrofitting drawing (Shed 3 Yarn Godown).

**Description:** An Undocumented single-storied shed was found structurally connected at the west side. The building engineer is required to update the as built drawing.

| 22. | Discrepancy in as built and retrofitting drawing (Shed 3 Yarn Godown). | The building engineer is required to update the as-built and retrofitting drawing. | within 6 weeks |

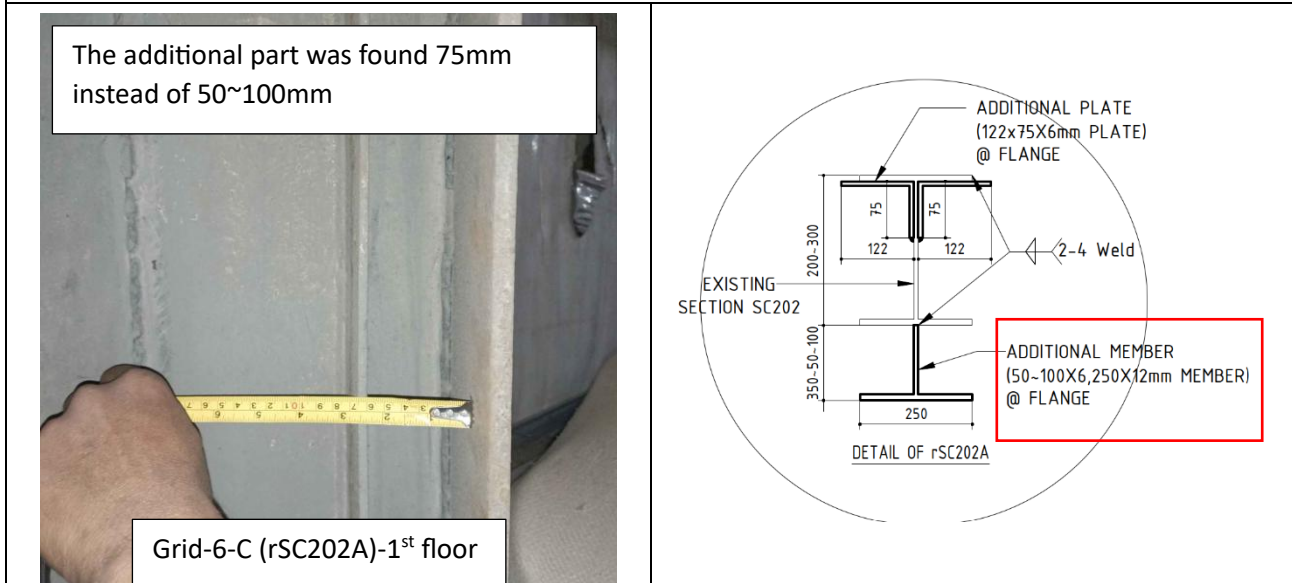
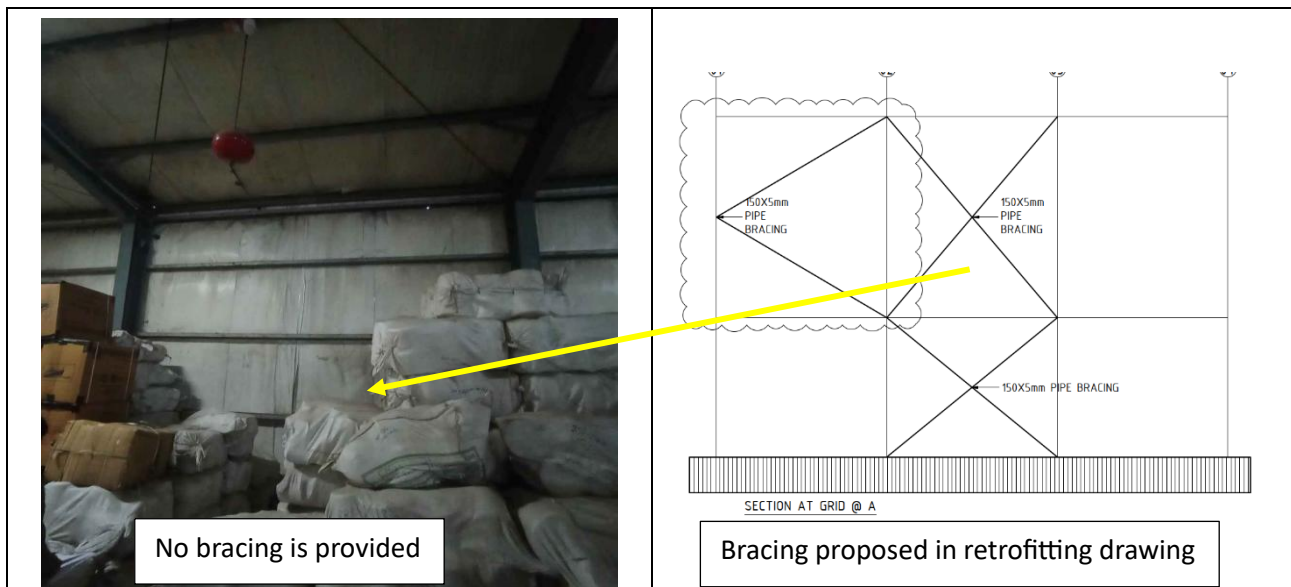
**Description:** Discrepancy found between retrofitting drawing and on site condition. The building engineer is required to update the retrofitting drawing.

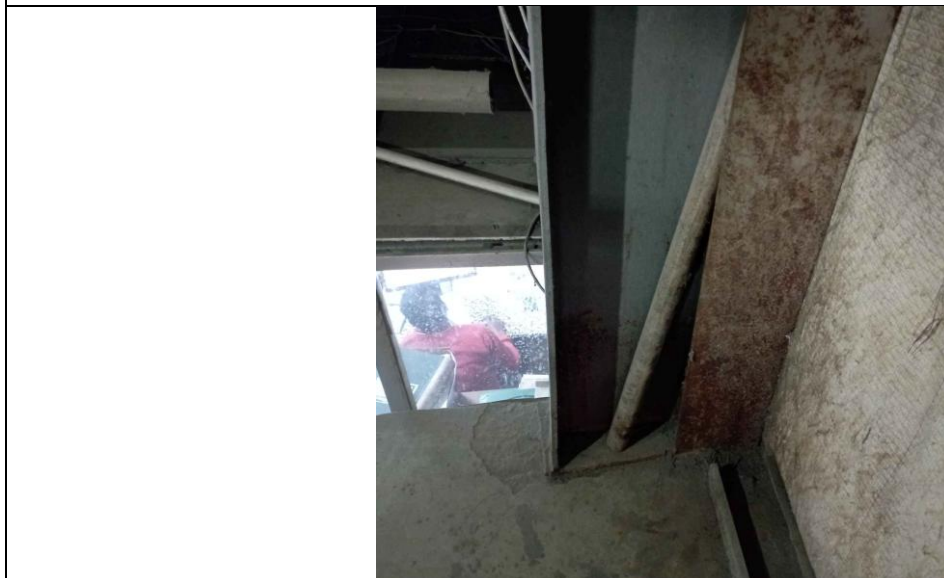
**Observation 11:** Corrosion on steel members (Shed 3 Yarn Godown).

**Description:** Corrosion was observed on steel members at several locations. The building engineer is required to remove the corrosion and provide rust-proof paint on steel members.

| 23. | Corrosion on steel members (Shed 3 Yarn Godown). | The building engineer is required to remove the corrosion and provide rust-proof paint on steel members. | within 6 weeks |

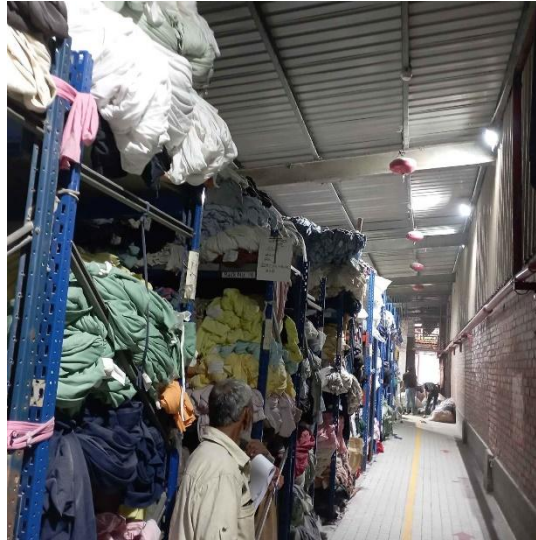
**Observation-12:** Non-structural elements found not anchored/braced (Shed 3 Yarn Godown).

**Description:** Nonstructural elements (storage racks) were found not anchored/braced. The building engineer is required to anchor/brace all nonstructural elements within the factory.

| 24. | Nonstructural elements found not anchored/braced (Shed 3 Yarn Godown). | The building engineer is required to anchor/brace all nonstructural elements within the factory. | within 6 months |

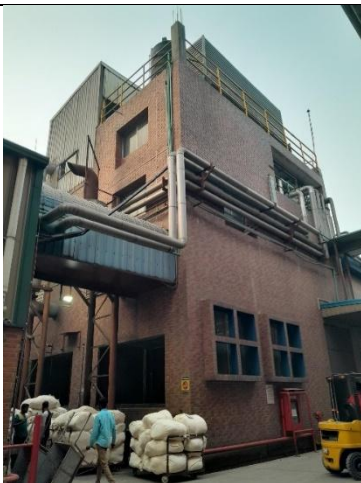
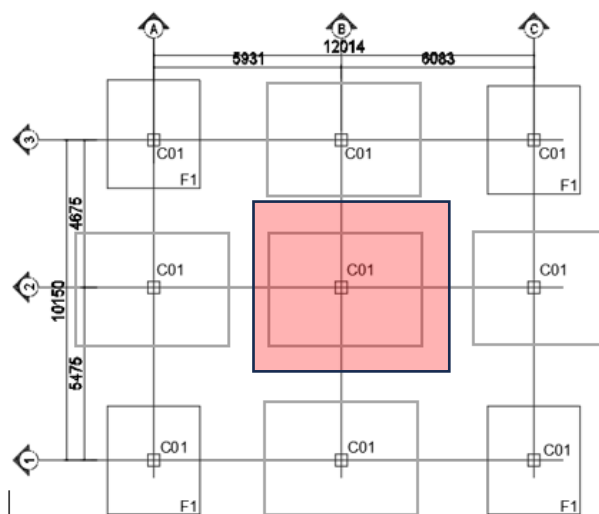
Foundation layout

**Observation 13:** High stress in foundation that requires immediate design review (Shed 4 Diseal Generator & Chiller Building).

**Description:** Cursory calculation indicates the high stress in foundation at the marked locations considering the live load of 2 kPa on the 1<sup>st</sup> floor, 1 kPa on the roof sheet, allowable soil bearing capacity 1 ksf (FoS:2.5) assuming the footing depth 1.6 m considering the onsite condition and found of adjacent structures (footing depth from EGL not shown). The building engineer is required to carry out a Detailed Engineering Assessment (DEA) to check the foundation adequacy and prepare remedial scheme.

| 25. | High stress in column and foundation that requires immediate design review (Shed 4-Diseal, Generator and Chiller). | The building engineer is required to carry out a Detailed Engineering Assessment (DEA). | Immediate |
| 26. | | Produce and actively manage load plan | within 6 weeks |
| 27. | | Verify in-situ concrete and steel strength. | within 6 weeks |
| 28. | | Implement remediation work from DEA. | within 6 months |

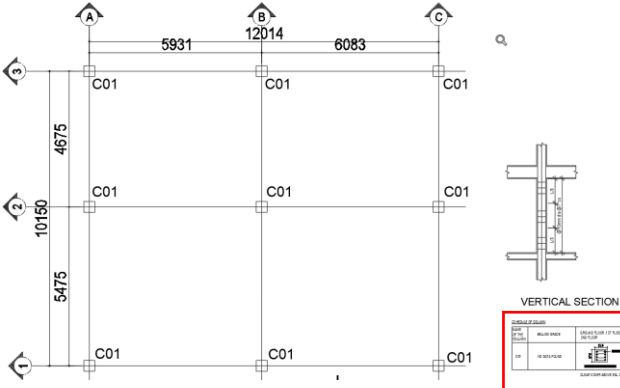
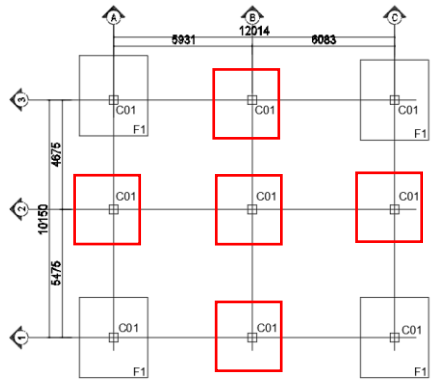
**Observation 14:** Incomplete as built drawing (Shed 4 Diseal Generator & Chiller Building).

| <p><b>Description:</b> During inspection a set of drawings was found on site for the structure. But pedestal column and foundation layout information were found incomplete. Also, the external steel stair and PVC water tank were not shown in the drawing. The building engineer is required to survey the full structure and prepare complete drawings also check the stability system.</p> | |

| 29. | Incomplete as-built drawing (Shed 4-Diseal, Generator and Chiller). | Prepare detailed and accurate as-built drawing | within 6 weeks |

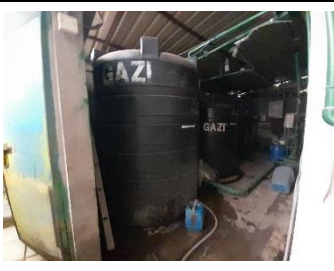
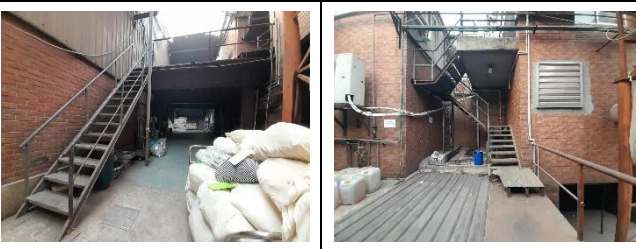
| <p>PVC water tank</p> | <p>External steel stair</p> |

| 30. | | Check the adequacy of the stair. | within 6 weeks |
| 31. | | Implement the remedial works where necessary. | within 6 months |

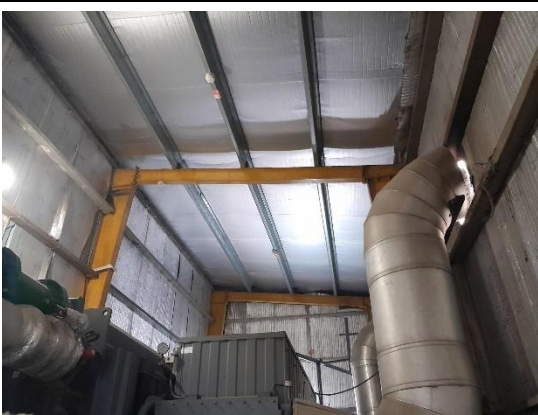
| <p><b>Observation 15:</b> Lack of lateral stability (Shed 4 Diseal Generator &amp; Chiller Building)</p> | |
| <p><b>Description:</b> Lateral load transfer media is not provided to transfer the lateral load. The building engineer is required to carry out an Engineering Assessment (EA) to check the lateral stability of the shed and suggest necessary remedial action.</p> | |

| 32. | Lack of lateral Stability of the shed (Shed 4-Diseal, Generator and Chiller). | The building engineer is required to check the lateral stability of the shed. | within 6 weeks |

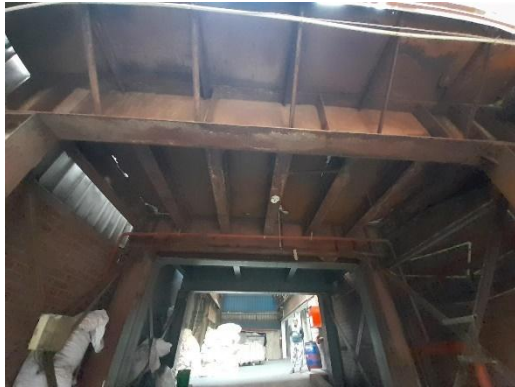
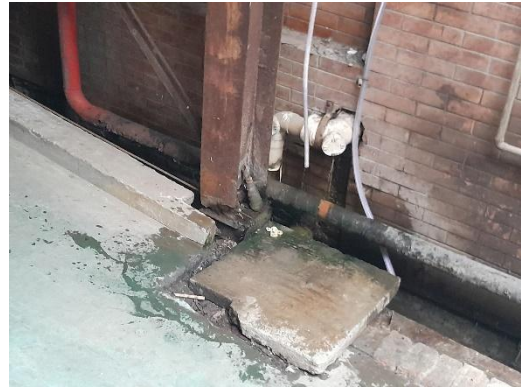
**Observation 16:** Severe corrosion on steel member of steel stair. (Shed 4 Diseal Generator & Chiller Building).

Corrosion on steel member of steel stair

**Description:** During inspection, severe corrosion has been identified on a steel member of the steel stair. The corrosion has significantly compromised the structural integrity of the affected component, posing potential safety hazards such as reduced load-bearing capacity, material deterioration, and increased risk of failure. Remove the corrosion/rust and apply anti-corrosive coating to the affected steel member, also provide adequacy of the external steel stair based on effective plate thickness.

| 33. | Severe corrosion on steel member of steel stair. (Shed 4 Diseal Generator & Chiller Building). | Remove the corrosion/rust and apply anti-corrosive coating to the affected steel member. | within 6 weeks |

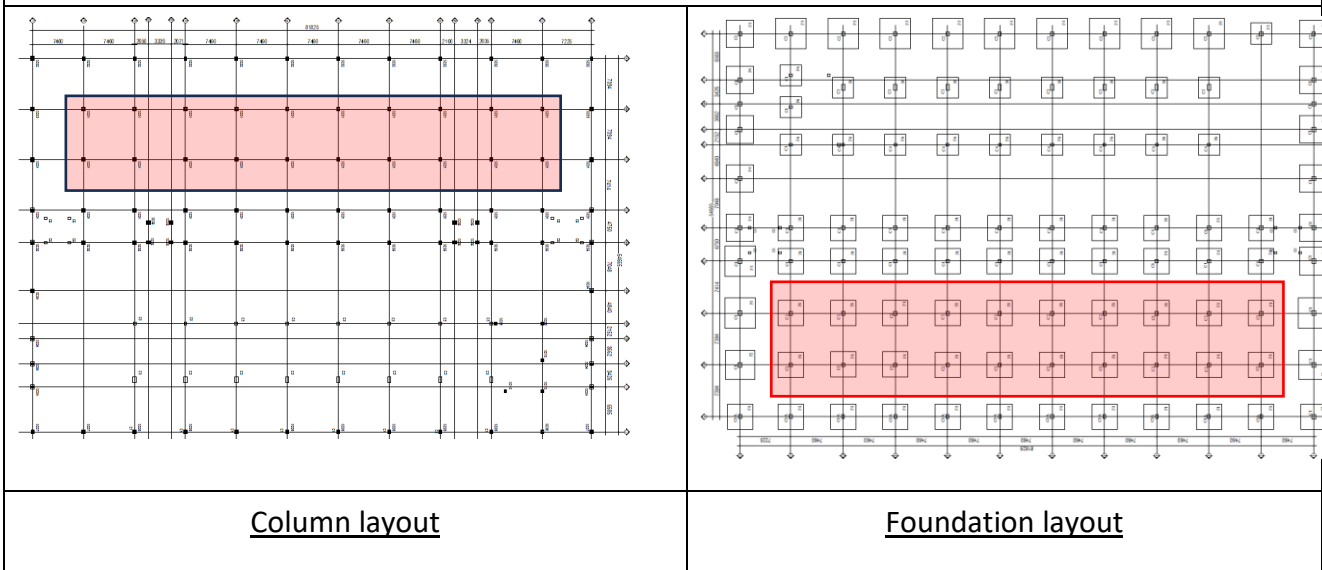
**Observation 17:** High stress in column and foundation that requires immediate design review (Shed 6 Yarn Dyeing).

**Description:** cursory calculation indicates the high stress in Steel column and foundation at the marked locations considering the live load of 4.8 kPa on the 1<sup>st</sup> floor, 1 kPa on the roof sheet. Also, allowable soil bearing capacity 1 ksf (FoS 2.50) assuming the footing depth 1.5 m, considering the onsite condition & adjacent structures (footing depth from EGL not shown). The building engineer is required to carry out a Detailed Engineering Assessment (DEA) and check the steel column foundation adequacy.

| 34. | High stress in column and foundation that requires immediate design review (Shed 6-Yarn Dyeing). | The building engineer is required to carry out a Detailed Engineering Assessment (DEA). | Immediate |
| 35. | | Produce and actively manage load plan | within 6 weeks |
| 36. | | Verify in-situ concrete and steel strength. | within 6 weeks |
| 37. | | Implement remediation work from DEA. | within 6 months |

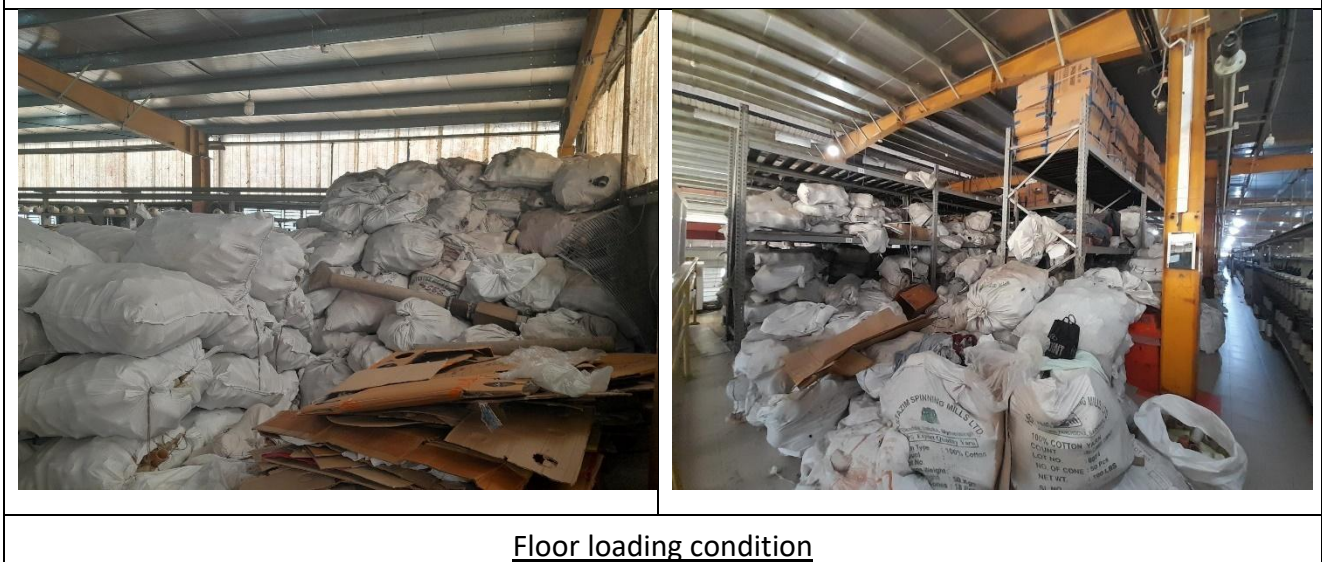
**Observation 18:** Uncontrolled floor load management. (Shed 6 Yarn Dyeing).

**Description:** During inspection, uncontrolled floor loading placement was found on the 1<sup>st</sup> and 2<sup>nd</sup> floor. The building engineer is required to provide load restriction height marking in the storage zone as per accepted floor load plan.

| 38. | Uncontrolled floor load management. (Shed 6 Yarn Dyeing). | The building engineer is required to provide storage area and load restriction height marking as per accepted floor load plan. | within 6 weeks |

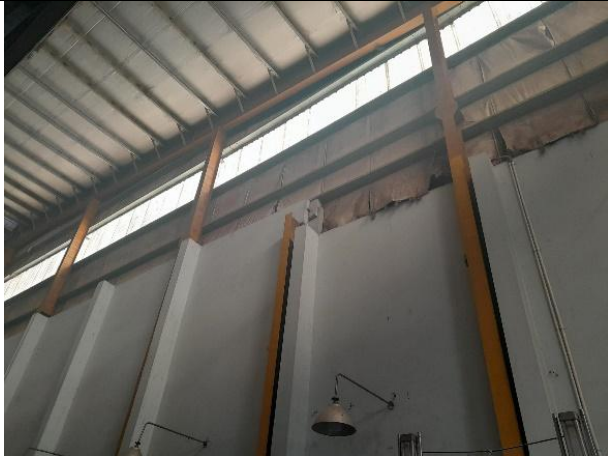
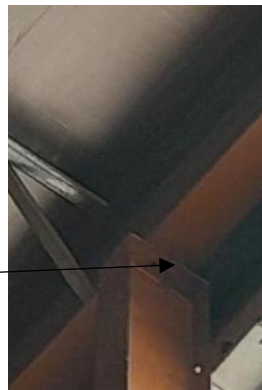
**Observation 19:** Incomplete as built drawing (Shed 6 Yarn Dyeing).

Steel column not continued as per drawing.

Rebar information missing in RC column schedule

Connection details missing

Pedestal column Foundation details missing

**Description:** During inspection, a set of as built drawings were found on site, but lack of information was observed in the drawing. Also, an undocumented steel mezzanine was found which was not shown in provided drawing. The building engineer is required to survey the full structure and produce accurate as-built drawing for the structure and submit to RSC for review along with DEA report.

| 39. | Incomplete as built drawing (Shed 6 Yarn Dyeing). | The building engineer is required to survey the full structure and produce accurate as-built drawing for the structure and submit to RSC for review along with DEA report. | within 6 weeks |

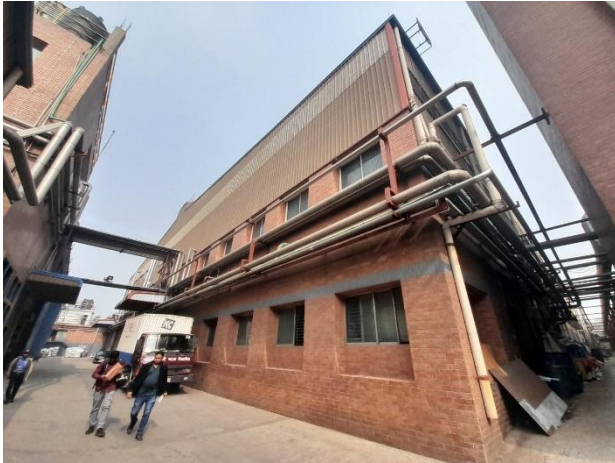
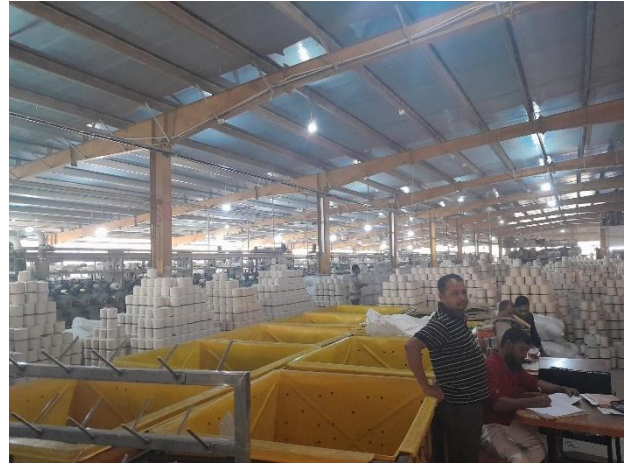
**Observation 20:** Lack of lateral stability (Shed 6 Yarn Dyeing).

Roof Framing system

**Description:** During inspection, Lateral load transfer media is not provided to transfer the lateral load at roof shed. Also, no vertical bracing was found provided. The building engineer is required to check the lateral stability of the structure as part of DEA.

| 40. | Lack of lateral stability (Shed 6 Yarn Dyeing). | The building engineer is required to check the lateral stability of the shed. | within 6 weeks |

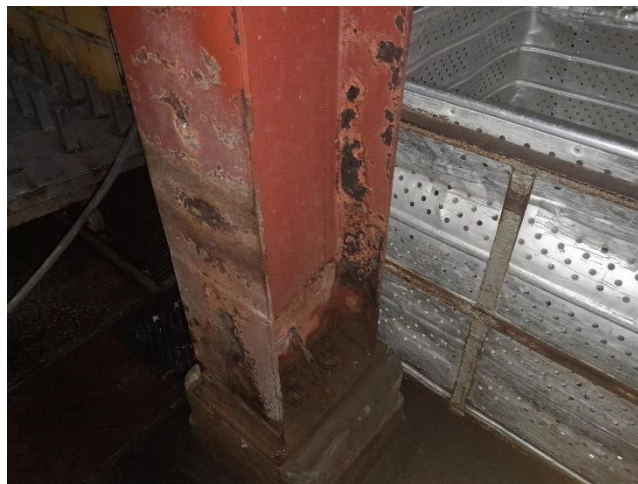
**Observation 21:** Severe corrosion on steel member of steel column. (Shed 6 Yarn Dyeing).

Corrosion on steel member

**Description:** Corrosion was observed on steel members at several locations. The building engineer is required to remove the corrosion and provide rust-proof paint on steel members.

| 41. | Severe corrosion on steel member of steel column. (Shed 6 Yarn Dyeing). | The building engineer is required to remove the corrosion and provide rust-proof paint on steel members. | within 6 weeks |

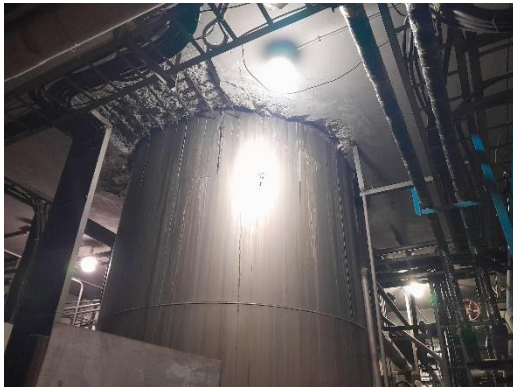
| <b>Observation 22:</b> Slab punch and exposed rebar on the mezzanine floor. (Shed 6 Yarn Dyeing). | | | |
| <u>Slab punch on the mezzanine floor</u> | | | |
| <b>Description:</b> During inspection, slab punch was observed in slab of mezzanine floor, also corroded exposed rebar was observed. The building engineer is required to check for slab adequacy around the opening and repair exposed corroded rebar of slab. | | | |

| 42. | Slab punch and exposed rebar on the mezzanine floor. (Shed 6 Yarn Dyeing). | The building engineer is required to check for slab adequacy around the opening and repair exposed corroded rebar of slab. | within 6 weeks |

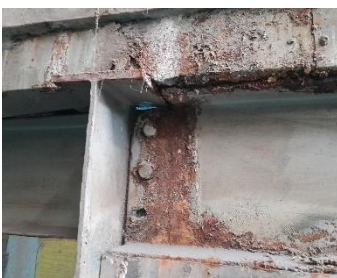
| <b>Observation 23:</b> Connection gap and bolt missing. (Shed 6 Yarn Dyeing). | | | |
| <u>Bolt missing</u> | | <u>Connection gap</u> | |
| <b>Description:</b> Few bolts were missing, and connection gaps were observed in several places. The building engineer is required to identify all affected areas, provide adequate bolts, and repair all connection gaps using a suitable method. | | | |

| 43. | Connection gap and bolt missing. (Shed 6 Yarn Dyeing). | The building engineer is required to identify all affected areas, provide adequate bolts, and repair all connection gaps using a suitable method. | within 6 weeks |

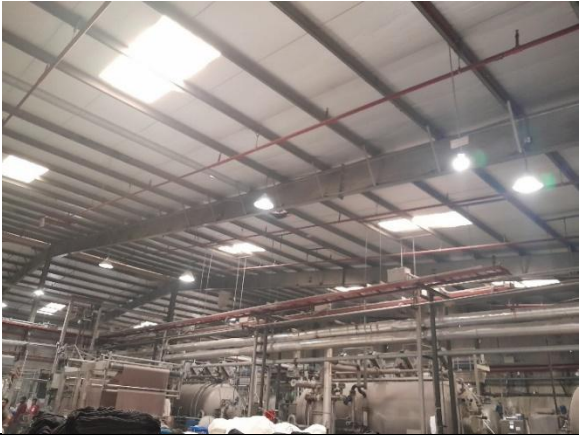
| <b>Observation 24:</b> Lack of lateral stability (Shed 9 (Dyeing KCL)). | |
| <u>Absence of lateral load transfer media</u> | <u>Bracing disconnected</u> |
| <b>Description:</b> Lateral load transfer media is not provided to transfer the lateral load at roof shed. Also, few vertical bracings was found disconnected. The building engineer is required to carry out EA to check the lateral stability of the structure and suggest necessary remedial measures. | |

| 44. | Lack of lateral stability (Shed 9 (Dyeing KCL). | The building engineer is required to check the lateral stability of the structure. | within 6 weeks |
| 45. | | Implement remediation work from DEA. | within 6 months |

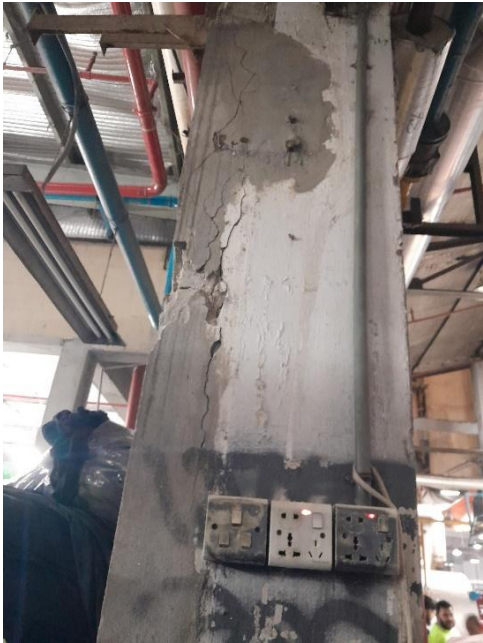
| <b>Observation 25:</b> Crack on ground floor slab and column. (Shed 9 (Dyeing KCL)). | |
| <u>Column crack due to demolition works</u> | <u>Ground floor crack</u> |
| <b>Description:</b> During inspection, cracks were found on columns and ground floor of Shed 9 both parts. The building engineer is required to investigate the reason & extent of cracks and produce an investigation report with a repair methodology. Submit investigation report to RSC for review. | |

| 46. | Crack on ground floor slab and column. (Shed 9 (Dyeing KCL). | The building engineer is required to investigate the identified cracks and produce an investigation report, along with a detailed repair methodology, must be submitted to RSC. | within 6 weeks |

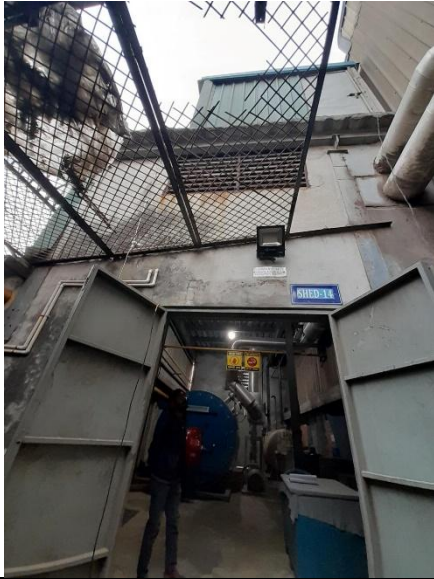
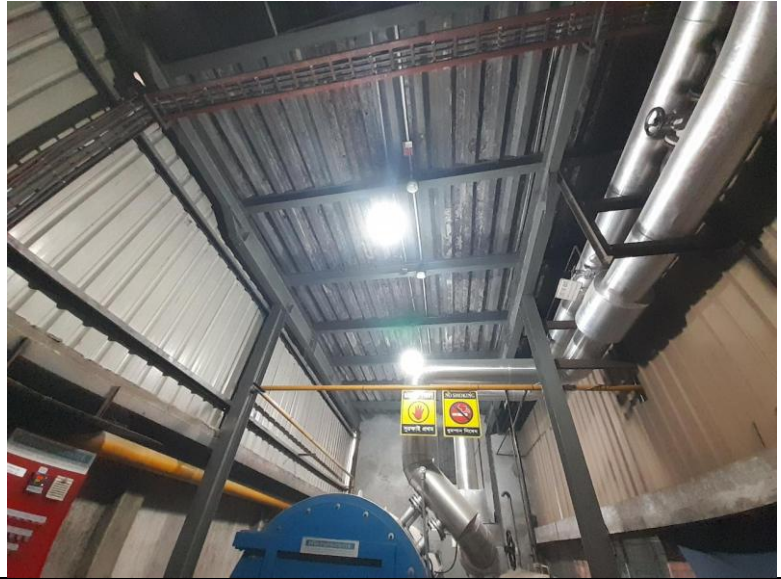
**Observation-26:** Lack of design documents (Shed 14 New Thermal Boiler).

**Description:** As per BNBC, every building or structure designed shall have its design documents prepared in accordance with the provision of Section 1.9.1. The design document shall include a design report, and a set of structural drawings, which shall be prepared in compliance with section 1.9.1.1 and section 1.9.1.2 as per BNBC. At the time of inspection, a design report was not available. Also, no drawing was available for the substructure. The building engineer is required to prepare a full set of as-built drawings and a Detailed Engineering Assessment (DEA) for the structure.

| 47. | Lack of design documents (Shed 14 New Thermal Boiler). | The building engineer is required to prepare a full set of as-built drawings and a Detailed Engineering Assessment (DEA) for the structure. | within 6 weeks |
| 48. | | Implement remediation work from DEA. | within 6 months |

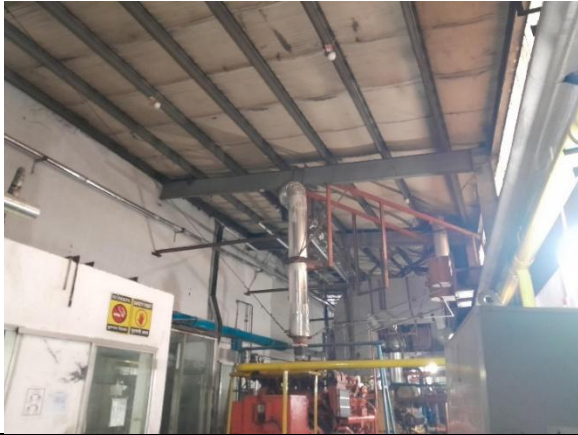
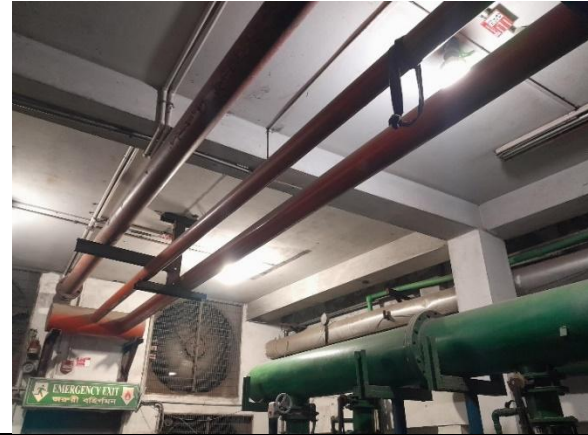
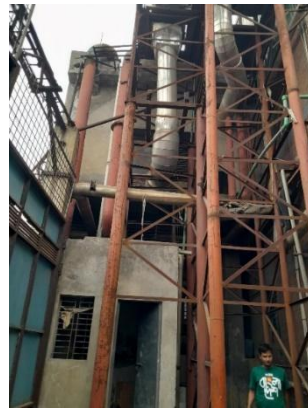
**Observation-27:** Lack of design documents (Shed 17 Boiler & Generator Room (Beside Yarn Dyeing)).

**Description:** As per BNBC, every building or structure designed shall have its design documents prepared in accordance with the provision of Section 1.9.1. The design document shall include a design report, and a set of structural drawings, which shall be prepared in compliance with section 1.9.1.1 and section 1.9.1.2 as per BNBC. At the time of inspection, a design report was not available. Also, no drawing was available for the substructure. The building engineer is required to prepare a full set of as-built drawings and a Detailed Engineering Assessment (DEA) for the structure.

| 49. | Lack of design documents (Shed 17 Boiler & Generator Room (Beside Yarn Dyeing)). | The building engineer is required to prepare a full set of as-built drawings and a Detailed Engineering Assessment (DEA) for the structure. | within 6 weeks |
| 50. | | Implement remediation work from DEA. | within 6 months |

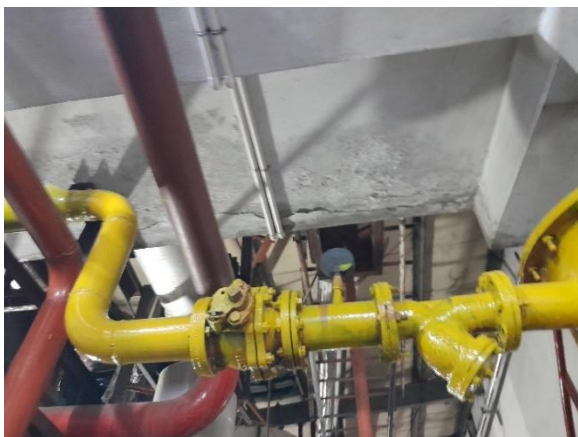
**Observation 28:** Crack on ground floor slab and 1st floor slab. (Shed 17 Boiler & Generator Room).

Crack on 1<sup>st</sup> floor slab

**Description:** During inspection, cracks were found on 1<sup>st</sup> floor slab and ground floor of Shed 17 and mezzanine floor. The building engineer is required to investigate the reason & extent of cracks and produce an investigation report with a repair methodology. Submit investigation report to RSC for review.

| 51. | Crack on ground floor slab and 1st floor slab. (Shed 17 Boiler & Generator Room). | The building engineer is required to investigate the identified cracks and produce an investigation report, along with a detailed repair methodology, must be submitted to RSC. | within 6 weeks |

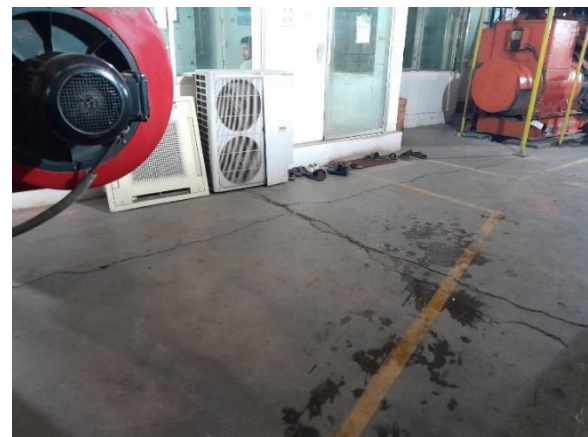
Crack on Ground floor slab

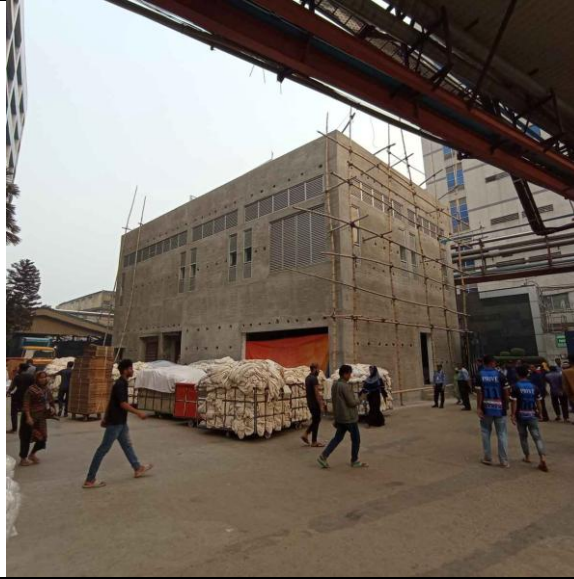
**Observation-29:** Lack of design documents (Compressor, Fire Control & Pump Room).

**Description:** As per BNBC, every building or structure designed shall have its design documents prepared in accordance with the provision of Section 1.9.1. The design document shall include a design report, and a set of structural drawings, which shall be prepared in compliance with section 1.9.1.1 and section 1.9.1.2 as per BNBC. At the time of inspection, a design report was not available. Also, no drawing was available for the substructure. The building engineer is required to prepare a full set of as-built drawings and a Detailed Engineering Assessment (DEA) for the structure.

| 52. | Lack of design documents (Compressor, Fire Control & Pump Room). | The building engineer is required to carry out a Detailed Engineering Assessment (DEA). | within 6 weeks |
| 53. | | Implement remediation work from DEA. | within 6 months |

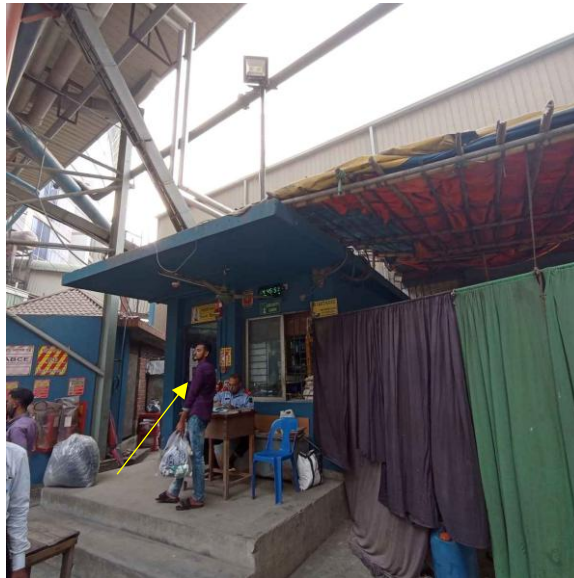
**Observation-30:** Lack of as-built drawing (Security Room).

**Description:** No as-built drawing was available of the structure. The building engineer is required to prepare a full set of as-built drawings

| 54. | Lack of as-built drawing (Security Room). | The building engineer is required to update the as-built and retrofitting drawing. | within 6 weeks |

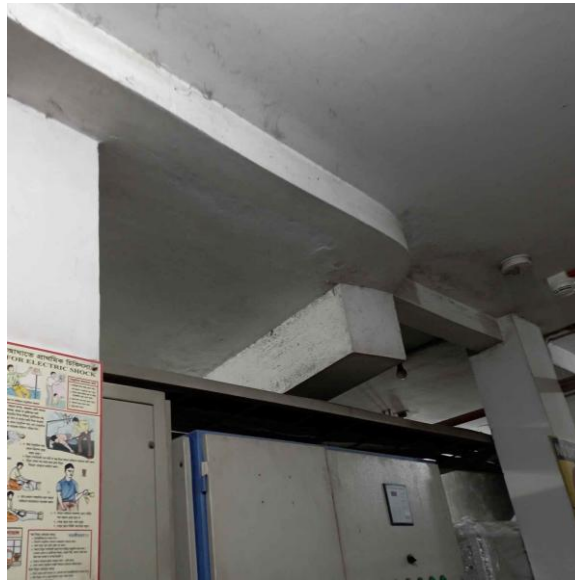
**Observation-31:** Unclear load path (Substation Room).

**Description:** The structural system of the structure was observed as a mix of flat slab and beam-column. However, at one place a beam was found as cantilevered. The load path was unclear. The building engineer is required to prepare an Engineering Assessment (EA) to check the stability of the structure.

| 55. | Unclear load path (Substation Room). | The building engineer is required to carry out a Detailed Engineering Assessment (DEA). | within 6 weeks |
| 56. | | Implement remediation work if required. | within 6 months |

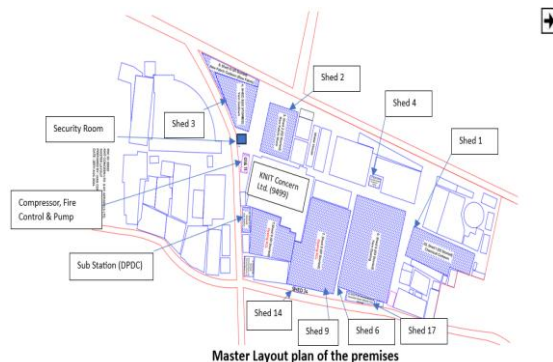
**Observation 32:** Structural connection of the building (Shed 6, Shed 9, Shed 17).

**Description:** During the inspection, the structures were found connected with the adjacent structures. The building engineers is required to investigate the structures and determine the structural connections. Analysis of the structures is required to be carried out based on the structural connections.

| 57. | Structural connection of the building (Shed 6, Shed 9, Shed 17). | The building engineer is required to investigate the structures and determine the structural connections. Analysis of the structures is required to be carried out based on the structural connections. | within 6 weeks |
