# Hamza Textiles Ltd.

Nayapara, Kashimpur, Gazipur-1346

29 January 2025

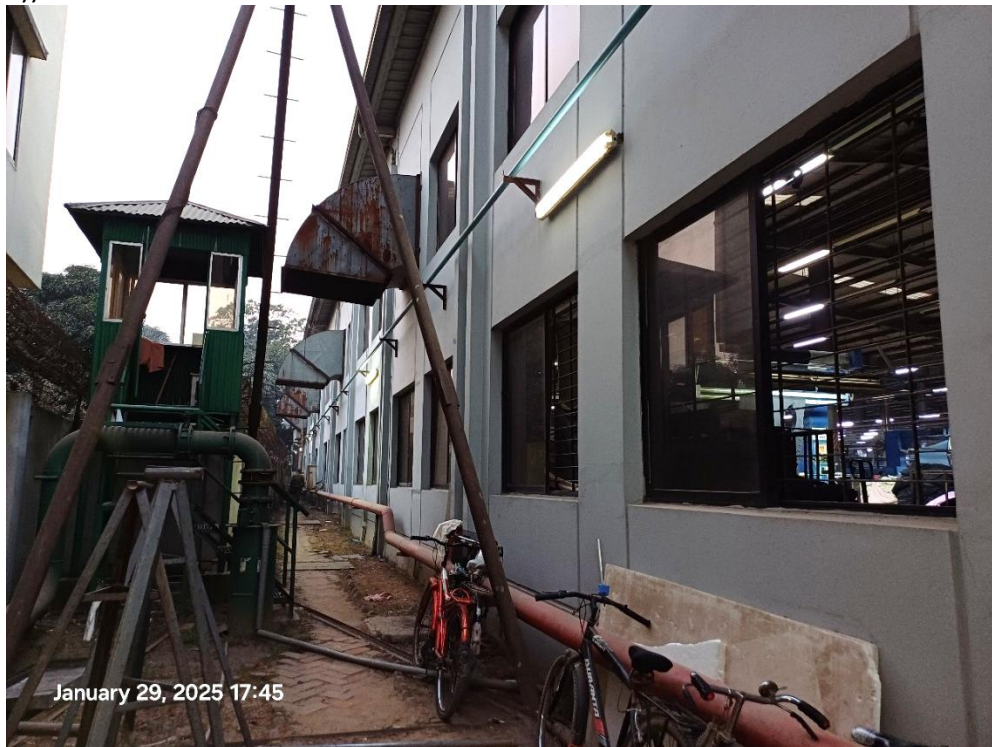
**Observation-1:** DEA report needs to be reviewed against lateral loading. (Building-1: Dyeing Production Shed (Block A))

**Description:** The prepared DEA report needs to be reviewed against lateral forces. Submit the DEA report to the RSC for detailed review.

| Item No | Observation | Action Plan | Timeline |
|---|---|---|---|
| 1. | DEA report needs to be reviewed against lateral loading. (Building-1: Dyeing Production Shed (Block A)) | The prepared DEA report needs to be reviewed against lateral forces. Submit the DEA report to the RSC for detailed review. | within 6 weeks |
| 2. | | Carry out remedial work if required. | within 6 months |

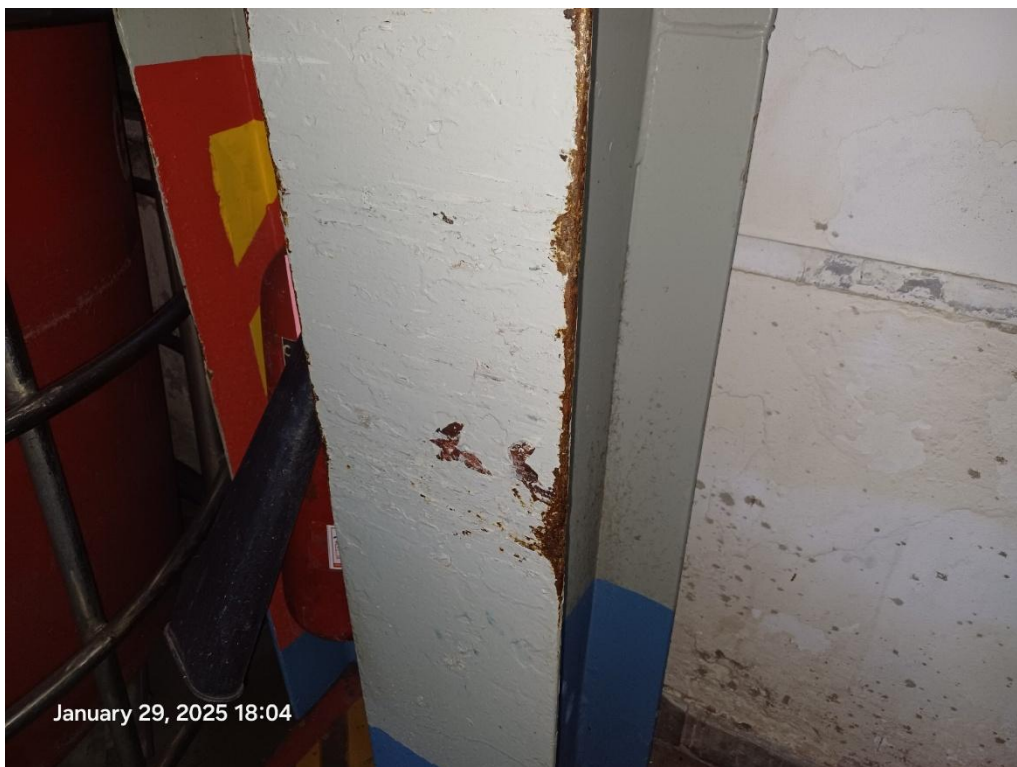
**Observation-2:** Corrosion on steel members. (Building-1: Dyeing Production Shed (Block A))

**Description:** Corrosion was observed on the steel members in Building 1. The building engineer is required to remove the corrosion with a suitable method and provide an anti-corrosive coating.

| Item No | Observation | Action Plan | Timeline |
|---|---|---|---|
| 3. | Corrosion on steel members. (Building-1: Dyeing Production Shed (Block A)) | The building engineer is required to remove the corrosion with a suitable method and provide an anti-corrosive coating. | within 6 weeks |

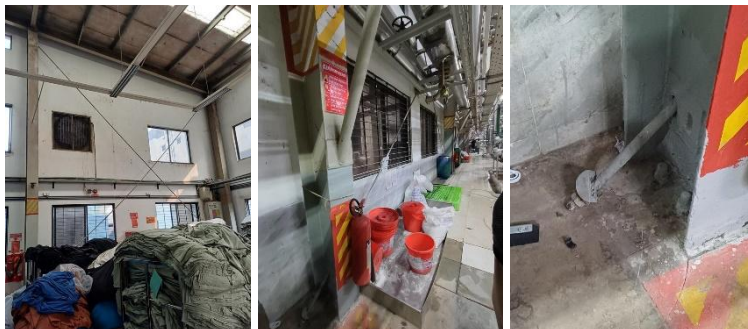
**Observation-3:** Loose & cut-off bracing. (Building-1: Dyeing Production Shed (Block A))

**Description:** Loose and cut off braces were observed in the shed. The building engineer is required to identify the locations, tighten the braces and reinstall the cut-off braces.

| Item No | Observation | Action Plan | Timeline |
|---|---|---|---|
| 4. | Loose bracing and cut-off bracing. (Building-1: Dyeing Production Shed (Block A)) | The building engineer is required to identify the locations, tighten the braces and reinstall the cut-off braces. | within 6 weeks |

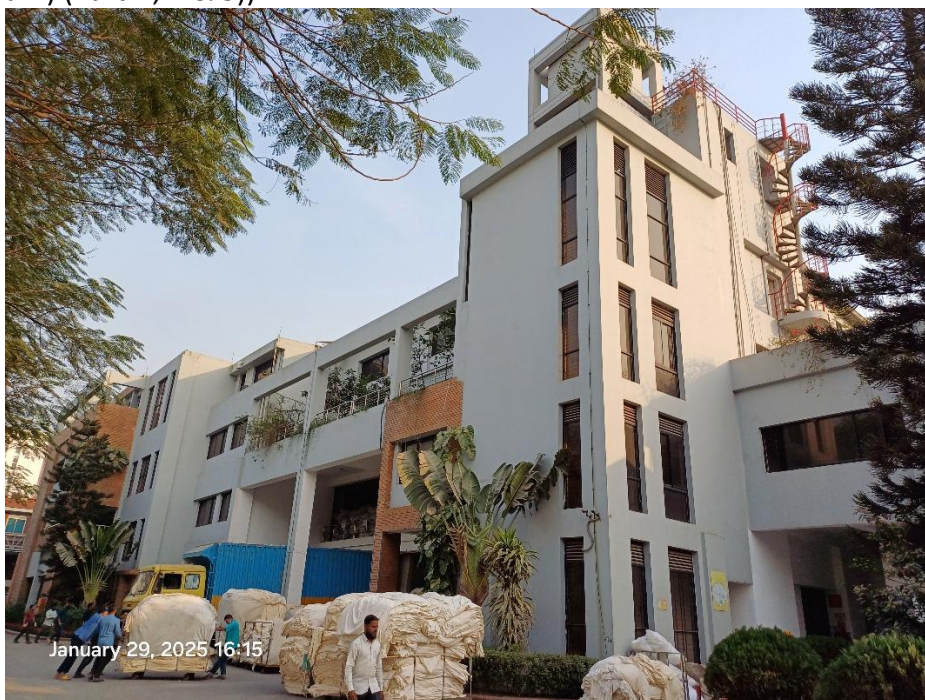
**Observation-4:** DEA report needs to be reviewed against lateral loading. (Building-2: Four Storied Steel Building (Hamza-1) (Part-1, 2 & 3))

**Description:** The prepared DEA report needs to be reviewed against lateral forces. Submit the DEA report to the RSC for detailed review.

| Item No | Observation | Action Plan | Timeline |
|---|---|---|---|
| 5. | DEA report needs to be reviewed against lateral loading. (Building-2: Four Storied Steel Building (Hamza-1) (Part-1, 2 & 3)) | The prepared DEA report needs to be reviewed against lateral forces. Submit the DEA report to the RSC for detailed review. | within 6 weeks |
| 6. | | Carry out remedial work if required. | within 6 months |

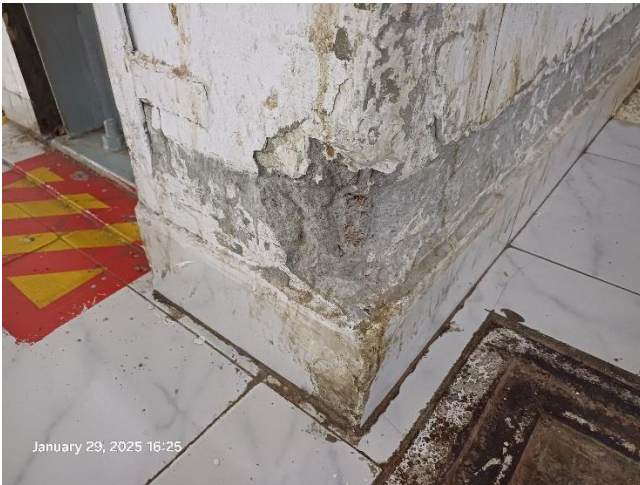
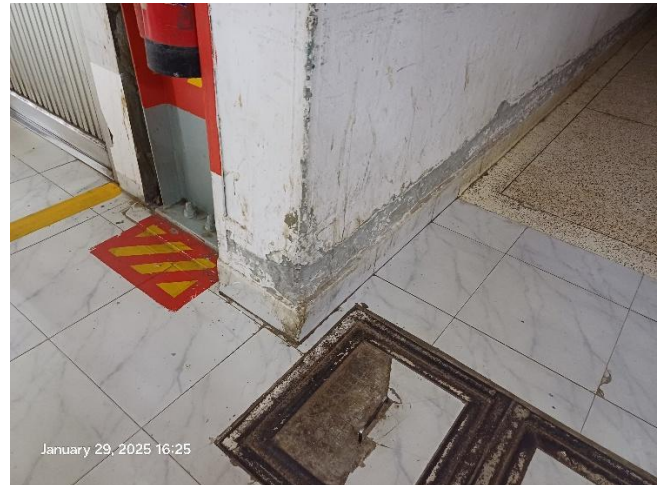
**Observation-5:** Column damaged due to trolley impact. (Building-2: Four Storied Steel Building (Hamza-1) (Part-1, 2 & 3))

**Description:** Columns are damaged due to the trolley impact on different floor levels. The building engineer is required to repair the damage to the columns and provide a column guard to prevent the trolley impact.

| Item No | Observation | Action Plan | Timeline |
|---|---|---|---|
| 7. | Column damaged due to trolley impact. (Building-2: Four Storied Steel Building (Hamza-1) (Part-1, 2 & 3)) | The building engineer is required to repair the damage to the columns and provide a column guard to prevent the trolley impact. | within 6 weeks |

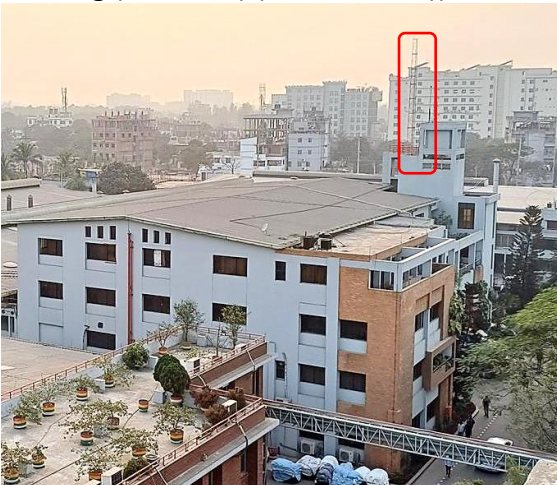
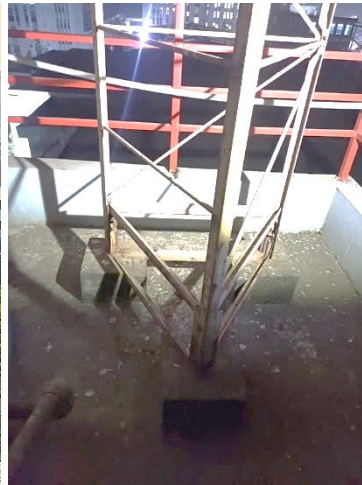
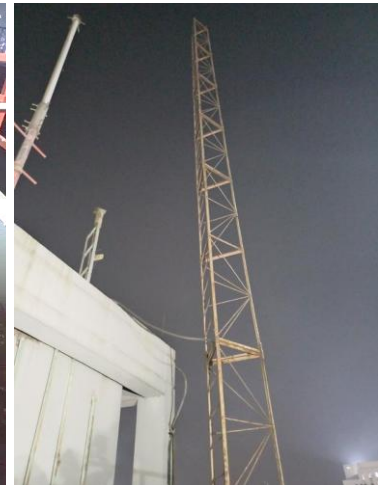
**Observation-6:** Undocumented telecom tower on the roof of Part 2. (Building-2: Four Storied Steel Building (Hamza-1) (Part-1, 2 & 3))

**Description:** There was a long telecom tower on the stair roof of the building. The building engineer is required to prepare as-built drawings with joint details, check the adequacy of the tower & roof slab, and incorporate all things in the design report.

| Item No | Observation | Action Plan | Timeline |
|---|---|---|---|
| 8. | Undocumented telecom tower on the roof of Part 2. (Building-2: Four Storied Steel Building (Hamza-1) (Part-1, 2 & 3)) | The building engineer is required to prepare as-built drawings with joint details, check the adequacy of the tower & roof slab and incorporate all things in the design report. | within 6 weeks |
| 9. | | Carry out remedial works if required. | within 6 months |

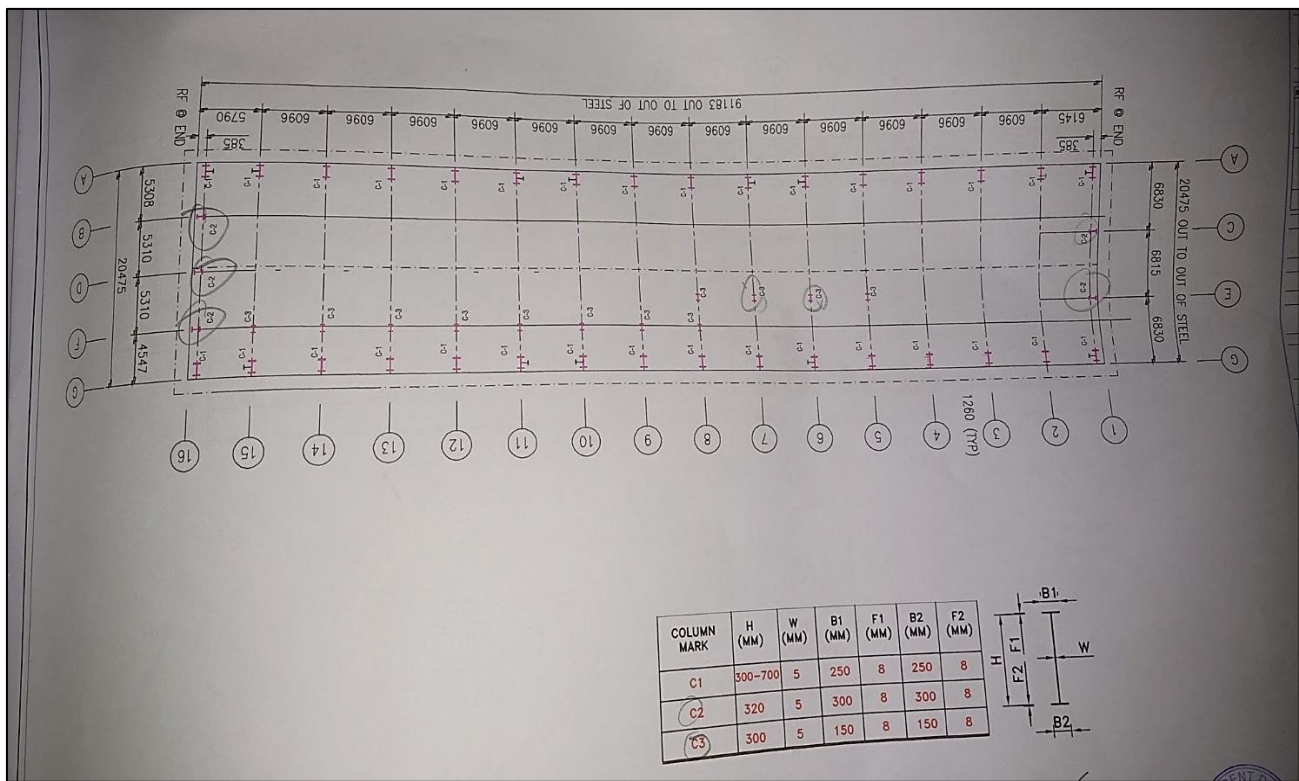
**Observation-7:** Discrepancy between the provided drawing and site condition for Part-1. (Building 3)

**Description:** During the inspection, discrepancies were observed between the provided drawing and actual site condition for Part-1. The building engineer is required to update the as-built drawing reflecting actual site condition.

| Item No | Observation | Action Plan | Timeline |
|---|---|---|---|
| 10. | Discrepancy between the provided drawing and site condition for Part-1. (Building 3) | The building engineer is required to update the as-built drawing reflecting actual site condition. | within 6 weeks |

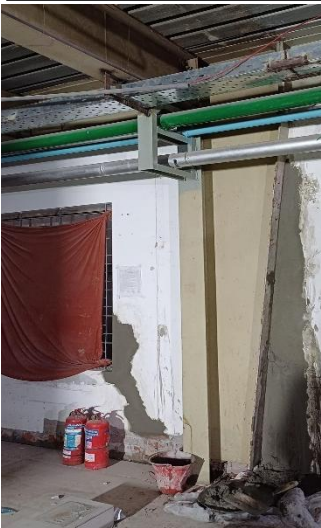
Mezzanine steel column C3 found tapered instead of regular straight shape

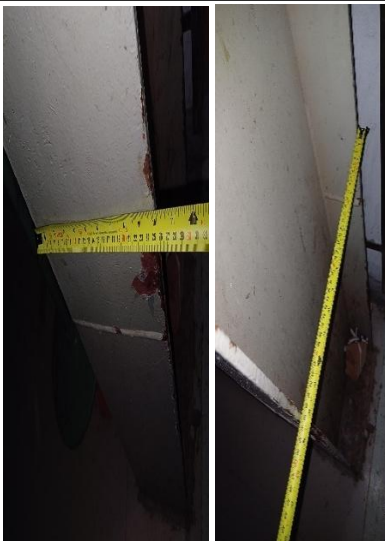
Steel column C2 size found F-255 X W-365 instead of F-300 X W-320

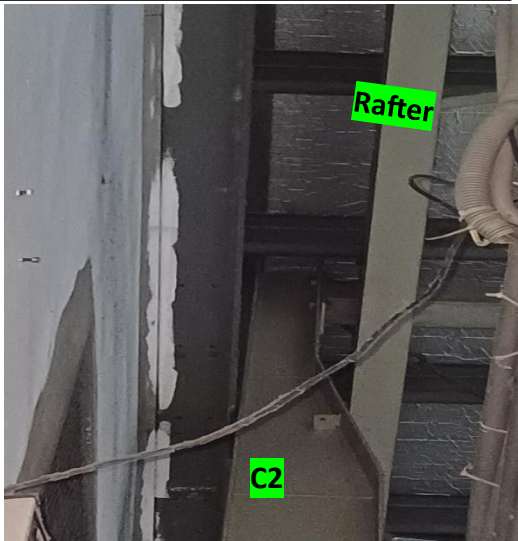
End grid rafter was not rested on column C2, no details found. Also, reduced section size was observed at the top level.

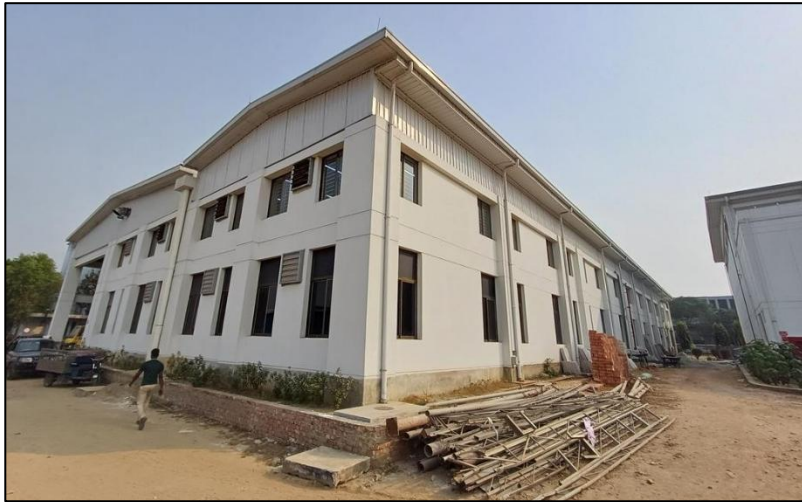
**Observation-8:** Incomplete as-built drawing for Part-2. (Building 3)

**Description:** During inspection, a hard copy of the structural drawing was not found on-site. Hence the structural drawing was not verified. The building engineer is required to prepare the hard copy of the as-built drawings on the factory site, which will be verified in the further inspection.

| Item No | Observation | Action Plan | Timeline |
|---|---|---|---|
| 11. | Incomplete as-built drawing for Part-2. (Building 3) | The factory is required to prepare a hard copy of the as-built drawings on the factory site, which will be verified in further inspection. | within 6 weeks |

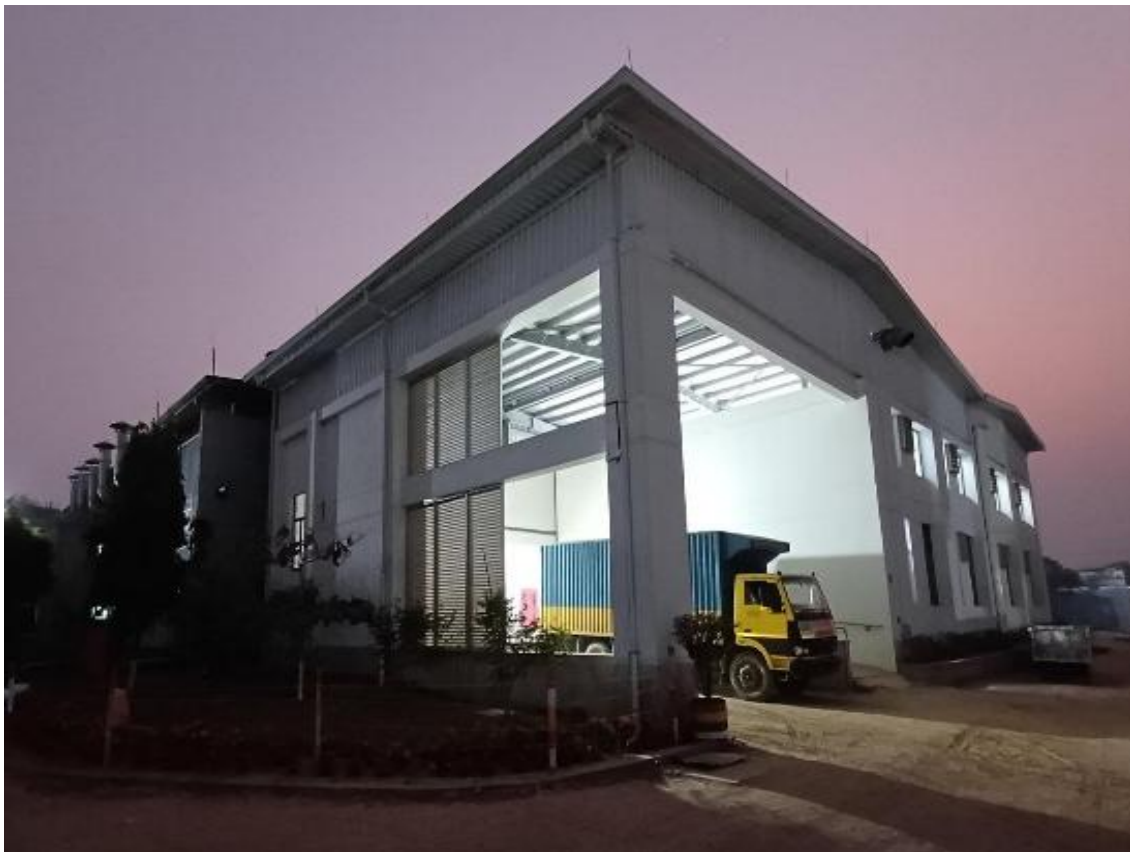
**Observation-9:** Design report needs to be reviewed against lateral loading. (Building 3)

**Description:** The design report prepared needs to be reviewed against lateral forces. Submit the design report to the RSC for detailed review.

| 12. | Design report needs to be reviewed against lateral loading. (Building 3) | The design report prepared needs to be reviewed against lateral forces. Submit the design report to the RSC for detailed review. | within 6 weeks |
| 13. | | Carry out remedial work if required. | within 6 months |

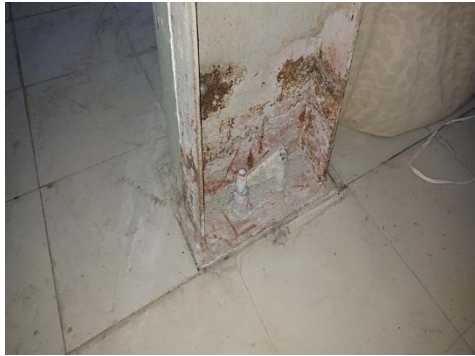
**Observation-10:** Corrosion on steel member. (Building 3)

**Description:** During the inspection, corrosion was observed on the steel column. The factory is required to repair/replace the corroded member and apply anti-corrosive coating.

| 14. | Corrosion on steel member. (Building 3) | The factory is required to repair/replace the corroded member and apply anti-corrosive coating. | within 6 weeks |

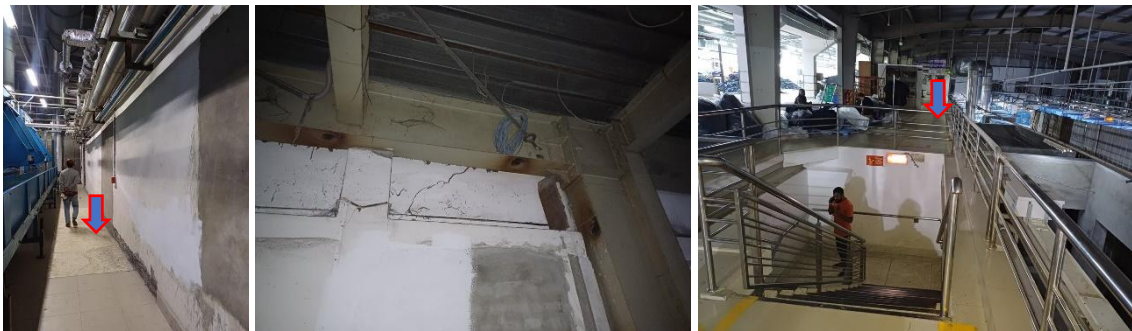
**Observation-11:** Settlement of floor and deflected slab on 1<sup>st</sup> floor. (Building 3)

**Description:** Settlement of ground and 1<sup>st</sup> floor was found on the marked location. The building engineer is required to investigate the geotechnical capacity of the foundation, allowable settlement limit, deflection of floor slabs and structural adequacies. Submit the investigation report to the RSC for review and carry out necessary remedial works as per the outcome of the settlement investigation report.

| 15. | Settlement of ground floor and deflected 1 <sup>st</sup> floor. (Building 3) | The building engineer is required to investigate the geotechnical capacity of the foundation, allowable settlement limit, deflection of floor slabs and structural adequacies. Submit the investigation report to the RSC for review. | within 6 weeks |
| 16. | | Carry out necessary remedial works as per the outcome of the settlement investigation report. | within 6 months |

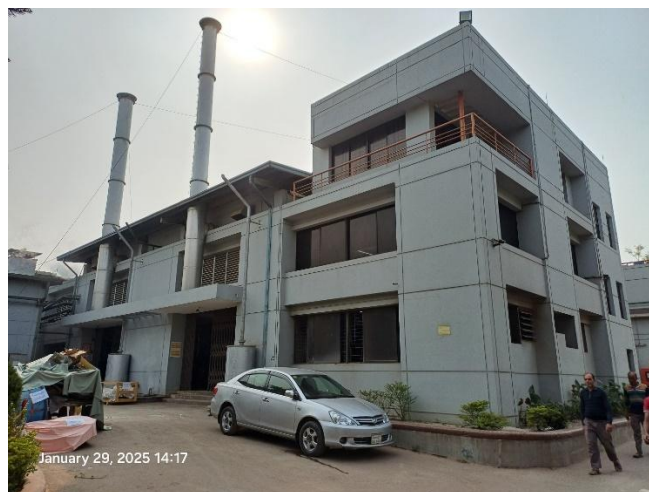
**Observation-12:** DEA report needs to be reviewed against lateral loading. (Building-4: Boiler & Compressor Shed (Hamza-1) (Part-1 & 2))

**Description:** The prepared DEA report needs to be reviewed against lateral forces. Submit the DEA report to the RSC for detailed review.

| 17. | DEA report needs to be reviewed against lateral loading. (Building-4: Boiler & Compressor Shed (Hamza-1) (Part-1 & 2)) | The prepared DEA report needs to be reviewed against lateral forces. Submit the DEA report to the RSC for detailed review. | within 6 weeks |
| 18. | | Carry out remedial work if required. | within 6 months |

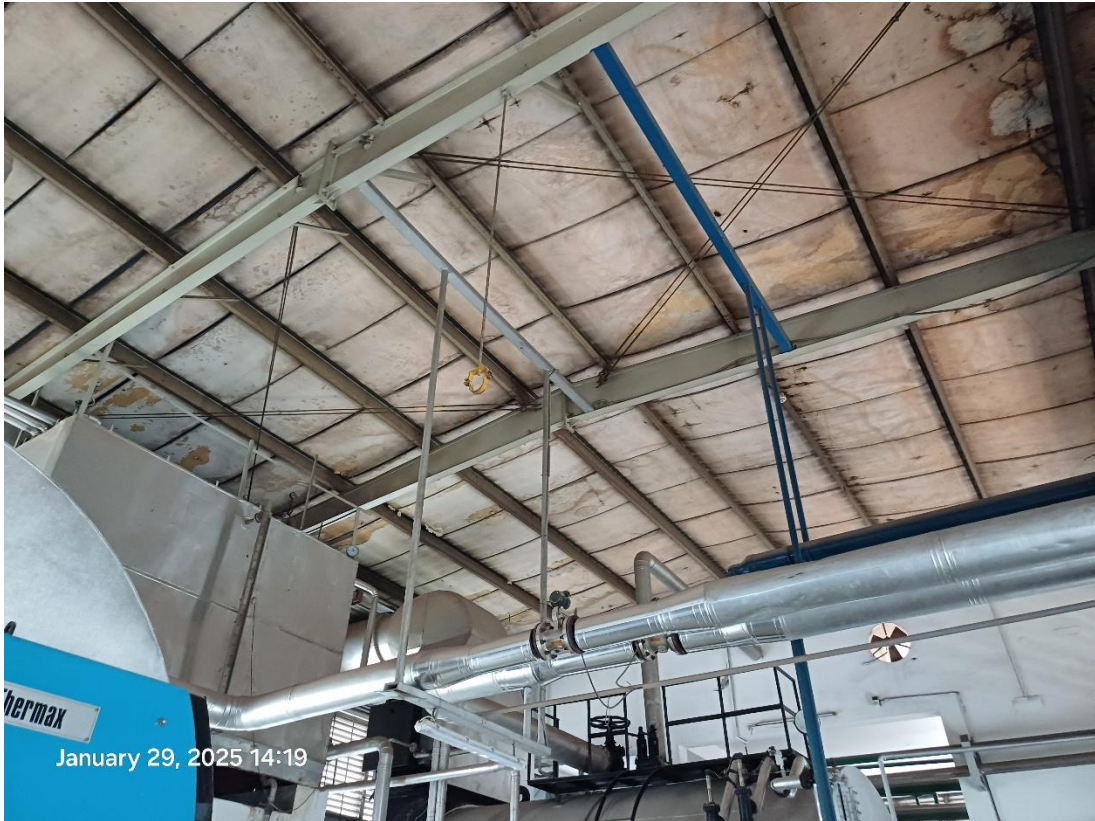
**Observation-13:** Incomplete as-built drawing. (Building-4: Boiler & Compressor Shed (Hamza-1) (Part-1 & 2))

**Description:** During inspection, a hard copy of the structural drawing was not found on-site. Hence the structural drawing was not verified.

The factory is required to prepare the hard copy of the as-built drawings and keep them on the factory site, which will be verified in further inspection.

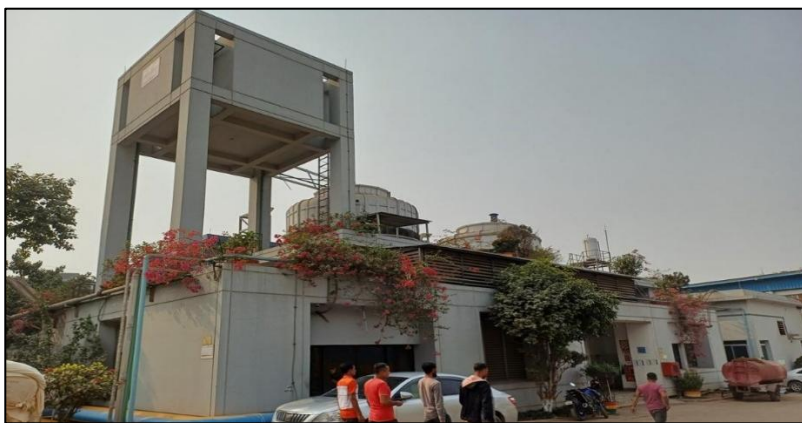
**Observation-14:** Incomplete as-built drawing. (Building 5)

**Description:** During inspection, a hard copy of the structural drawing was not found on-site. Hence the structural drawing was not verified.

The factory is required to prepare the hard copy of the as-built drawings on the factory site, which will be verified in the further inspection.

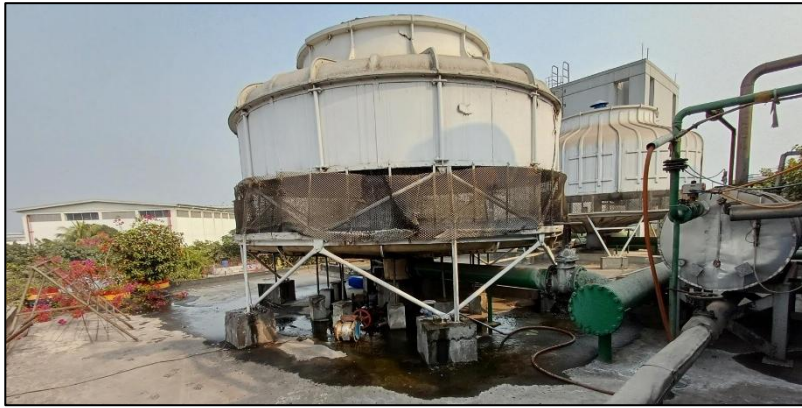
**Observation-15:** Stagnant water on the roof. (Building 5)

**Description:** During the inspection, stagnant water was observed beside the cooling tower areas. The factory is required to remove all stagnant water and improve the drainage system.

| 21. | Stagnant water on the roof. (Building 5) | The factory is required to remove all stagnant water and improve the drainage system. | within 6 months |

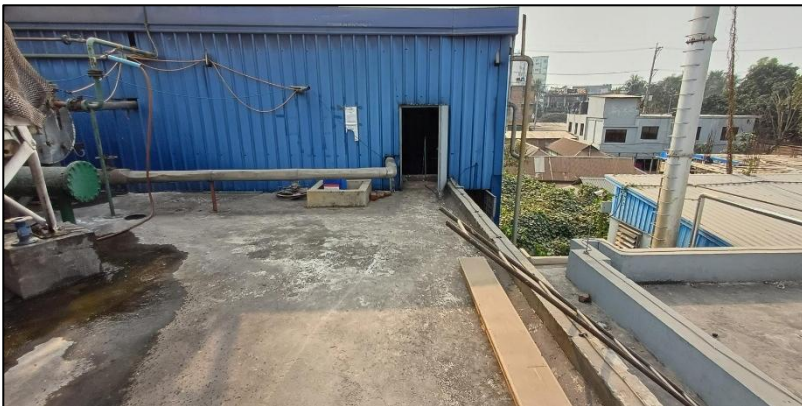
**Observation-16:** Possible falling hazard from roof. (Building 5)

**Description:** During the inspection, it was noted that the roof peripheral lacked barriers at its edges, creating a potential falling hazard. The factory is required to install appropriate safety barriers/parapet to mitigate the risk of falls and ensure compliance with safety standards.

| 22. | Possible falling hazard from roof. (Building 5) | The factory is required to install appropriate safety barriers/parapet to mitigate the risk of falls and ensure compliance with safety standards. | within 6 weeks |

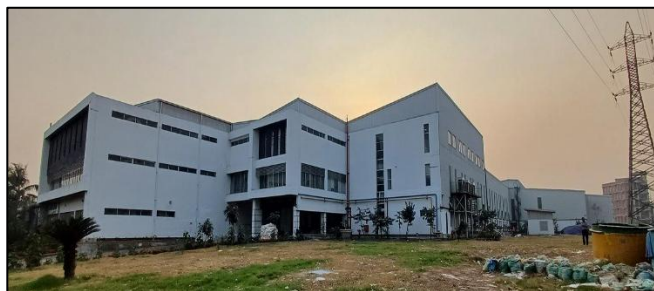
**Observation-17:** Incomplete as-built drawing. (Building 6)

**Description:** During inspection, a hard copy of the structural drawing was not found on-site. Hence the structural drawing was not verified. The factory is required to prepare the hard copy of the as-built drawings on the factory site, which will be verified in the further inspection.

| 23. | Incomplete as-built drawing. (Building 6) | The factory is required to prepare a hard copy of the as-built drawings on the factory site, which will be verified in further inspection. | within 6 weeks |

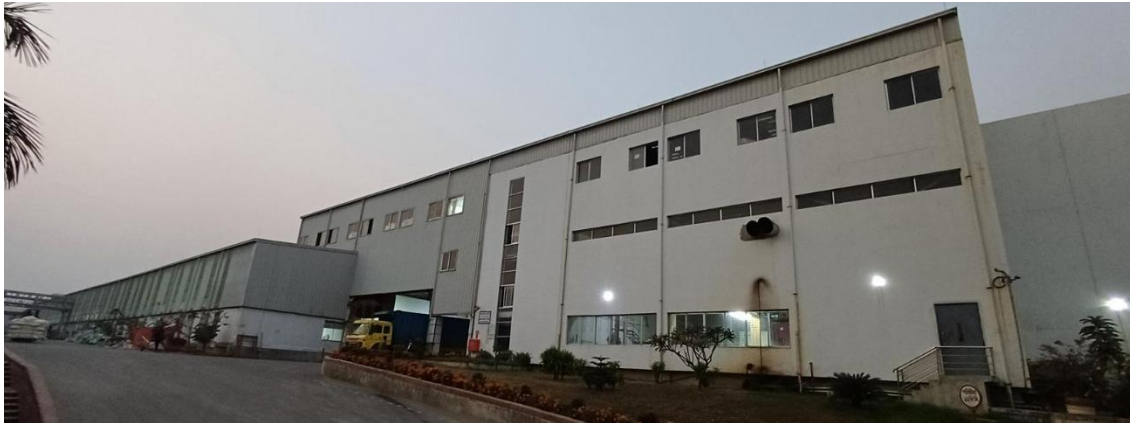
**Observation-18:** Design report needs to be reviewed against lateral loading. (Building 6)

**Description:** The design report prepared needs to be reviewed against lateral forces. Submit the design report to the RSC for detailed review.

| 24. | Design report needs to be reviewed against lateral loading. (Building 6) | The design report prepared needs to be reviewed against lateral forces. Submit the design report to the RSC for detailed review. | within 6 weeks |
| 25. | | Carry out remedial work if required. | within 6 months |

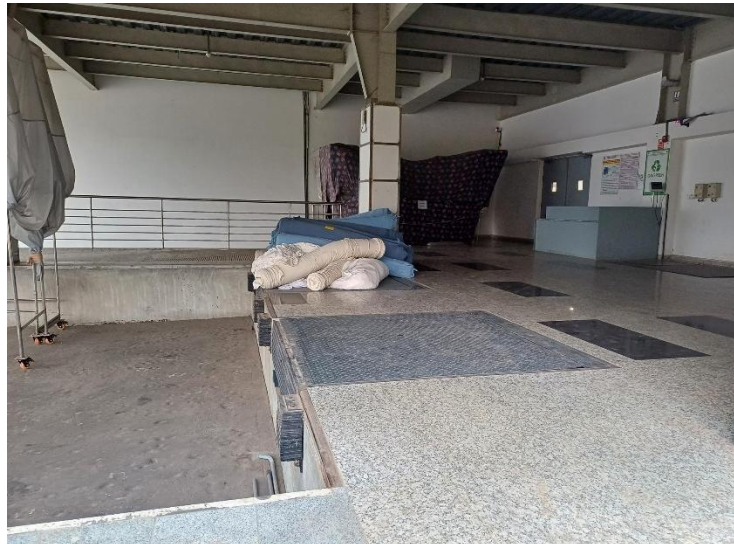
**Observation-19:** Possible falling hazard in the load-unload zone (Building 6).

**Description:** During the inspection, it was noted that the elevated loading-unloading platform lacked railings or barriers at its edges, creating a potential falling hazard. The factory is required to install appropriate safety barriers or railings to mitigate the risk of falls and ensure compliance with safety standards.

| 26. | Possible falling hazard in the load-unload zone. (Building 6) | The factory is required to install appropriate safety barriers or railings to mitigate the risk of falls and ensure compliance with safety standards. | within 6 weeks |

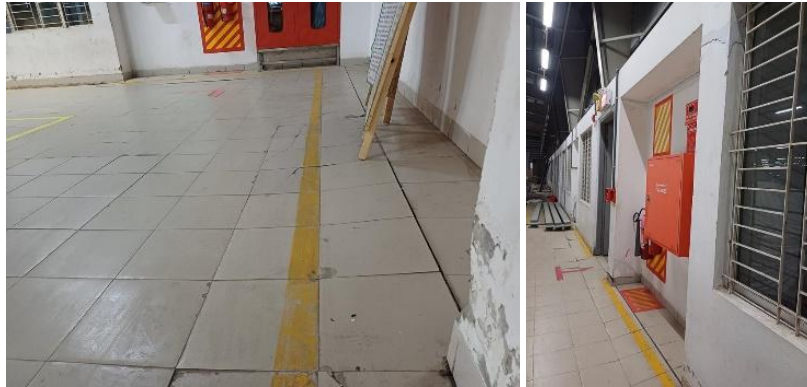
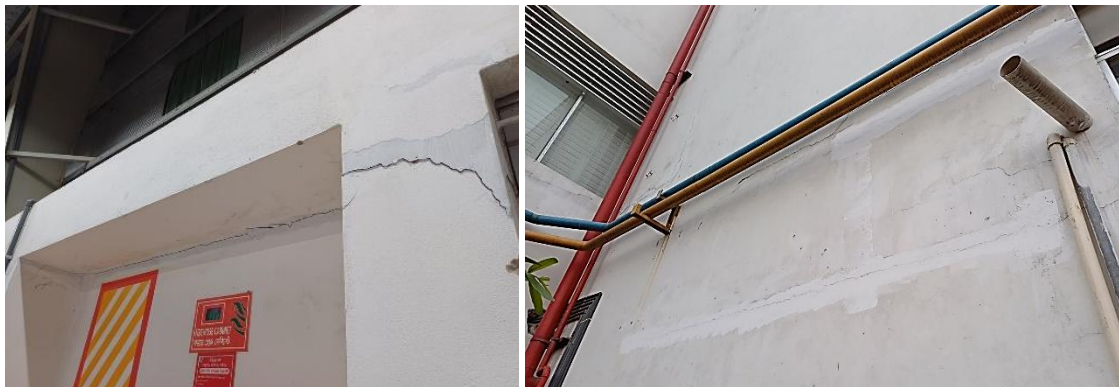
**Observation-20:** Settlement of ground floor and crack on brick wall. (Building 6)

**Description:** Settlement of the ground floor observed and cracks on the brick wall were found. The building engineer is required to investigate the onsite condition, check the settlement limit, and prepare an investigation report along with the design report. Submit design documents with necessary remedial actions to the RSC for review.

| 27. | Settlement of ground floor and crack on brick wall. (Building 6) | The building engineer is required to investigate the onsite condition, check the settlement limit, and prepare an investigation report along with design report. Submit design documents with necessary remedial actions to the RSC for review. | within 6 weeks |
| 28. | | Repair the brick wall and deflected floor as per outcome of investigation report. | within 6 months |

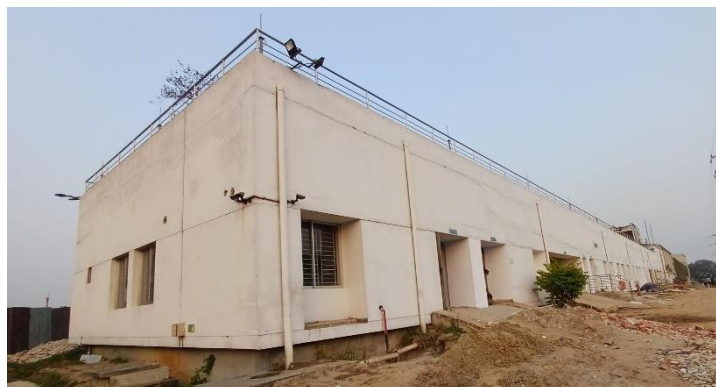
**Observation-21:** Incomplete as-built drawing. (Building 7)

**Description:** During inspection, a hard copy of the structural drawing was not found on-site. Hence the structural drawing was not verified. The factory is required to prepare the hard copy of the as-built drawings on the factory site, which will be verified in the further inspection.

| 29. | Incomplete as-built drawing. (Building 7) | The factory is required to prepare a hard copy of the as-built drawings on factory site which will be verified in further inspection. | within 6 weeks |

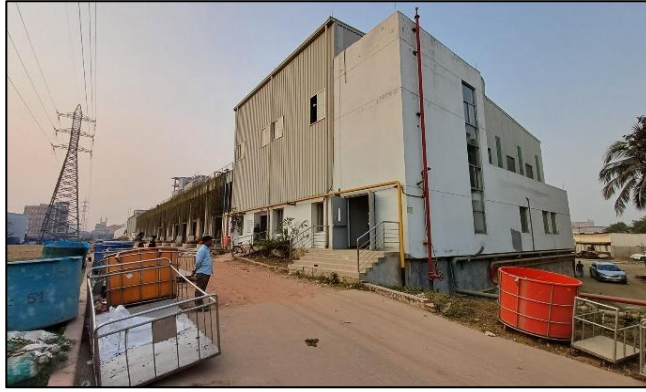
**Observation-22:** Design report needs to be reviewed against lateral loading. (Building 7)

**Description:** The design report prepared needs to be reviewed against lateral forces. Submit the design report to the RSC for detailed review.

| 30. | Design report needs to be reviewed against lateral loading. (Building 7) | The design report prepared needs to be reviewed against lateral forces. Submit the design report to the RSC for detailed review. | within 6 weeks |
| 31. | | Carry out remedial work if required. | within 6 months |

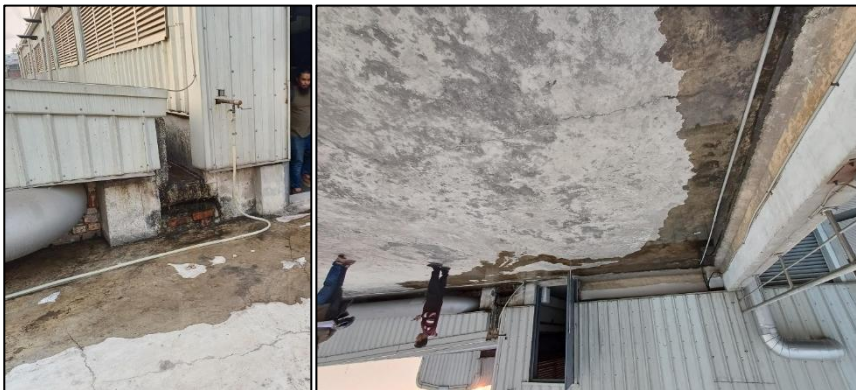
**Observation-23:** Stagnant water on the roof. (Building 7)

**Description:** During the inspection, stagnant water was observed beside the cooling tower areas. The factory is required to remove all stagnant water and improve the drainage system.

| 32. | Stagnant water on the roof. (Building 7) | The factory is required to Remove all stagnant water and improve the drainage system. | within 6 months |

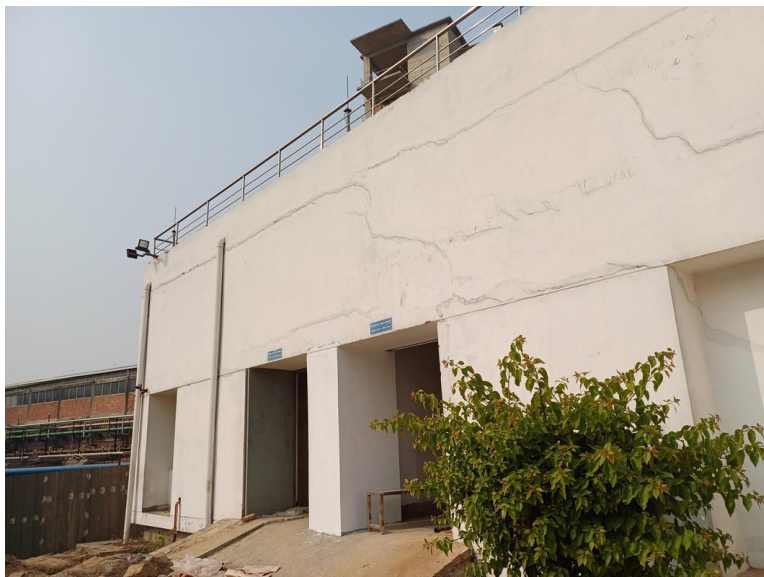
**Observation-24:** Hairline crack on masonry wall (Building 7).

**Description:** During the inspection, hairline cracks were observed on the brick wall. The factory is required to repair the masonry wall cracks as per the recommendation of the building engineer. Also, check the possibility of settlement in the design report.

| 33. | Hairline crack on masonry wall. (Building 7) | The factory is required to repair the masonry wall cracks as per the recommendation of the building engineer. Also, check the possibility of settlement in the design report. | within 6 weeks |

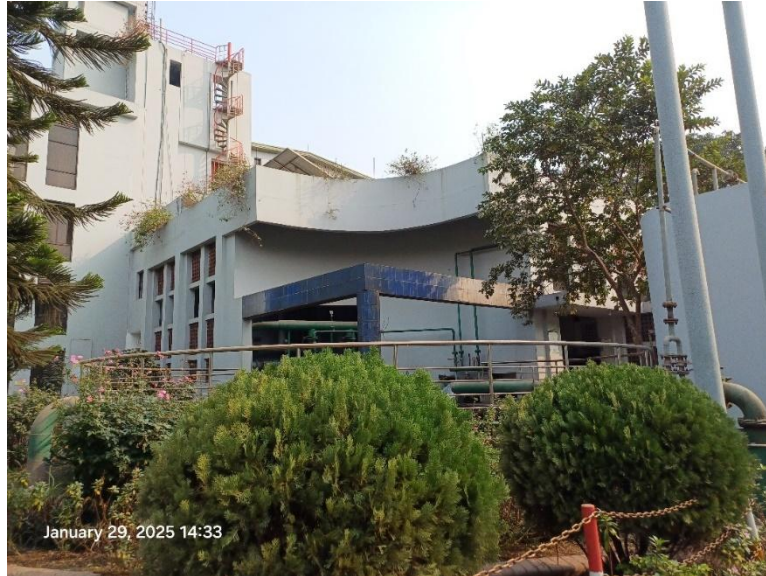
**Observation-25:** Incomplete as-built drawing. (Building-8: WTP Building- 1)

**Description:** During inspection, a hard copy of the structural drawing was not found on-site. Hence the structural drawing was not verified.

The factory is required to prepare the hard copy of the as-built drawings and keep them on the factory site, which will be verified in further inspection.

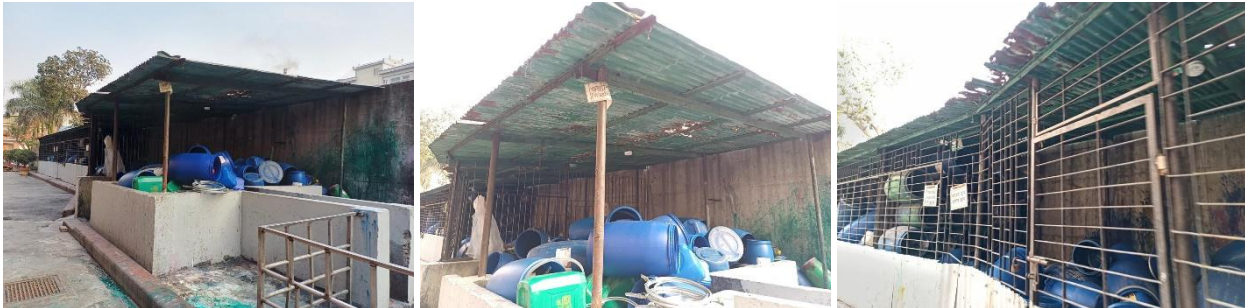
**Observation-26:** Lack of lateral bracing and improper joint for drum store sheds adjacent to ETP. (Building-9: ETP -1)

**Description:** Lateral stability system, including bracing, is absent for drum store sheds. Also, connections are not proper and the steel members are corroded.

The building engineer is required to provide a bracing system, repair the connections and apply anti-corrosive coating on steel members.

| 35. | Lack of lateral bracing and improper joint for drum store sheds adjacent to ETP. (Building-9: ETP -1) | The building engineer is required to provide bracing system & connections and include adequacy check in the safety check report. | within 6 weeks |
| 36. | | Carry out remedial works and apply anti-corrosive coating on steel members. | within 6 months |

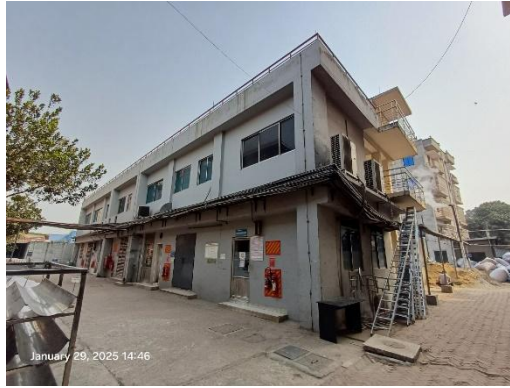
**Observation-27:** DEA report needs to be reviewed against lateral loading. (Building-10: ETP Monitoring Building-1)

**Description:** The prepared DEA report needs to be reviewed against lateral forces. Submit the DEA report to the RSC for detailed review.

| 37. | DEA report needs to be reviewed against lateral loading. (Building-10: ETP Monitoring Building-1) | The prepared DEA report needs to be reviewed against lateral forces. Submit the DEA report to the RSC for detailed review. | within 6 weeks |
| 38. | | Carry out remedial work if required. | within 6 months |

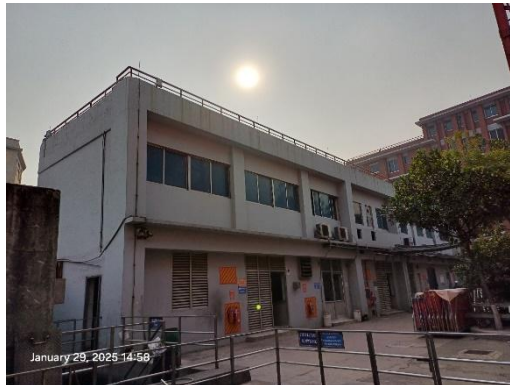
**Observation-28:** Incomplete as-built drawing. (Building-10: ETP Monitoring Building-1)

**Description:** During inspection, a hard copy of the structural drawing was not found on-site. Hence the structural drawing was not verified.

The factory is required to prepare the hard copy of the as-built drawings and keep them on the factory site, which will be verified in further inspection.

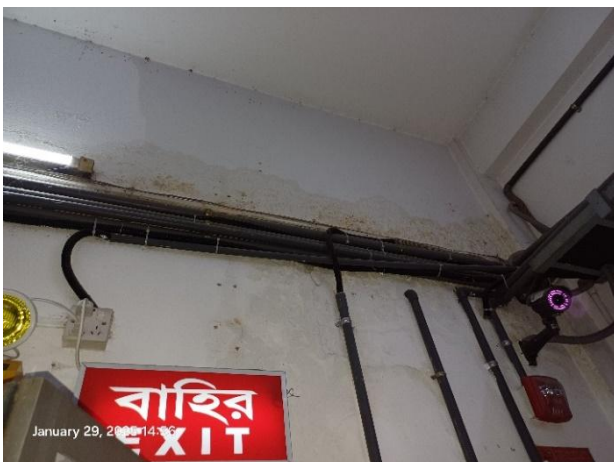
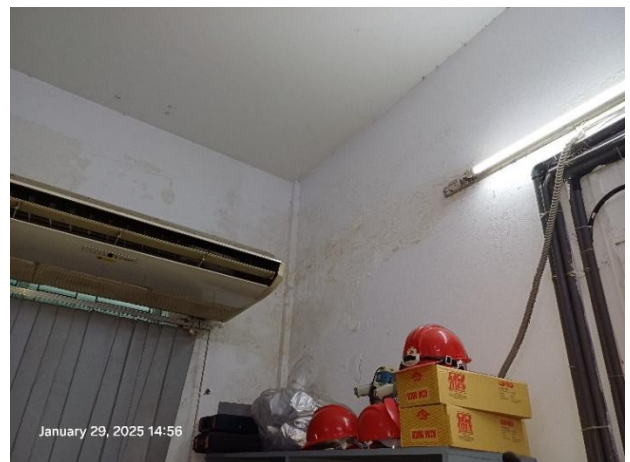
**Observation-29:** Dampness on brick wall. (Building-10: ETP Monitoring Building-1)

**Description:** Dampness was observed on the brick wall of the ground floor. Building engineer to seal the source of water and repair the dampness with a suitable method.

| 40. | Dampness on brick wall. (Building-10: ETP Monitoring Building-1) | Building engineer to seal the source of water and repair the dampness with a suitable method. | within 6 weeks |

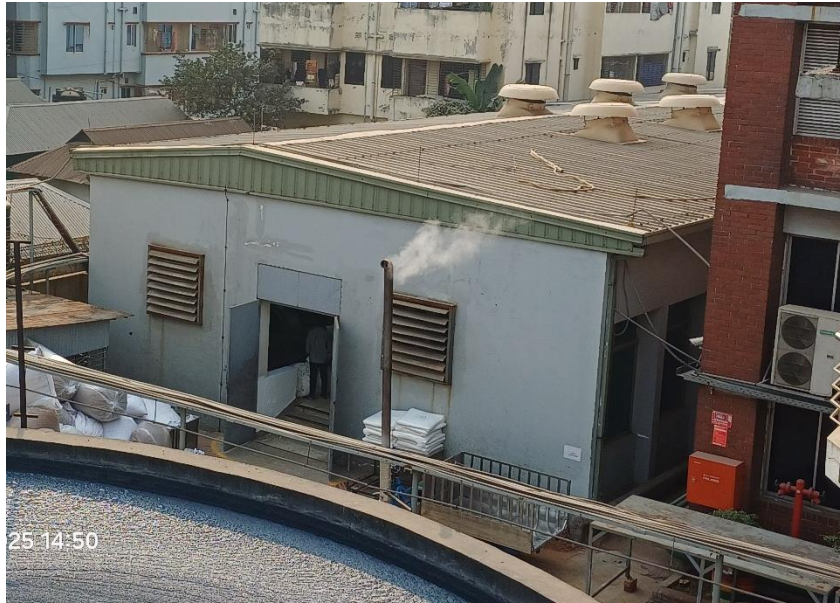
**Observation-30:** Lack of design documents. (Building-11: Acid Wash Shed)

**Description:** Design documents were not available for Building-11: Acid Wash Shed. The building engineer is required to prepare the design documents, including a design report, and as-built drawings as per 1.9.1 BNBC (Part-6).

| 41. | Lack of design documents. (Building-11: Acid Wash Shed) | The building engineer is required to prepare design documents (including design reports, load plans, and material test reports) in compliance with section 1.9.1 (part-6, BNBC) and submit them to RSC. | within 6 weeks |
| 42. | | Implement remediation work if required. | within 6 months |

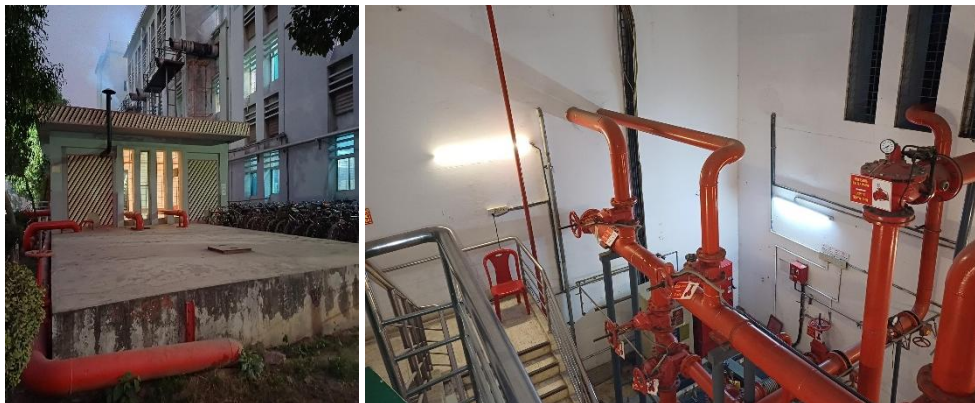
**Observation-31:** Incomplete as-built drawing. (Building 12)

**Description:** During inspection, a hard copy of the structural drawing was not found on-site. Hence the structural drawing was not verified.

The factory is required to prepare the hard copy of the as-built drawings on the factory site, which will be verified in the further inspection.

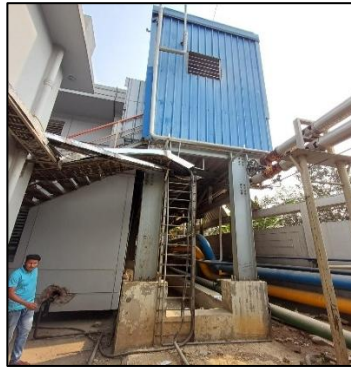
**Observation-32:** Incomplete as-built drawing. (Building 13)

**Description:** During inspection, a hard copy of the structural drawing was not found on-site. Hence the structural drawing was not verified. The factory is required to prepare the hard copy of the as-built drawings on the factory site, which will be verified in the further inspection.

| 44. | Incomplete as-built drawing. (Building 13) | The factory is required to prepare a hard copy of the as-built drawings on factory site which will be verified in further inspection. | within 6 weeks |

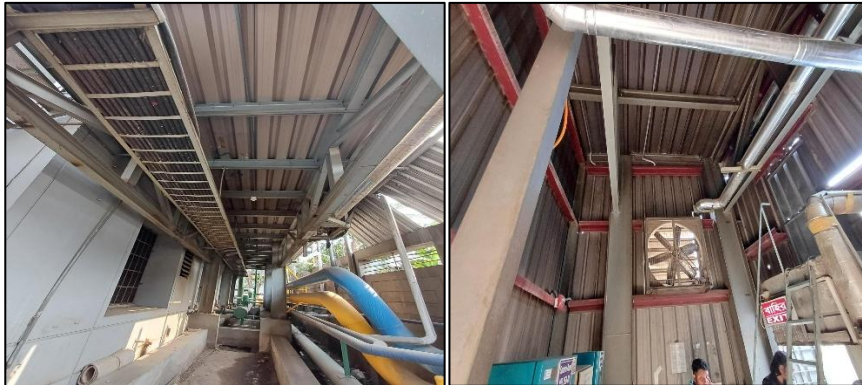
**Observation-33:** Design report needs to be reviewed against lateral loading. (Building 13)

**Description:** The design report prepared needs to be reviewed against lateral forces. Submit the design report to the RSC for detailed review.

| 45. | Design report needs to be reviewed against lateral loading. (Building 13) | The design report prepared needs to be reviewed against lateral forces. Submit the design report to the RSC for detailed review. | within 6 weeks |
| 46. | | Carry out remedial work if required. | within 6 months |
