# Shanta Expression Limited (Extention)

26 February 2025

## Structural Inspection Report

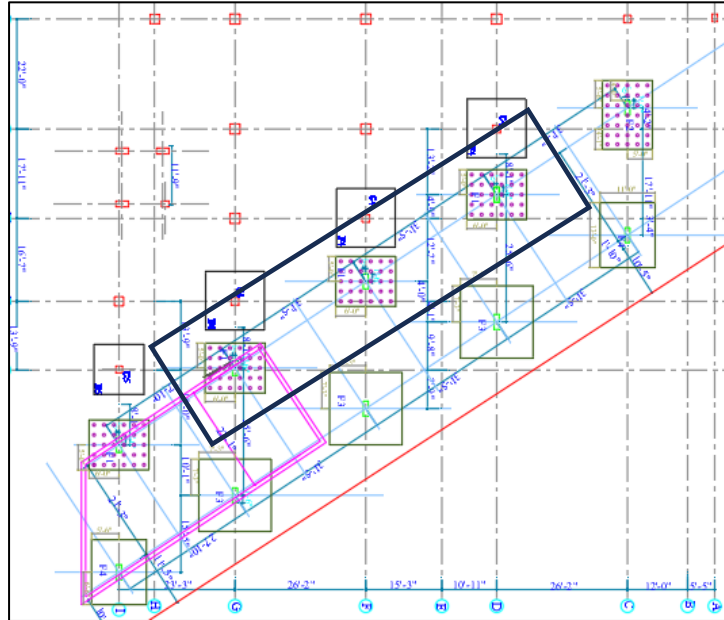
**Observation 01:** Marginally stress above normal design limit in column and foundation (Production & Utility Building).

**Description:** Cursors calculation indicates that stress in the columns and foundation exceeds the normal design limit in the highlighted columns and foundation (marked in the layout) for the 7-storied structure.

Building engineer is required to perform in-situ material strength, review the design of the foundation stress and prepare a Detail Engineering Assessment (DEA) report with a proper remediation plan and submit to RSC for review.

| SL | Observation | Action Plan | Timeline |
|---|---|---|---|
| 1. | Marginally stress above normal design limit in column and foundation (Production & Utility Building). | Verify in-situ concrete material strength by taking concrete cores (minimum 4 nos and 100 mm diameter) from lower tier building columns. | within 6 weeks |
| 2. | | Building engineer is required to review, design of foundation stress and prepare a Detail Engineering Assessment (DEA) report with proper remediation plan and submit to RSC for review. | within 6 weeks |
| 3. | | Carry out suggested remedial works if required. | within 6 months |

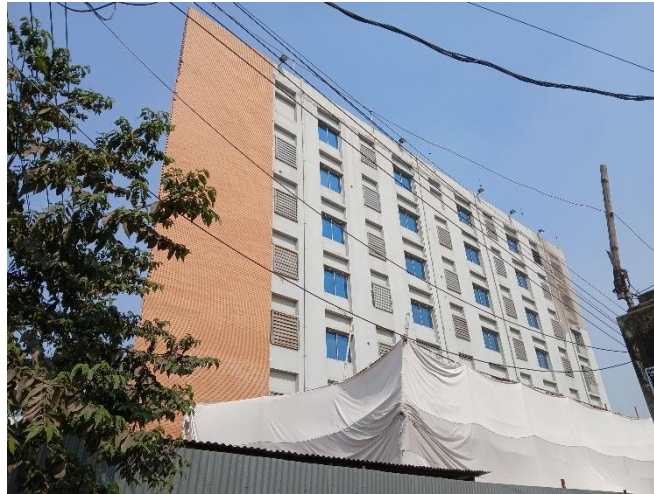
**Observation 02:** Lack of Lateral Stability (Production & Utility Building).

**Description:** This structure is a 7 storied structure with a single bay and the width of this building is very less compared to its length.

The building engineer is required to check the stability of this structure against lateral forces, stresses and serviceability's as part of DEA and submit to RSC for review.

| SL | Observation | Action Plan | Timeline |
|---|---|---|---|
| 4. | Lack of Lateral Stability (Production & Utility Building). | The building engineer is required to check the stability of this structure against lateral forces, stresses and serviceability's as part of DEA and submit to RSC for review. | within 6 weeks |

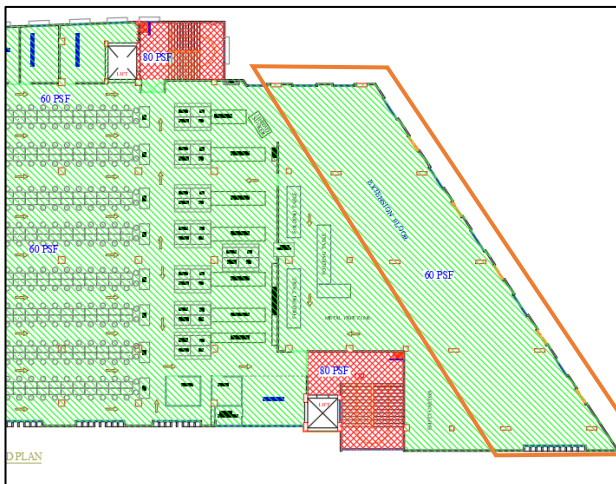
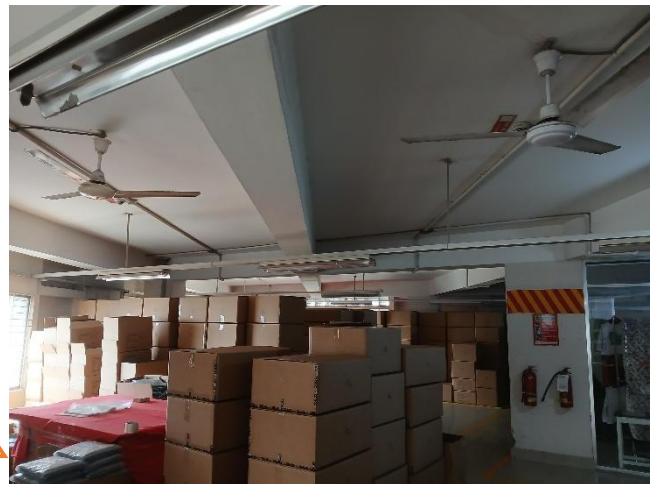
**Observation-3:** Occupancy doesn't match with prepared load plan and onsite floor uses (Production & Utility Building).

**Description:** Prepared load plans are not matched with the current floor loading on some floors. Some temporary stores were found on the 3rd to 5<sup>th</sup> floor, which are designated as 3 kPa live load in prepared load plan for regular uses.

Building engineer is required to update load plan as per floor uses.

| SL | Observation | Action Plan | Timeline |
|---|---|---|---|
| 5. | Occupancy doesn't match with prepared load plan and onsite floor uses (Production & Utility Building). | The building engineer is required to prepare floor load plan and implement management program (posting, marking & maintaining). | within 6 weeks |

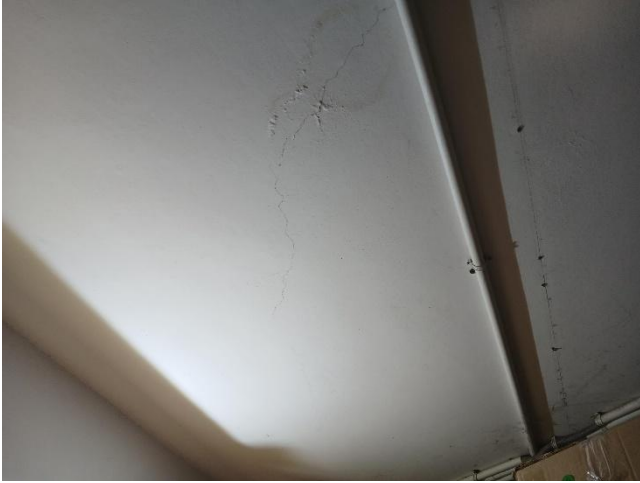
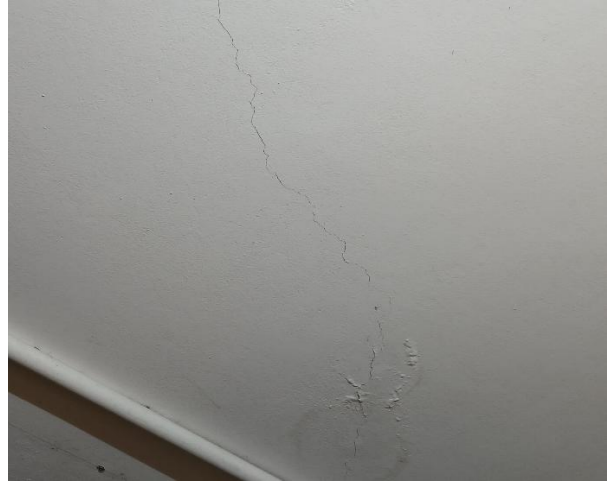
**Observation 4:** Cracks and signs of water intrusion on bottom of roof slab (Production & Utility Building).

**Description:** Cracks and signage of water intrusion were observed on bottom of roof slab. The building engineer is required to prepare an investigation report with suitable remedial method and submit to RSC for review.

| SL | Observation | Action Plan | Timeline |
|---|---|---|---|
| 6. | Cracks and signage of water intrusion on the bottom of the roof slab (Production & Utility Building). | The building engineer is required to prepare an investigation report with suitable remedial method and submit to RSC for review. | within 6 weeks |
| 7. | | Carry out suggested remedial works if required. | within 6 months |

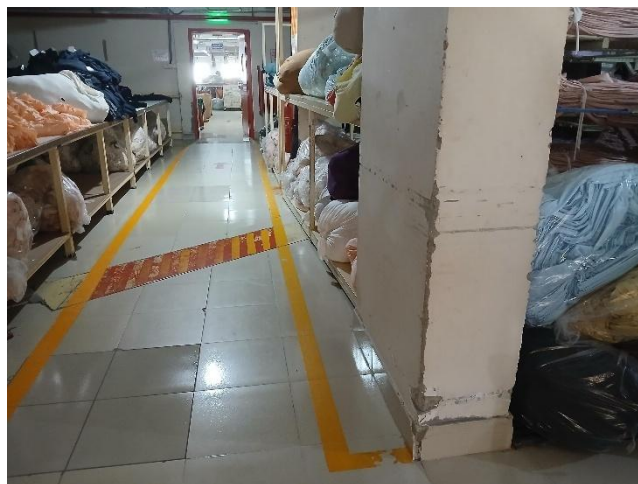
**Observation 5:** Trolley impact and surface damage (Production & Utility Building).

Trolley impact and surface damage on columns

**Description:** Damage due to trolley impact was observed on different floor columns. The building engineer is required to provide columns guard to protect from trolley impact.

| SL | Observation | Action Plan | Timeline |
|---|---|---|---|
| 8. | Trolley impact and surface damage (Production & Utility Building). | The building engineer is required to provide column guard to protect from trolley impact. | within 6 months |

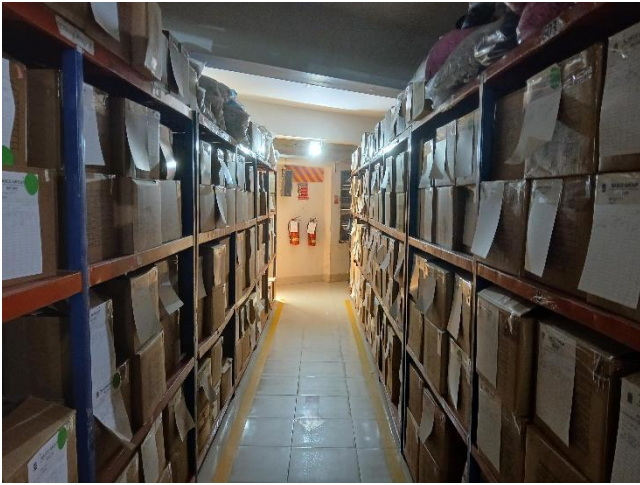
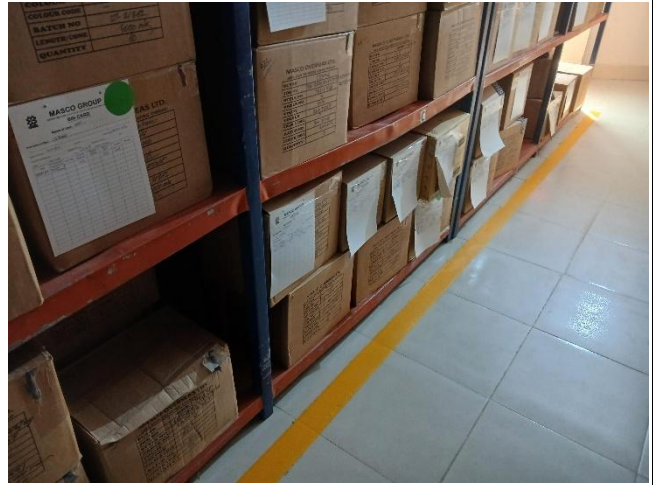
**Observation 6:** Lack of anchorage/braced of non-structural elements (Production & Utility Building).

**Description:** Non-structural elements (storage racks) were found not anchored & unbraced. The factory is required to brace/anchor all the non-structural elements within the building.

| SL | Observation | Action Plan | Timeline |
|---|---|---|---|
| 9. | Lack of anchorage / bracing of non-structural elements. (Production & Utility Building). | The factory is required to brace/anchor all the non-structural elements within the building. | within 6 months |

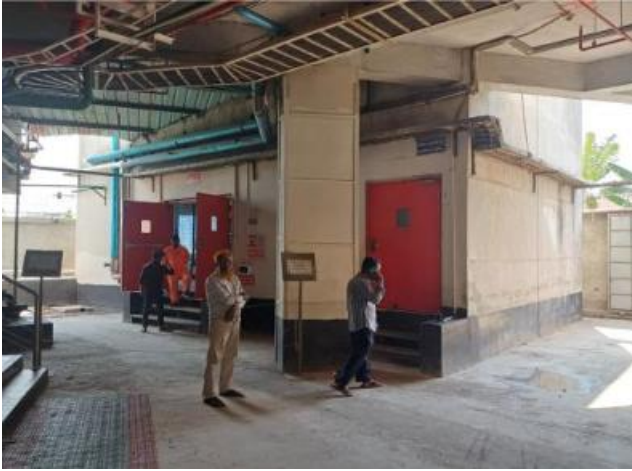
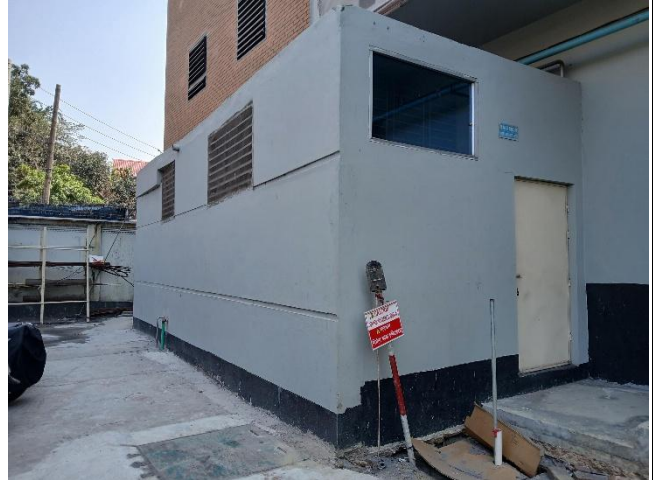
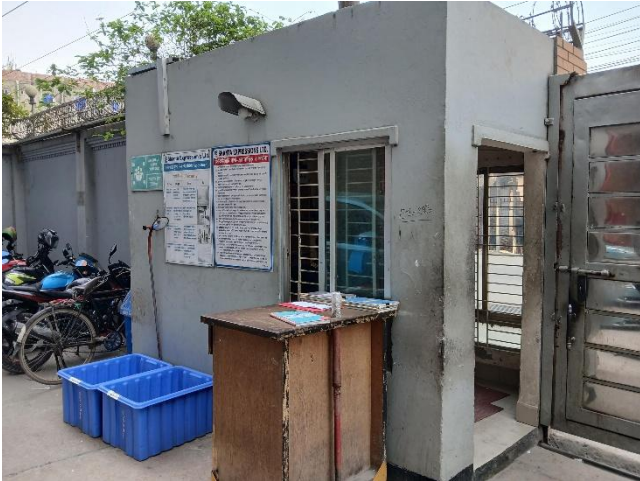
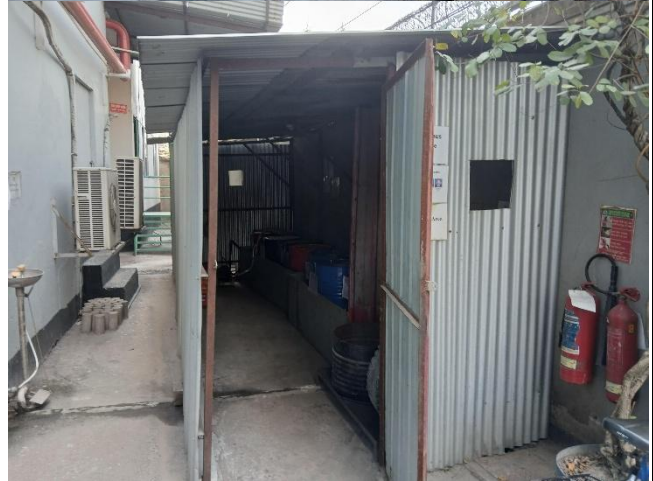
**Observation 7:** Lack of as-built drawings (Boiler room, RMS & CP Room & Security room)

**Description:** During inspection, no credible drawings were available for these structures. The building engineer is required to survey these structures and prepare accurate as-built drawings.

| SL | Observation | Action Plan | Timeline |
|---|---|---|---|
| 10 | Lack of as-built drawings (Boiler room, RMS & CP Room, Security room & DIESEL Store shed) | The building engineer is required to survey these structures and prepare accurate as-built drawings with foundation details. | within 6 weeks |
