# Santic (Bangladesh) Co. Ltd.

27 February 2025

## Structural Inspection Report

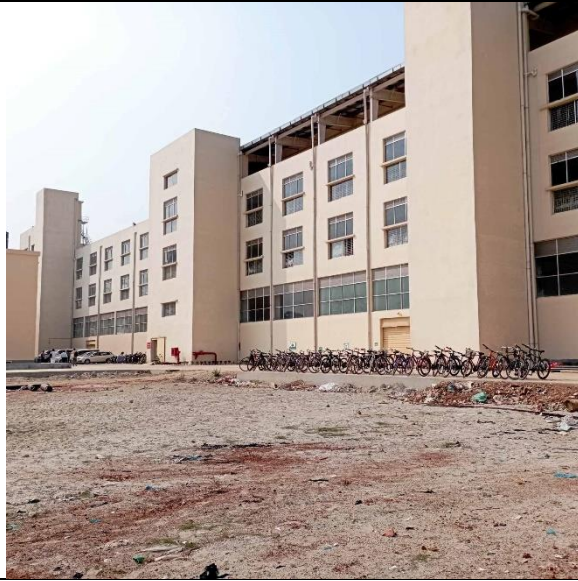
### Observation 1: Lack of design report. (Main Building).

**Description:** As per BNBC, every building or structure designed shall have its design documents prepared in accordance with the provisions of Section 1.9.1. The design document shall include a design report and a set of structural drawings, which shall be prepared in compliance with section 1.9.1.1 and section 1.9.1.2 as per BNBC. At the time of the inspection, the design report was not available. Besides, 7 set MS plate test reports were available (5 mm, 6mm, 8mm, 10mm, 12mm, 16mm, 20mm); for 5,6 & 8 mm achieved 450 MPa, 10mm =282 MPa, 12mm=441 MPa, 16mm= 401MPa, 20mm=373 MPa achieved.

The building engineer is required to prepare a set of design reports based on steel strength in compliance with section 1.9.1 (part-6, BNBC). Also, confirm the design strength of steel.

| Item No. | Observation | Action Plan | Timeline |
|---|---|---|---|
| 1. | Lack of design report. (Main Building). | The building engineer is required to prepare a design report as per 1.9.1-BNBC and submit it to RSC for review. | within 6 weeks |
| 2. | | Also, confirm the design strength of steel. | within 6 weeks |
| 3. | | Implement remediation work if required. | within 6 months |

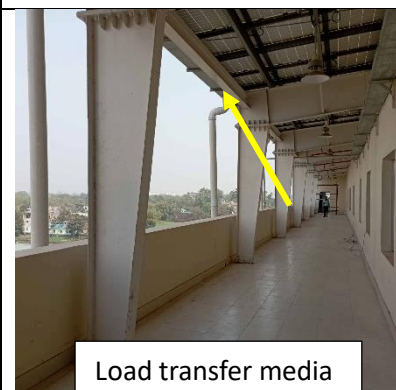
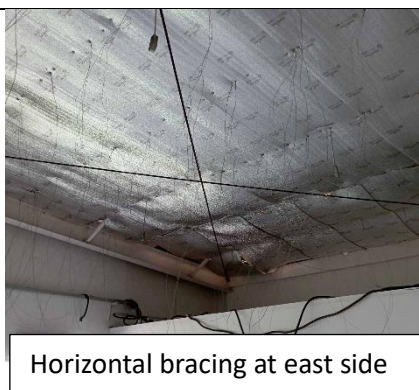
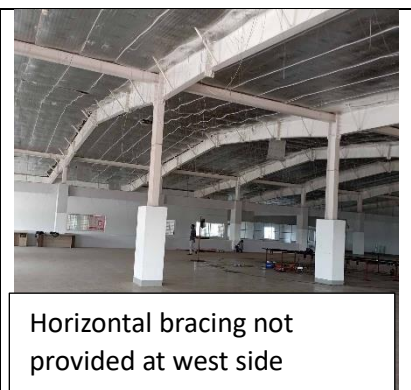
### Observation 2: Incomplete lateral stability system of roof shed (Main Building).

**Description:** Load transfer media is provided; horizontal bracing is provided on the east side but not on the west side. No vertical bracing is provided to resist the lateral load for the shed part. The building engineer is required to check the lateral stability of the roof shed.

| Item No. | Observation | Action Plan | Timeline |
|---|---|---|---|
| 4. | Incomplete lateral stability system of roof shed (Main Building). | The building engineer is required to check the lateral stability of the roof shed. | within 6 weeks |

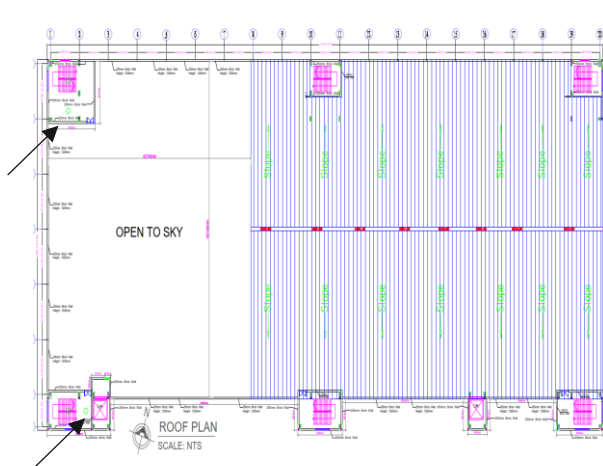
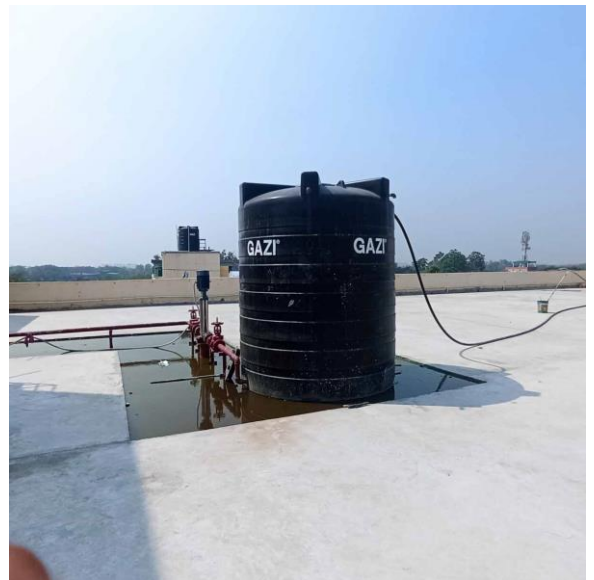
**Observation-3:** Discrepancy in provided drawing (Main Building).

**Description:** 5 plastic tanks were found (capacity 7500 liters each), but only two tanks were shown in the drawing. The building engineer is required to update the as-built drawing.

| Item No. | Observation | Action Plan | Timeline |
|---|---|---|---|
| 5. | Discrepancy in as-built drawing (Main Building). | The building engineer is required to update the as-built drawing. | within 6 weeks |

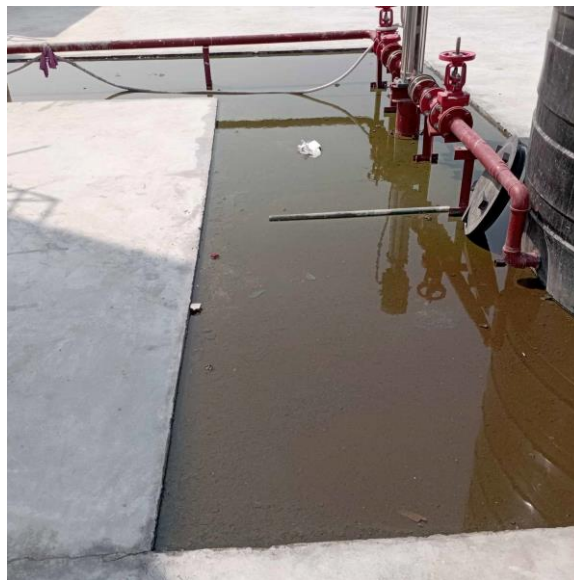
**Observation-4:** Water ponding on roof Slab (Main Building).

**Description:** Water ponding on roof slab due to poor drainage system. The building engineer is required to improve the drainage system on the roof slab.

| Item No. | Observation | Action Plan | Timeline |
|---|---|---|---|
| 6. | Water ponding on roof Slab (Main Building). | The building engineer is required to improve the drainage system on the roof slab. | within 6 weeks |

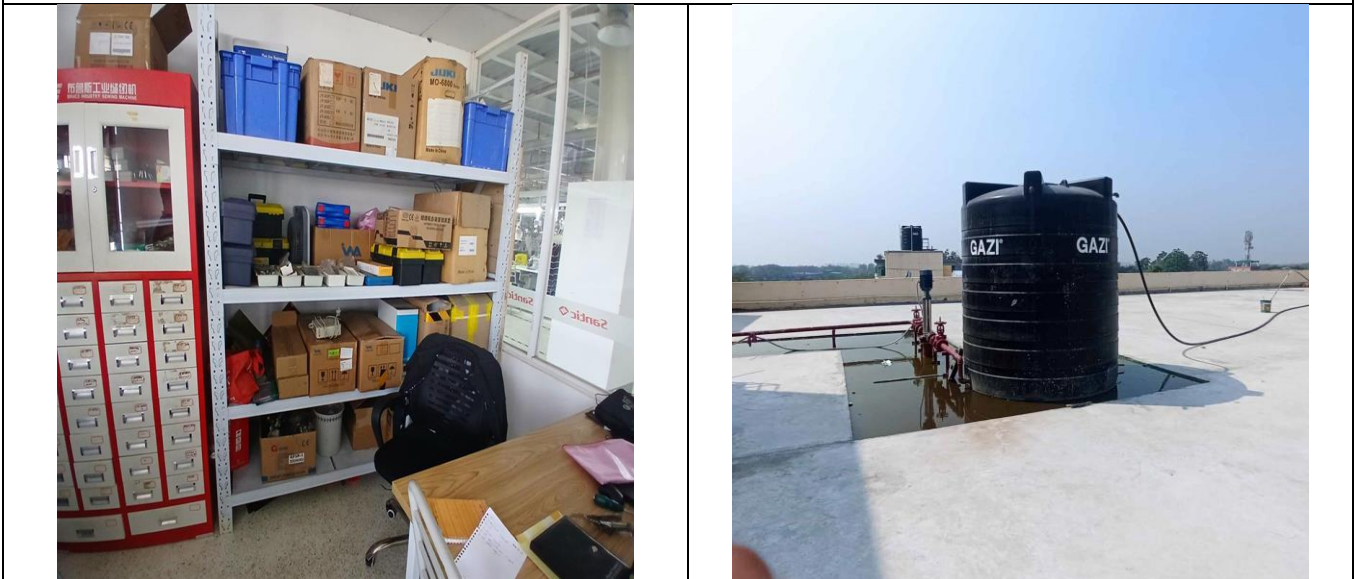
**Observation 5:** Non-structural elements were found not anchored/braced. (Main Building).

**Description:** Storage rack/plastic tanks were found without being braced/anchored. The building engineer is required to brace/anchor all non-structural elements.

| Item No. | Observation | Action Plan | Timeline |
|---|---|---|---|
| 7. | Non-structural elements were found not anchored/braced. (Main Building). | The building engineer is required to brace/anchor all non-structural elements. | within 6 months |

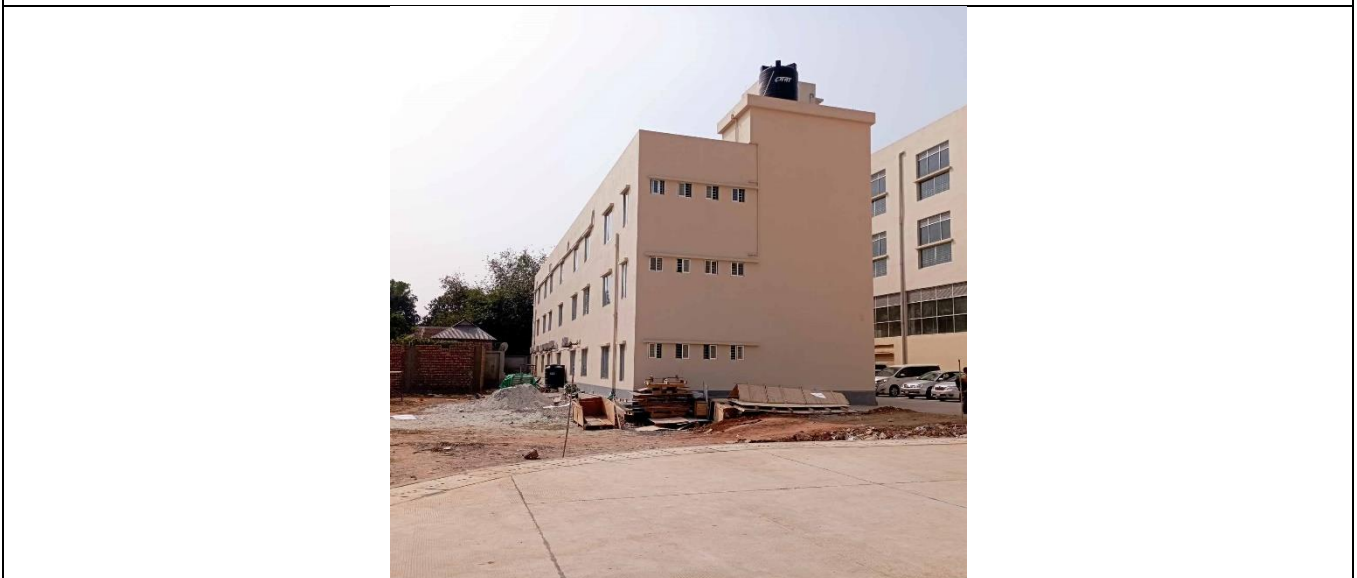
**Observation 6:** Lack of design report and test report (Dining Building).

**Description:** As per BNBC, every building or structure designed shall have its design documents prepared in accordance with the provisions of Section 1.9.1. The design document shall include a design report, and a set of structural drawings, which shall be prepared in compliance with section 1.9.1.1 and section 1.9.1.2 as per BNBC. At the time of the inspection, the design report was not available. Also, no concrete cylinder test report was available. The building engineer is required to prepare a set of design reports based on in situ concrete strength in compliance with section 1.9.1 (part-6, BNBC).

| Item No. | Observation | Action Plan | Timeline |
|---|---|---|---|
| 8. | Lack of design report and test report (Dining Building). | The building engineer is required to prepare a design report as per 1.9.1-BNBC and submit it to RSC for review. | within 6 weeks |
| 9. | | Take a minimum of 4 (100 mm diameter) concrete cylinder cores from the column (lower level). | within 6 weeks |
| 10. | | Implement remediation work if required. | within 6 months |

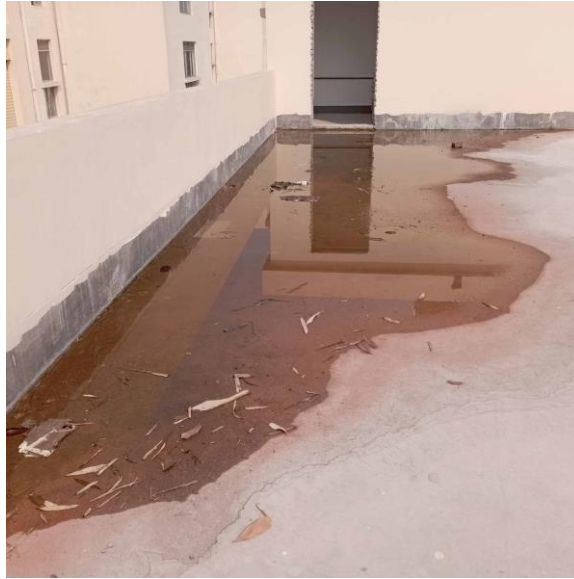
**Observation-7:** Water ponding on roof Slab (Dining Building).

**Description:** Water ponding on roof slab due to poor drainage system. The building engineer is required to improve the drainage system on the roof slab.

| Item No. | Observation | Action Plan | Timeline |
|---|---|---|---|
| 11. | Water ponding on roof Slab (Dining Building). | The building engineer is required to improve the drainage system on the roof slab. | within 6 weeks |

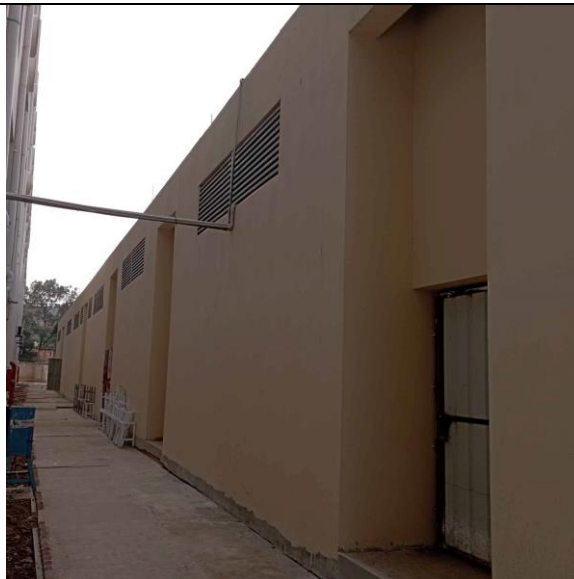
**Observation 8:** Lack of design report (Utility Building).

**Description:** As per BNBC, every building or structure designed shall have its design documents prepared in accordance with the provisions of Section 1.9.1. The design document shall include a design report, and a set of structural drawings, which shall be prepared in compliance with section 1.9.1.1 and section 1.9.1.2 as per BNBC. At the time of the inspection, the design report was not available.  
The building engineer is required to prepare a set of design reports in compliance with section 1.9.1 (part-6, BNBC).

| 12. | Lack of design report (Utility Building). | The building engineer is required to prepare a design report as per 1.9.1-BNBC and submit it to RSC for review. | within 6 weeks |
| 13. | | Implement remediation work if required. | within 6 months |

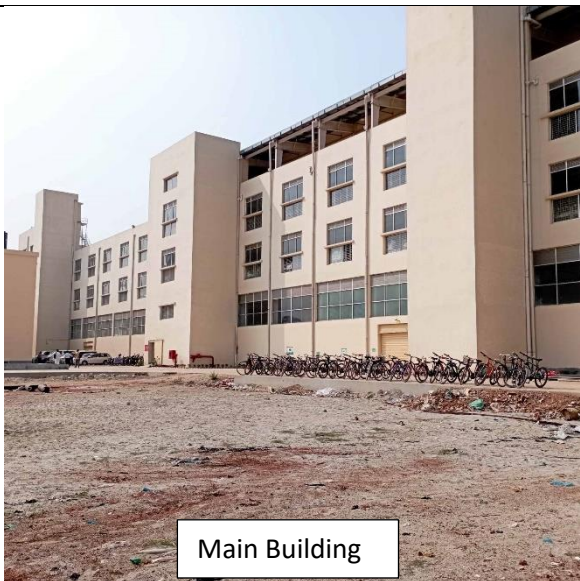
Main Building

**Observation 9:** Lack of approval layout/drawing from local authority. (All structures).

**Description:** No approval layout/drawing was available from the local authority for any of the structures. The factory is required to collect approval layout/drawing from the relevant local authority for all structures within the factory.

| 14. | Lack of approval layout/drawing from local authority. (All structures). | The factory is required to collect approval layout/drawing from the relevant local authority for all structures within the factory. | within 6 months |
