# Ocean Sweater Ind. (Pvt). Ltd. (Extension)

Islampur, Joydebpur, Gazipur.

3 March 2025

## 1. Executive Summary

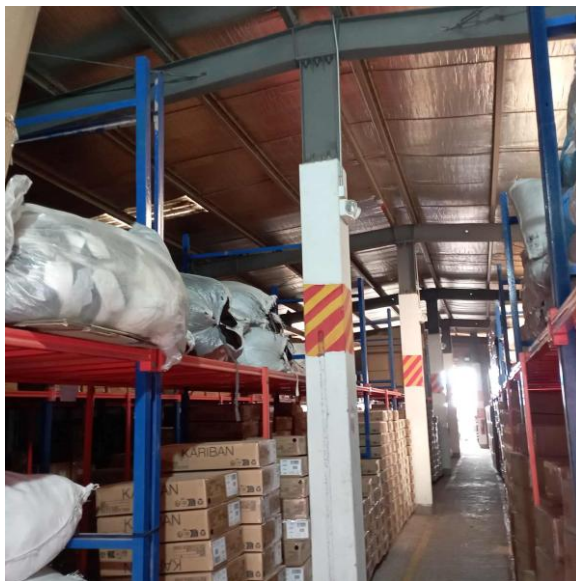
### Observation 1: Lack of lateral stability (Shed-1).

**Description:** Lateral load transfer media and vertical bracing are not provided to transfer and resist the lateral load. The building engineer is required to check the lateral stability of the structure and prepare a design report as per 1.9.1 BNBC.

| Item No. | Observation | Action Plan | Timeline |
|---|---|---|---|
| 1. | Lack of lateral stability (Shed-1). | The building engineer is required to check the lateral stability of the structure and prepare a design report as per 1.9.1 BNBC. | within 6 weeks |
| 2. | | Implement remediation work if required. | within 6 months |

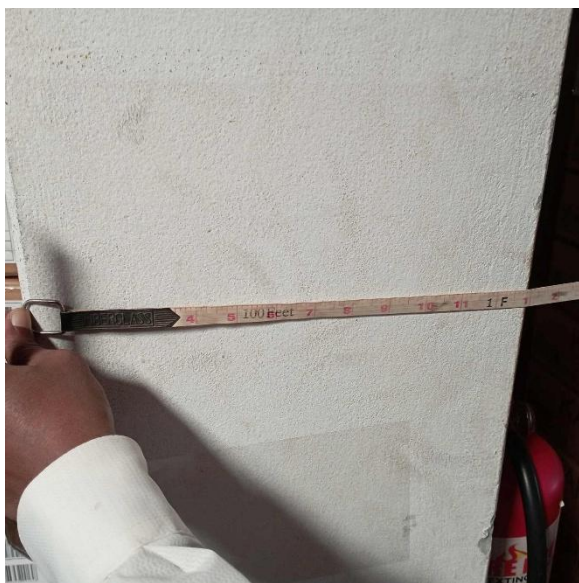
### Observation 2: Discrepancy and missing information in the provided drawing (Shed-1).

**Description:** All the columns were found as 300mmX300mm instead of 375mmX300mm. Also, no details of the steel part are provided in the drawing. The building engineer is required to prepare a full set of accurate as-built drawings.

| Item No. | Observation | Action Plan | Timeline |
|---|---|---|---|
| 3. | Discrepancy and missing information in the provided drawing (Shed-1). | The building engineer is required to prepare a full set of accurate as-built drawings. | within 6 weeks |

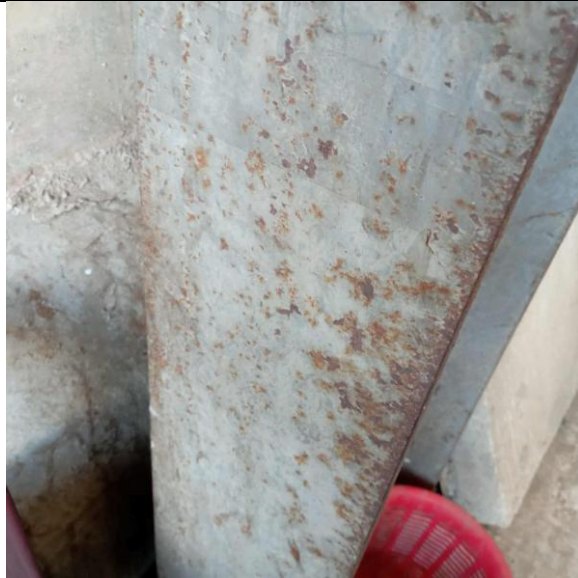
**Observation 3:** Corrosion on steel members (Shed-1).

**Description:** Corrosion was observed on steel members at several locations. The building engineer is required to remove the corrosion and provide rust-proof paint on steel members.

| Item No. | Observation | Action Plan | Timeline |
|---|---|---|---|
| 4. | Corrosion on steel members (Shed-1). | The building engineer is required to remove the corrosion and provide rust-proof paint on steel members. | within 6 weeks |

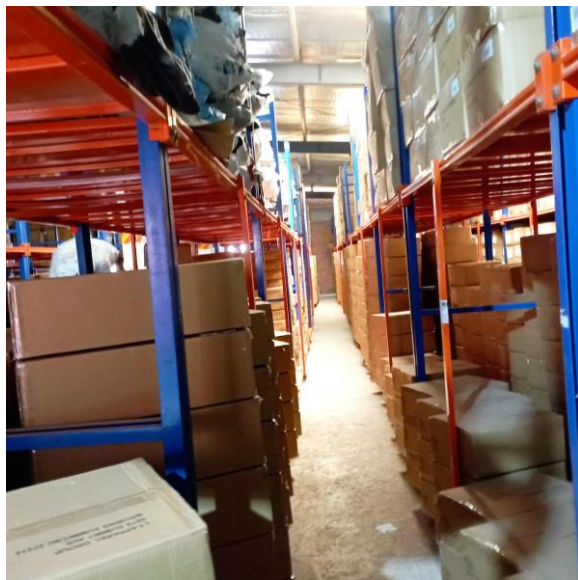
**Observation-4:** Non-structural elements found not anchored/braced (Shed-1).

**Description:** Nonstructural elements (storage racks) were found not anchored/braced. The building engineer is required to anchor/brace all nonstructural elements within the factory.

| Item No. | Observation | Action Plan | Timeline |
|---|---|---|---|
| 5. | Non-structural elements found not anchored/braced (Shed-1). | The building engineer is required to anchor/brace all nonstructural elements within the factory. | within 6 months |

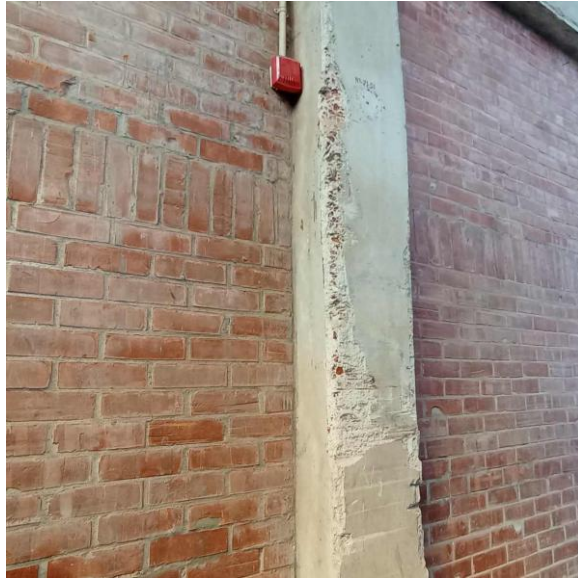
**Observation-5:** Column damage due to vehicle impact (Shed-1).

**Description:** Column damage due to vehicle impact. The building engineer is required to repair column damage and provide a barrier to avoid vehicle impact.

| Item No. | Observation | Action Plan | Timeline |
|---|---|---|---|
| 6. | Column damage due to vehicle impact (Shed-1). | The building engineer is required to repair column damage and provide a barrier to avoid vehicle impact. | within 6 weeks |

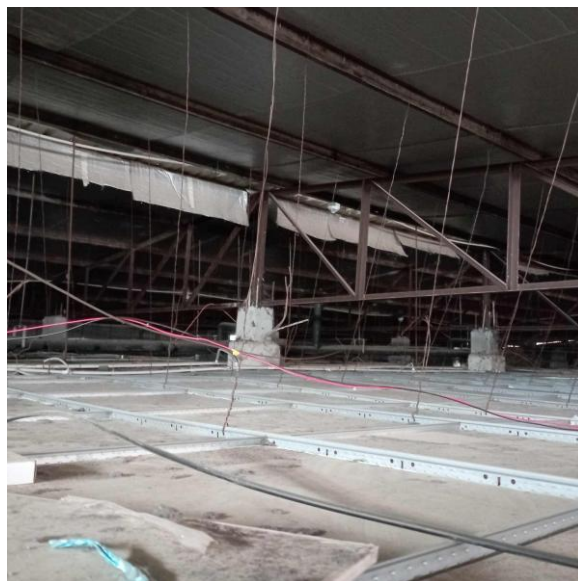
**Observation 6:** Lack of lateral stability (Shed-2).

**Description:** Lateral load transfer media and vertical bracing are not provided to transfer and resist the lateral load. The building engineer is required to check the lateral stability of the structure and prepare a design report as per 1.9.1 BNBC.

| Item No. | Observation | Action Plan | Timeline |
|---|---|---|---|
| 7. | Lack of lateral stability (Shed-2). | The building engineer is required to check the lateral stability of the structure and prepare a design report as per 1.9.1 BNBC. | within 6 weeks |
| 8. | | Implement remediation work if required. | within 6 months |

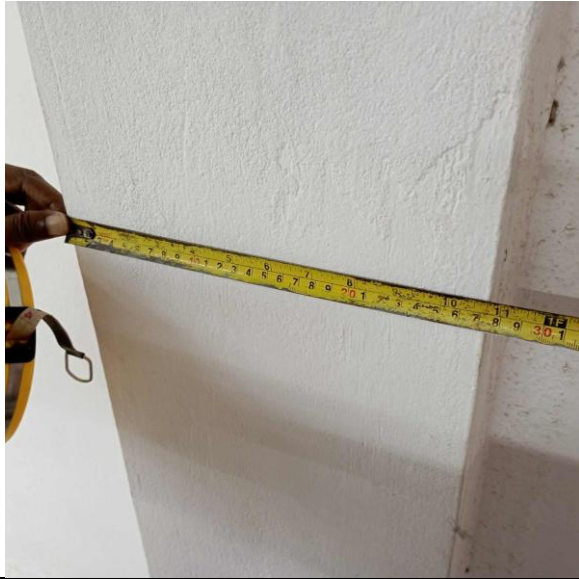
**Observation 7:** Discrepancy and missing information in the provided drawing (Shed-2).

**Description:** All the periphery column (C1) was found as 250mmX250mm instead of 300mmX300mm. Also, no details of the steel part are provided in the drawing. The building engineer is required to prepare a full set of accurate as-built drawing.

| Item No. | Observation | Action Plan | Timeline |
|---|---|---|---|
| 9. | Discrepancy and missing information in the provided drawing (Shed-2). | The building engineer is required to prepare a full set of accurate as-built drawings. | within 6 weeks |

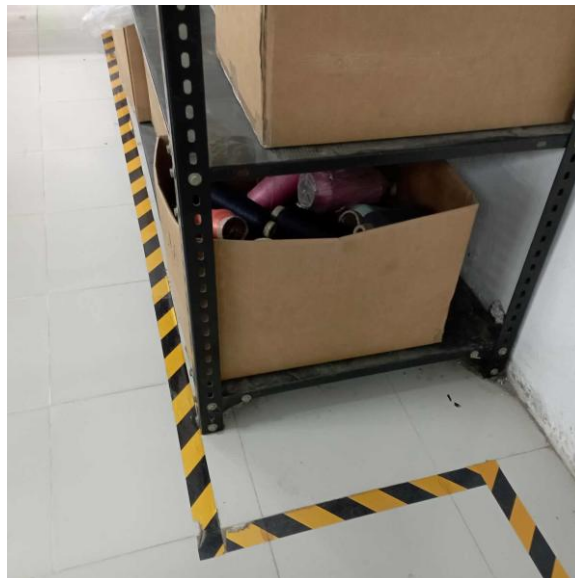
**Observation-8:** Non-structural elements found not anchored/braced (Shed-2).

**Description:** Nonstructural elements (storage racks) were found not anchored/braced. The building engineer is required to anchor/brace all nonstructural elements within the factory.

| Item No. | Observation | Action Plan | Timeline |
|---|---|---|---|
| 10. | Non-structural elements found not anchored/braced (Shed-2). | The building engineer is required to anchor/brace all nonstructural elements within the factory. | within 6 months |
