# Chic Wings (BD) Intimates Co. Ltd.

Plot # 01, Sector # 07/A, South Haliashahar, CEPZ, Chattogram-4223, Bangladesh  
(22.299602, 91.772818)

3 March 2025

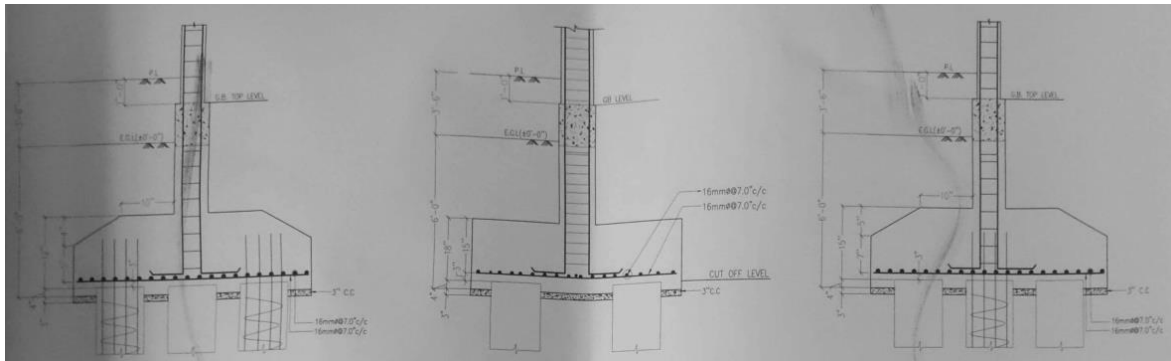
Construction drawing

**Observation-1:** Substructure retrofitting works need to be verified & assessed (Production Building)

**NOTE:**  
THE PILE CAPS HAD BEEN RETROFITTED PREVIOUSLY

**Description:** The as-built drawings indicate pile cap thicknesses of 750mm, 900mm, and 900mm, whereas the construction drawings specify 400mm, 550mm, and 475mm, respectively. Additionally, the pile caps and peripheral grade beams (highlighted in yellow in the figure) are labeled as retrofitted in the as-built drawings. However, the factory could not provide any pictorial evidence, QC certification, or sufficient test reports for the retrofitting works, apart from four sets of cylinder test reports (two for columns and two for grade beam retrofitting). Furthermore, the EA report assumes a rebar yield strength of 72.5 ksi for the retrofitting work, but no supporting test report was available.

| Item No. | Observation | Action Plan | Timeline |
|---|---|---|---|
| 1 | Substructure retrofitting works need to be verified & assessed (Production Building)<br><br>Additional Core on the 4th floor (Production Building)<br><br>Additional column on ground floor (Production Building) | Verify substructure retrofitting works | within 6 weeks |

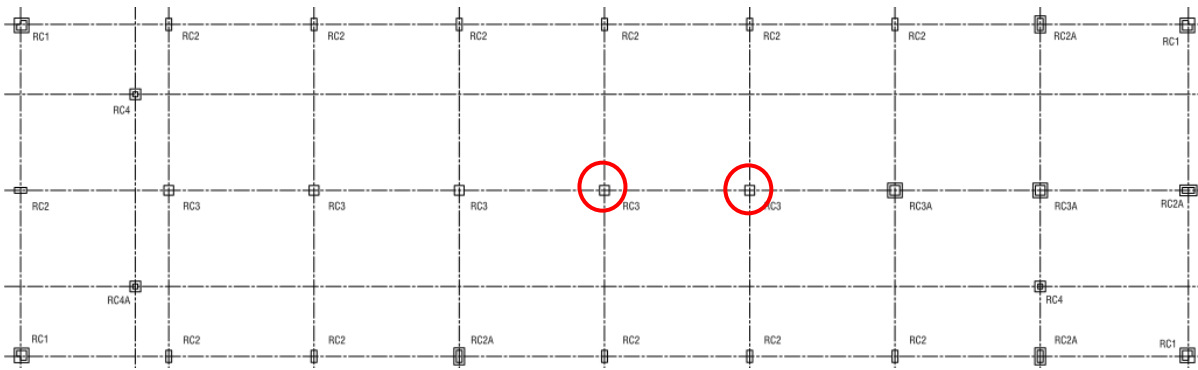
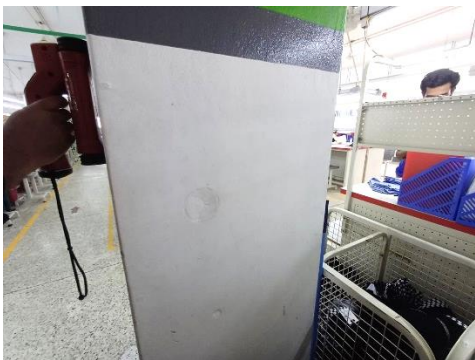
4th floor column layout

**Observation-2:** Additional Core on the 4th floor (Production Building)

**Description:** According to the available core test report, six cores were extracted from ground-floor columns. However, two additional core extraction marks, highlighted in red on the column layout, were observed on the 4th floor.

| Item No. | Observation | Action Plan | Timeline |
|---|---|---|---|
| 2 | | Factory is required to survey the whole structure, identify all additional cores, incorporate all concrete core test results in the assessment of the building and submit the assessment report to the RSC for review. | within 6 weeks |

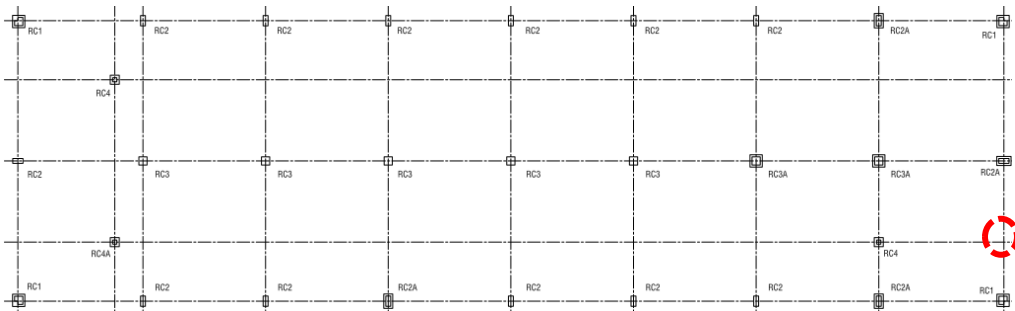
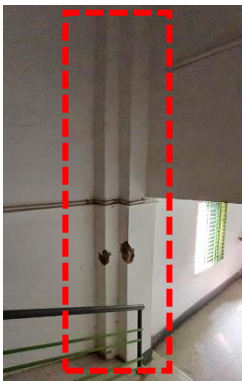
Column Layout

**Observation-3:** Additional column on ground floor (Production Building)

**Description:** An undocumented ground-floor column has been found, and its connection to the main framing system needs to be verified.

| Item No. | Observation | Action Plan | Timeline |
|---|---|---|---|
| 3 | | Confirm the load path of the additional column | within 6 weeks |

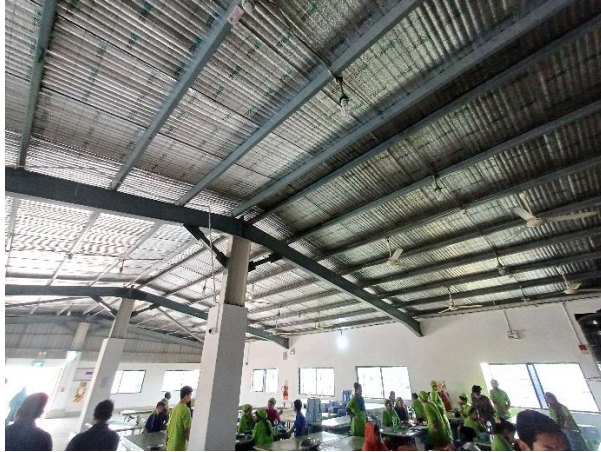
Roof Shed above 5th floor dining

**Observation-4:** Lack of lateral stability system of roof sheds (Production Building)

**Description:** Portal frame was observed in the short direction. Compression strut or load transfer media was not observed in the long direction.

| Item No. | Observation | Action Plan | Timeline |
|---|---|---|---|
| 6 | Lack of lateral stability system of roof sheds (Production Building) | Building engineer is required to check the lateral stability of the shed as part of the Engineering Assessment (EA). | within 6 weeks |
| 7 | | Carry out suggested remedial works if required | within 6 months |

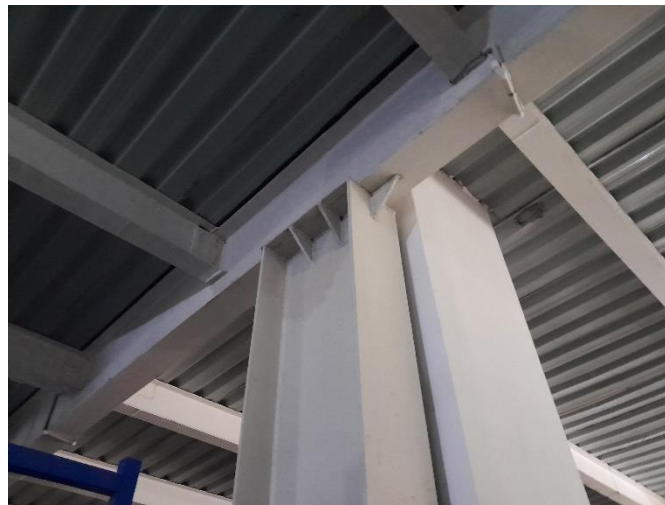
**Observation-5:** Lack of stability of self-supported steel structure on the ground floor (Production Building)

**Description:** In the north-south direction, the columns are interconnected by steel beams, providing lateral support. However, in the east-west direction, there are no beam connections between the columns, requiring an assessment of the structural stability in that direction.

| Item No. | Observation | Action Plan | Timeline |
|---|---|---|---|
| 8 | Lack of stability of self-supported steel structure on the ground floor (Production Building) | Building engineer is required to check the stability of the structure as part of the Engineering Assessment (EA). | within 6 weeks |
| 9 | | Carry out suggested remedial works if required | within 6 months |

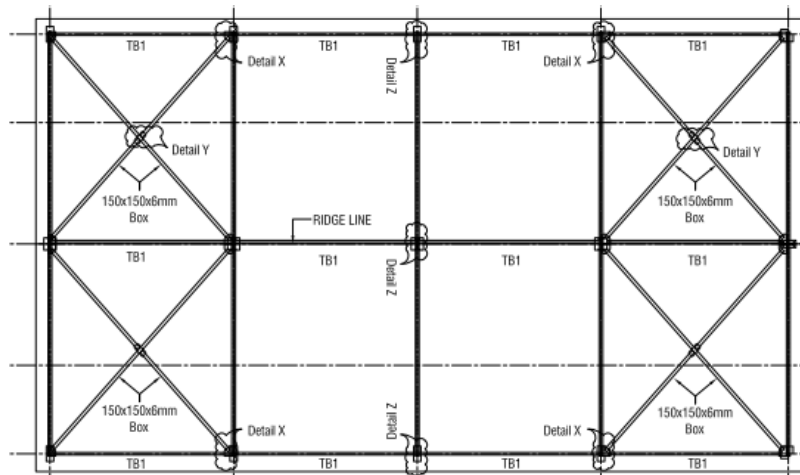
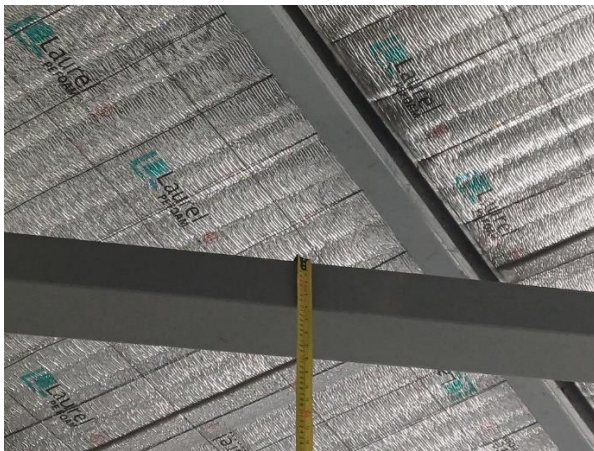
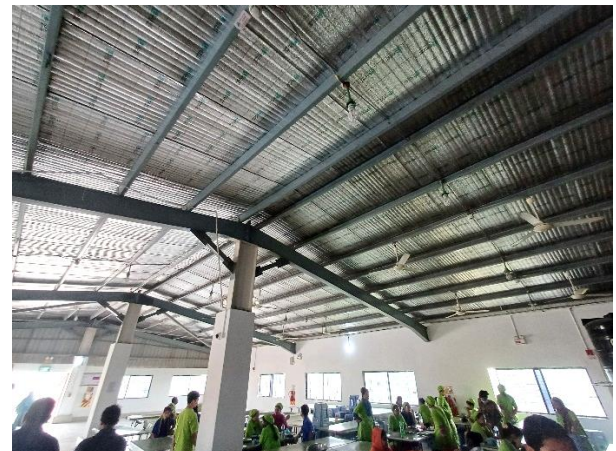
**Observation-6:** Discrepancies in as-built drawing (Production Building)

**Description:** Roof bracings were found 100X100mm box instead 150X150mm box and compression strut (TB1 in drawing) were not found.

| Item No. | Observation | Action Plan | Timeline |
|---|---|---|---|
| 10 | Discrepancies in as-built drawing (Production Building) | The building engineer is required to survey the whole structure and update the as-built drawings as per site condition. | within 6 weeks |

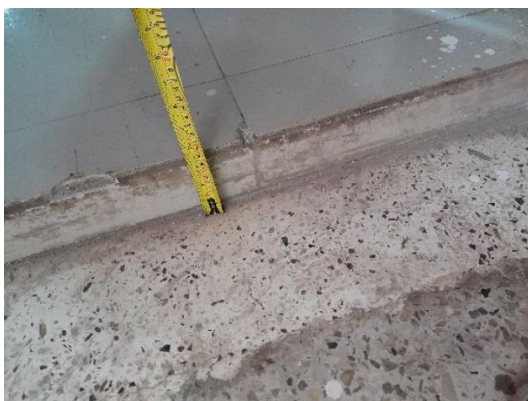
Build-up at 5th floor dining

**Description:** 90 mm build-up was observed in the 5th-floor dining area, along with 200 mm and 375 mm build-ups and 90 mm thick false slab in the toilet area, all of which were not mentioned in the drawing.

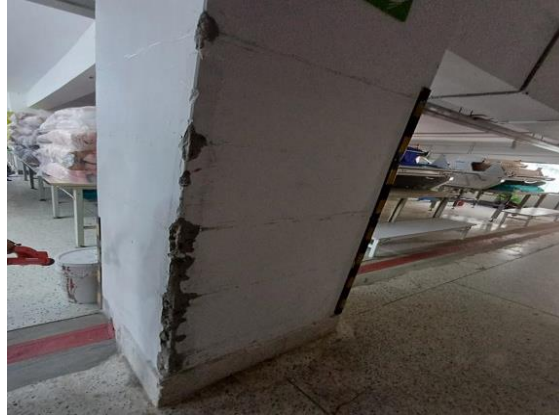
**Observation-7:** Column susceptible to trolley impact (Production Building)

**Description:** During the inspection, the column edges of several floors were found affected due to trolley impact. The factory is required to provide safety barriers to protect the columns from trolley/vehicle impact.

| Item No. | Observation | Action Plan | Timeline |
|---|---|---|---|
| 11 | Column susceptible to trolley impact (Production Building) | The building engineer is required to provide barriers around the column to protect the columns from trolley/vehicle impact. | within 6 months |

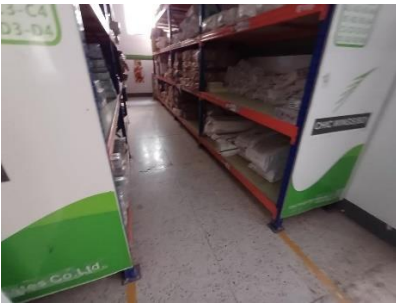
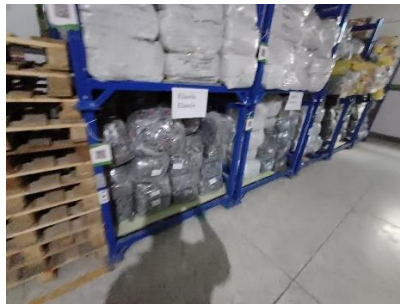
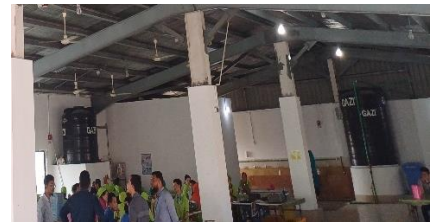
**Observation-8:** Non-structural elements found unbraced/not anchored (Production Building)

**Description:** Unbraced and unanchored steel storage racks were found on the ground floor and PVC water tanks were found unbraced on the 5<sup>th</sup> floor dining area.

| Item No. | Observation | Action Plan | Timeline |
|---|---|---|---|
| 12 | Non-structural elements found unbraced/not anchored (Production Building) | The factory is required to brace/anchor all non-structural elements (storage racks) to prevent falling during Seismic. | within 6 months |

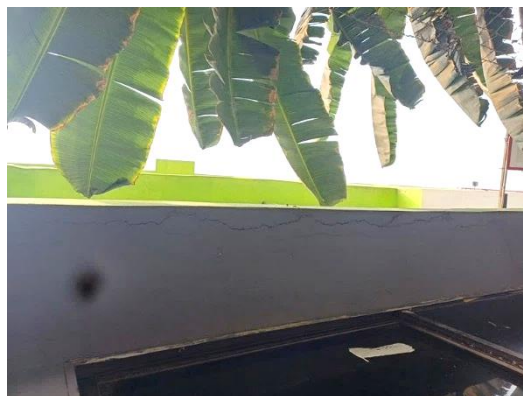
**Observation-9:** Crack & dampness in cornice (Production Building)

**Description:** Cracks & dampness in cornice were observed at several locations.

| Item No. | Observation | Action Plan | Timeline |
|---|---|---|---|
| 13 | Crack & dampness in cornice (Production Building) | The factory is required to check the reason for crack and repair the cracks with suitable methods. | within 6 weeks |

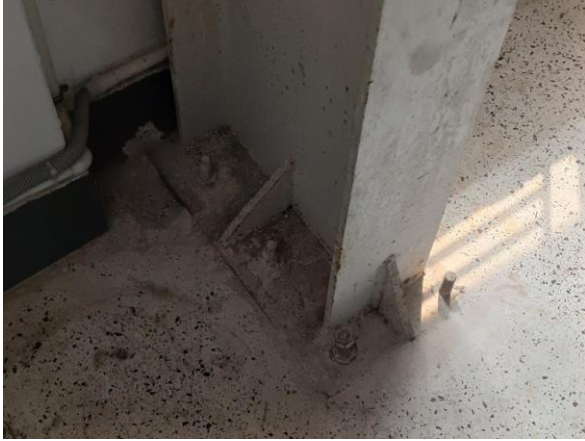
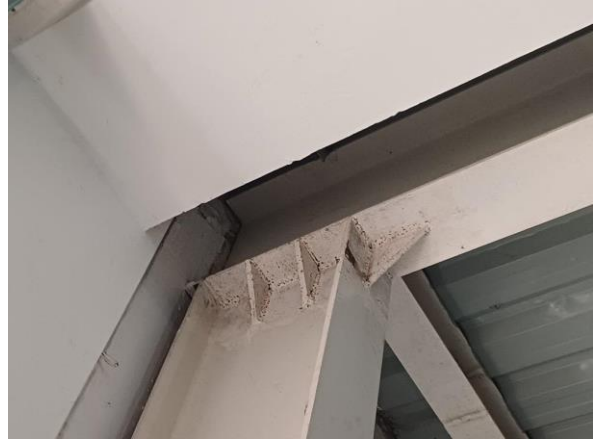
**Observation-10:** Corrosion on steel member of ground floor steel structure (Production Building)

**Description:** During the inspection, corrosion was observed on several steel members.

| Item No. | Observation | Action Plan | Timeline |
|---|---|---|---|
| 14 | Corrosion on steel member of ground floor steel structure (Production Building) | The factory is required to remove rust and apply anti-corrosive paint on steel members. | within 6 weeks |

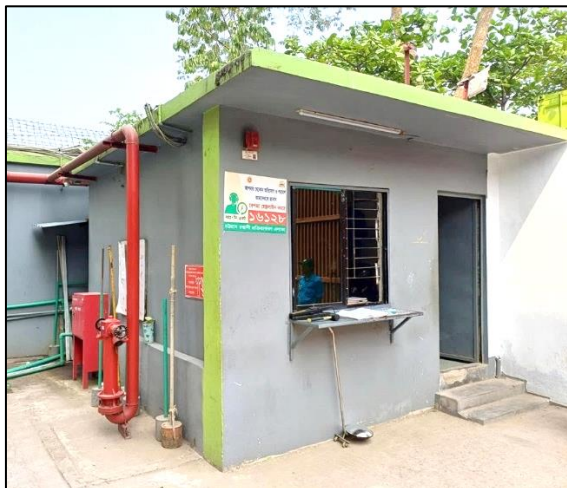
Security Building & Fire Command Room

**Observation-11:** Lack of as-built drawing (Security Building & Fire Command Room and Old Transformer Room)

**Description:** During inspection, as-built drawing of the structures was not available onsite.

| Item No. | Observation | Action Plan | Timeline |
|---|---|---|---|
| 15 | Lack of as-built drawing (Security Building & Fire Command Room and Old Transformer Room) | The building engineer is required to survey the whole structure and produce the as-built drawings as per site condition. | within 6 weeks |
