# Fin-Bangla Apparels Ltd. (Extension)

10 March 2025

## **1. Building Information**

1. Central Store Shed
2. Store Office Building

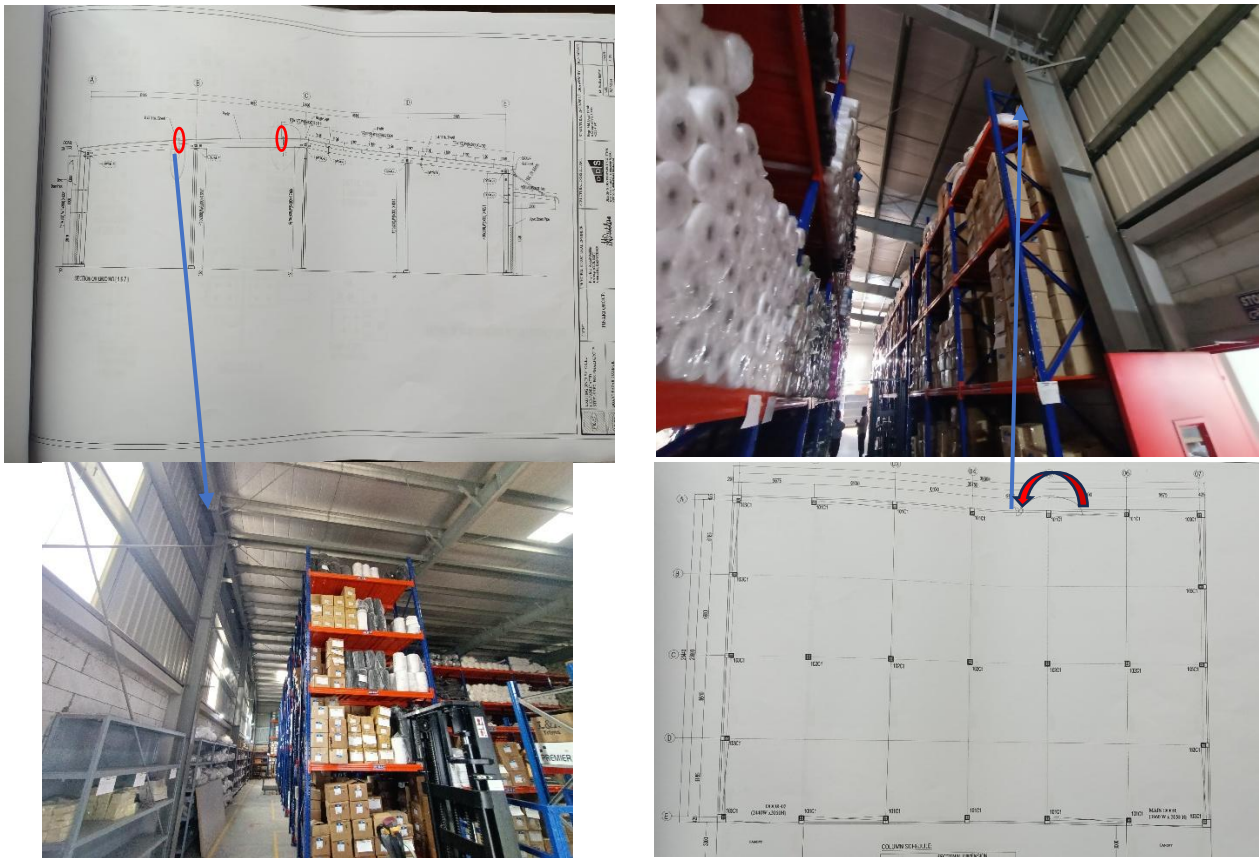
### Observation-1: Mismatches in as-built drawings (Central Store Shed).

**Description:** All rafter connections were not shown in sectional drawings. Also, the location of vertical bracing at North was found in between grid 4 & 5 instead of grid 5 & 6. Mismatches are shown in red on drawings. Building engineer is required to survey the whole structure and prepare accurate as-built drawings for the structure.

| Item No | Observation | Action Plan | Timeline |
|---|---|---|---|
| 1. | Mismatches in as-built drawings (Central Store Shed). | Building engineer is required to survey the whole structure and prepare accurate as-built drawings for the structure. | within 6 weeks |

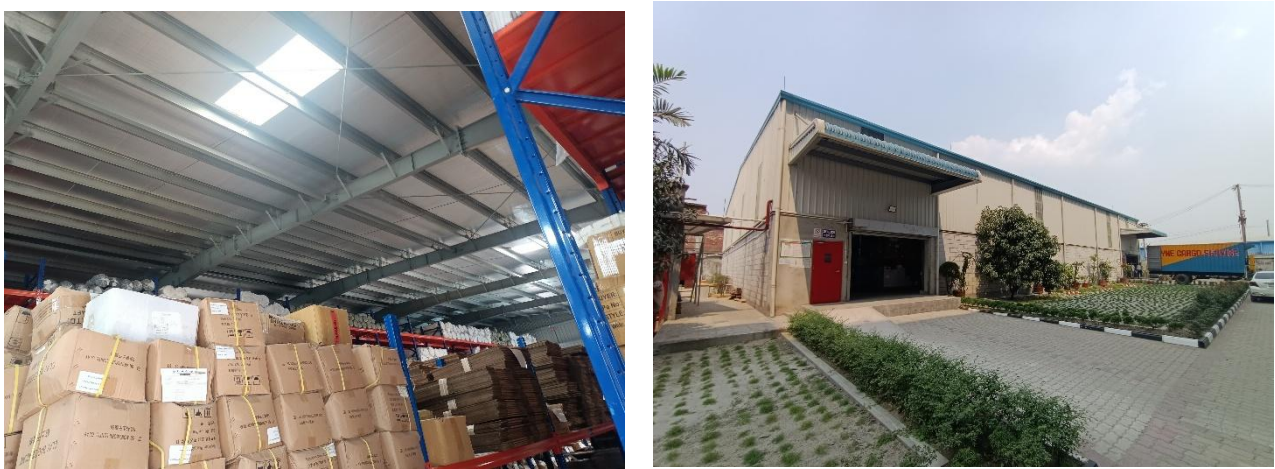
### Observation 2: Design report needs to be reviewed against lateral forces (Central Store Shed).

**Description:** A design report has been prepared for the single storied shed. The prepared design report needs to be reviewed against lateral forces. Submit the design report to the RSC for detailed review.

| Item No | Observation | Action Plan | Timeline |
|---|---|---|---|
| 2. | Design report needs to be reviewed against lateral forces (Central Store Shed). | The building engineer is required to revise the design report and submit it to RSC for review against lateral forces. | within 6 weeks |
| 3. | Design report needs to be reviewed against lateral forces (Central Store Shed). | Carry out remedial work if required. | within 6 months |

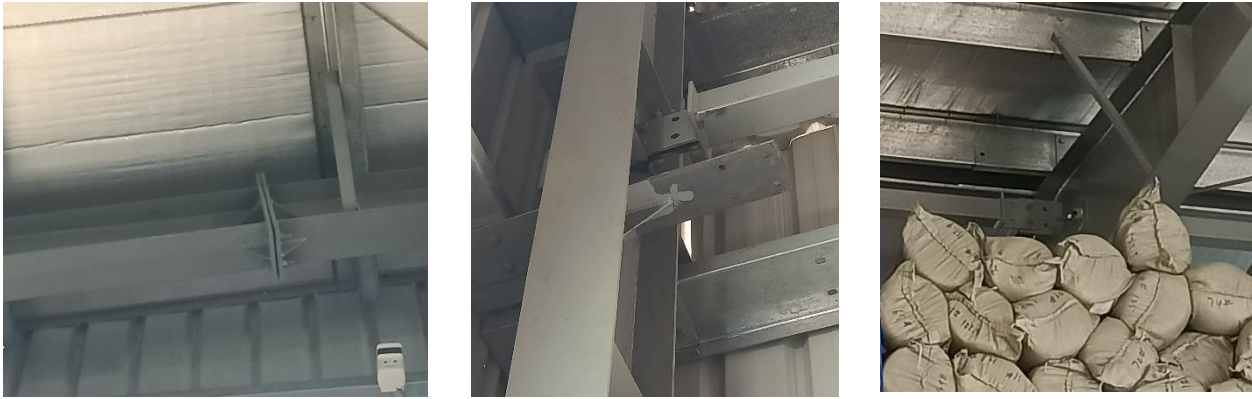
**Observation-3:** Connection gap and bolt missing (Central Store Shed).

**Description:** Connection gap between two rafter joints were found at the gable frame. Also, bolts missing were observed in strut connection.

| Item No | Observation | Action Plan | Timeline |
|---|---|---|---|
| 4. | Connection gap and bolt missing (Central Store Shed). | The building engineer is required to carry out suitable remedial works. | within 6 weeks |
| 5. | Connection gap and bolt missing (Central Store Shed). | Install missing bolts where necessary. | within 6 weeks |

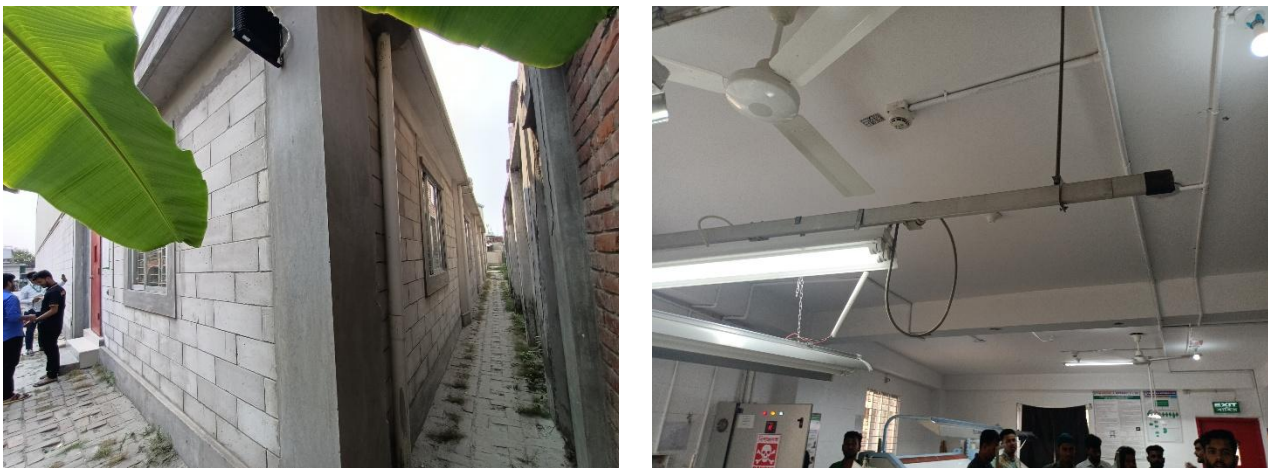
**Observation-4:** Lack of architectural drawings (Store Office Shed).

**Description:** As-built structural drawings were not available for these sheds. Building engineer is required to survey the whole structure and prepares full set of as-built architectural drawings.

| Item No | Observation | Action Plan | Timeline |
|---|---|---|---|
| 6. | Lack of architectural drawings (Store Office Shed). | Building engineer is required to survey the whole structure and prepares full set of as-built architectural drawings. | within 6 weeks |

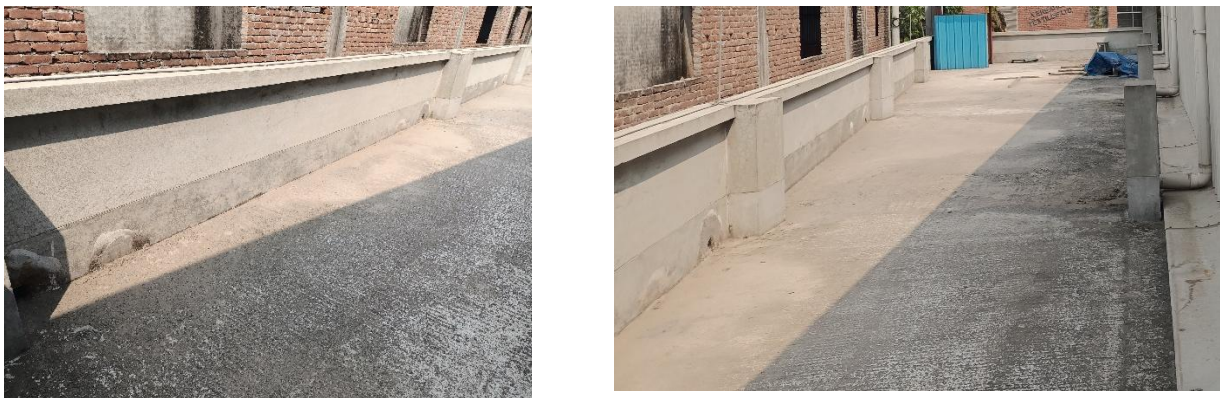
**Observation-5:** Improper roof drainage system (Store Office Building).

**Description:** Sign of water clogging was observed in the existing roof which indicates improper drainage system. Building engineer is required to improve the roof drainage providing adequate slope and discharge point.

| Item No | Observation | Action Plan | Timeline |
|---|---|---|---|
| 7. | Improper roof drainage system (Store Office Building). | Building engineer is required to improve the roof drainage providing adequate slope and discharge point. | within 6 months |
