Knit Concept Ltd

9 March 2025

1. Building Information

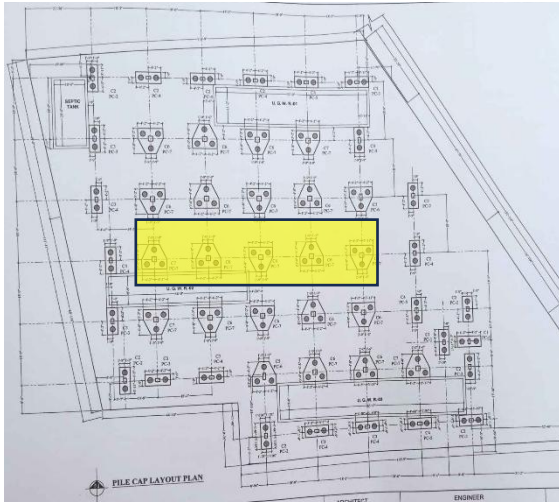
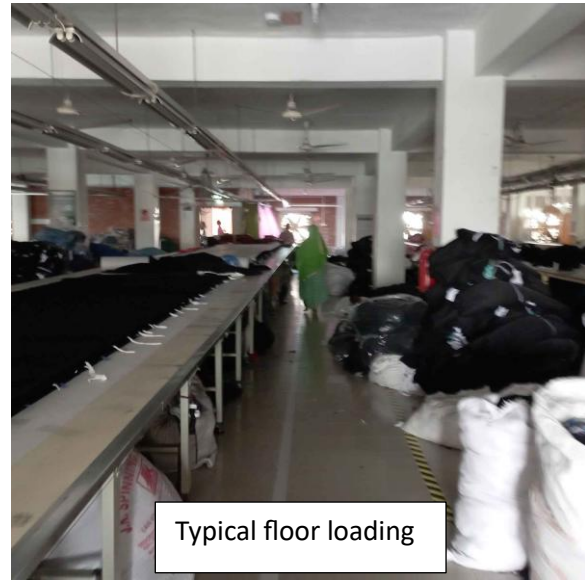
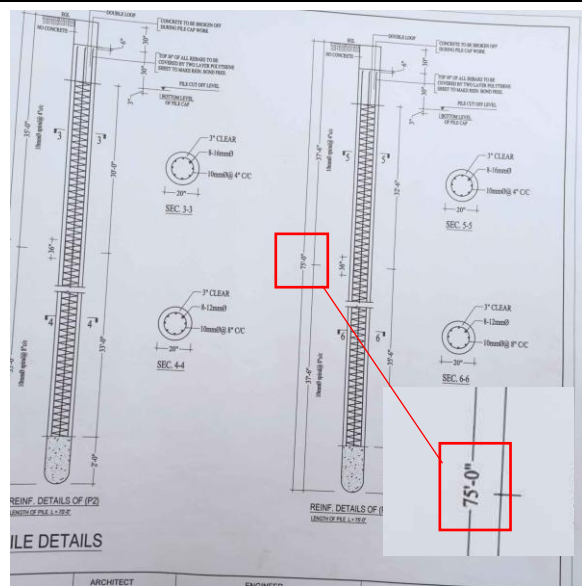
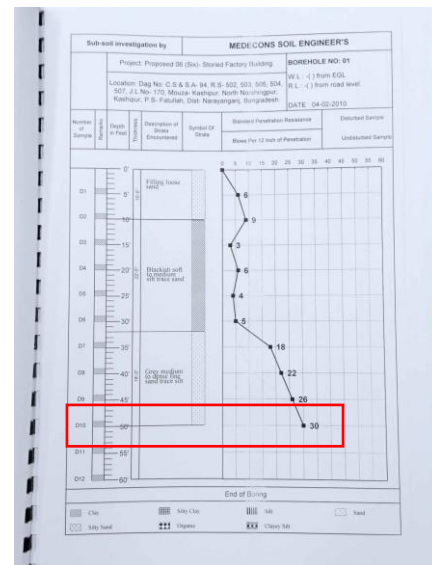
Observation 1: Stress in the foundation exceeds the normal design limit (Factory Building).

Typical floor loading

Description: cursory calculation indicates that stress in the foundation exceeds the normal design limit at marked locations considering the live load 3 kPa and allowable pile capacity 37.5-ton (FoS:2.5) at 14.63 m (48 feet) depth recommended in soil test report. Although as per the provided drawing, the pile depth is 22.86 m (75 feet), borehole data is available only up to 15.28 m (50 feet). A geotechnical engineer is required to prepare a new soil test report to determine the actual pile capacity up to the full depth of the pile. Based on the actual pile capacity, the building engineer is required to check the adequacy of the foundation and prepare a design report as per 1.9.1 BNBC. Submit it to RSC for review.

Item No.	Observation	Action Plan	Timeline
1.	Stress in the foundation exceeds the normal design limit (Factory Building).	A geotechnical engineer is required to prepare a new soil test report to determine the actual pile capacity up to the full depth of the pile.	within 6 weeks

2.		Based on the actual pile capacity, the building engineer is required to check the adequacy of the foundation and prepare a design report as per 1.9.1 BNBC. Submit it to RSC for review.	within 6 weeks

3.		Produce and actively manage a floor load plan.	within 6 weeks
4.		Implement remediation work if required.	within 6 months
5.		Implement floor load plan.	within 6 months

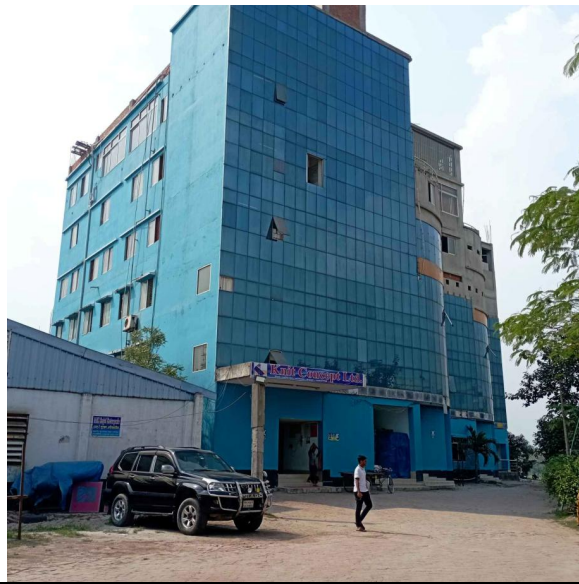
Observation 2: Lack of material test report (Factory Building).

Description: No material test report (concrete/rebar) was available at the time of inspection. The building engineer is required to take a minimum of 4 no of 100 mm diameter concrete core from columns (lower level) to verify the in-situ concrete strength.

6.	Lack of material test report (Factory Building).	Take a minimum of 4 no of 100 mm diameter concrete core from columns (lower level) to verify the in-situ concrete strength.	within 6 weeks

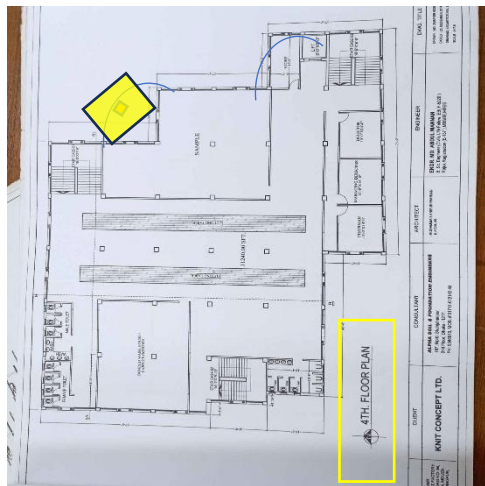
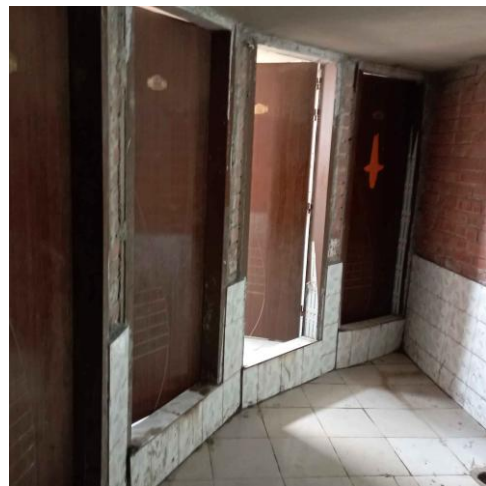
Observation 3: Stress in flat slab exceeds the normal design limit (Factory Building).

Description: Cursory calculation indicates that stress in flat slab exceeds the normal design limit at marked locations on the 4th floor due to brick partition walls and floor build-up, considering the live load of 2 kPa and minimum concrete strength (16.3 MPa) based on aggregate type. The building engineer is required to check the adequacy of the flat slab as part of the design report.

7.	Stress in flat slabs exceeds the normal design limit (Factory Building).	The building engineer is required to check the adequacy of the flat slab as part of the design report.	within 6 weeks

8.		Take a minimum of 2 no of concrete core from the slab to verify the in-situ concrete strength.	within 6 weeks
9.	Discrepancy in construction/local authority approval drawing (Factory Building).	The factory is required to collect a revised permit drawing/layout from the local authority for the additional floor at the roof and reflect the onsite condition. Otherwise, remove the undocumented floor from the roof.	within 6 months

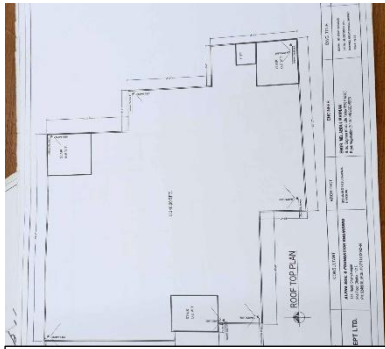
Roof layout (construction drawing)

Observation 4: Discrepancy in construction/local authority approval drawing (Factory Building).

Description: The additional floor on the roof was not shown both in the as-built drawing and layout from the local authority approval drawing. Also, the shape of the building on the east side is slightly different from both the as-built drawing and the layout from the local authority's approval drawing. The building engineer is required to produce an accurate as-built drawing as per on-site conditions. Also, collect a revised permit drawing/layout from the local authority for the additional floor at the roof and reflect the onsite condition. Otherwise, remove the undocumented floor at the roof.

10.		Also, prepare an accurate as-built drawing as per the onsite condition.	within 6 weeks
11.	Lack of lateral stability (Utility Shed).	The building engineer is required to check the lateral stability of the shed and prepare an Engineering Assessment (EA) report as per 1.9.1 BNBC.	within 6 weeks

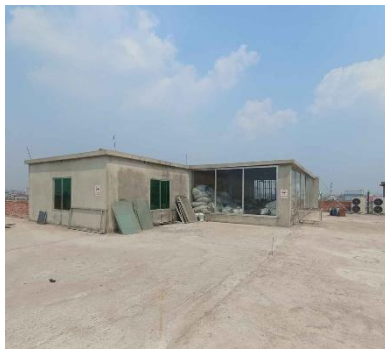
Undocumented extension at roof

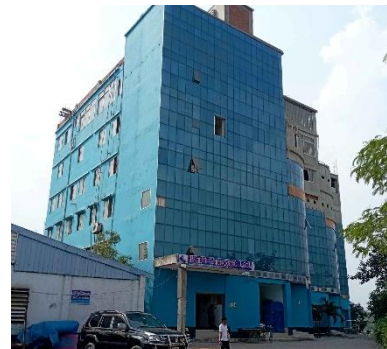
Shape of the building doesn't match with drawing

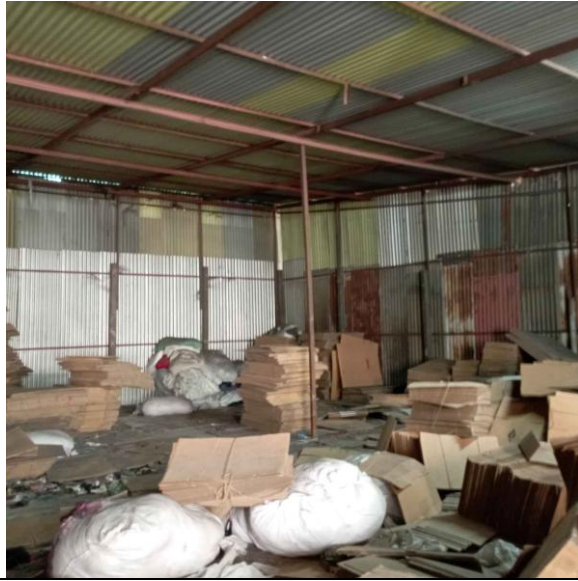
Observation 5: Lack of lateral stability (Utility Shed).

Description: No load transfer media, horizontal bracing, or vertical bracing are provided to transfer and resist the lateral load. The building engineer is required to check the lateral stability of the shed and prepare an Engineering Assessment (EA) report as per 1.9.1 BNBC.

12.		Implement remediation work if required.	within 6 months

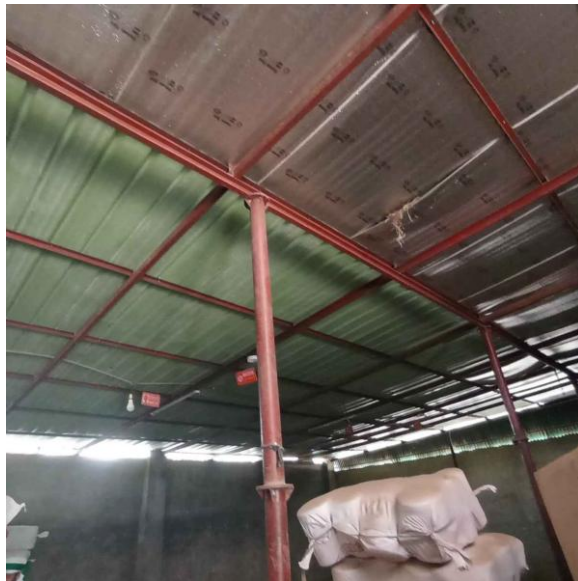
Observation 6: Absence of bracing system (Yarn Store Shed).

Description: No load transfer media, horizontal bracing, or vertical bracing are provided to transfer and resist the lateral load. The building engineer is required to prepare a safety check report with a remediation plan.

13.	Absence of bracing system (Yarn Store Shed).	The building engineer is required to prepare a safety check report with a remediation plan incorporating a bracing system.	within 6 weeks
14.		Implement remediation work where required.	within 6 months
15.	Nonstructural elements found not anchored/braced (Yarn Store Shed).	The building engineer is required to anchor/brace all nonstructural elements within the factory.	within 6 months
16.	Lack of approval layout/drawing from local authority. (Yarn Store Shed, Utility Shed).	The factory is required to collect approval layout/drawing from the relevant local authority for all structures within the factory.	within 6 months

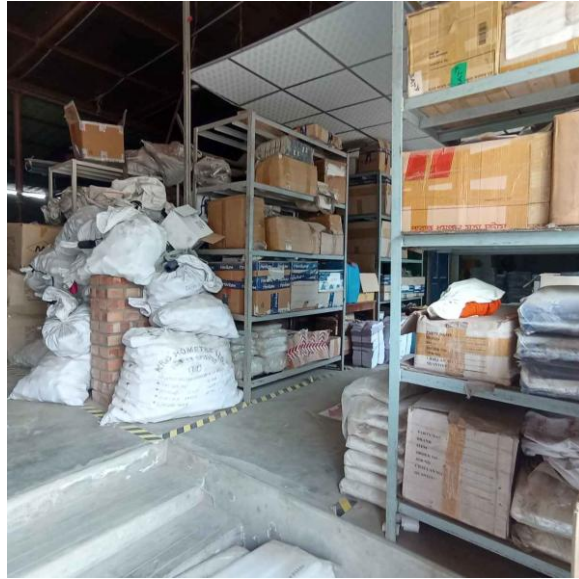
Observation-7: Nonstructural elements found not anchored/braced (Yarn Store Shed).

Description: Nonstructural elements (storage racks) were found not anchored/braced. The building engineer is required to anchor/brace all nonstructural elements within the factory.

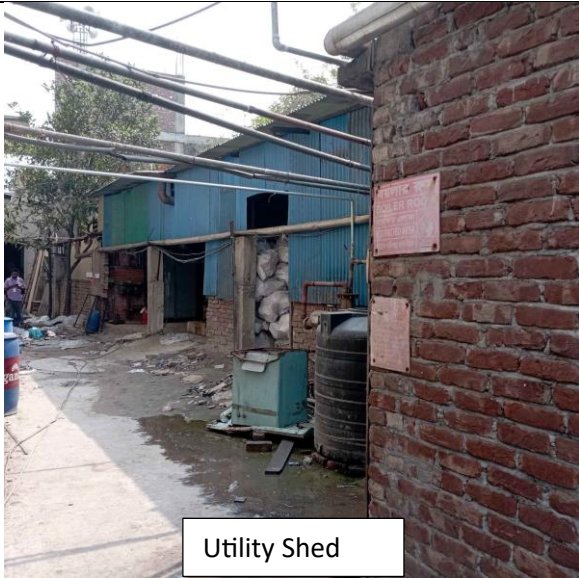
Utility Shed

Observation 8: Lack of approval layout/drawing from local authority. (Yarn Store Shed, Utility Shed).

Description: No approval layout/drawing was available from the local authority for any of the structures. The factory is required to collect approval layout/drawing from the relevant local authority for all structures within the factory.
