# Sparrow Apparels Ltd. (Extension)

251 Chandoan, Luxmipura, Gazipur

## Structural Inspection Report

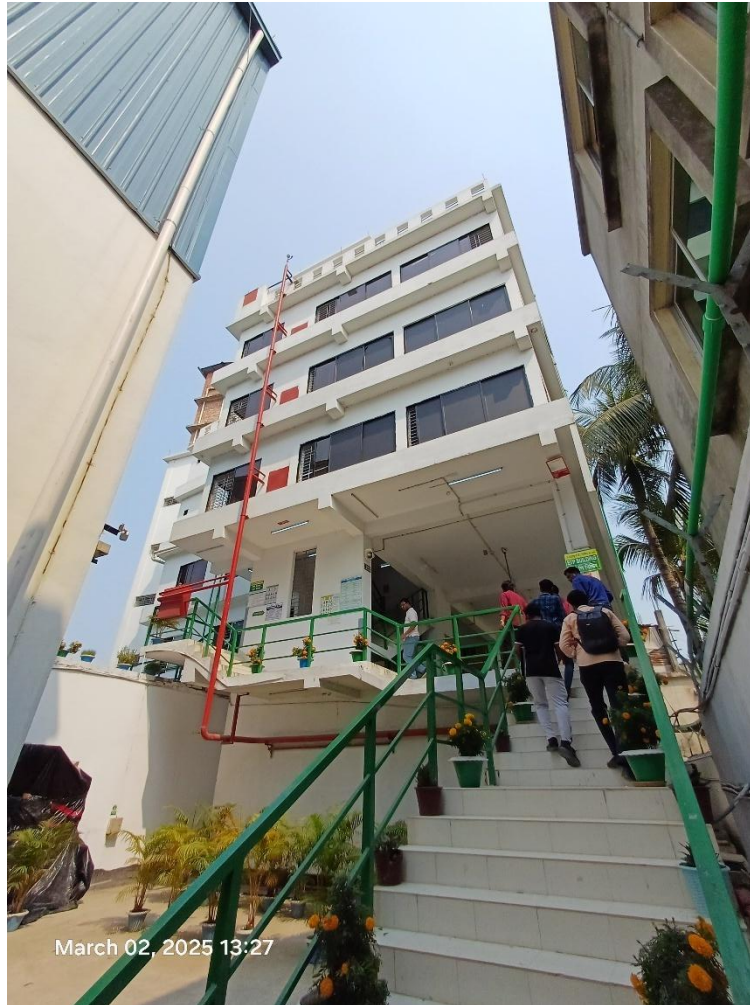
**Observation-1:** Lack of design documents. (ETP-Building# 5)

**Description:** As per BNBC, every building or structure designed shall have its design documents prepared following the provision of Section 1.9.1. The design document shall include a design report and a set of structural drawings, which shall be prepared in compliance with sections 1.9.1.1 and 1.9.1.2 as per BNBC.

At the time of inspection, design documents (design report, load plan, and adequate material test reports) were not available, which are required to be prepared in compliance with section 1.9.1 (part-6, BNBC).

| Item No | Observation | Action Plan | Timeline |
|---|---|---|---|
| 1. | Lack of design documents. (ETP-Building# 5) | The building engineer is required to prepare design documents (including design reports, material test reports, live load plan) in compliance with section 1.9.1 (part 6, BNBC). | within 6 weeks |
| 2. | | Carry out remedial work if required. | within 6 months |

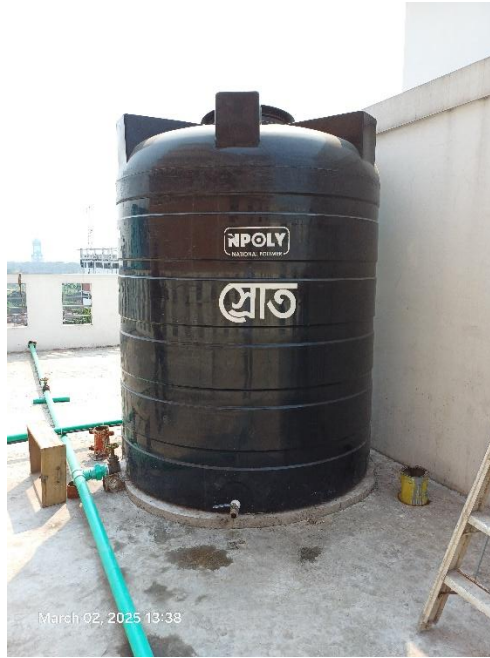
**Observation-2:** Non-structural elements found unbraced/not anchored. (ETP-Building# 5)

**Description:** Non-structural elements suspended from, attached to, or resting atop the structure shall be adequately anchored and braced to resist earthquake forces. The factory is required to brace/anchor all non-structural elements.

| Item No | Observation | Action Plan | Timeline |
|---|---|---|---|
| 3. | Non-structural elements found unbraced/not anchored. (ETP-Building# 5) | Factory is required to brace/anchor all non-structural elements. | within 6 months |

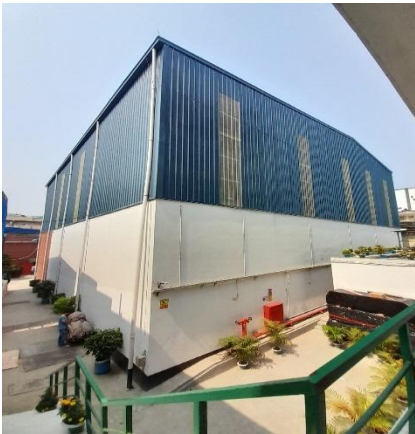
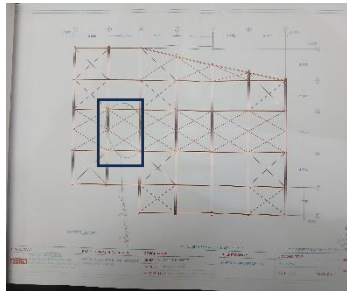
**Observation-3:** Lack of design documents and lateral stability. (New warehouse shed)

Missing horizontal  
bracing in the marked  
location

**Description:** Horizontal & Vertical bracing was found missing in the marked location. Also, no design documents were observed during the inspection. As per BNBC, every building or structure designed shall have its design documents prepared following the provision of Section 1.9.1. The design document shall include a design report and a set of structural drawings, which shall be prepared in compliance with sections 1.9.1.1 and 1.9.1.2 as per BNBC.

The building engineer is required to prepare an Engineering Assessment (EA) and check the lateral stability of the shed.

| Item No | Observation | Action Plan | Timeline |
|---|---|---|---|
| 4. | Lack of design documents and incomplete lateral stability system. (New warehouse shed) | The building engineer is required to prepare Engineering Assessment (EA) and check the lateral stability of the shed. | within 6 weeks |
| 5. | | Carry out the suggested remedial work (if any). | within 6 months |

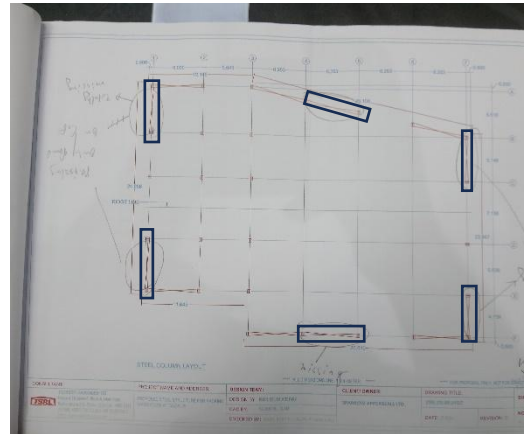
Missing vertical bracing in the marked  
location

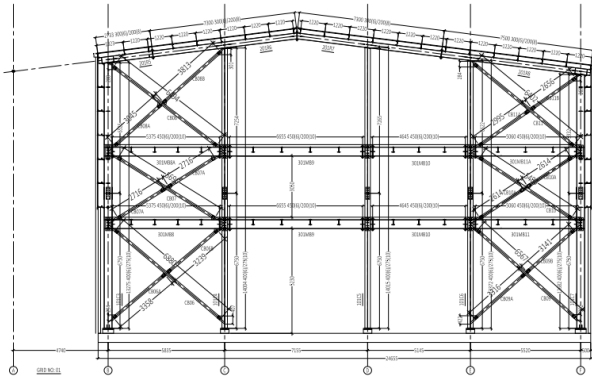
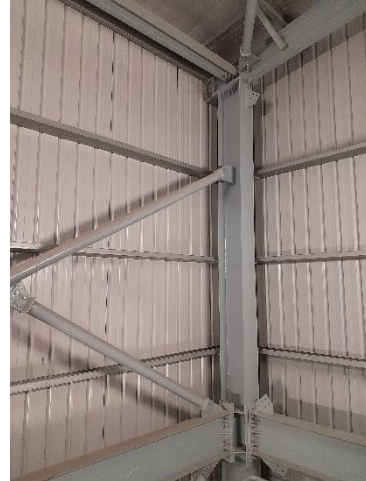
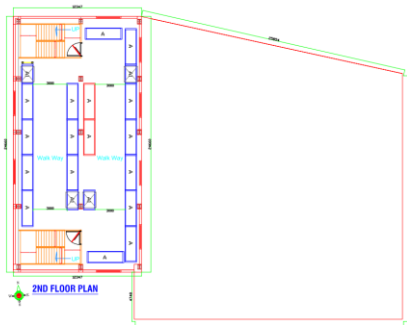
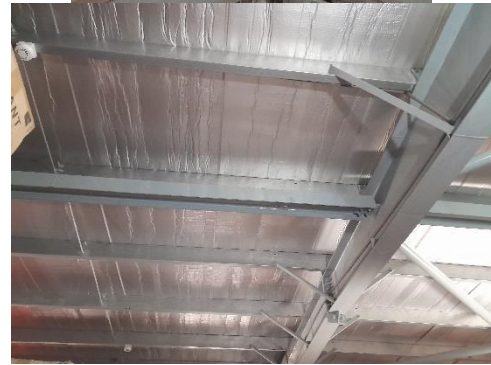
**Observation-4:** Mismatch in as-built drawings. (New warehouse shed)

**Description:** Eccentric bracing found onsite drawings show concentric bracing, bracing size does not match the site condition, architectural drawing, strut orientation not match with the site condition.

Building engineer is required to survey the structure and prepare accurate as-built drawings.

| Item No | Observation | Action Plan | Timeline |
|---|---|---|---|
| 6. | Mismatch in as-built drawings. (New warehouse shed) | Building engineer is required to survey the structure and prepare accurate as-built drawings. | within 6 weeks |

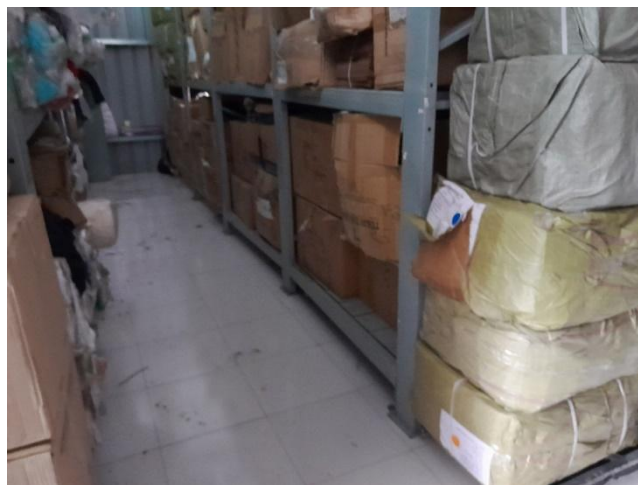
**Observation-5:** Non-structural elements found unbraced/not anchored. (New warehouse shed)

**Description:** Non-structural elements suspended from, attached to or resting atop the structure shall be adequately anchored and braced to resist earthquake forces. The factory is required to brace/anchor all non-structural elements.

| Item No | Observation | Action Plan | Timeline |
|---|---|---|---|
| 7. | Non-structural elements found unbraced/not anchored. (New warehouse shed) | Factory is required to brace/anchor all non-structural elements. | within 6 months |

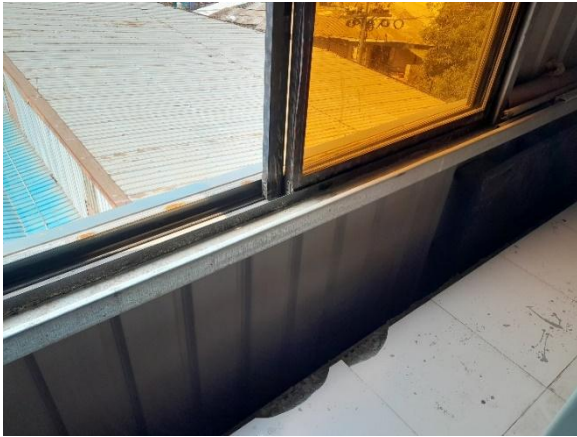
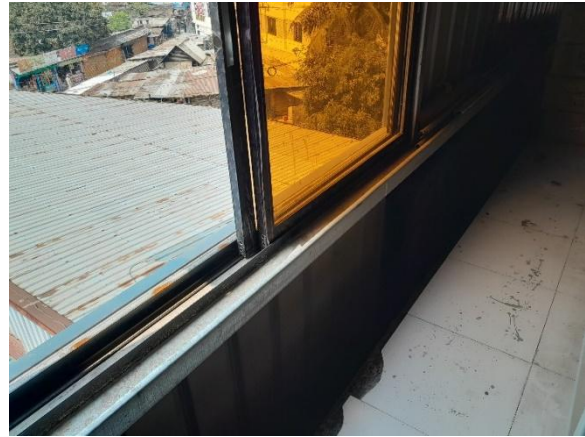
**Observation-6:** Falling Hazard. (New warehouse shed)

**Description:** No fall protection was provided on the window and the edge of the floor where a clear gap was found, which may cause a falling hazard. The factory is required to provide fall protection to avoid possible falling hazards.

| Item No | Observation | Action Plan | Timeline |
|---|---|---|---|
| 8. | Falling Hazard. (New warehouse shed) | The factory is required to provide fall protection to avoid possible falling hazards. | within 6 weeks |

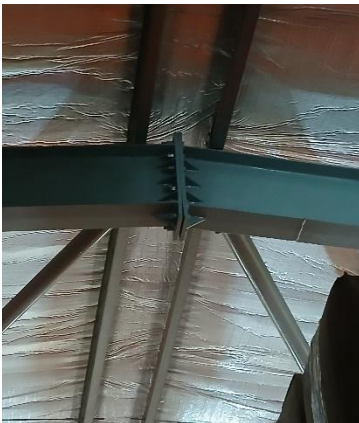
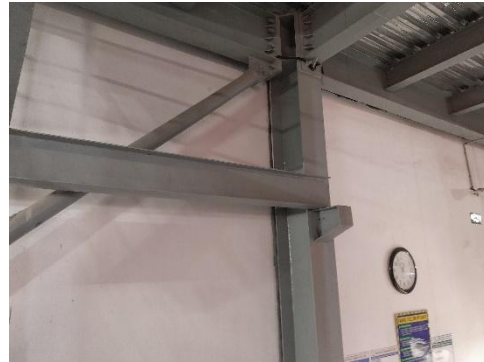
**Observation-7:** Gap in connection and poor joint (New warehouse shed)

**Description:** Connection gap was found, and poor joint details were observed.

Building engineer is required to repair the gap with a suitable method and also check the connection adequacy as part of EA.

| Item No | Observation | Action Plan | Timeline |
|---|---|---|---|
| 9. | Gap in connection and poor joint detail (New warehouse shed) | Building engineer is required to repair the gap with a suitable method. | within 6 weeks |
| 10. | | Also, check the connection adequacy as part of EA. | within 6 weeks |

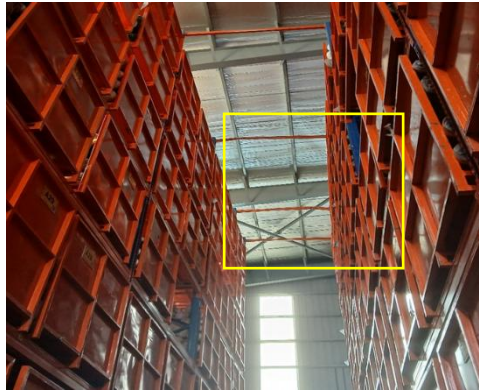
**Observation-8:** Damaged structural elements (New warehouse shed)

**Description:** Damage was observed on the braced elements of the racks. Building engineer is required to check the design of the braced elements and repair the elements with a suitable method.

| Item No | Observation | Action Plan | Timeline |
|---|---|---|---|
| 11. | Damaged structural elements. (New warehouse shed) | Building engineer is required to check the design of the braced elements and repair the elements with a suitable method. | within 6 weeks |

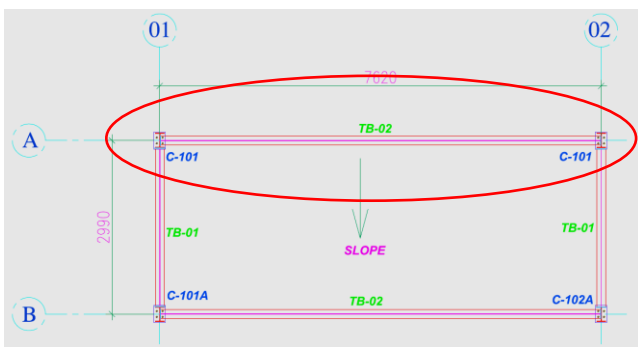
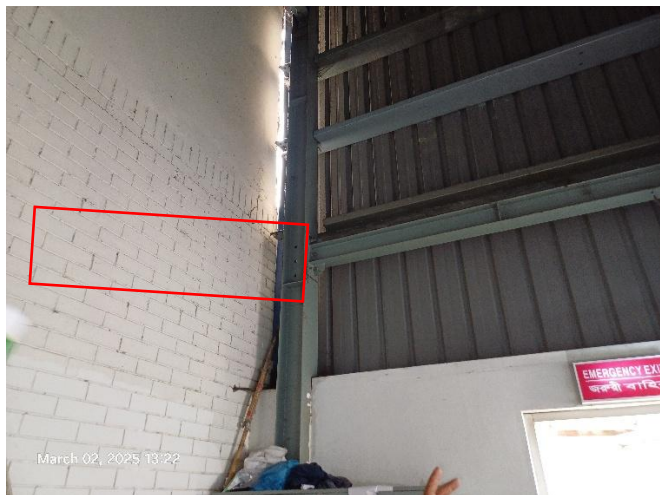
**Observation-9:** Mismatch in as-built drawing. (Fabric Segregation Shed)

**Description:** As per the as-built drawing, a tie beam is missing on site. The building engineer is required to update the as-built drawing and submit it to RSC.

| Item No | Observation | Action Plan | Timeline |
|---|---|---|---|
| 12. | Mismatch in the as-built drawing. (Fabric Segregation Shed) | The building engineer is required to update the as-built drawing and submit it to RSC. | within 6 weeks |

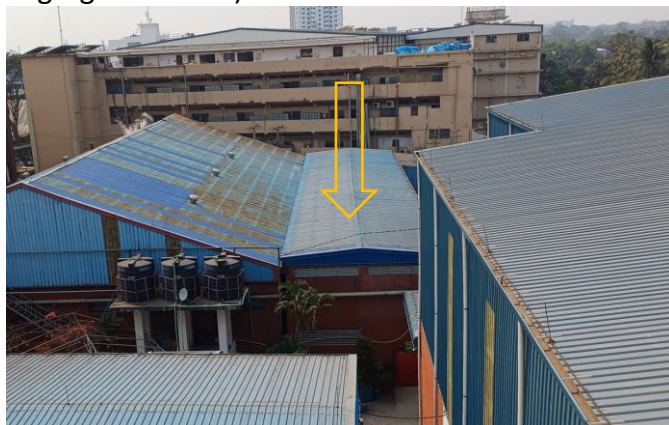
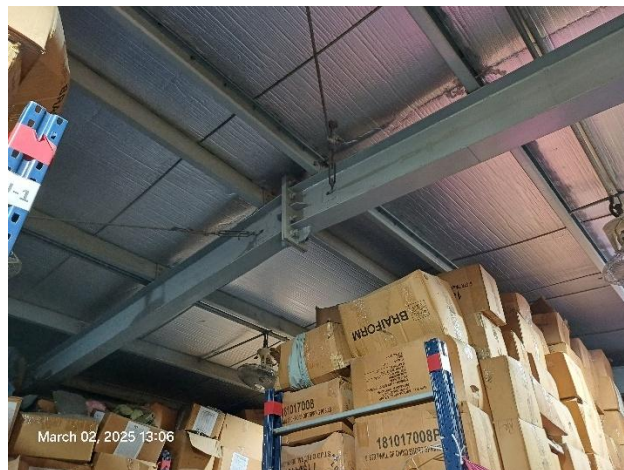
**Observation-10:** Design report is required to be reviewed by RSC for lateral loading. (Fabric Segregation Shed)

**Description:** The design report has been prepared for the 2-storied shed building. On the other hand, some mismatches were found. The building engineer is required to revise the design report considering the onsite condition and lateral forces.

| 13. | Design report required to be reviewed by RSC for lateral loading. (Fabric Segregation Shed) | The building engineer is required to revise the design report as per on-site conditions and for lateral loading. Submit the revised design report to RSC for review. | within 6 weeks |
| 14. | | Carry out the suggested remedial work if required. | within 6 months |

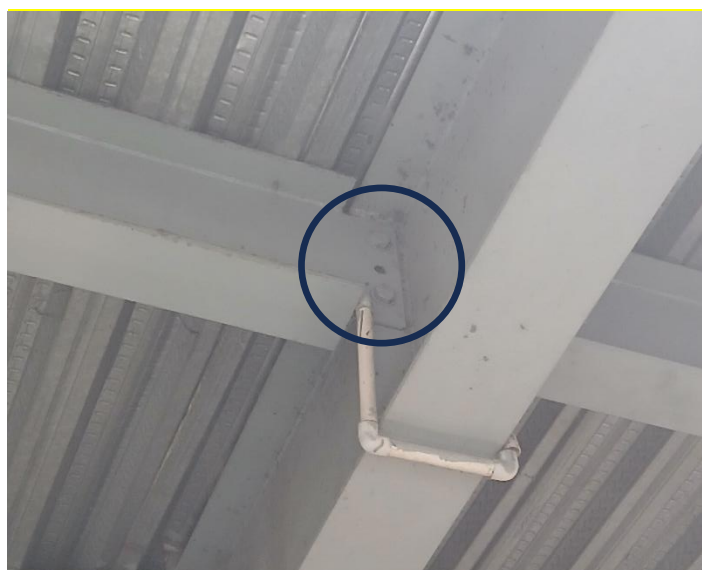
**Observation-11:** Missing bolts. (Fabric Segregation Shed)

**Description:** Missing bolts were observed in some locations of Fabric Segregation Shed. The building engineer is required to install all missing bolts in all locations.

| 15. | Missing bolts. (Fabric Segregation Shed) | The building engineer is required to install all missing bolts in all locations. | within 6 weeks |

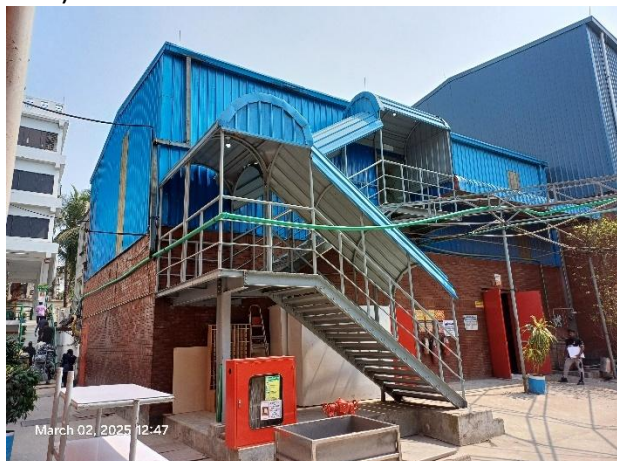
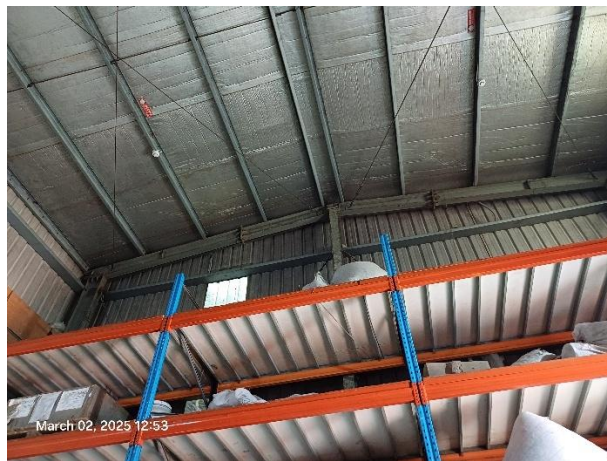
**Observation-12:** Lack of design documents and absence of lateral stability system. (Washing Store Shed)

**Description:** The roof of the structure has no obvious lateral stability system (strut). Also, no design documents were observed during the inspection.

At the time of inspection, design documents (design report, load plan and material test reports) were not available, which are required to be prepared in compliance with section 1.9.1 (part-6, BNBC).

| 16. | Lack of design documents and incomplete lateral stability system. (Washing Store Shed) | The building engineer is required to prepare design documents (including design reports, material test reports, live load plan and accurate as-built drawings) in compliance with section 1.9.1 (part 6, BNBC). Check the lateral stability of the structure. | within 6 weeks |
| 17. | | Carry out the suggested remedial work (if any). | within 6 months |

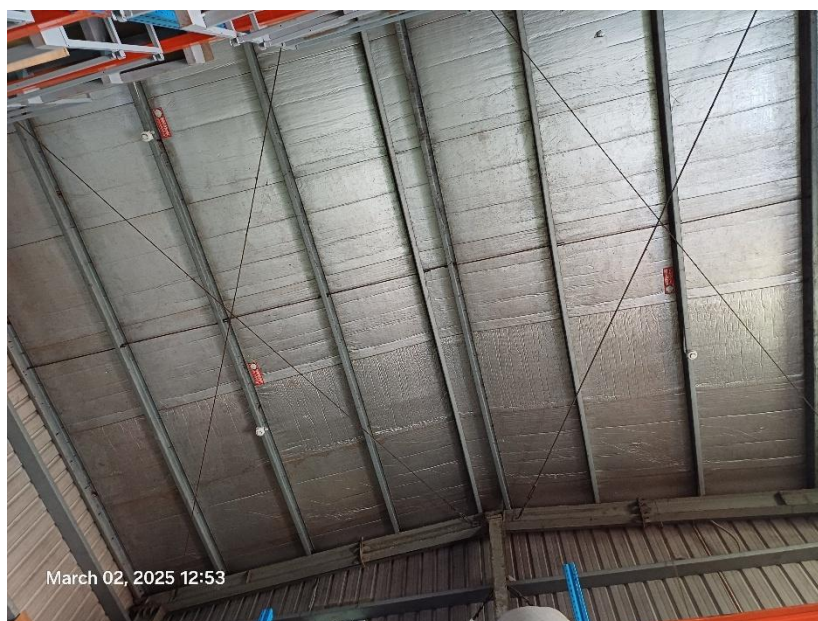
**Observation-13:** Loose cable bracings on wall and roof. (Washing Store Shed)

**Description:** During the inspection, the bracings were found loose. Building engineer is required to tighten all the loose bracings.

| 18. | Loose cable bracings on wall and roof. (Washing Store Shed) | Building engineer is required to tighten all the loose bracings. | within 6 weeks |

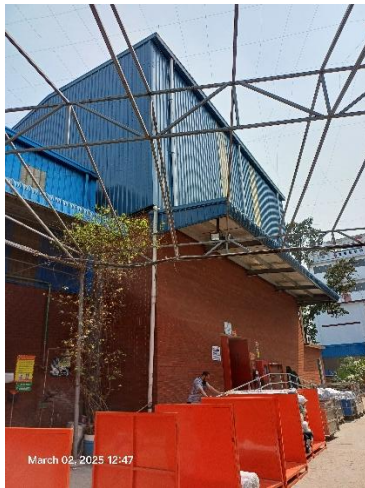
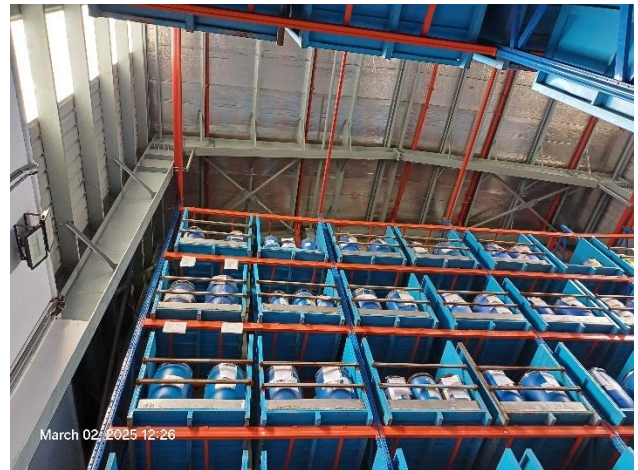
**Observation-14:** Lack of design documents. (Chemical Store Shed)

**Description:** As per BNBC, every building or structure designed shall have its design documents prepared following the provision of Section 1.9.1. The design document shall include a design report and a set of structural drawings, which shall be prepared in compliance with sections 1.9.1.1 and 1.9.1.2 as per BNBC.

At the time of inspection, design documents (design report, and adequate material test reports) were not available, which are required to be prepared in compliance with section 1.9.1 (part-6, BNBC).

| 19. | Lack of design documents. (Chemical Store Shed) | The building engineer is required to prepare design documents (including design reports, material test reports) in compliance with section 1.9.1 (part 6, BNBC). | within 6 weeks |
| 20. | | Carry out the suggested remedial work (if any). | within 6 months |
