# Dekko Washing Ltd.

Narashinghopur, Zirabo, Ashulia, Savar, Dhaka-1341, Bangladesh.

10 March 2025

## 2. Observations

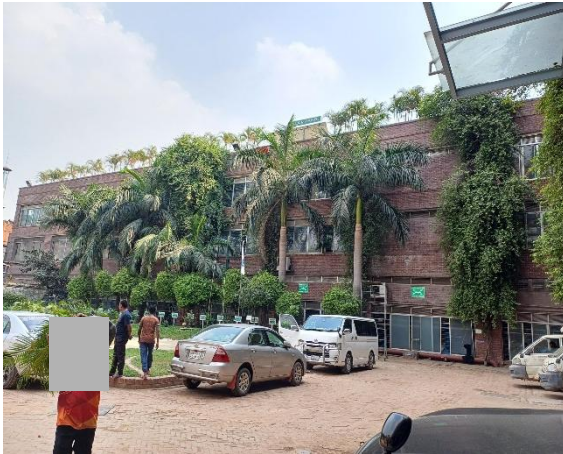
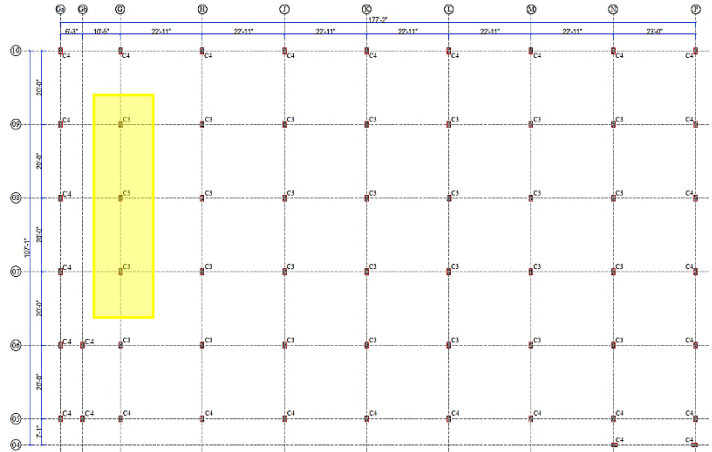
### Observation 1: Stress in the column exceeds the normal design limit. [Washing Building]

**Description:** The cursory calculation indicates that columns are stressed above the normal design limit at the marked locations considering the prepared load plan, equivalent concrete core strength, and 415 MPa re-bar strength. The building engineer is required to review design and column stresses based on in-situ concrete strength at the marked location. Produce and actively manage load management plans.

| Item No | Observation | Action Plan | Timeline |
|---|---|---|---|
| 1. | Stress in the column exceeds the normal design limit.<br>[Washing Building] | The building engineer is required to review design and column stresses based on in-situ concrete strength at the marked location. | within 6 weeks |
| 2. | | Produce and actively manage load management plans. | within 6 weeks |
| 3. | | Implement remediation work if required. | within 6 months |
| 4. | | Implement a load management plan. | within 6 months |

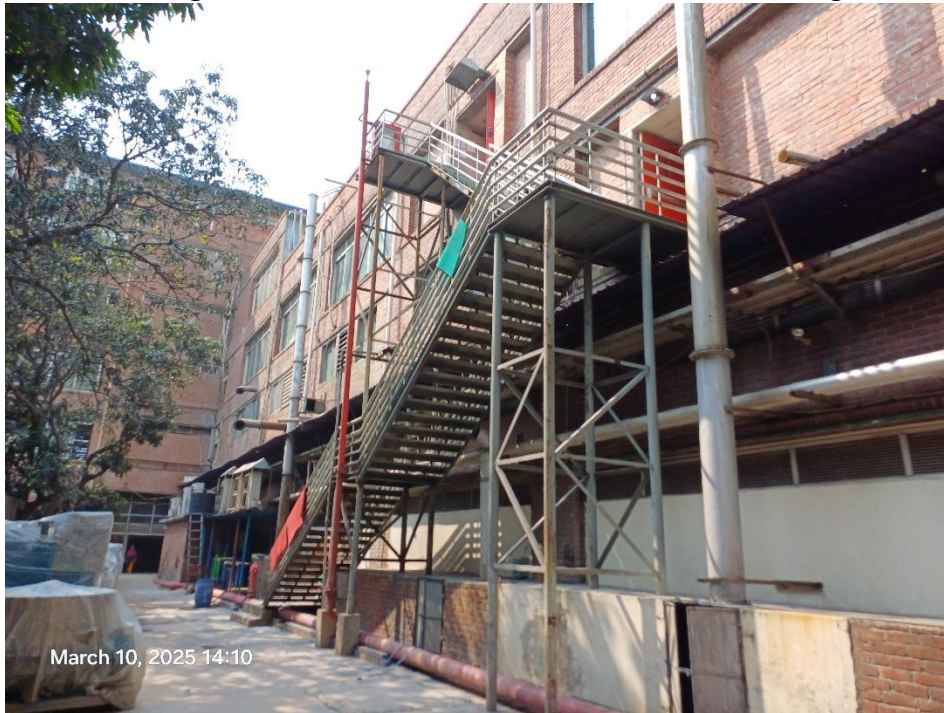
**Observation 3:** Lack of design documents of the external steel stair. [Washing Building]

**Description:** As per BNBC, every building or structure designed shall have its design documents prepared following the provision of Section 1.9.1. The design document shall include a design report and a set of structural drawings, which shall be prepared in compliance with sections 1.9.1.1 and 1.9.1.2 as per BNBC.

At the time of inspection, design documents (design report, as-built drawing, load plan, and adequate material test reports) were not available, which are required to be prepared in compliance with section 1.9.1 (part-6, BNBC).

| Item No | Observation | Action Plan | Timeline |
|---|---|---|---|
| 6. | Lack of design documents of the external steel stair.<br>[Washing Building] | The building engineer is required to prepare design documents (including design reports, material test reports, live load plan and as-built drawings) in compliance with section 1.9.1 (part 6, BNBC). | within 6 weeks |
| 7. | | Produce accurate as-built drawings. | within 6 weeks |
| 8. | | Carry out the suggested remedial work (if any). | within 6 months |

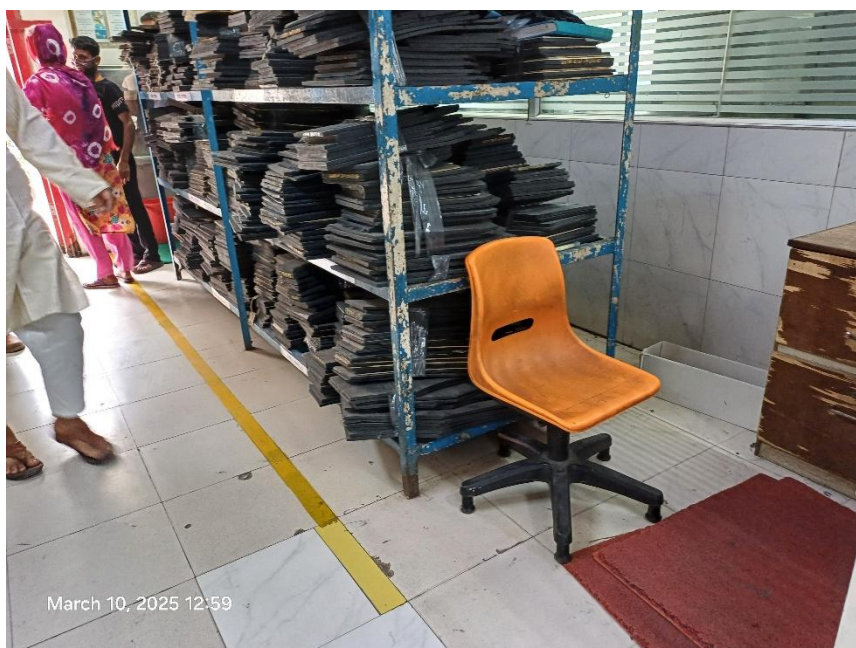
**Observation 4:** Non-structural elements not anchored or braced. [Washing Building]

**Description:** Some racks on floors are not anchored or braced to resist lateral (earthquake) forces. The factory is required to anchor/brace all non-structural elements adequately to resist earthquake forces.

| Item No | Observation | Action Plan | Timeline |
|---|---|---|---|
| 9. | Non-structural elements not anchored or braced.<br>[Washing Building] | The factory is required to anchor/brace all non-structural elements adequately to resist earthquake forces. | within 6 months |

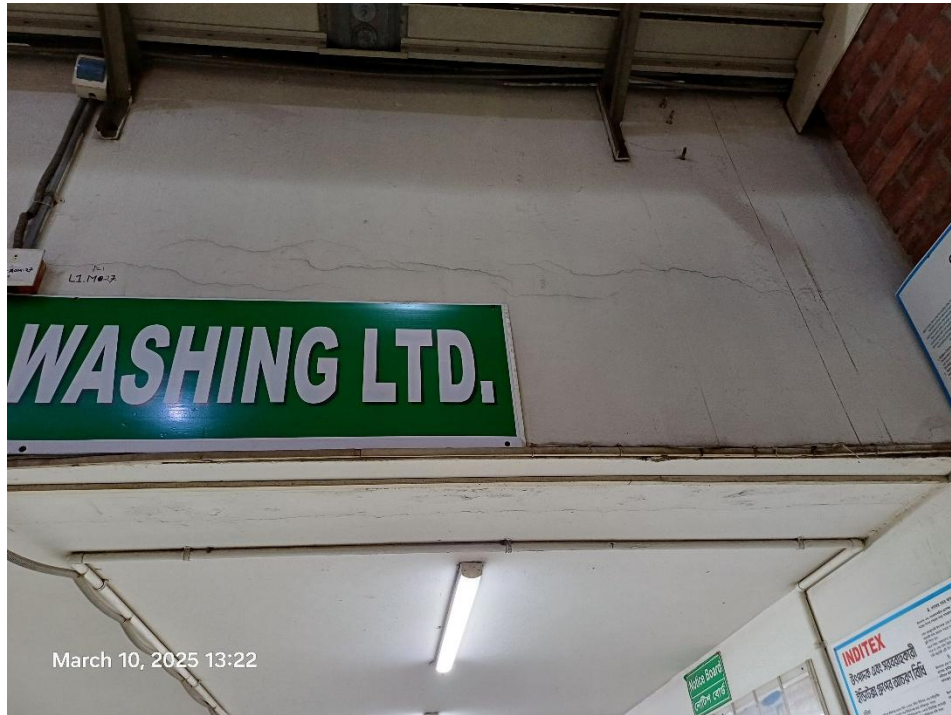
**Observation 5:** Hairline crack on masonry wall. [Washing Building]

**Description:** During the inspection, hairline cracks were observed on the brick wall. The factory is required to repair the masonry wall cracks as per the recommendation of the building engineer.

| Item No | Observation | Action Plan | Timeline |
|---|---|---|---|
| 10. | Hairline crack on masonry wall.<br>[Washing Building] | The factory is required to repair the masonry wall cracks as per the recommendation of the building engineer. | within 6 weeks |

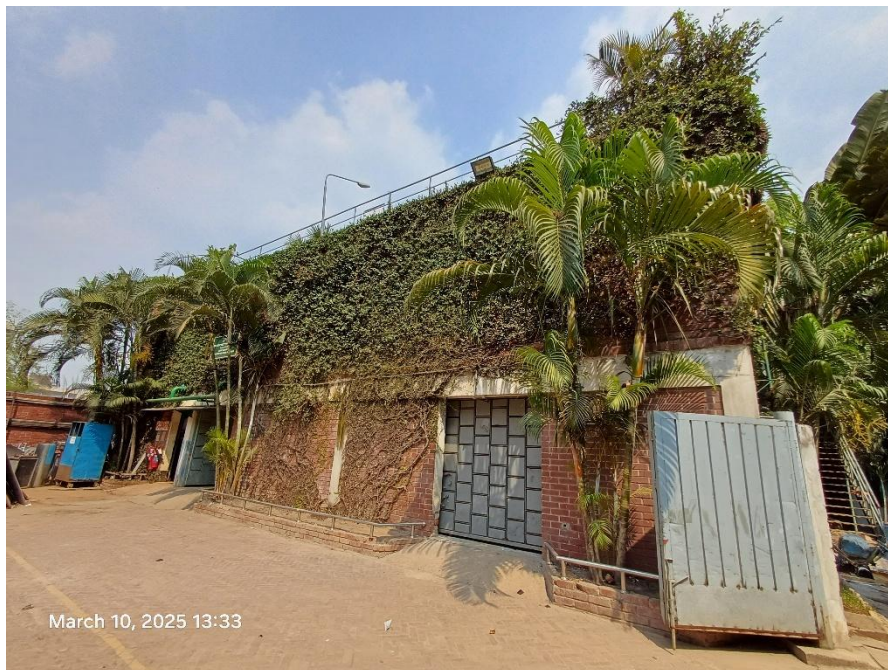
**Observation 6:** Lack of design documents. [ETP Plant]

**Description:** The design report and as built drawings were not prepared for ETP Plant. The building engineer is required to prepare as-built drawings and design report following BNBC (part-6, section 1.9.1).

| Item No | Observation | Action Plan | Timeline |
|---|---|---|---|
| 11. | Lack of design documents.<br>[ETP Plant] | The building engineer is required to survey structures and prepare a full set of as-built drawings. | within 6 weeks |
| 12. | | The building engineer is required to prepare design report following BNBC (part-6, section 1.9.1). | within 6 weeks |
| 13. | | Carry out remedial work if required. | within 6 months |

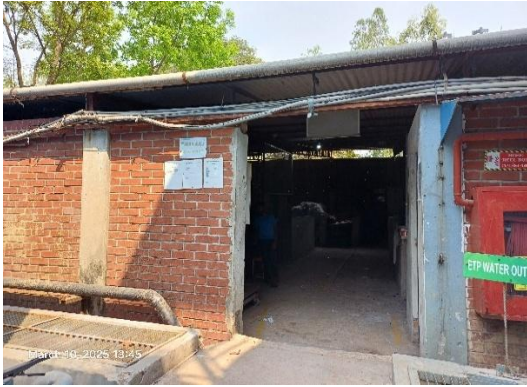
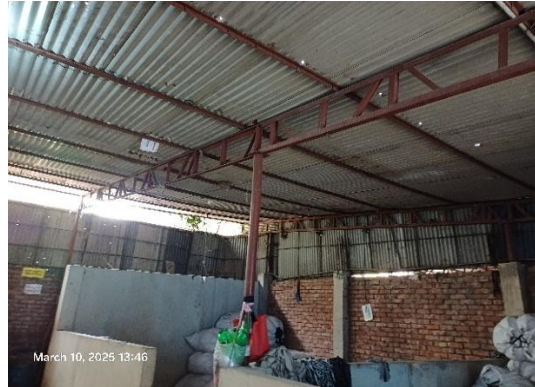
**Observation 7: Lack of lateral stability system. [Wastage Shed]**

**Description:** Absence of bracing system, inadequate members and non-engineered connection were observed. The building engineer is required to check the member, connection & stability system of the structure and suggest proper remediation accordingly as part of safety check report.

| Item No | Observation | Action Plan | Timeline |
|---|---|---|---|
| 14. | Lack of lateral stability system.<br>[Wastage Shed] | The building engineer is required to check the member, connection & stability system of the structure as part of safety check and suggest proper remediation accordingly. | within 6 weeks |
| 15. | | Carry out remedial work if required. | within 6 months |

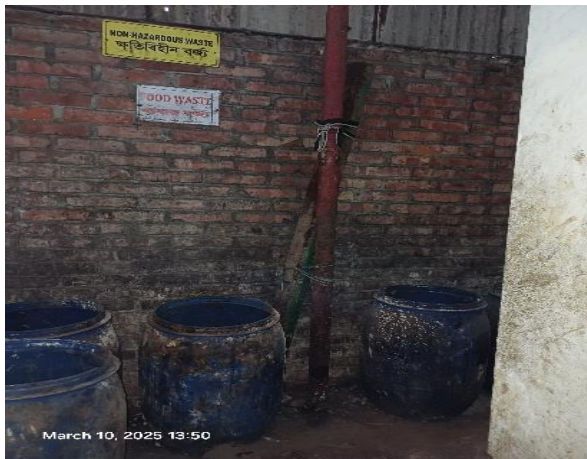
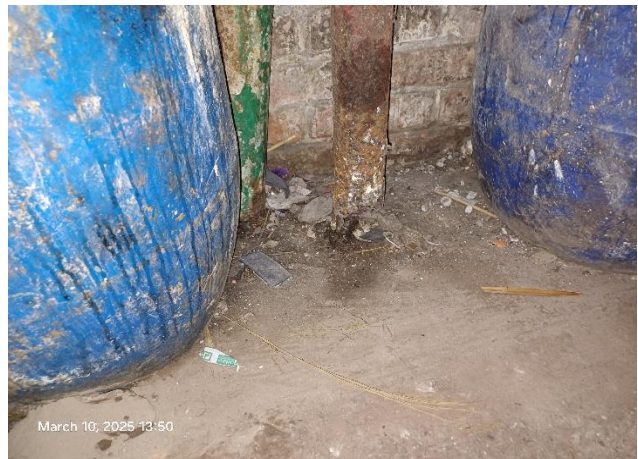
**Observation 8: Damaged structural elements. [Wastage Shed]**

**Description:** Damage was observed on the pipe column of the wastage shed. The building engineer is required to check the design of the column and repair the elements with a suitable method.

| 16. | Damaged structural elements.<br>[Wastage Shed] | The building engineer is required to check the design of the column and repair the elements with a suitable method. | within 6 weeks |

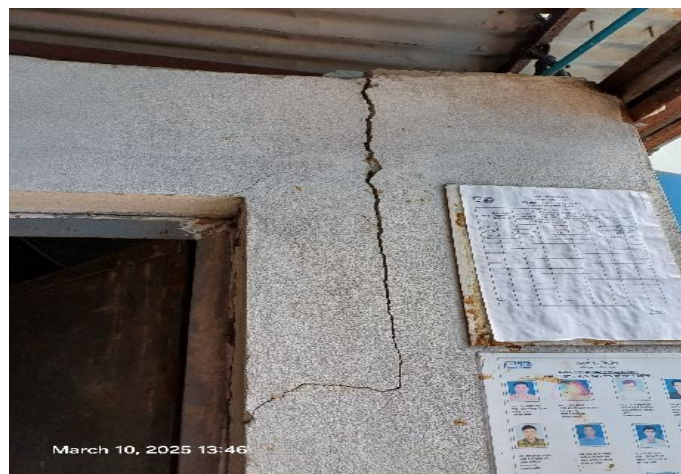
**Observation 9: Hairline crack on masonry wall. [Wastage Shed]**

**Description:** During the inspection, hairline cracks were observed on the brick wall. The factory is required to repair the masonry wall cracks as per the recommendation of the building engineer.

| 17. | Hairline crack on masonry wall.<br>[Wastage Shed] | The factory is required to repair the masonry wall cracks as per the recommendation of the building engineer. | within 6 weeks |

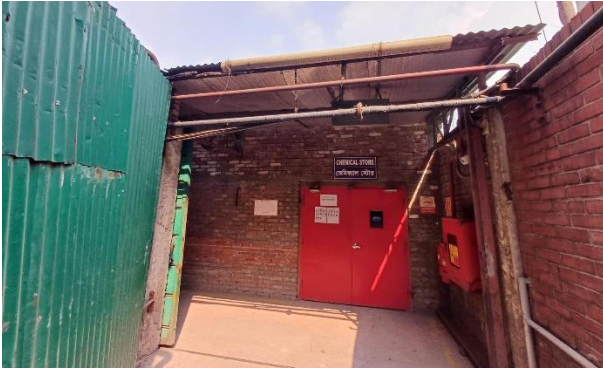
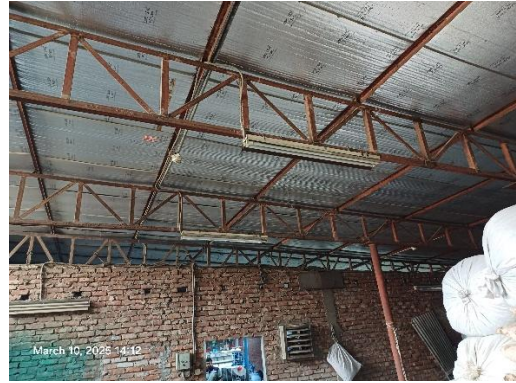
**Observation 10: Lack of lateral stability system. [Store Shed]**

**Description:** The absence of a bracing system, apparent inadequate members, and non-engineered connection were observed. The building engineer is required to check the lateral stability with connection adequacy and prepare a design report as per 1.9.1 BNBC. Prepare a remediation plan.

| 18. | Lack of lateral stability system.<br>[Store Shed] | The building engineer is required to check the lateral stability with connection adequacy and prepare a design report as per 1.9.1 BNBC. Prepare a remediation plan. | within 6 weeks |
| 19. | | Carry out remedial work if required. | within 6 months |

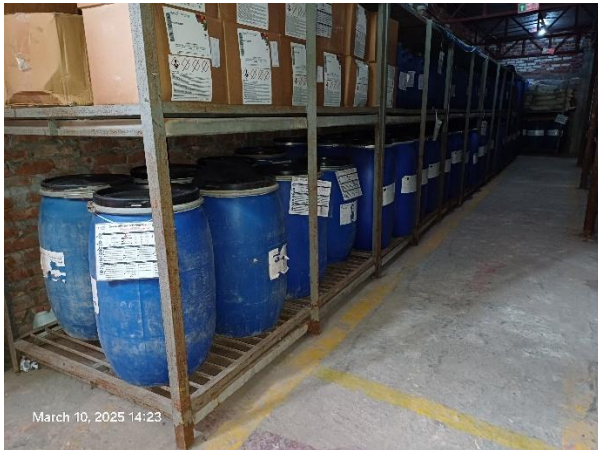
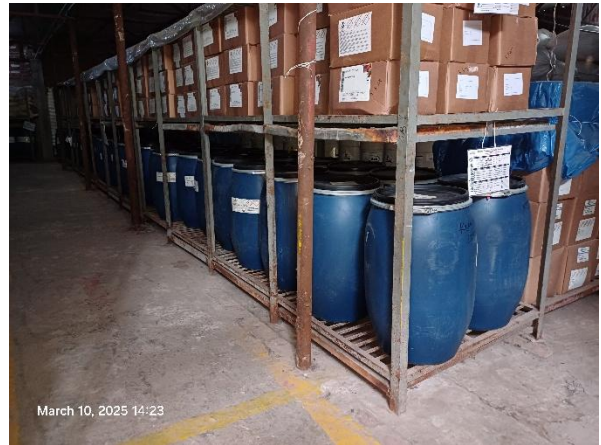
**Observation 11: Non-structural elements not anchored or braced. [Store Shed]**

**Description:** Some racks on floors are not anchored or braced to resist lateral (earthquake) forces. The factory is required to anchor/brace all non-structural elements adequately to resist earthquake forces.

| 20. | Non-structural elements are not anchored or braced.<br>[Store Shed] | The factory is required to anchor/brace all non-structural elements adequately to resist earthquake forces. | within 6 months |

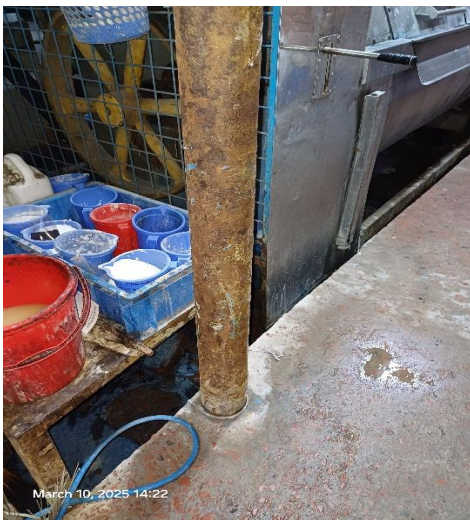
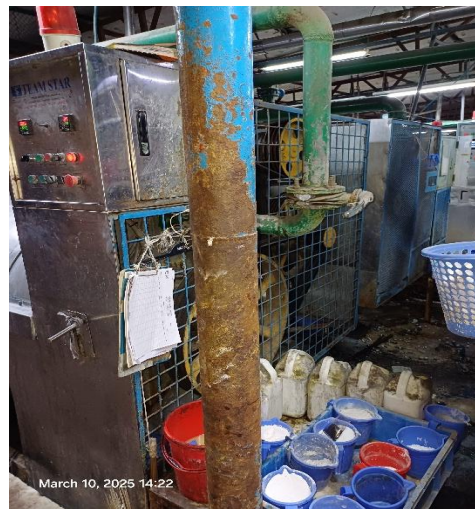
**Observation 12: Corrosion on steel members. [Store Shed]**

**Description:** Corrosion was observed on the steel members of the Store Shed. The building engineer is required to remove the corrosion with a suitable method and provide anti-corrosive coating.

| 21. | Corrosion on steel members.<br>[Store Shed] | The building engineer is required to remove the corrosion using a suitable method and provide an anti-corrosive coating. | within 6 weeks |

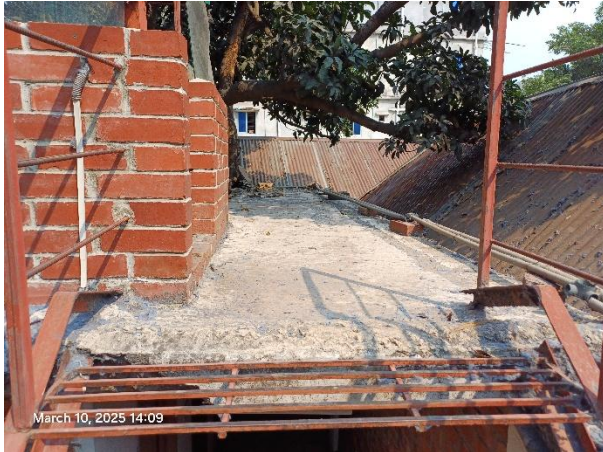
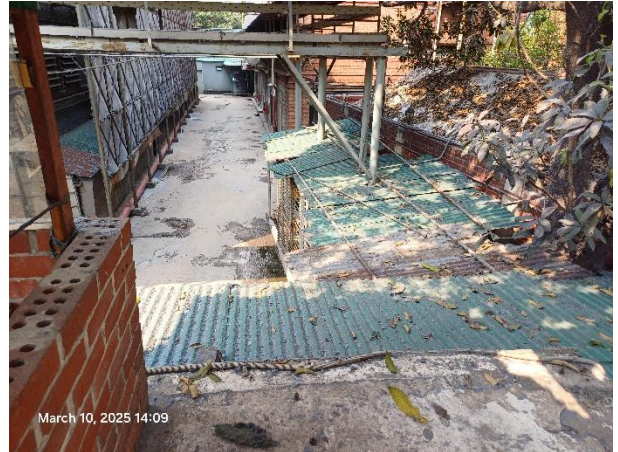
**Observation 13: Falling Hazard. [Male toilet block]**

**Description:** Railing/parapet was not provided on the roof, which may cause a falling hazard. The factory is required to provide railing/barriers to avoid possible falling hazards.

| 22. | Falling Hazard.<br>[Male toilet block] | The factory is required to provide railing/barriers to avoid possible falling hazards. | within 6 weeks |

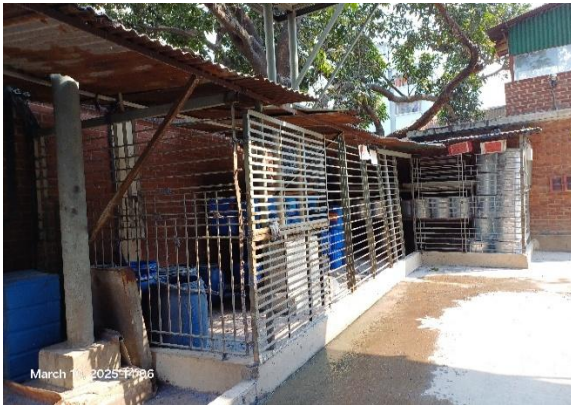
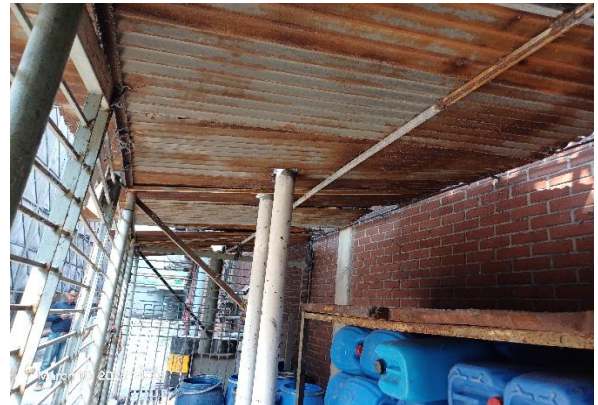
**Observation 14: Lack of lateral stability system. [Empty drum shed]**

**Description:** Absence of bracing system, inadequate members and non-engineered connection were observed. The building engineer is required to check the member, connection & stability system of the structure and suggest proper remediation accordingly as part of safety check report.

| 23. | Lack of lateral stability system.<br>[Empty drum shed] | The building engineer is required to check the member, connection & stability system of the structure as part of safety check and suggest proper remediation accordingly. | within 6 weeks |
| 24. | | Carry out remedial work if required. | within 6 months |

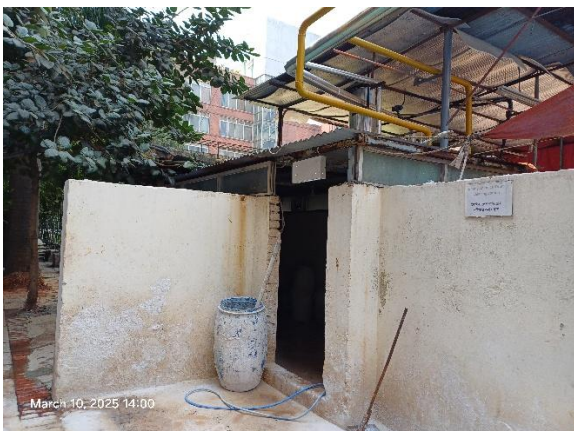
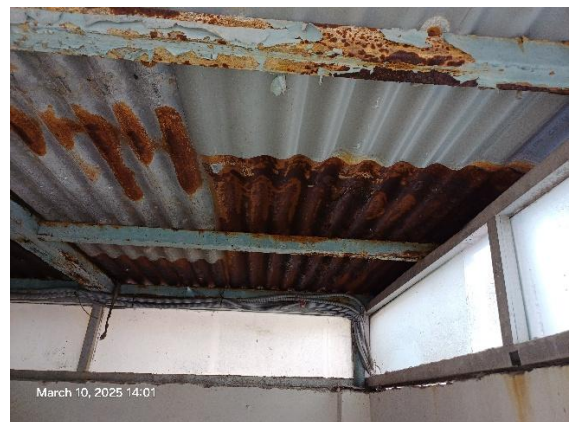
**Observation 15: Lack of lateral stability system. [Bleach Mixing Shed]**

**Description:** The bracing system is absent for Bleach Mixing Shed. Also, connections are not proper, and the steel members are corroded. The building engineer is required to provide a stability system, repair the connections and apply anti-corrosive coating on steel members.

| 25. | Lack of lateral stability system.<br>[Bleach Mixing Shed] | The building engineer is required to check the member, connection & stability system of the structure as part of safety check and suggest proper remediation accordingly. | within 6 weeks |
| 26. | | Carry out remedial work if required. | within 6 months |

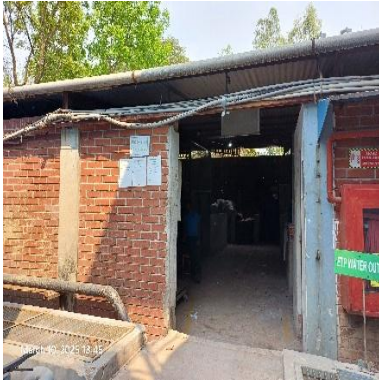
**Wastage Shed**

**Description:** As-built drawings were not found for the ancillary structures (Wastage Shed, Store Shed, CNG plant shed, Male toilet block, Empty drum shed, Bleach mixing shed). The building engineer is required to survey structures and prepare a full set of as-built drawings.

| 27. | Lack of as-built drawings.<br>[All ancillary structures] | The building engineer is required to survey structures and prepare a full set of as-built drawings. | within 6 weeks |
